**J. ARONSTEIN**  
**CONSULTING ENGINEER**

**HAZARDOUS FPE CIRCUIT BREAKERS**  
**AND PANELS**

*Information for Homeowners, Inspectors, and Electricians*  
*(Updated November 10, 2017)*

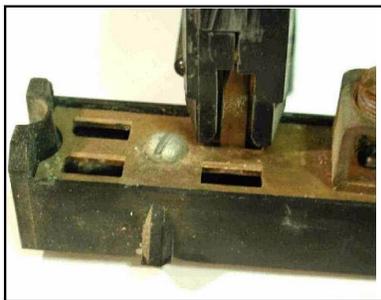
**A. Copper buss bar with punched openings.**

Even if it were possible to replace all of the suspect FPE Stab-Lok<sup>®</sup> breakers with a more trustworthy type, that would not correct hazardous internal failure modes intrinsic to many of the FPE panels. Nine FPE Stab-Lok<sup>®</sup> panels in the present study had some damage due to overheating at busbar contacts and connections. The overheating ranged from mild to severe in these failing panels.

The "panel" is the unit within the enclosure, on which the breakers are mounted. The main electrical service feeders (electrically live, from the meter) are connected at the panel, and the panel has an internal conductor system that distributes the power to the individual circuit breakers. The internal conductor system consists essentially of "busbars" (thick metal bars) that have sockets incorporated or attached, into which to which the breakers' "stab" contacts are inserted. There are several different busbar and Stab-Lok<sup>®</sup> constructions used in FPE panels, three of which are shown in Figure 2.

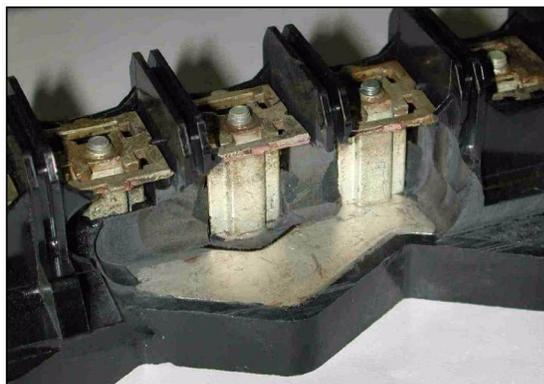
**A. Cutaway - Bussbar, Post, and Stab Socket Plate.**

A more serious failure of this type has been documented.<sup>1</sup> In that instance, the failure had been severe enough to ignite a smoldering fire on the plastic insulating material. The fundamental weakness in this design is the use of a single, relatively flimsy 8-32 screw to hold a structure together that can feed up to four half-width breakers with a total "ampacity" (rated circuit capacity) up to about 160 Amps. Figure 4 shows how the stab socket plate and post are attached to the bussbar.

**FIGURE 4 - CONDUCTING PATH FROM BUSSBAR TO STAB SOCKET**

Various material combinations were utilized by FPE in these assemblies. Some bussbars are copper, others are aluminum. Some posts are copper, others are aluminum. The worst case (most likely to fail) is where both the bussbar and the post are made of aluminum, and the best case (least likely to fail) is where both are made of copper. Inspectors (or homeowners, or electricians) have no way of knowing which materials are utilized in any particular FPE panel with this type of construction.

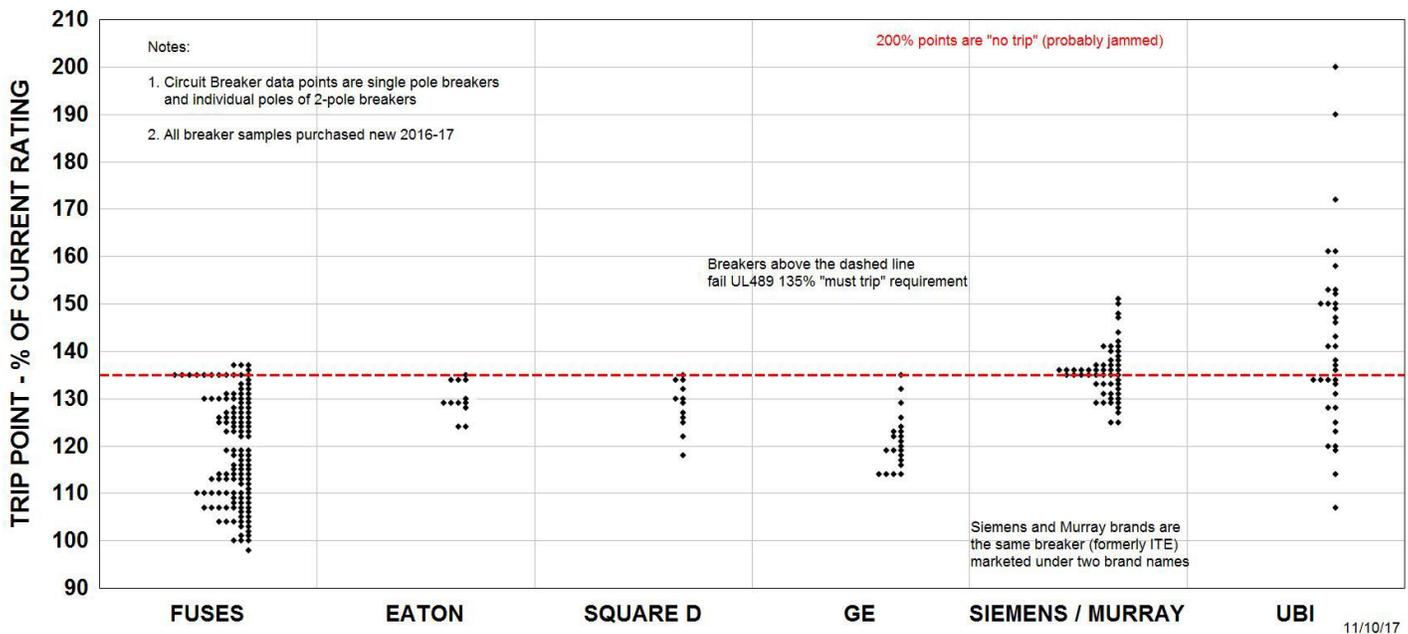
**FIGURE 11 - TEST RESULTS: FUSES AND NEW CIRCUIT BREAKERS**

If it is necessary to increase the amperage capacity of the service, then a new enclosure and panel inside it must be installed. Eaton, Square D, and General Electric circuit breakers have performed well in tests of new breakers and breakers from homes. Recent test results for Siemens and Murray breakers, and their predecessor ITE show a high failure rate for the 135% trip requirement, and these brands are not recommended. Test results on several brands of circuit breakers, purchased new in 2016 and 2017, are shown in Figure 11.

There are two options for replacement of the FPE Stab-Lok® panel. If it is not required to increase the service to higher amperage capacity, Eaton makes replacement panel inserts that install in the existing FPE enclosure.
