## **J. ARONSTEIN**

## **HAZARDOUS FPE CIRCUIT BREAKERS AND PANELS**

*(Updated as of May 25, 2007)*

*Information for Inspectors and Homeowners*

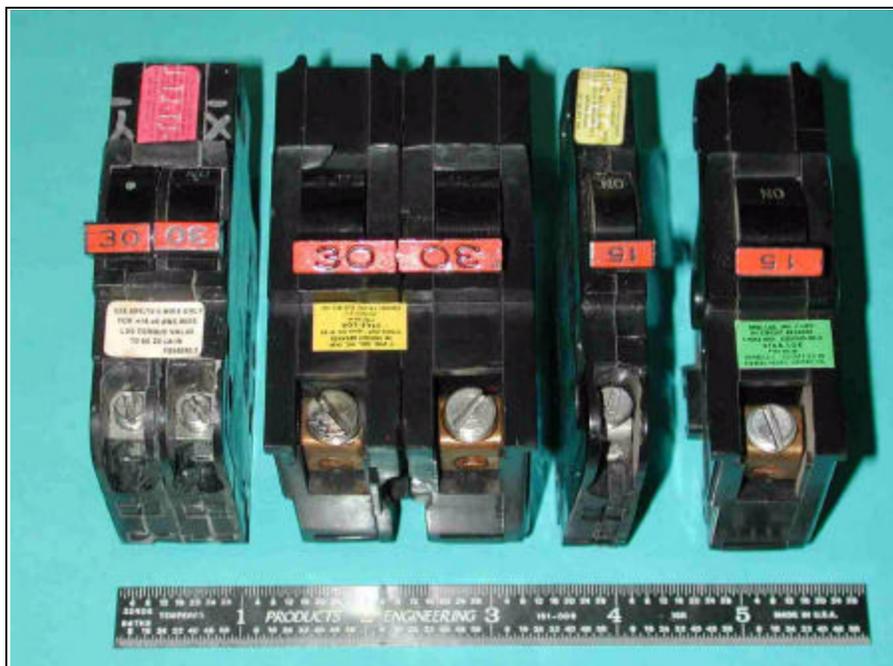
**FIGURE 1 - REPRESENTATIVE SAMPLES OF HALF- AND FULL-WIDTH FPE STAB-LOK® CIRCUIT BREAKERS** (left to right: 1/2-width double pole, full-width double pole, 1/2-width single-pole, full width single-pole)  
*Note that the color and style of the handle varied over the years.*
