J. ARONSTEIN
CONSULTING ENGINEER
BME, MSME, Ph.D., N.Y.S. P.E. LIC. NO. 39860
909 LONDONDERRY CT., SCHENECTADY, NY 12309
(845) 462-6452 AronsteinJ@verizon.net

HAZARDOUS FPE CIRCUIT BREAKERS AND PANELS

(Updated March 29, 2024)

Information for Homeowners, Inspectors, and Electricians

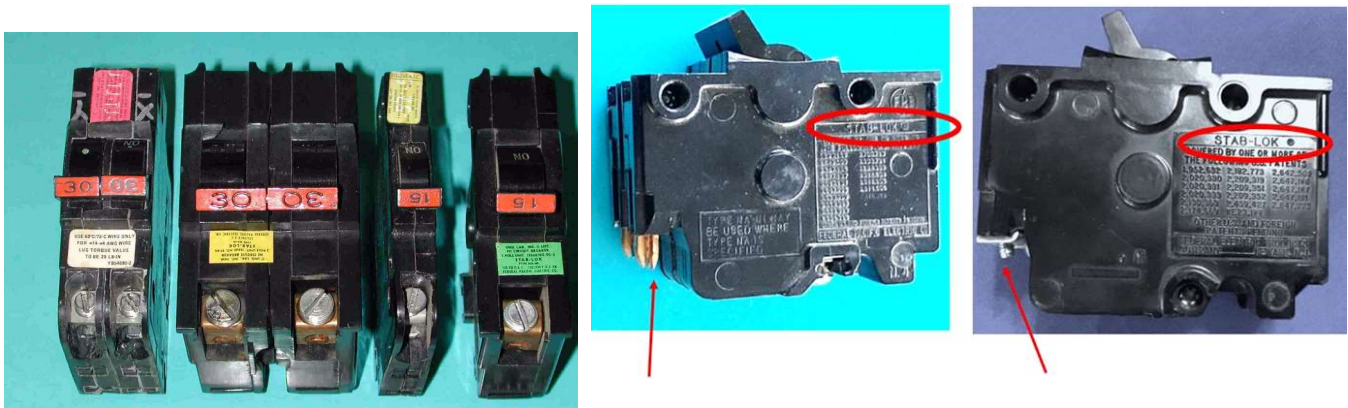
Types NA & NC plug in.

Type NB is "bolted" in.

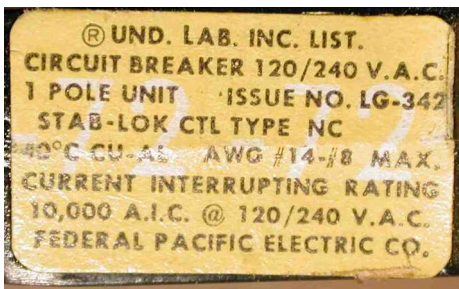
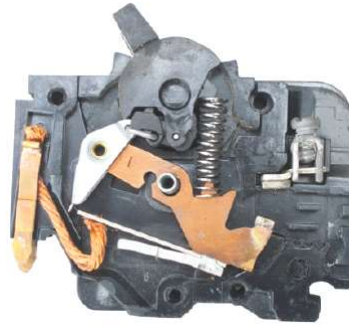
FIGURE 2 - PROCEDURAL PROTECTION vs CIRCUIT PROTECTION

***THE LABEL** and listing provide procedural protection for sellers, installers, and inspectors.*

***THE BREAKER'S** actual performance, - not the label - determines whether it provides proper electrical fire protection for a home.*

Electrical safety for the occupants of a building hinges on the actual performance of the breakers. The labels on the breakers provide no protection in the event of an electrical malfunction. FPE's testing and labeling fraud left building owners and occupants with an increased risk of fire and injury. The defective FPE Stab-Lok® breakers do not meet the functional requirements of the NEC or any other electrical safety code.

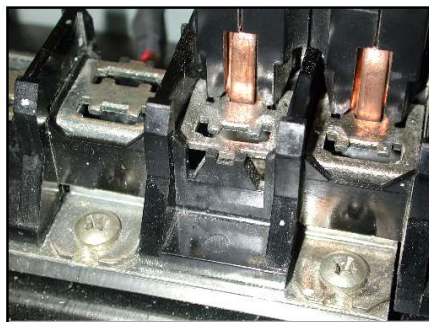
Even if it were possible to replace all of the suspect FPE Stab-Lok[®] breakers with a more trustworthy type, that would not correct hazardous internal failure modes intrinsic to many of the FPE panels. Nine FPE Stab-Lok[®] panels in the present study had some damage due to overheating at busbar contacts and connections. The overheating ranged from mild to severe in these failing panels.

The "panel" is the unit within the enclosure, on which the breakers are mounted. The main electrical service feeders (electrically live, from the meter) are connected at the panel, and the panel has an internal conductor system that distributes the power to the individual circuit breakers. The internal conductor system consists essentially of "bussbars" (thick metal bars) that have sockets incorporated or attached, into which the breakers' "stab" contacts are inserted. There are several different bussbar and Stab-Lok[®] constructions used in FPE panels, three of which are shown in Figure 5.

A. Copper buss bar with punched openings.

B. "Z" clip, clamped to bussbar with 10-32 screw.
