RESEARCH PAPER RP1046

TEST OF FLOOR COVERINGS FOR POST-OFFICE WORKROOMS

By Warren E. Emley and Carl E. Hofer

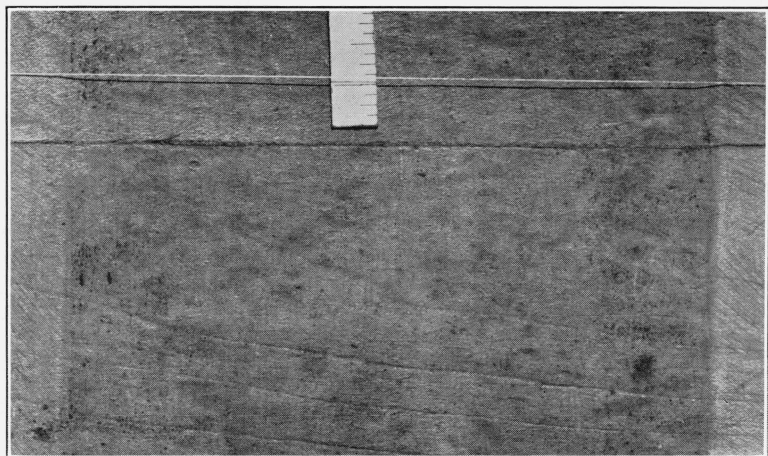
FIGURE 14.—*Maple plain strips $\frac{3}{32}$ inch thick, set on sleepers.*
Finished with one coat sealer, two undercoats, one finish coat.

The photographs show that the end grain (nos. 9 and 10) and the quartersawed grain (no. 11) wore appreciably under this test. Of the maple floors, there is little choice between the edge grain (no. 12) and the flat grain (no. 13); both stood up very well. Of the three methods of finishing examined, the four-coat job (no. 14) is better than the two-coat job (no. 15), and both are better than the linseed-oil finish. The differences, however, are in the appearance and the ability to keep the floor clean; there is not much difference in the wear.

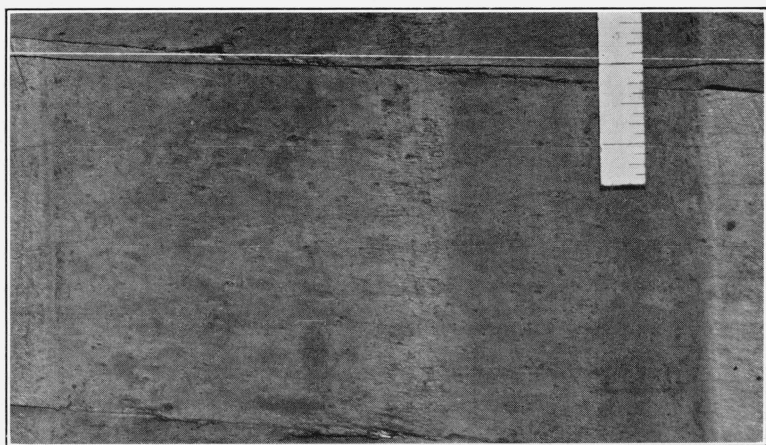
FIGURE 15.—*Maple plain strips $\frac{3}{32}$ inch thick, set on sleepers.*
Finished with one coat sealer and one finish coat.

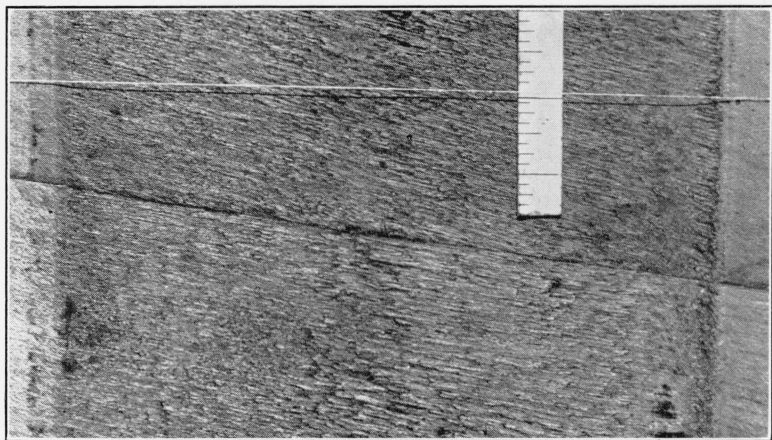
FIGURE 16.—*Maple plain strips $\frac{33}{32}$ inch thick, set on sleepers.*
Finished with two coats linseed oil and turpentine.
