# SP-291—10

## WHEN BAD THINGS HAPPEN TO GOOD [BUILDINGS]

### Dylan Freytag, Keith Kesner, Randall W. Poston, and Kenneth Bondy

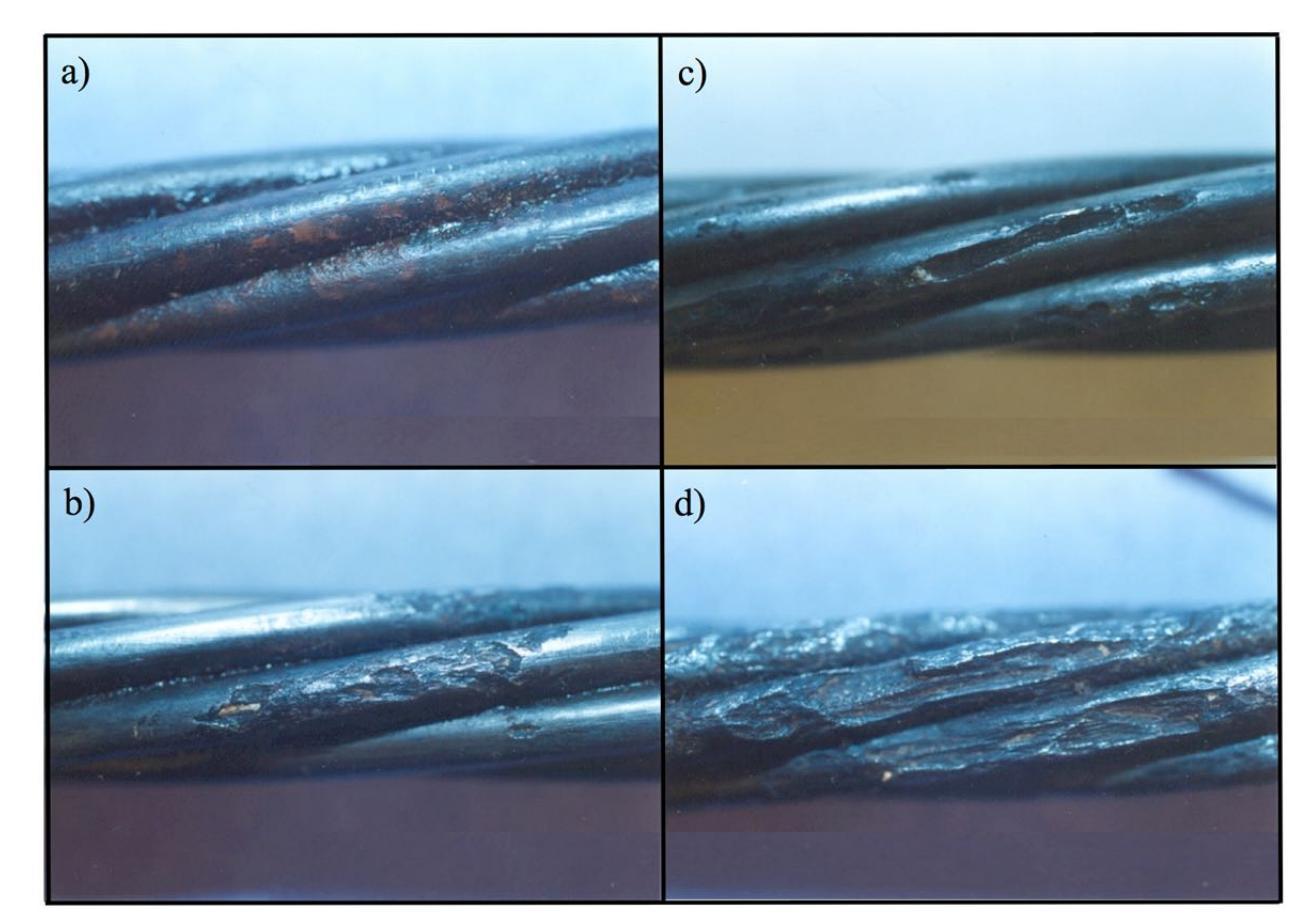
The severity of pits that can form and the approximate strength loss associated with each is summarized in Figure 2. As can be seen, even though pits develop on the surface of the prestressing strand of an unbonded tendon, there is residual strength as measured by mechanical tension testing of the strand. Even in the most severe case (deepest pits, Figure 2d), the residual strength can be as high as 75 percent of the guaranteed ultimate tensile strength (GUTS).
