Unpredictable Nature and Cause of Cracks at Gypsum Panel Ceiling Joints Perpendicular to Framing

By Frank Woeste and Joe Loferski

This is a revised version of an article first published in the May 2012 issue of *The Construction Specifier, www.constructionspecifier.com*.

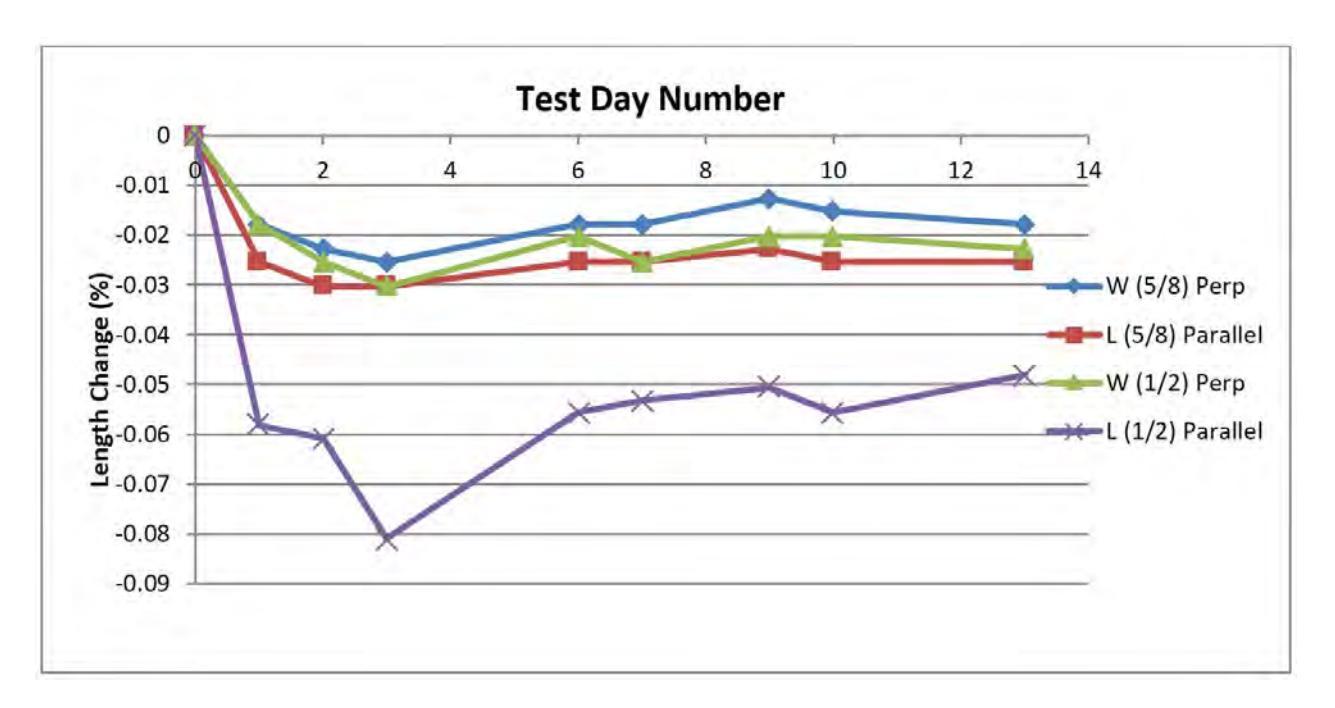
Figure 3. The "W" specimens were used to measure shrinkage in the panel width dimension and the "L" specimens were used to measure shrinkage in the panel length dimension. The specimens were conditioned at 75°F and 80% RH, and then placed into a chamber set to maintain 75°F and 27.5% RH.

We were surprised by the results, because the panels did not reflect the typical behavior of paper discussed earlier. The pilot study results were indeed instructive in that substantial bi-directional behavior was observed for the 1/2-inch specimen and the fact that the *stabilized length* of the L(1/2) specimen at 13 days when reaching an equilibrium condition at 75°F and 27.5%RH was substantially more than the length at 3 days.

concerned about in-service cracking potential, we suggest that the drywall manufacturers consider a "dimensional stability rating system" whereby different products would be tested and rated based on an average and maximum (spike type) shrinkage rate for both directions, W and L.
