Christchurch CBD: Lessons Learnt and Strategies for Foundation Remediation – 22 February 2011 Christchurch, New Zealand, Earthquake

K.M. Murahidy & A.F. Sleight

Tonkin & Taylor Ltd, Christchurch, New Zealand

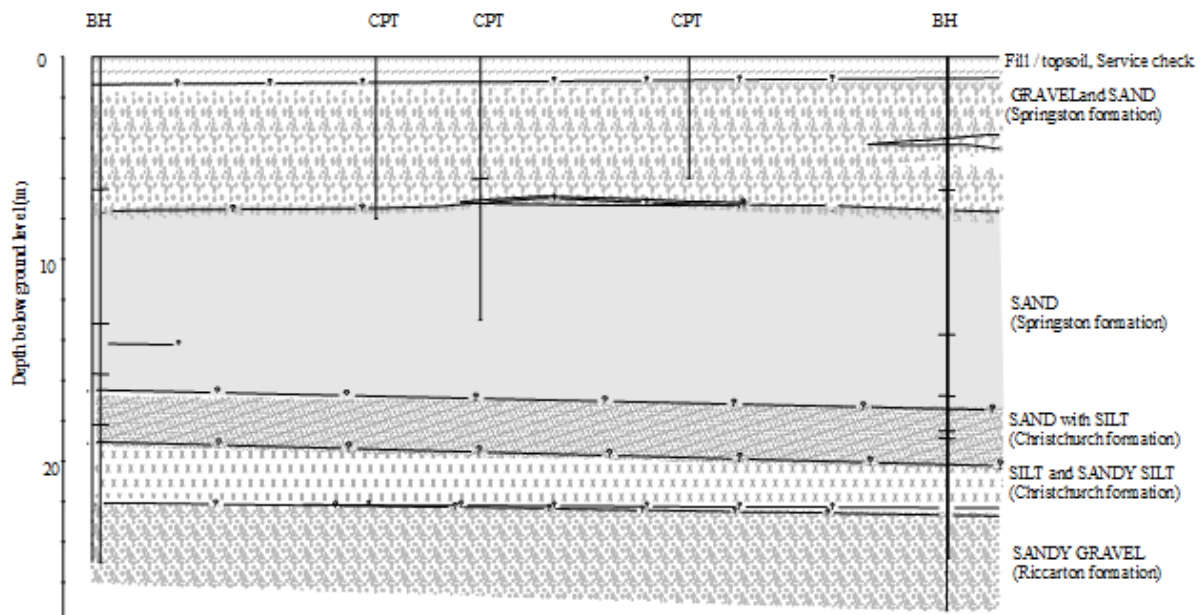
Figure 4.1 Generalised cross section

At the location of Buildings 1 and 2, the generalised subsurface profile comprises interbedded gravel with sand or sandy gravel with sand lenses to a depth of approximately 6 to 8 metres. These materials are underlain by interbedded alluvial silts, sands and gravels (Yaldhurst Member of the Springston Formation) to a depth of approximately 16 metres. Marine silty sands and sands of the Christchurch Formation underlie these materials to a depth of between approximately 19 and 20 metres below existing ground level. The SPT blow counts from the investigations indicate this material is generally medium dense to very dense.

Underlying the Christchurch Formation sands is a layer of silt/sandy silt, followed by dense sandy gravels of the Riccarton Formation at a depth of approximately 22 to 24 metres below existing ground level. This generalised stratigraphy is shown in Figure 4.1.
