U. S. FOREST SERVICE RESEARCH PAPER • FPL 18 • DECEMBER 1964

## *STRESSED SKIN PANEL PERFORMANCE*

*AFTER  
TWENTY-FIVE  
YEARS  
OF  
SERVICE*

By OTTO C. HEYER, Engineer, and R. F. BLOMQUIST<sup>1</sup>, Chemist

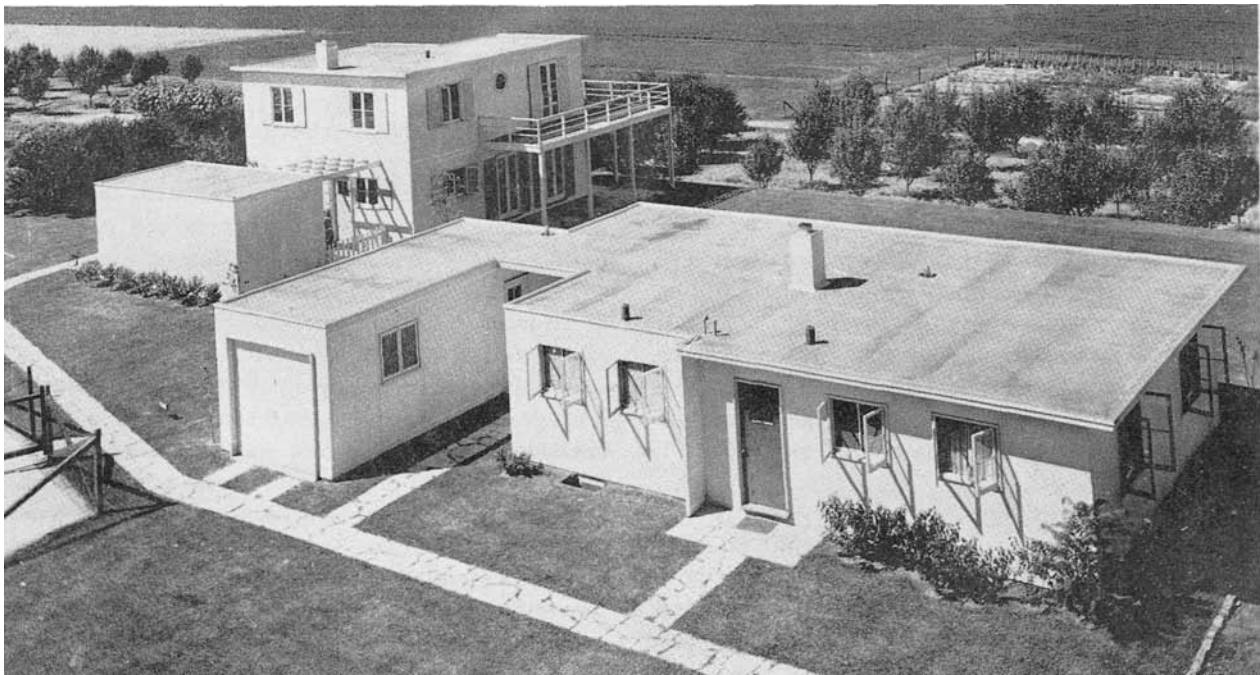
M 34209 F

Figure 2.--Prefabricated houses developed by the U.S. Forest Products Laboratory in 1937. Panels were removed from the one-story house (foreground) for evaluation purposes.

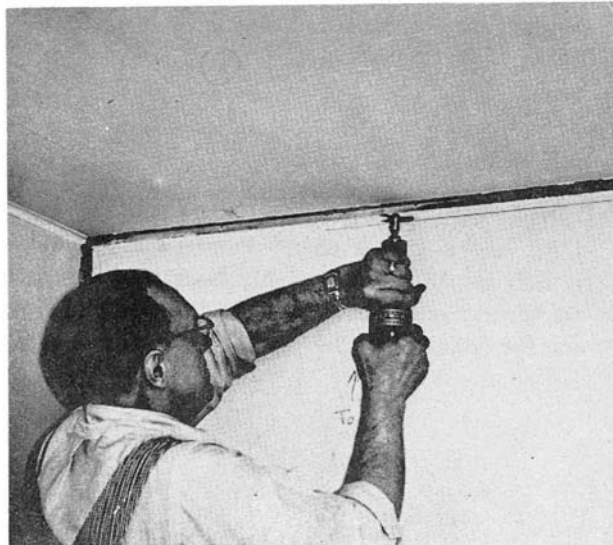
M 125 905

Figure 5.--Cutting edges of inside panel surface for removal from the wall.

To remove these panels, all the mechanical fastenings were first removed from the edges of the interior and exterior faces of the panel. A saw kerf was made around the interior face of the panel 1-1/4 inches from the edge of the plywood (fig. 5). After removing the 1-1/4-inch strip from the sides, top, and bottom of the panel, the panel was then removed from the wall.
