THE LAND TITLE BUILDING Philadelphia, Pennsylvania

PRESERVATION Tech Notes

MASONRY NUMBER 2

Stabilization and Repair of a Historic Terra Cotta Cornice

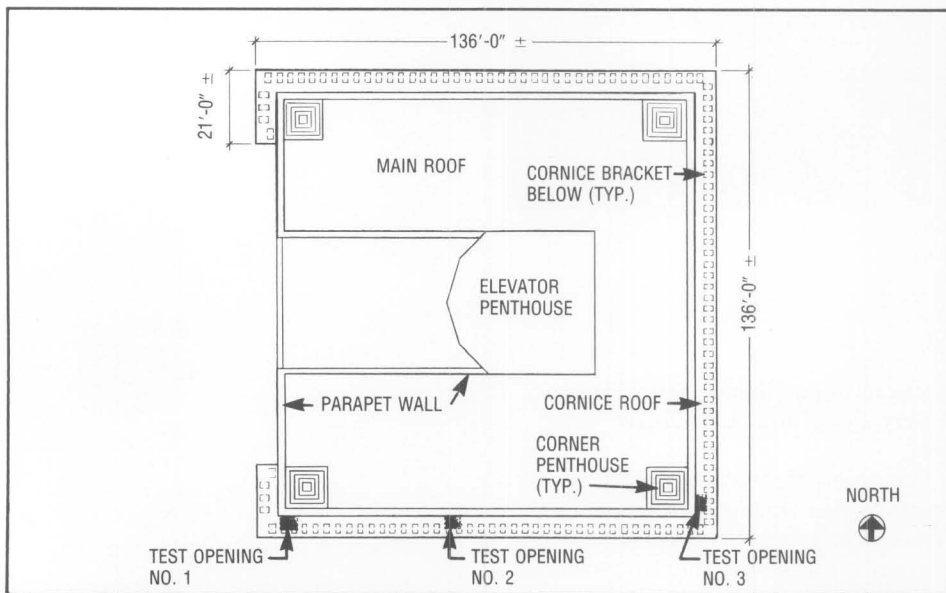
Figure 2. Roof plan of the 1902 tower showing the location of test openings in the cornice roof. Each bracket was later numbered consecutively so that easy reference could be made to a particular area of the cornice. Drawing by Jeffrey S. Levine.

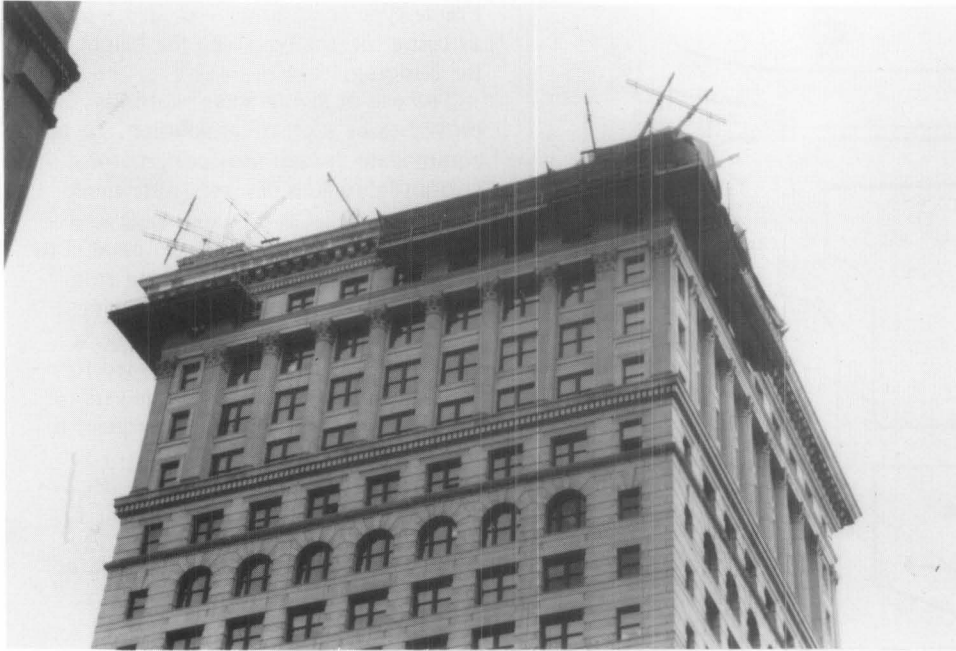
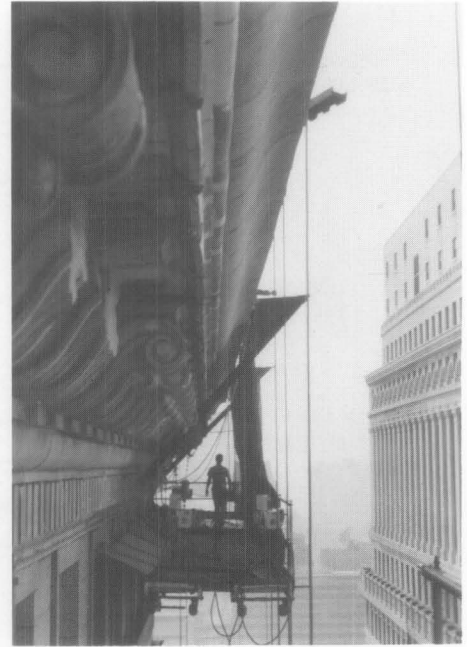
Figure 8. Access to the cornice was provided by cantilevered aerial scaffolds at the southeast and southwest corners of the cornice. All other locations were accessed by hanging two swing stages, side by side. The inner swing was hung off of a V-shaped bracket (shown) while the outer swing was hung from a steel deadman which projected horizontally across the cornice roof. Both the V-shaped bracket and the deadman were designed to transfer the weight of the swings vertically down through the center of the cornice. No load was placed on the outer edge of the cornice. Photos by Jeffrey S. Levine.

The use of swing-stage scaffolds proved to be a practical solution. To accommodate the tall projecting cornice, custom-fabricated brackets were made which permitted two swing-stage scaffolds to be hung side by side, parallel to and at a distance of about 2' out from the exterior wall. By tying the swing stages together and to the building, a stable work platform was provided for both the architect's detailed analysis of the cornice as well as the subsequent repair work (see figure 8). A narrow section of scaffolding placed on the deck of the swings allowed for work on the upper reaches of the cornice. Using 32' long swings, roughly 10 drops were required, with 1½ days of breakdown and setup time between drops. Two sets of double swings were employed for the job.

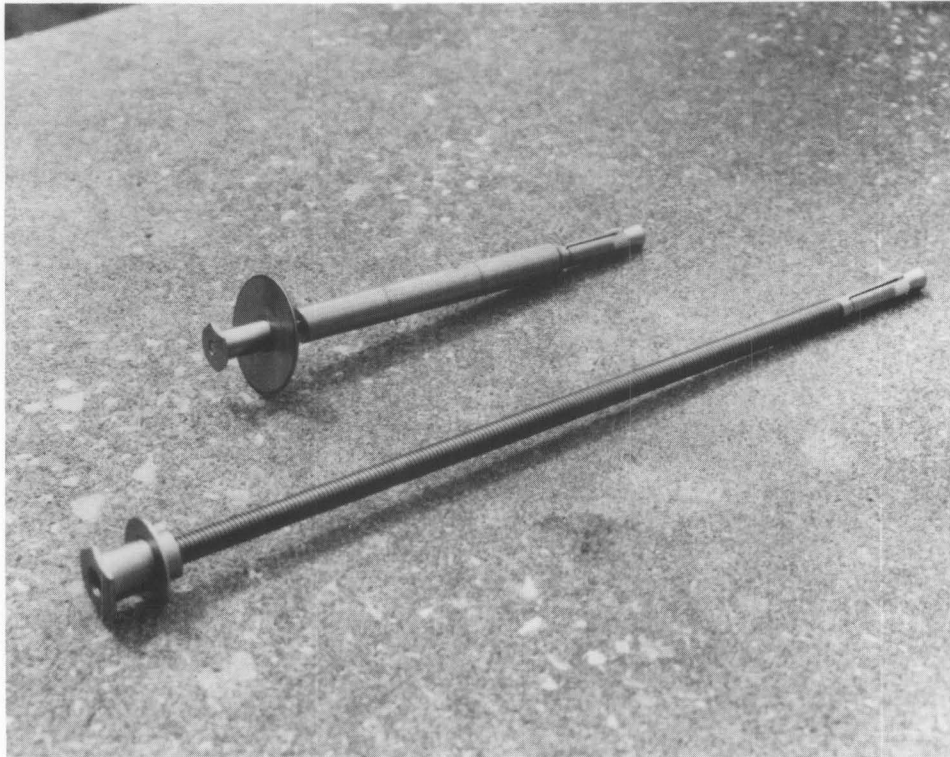
Figure 10. A standard mechanical anchor (top) and a variable length mechanical anchor. The variable length anchors were fabricated from 6' long threaded stainless steel rods, which were tapped at both ends to receive expansion assemblies (two anchors could be cut from each rod).

Stainless steel mechanical anchors, $\frac{7}{16}$ " in diameter and with bronze expansion assemblies, were employed for most other anchoring needs (see figure 10). Anchors of various lengths were special ordered from the manufacturer. The specified lengths were established in the planning phase by drilling test holes in the cornice at what were thought to be typical anchoring locations. A variable length anchor was also developed for use in unanticipated locations and in areas of the cornice where the original construction differed materially from the area in which test borings were conducted (see figure 10).

unknown condition of the masonry backup. Pull-out tests were conducted on a large random sample of installed anchors. Utilizing a safety factor of four, very few anchors failed. Those that did fail had been anchored into masonry backup and were easily replaced after drilling deeper into the backup material.
