## USES OF THE BOREHOLE CAMERA IN HYDROLOGIC INVESTIGATIONS RELATED TO COAL MINING<sup>1</sup>

Jay W. Hawkins<sup>2</sup> and Robert S. Evans

Proceedings America Society of Mining and Reclamation, 2004 pp 847-859

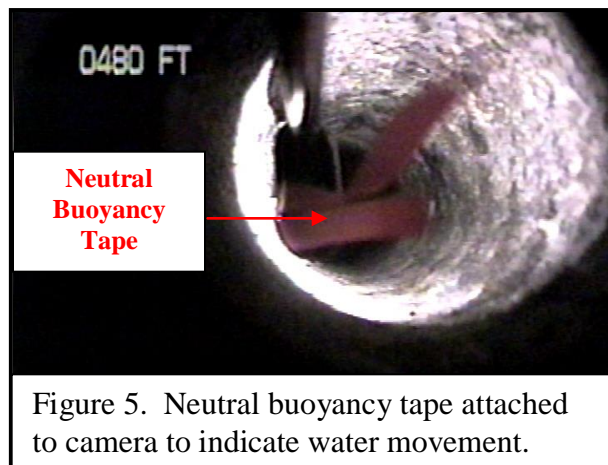
The borehole camera by itself may not be able to note inflow points below the water level, unless there is some variation in the color or clarity of the inflowing water. Therefore, a neutral-buoyancy tape (Fig. 5) was attached to the camera to identify water movement within the well bore, which indicates inflow points and a relative indication of the rate of flow. As

Figure 5. Neutral buoyancy tape attached to camera to indicate water movement.
