Installing a K-TYPE THERMOCOUPLE

The STE101 is a Type K Thermocouple exhaust gas temperature sensor, with mating connector.

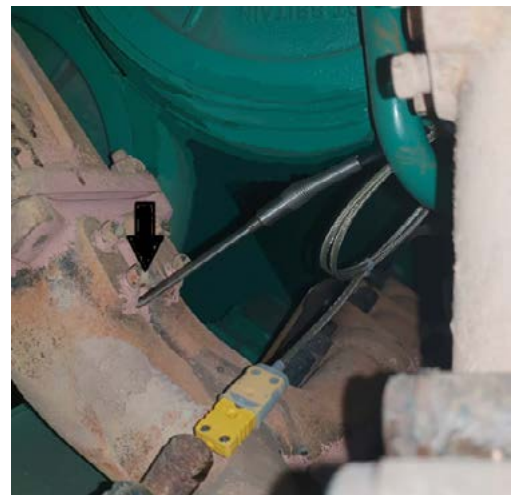
Figure 3: Exhaust Cylinder Merge

A thermocouple measures temperatures at their tip. The tip should be placed in the center of the exhaust stream to accurately measure the hottest point. The following uses an example of a dual exhaust outlet on a QTS30 engine. Your engine exhaust location may vary.

1. Locate the exhaust temperature probe in the engine exhaust outlet as near as possible to the point where all of the cylinders merge.
2. If the exhaust outlet is not easily accessible, place the sensor in the manifold outlet pipe.

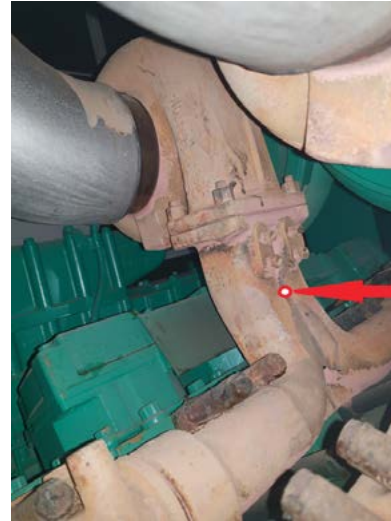
Figure 4: Mark Weld-In Bung Placement

1. Determine placement location for the thermocouple in each exhaust using the thermocouple dimensions to determine mounting location and manufacturer's information.
 - Route the wires away from any ignition components.
 - If the cabling length must be extended you must use the same type grade thermocouple wire to prevent temperature compensation errors. The extension wire and connector wire are specific to the thermocouple type being used. Using the incorrect wiring components between control and process thermocouple can result in erroneous readings. Contact your GAC contact for details on the cabling recommendations.
 - Avoid bending the thermocouple sheath.
2. Mark weld-in bung placement.
3. Drill and weld a bung.
4. Insert compression fitting into bung.

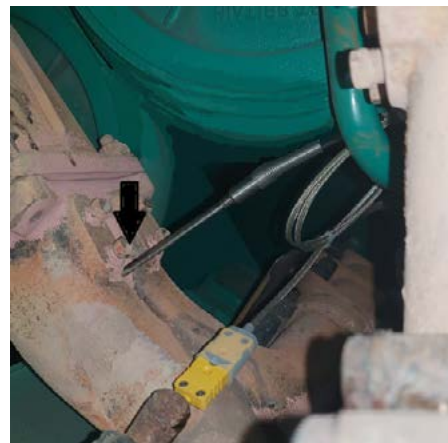
Figure 7: Insert Compression Fitting with Sensor Into Bung

5. Dry fit the sensor into the bung. Ensure the tip of the probe is within the outlet exhaust flow.
6. Apply anti-seize compound to the compression fitting threads and NPT threads.
7. Mount the sensor using the 1/4" NPT fitting.
8. Tighten compression fitting and sensor finger tight. Turn the sensor 2 full turns past finger tight.
9. Connect the sensor, ensuring the connector protection boot is in place.
