Document Title: Development and Analysis of Electrical Receptacle Fires

Author(s): Matthew E. Benfer, Daniel T. Gottuk

DEVELOPMENT AND ANALYSIS OF ELECTRICAL RECEPTACLE FIRES

Laboratory testing evaluated the impact of a wide range of variables on the formation of overheating connections in residential duplex receptacles. Two types of receptacle configurations have been evaluated: 1) those focused on terminal connections and 2) those focused on plug connections. Testing included 528 receptacle trials, 408 trials with various terminal connections and 120 trials with various plug connections. Thirteen pre-fabricated wall assemblies of 36 receptacles were placed in 8 compartment fire tests and 5 furnace fire tests. The variables evaluated in the fire exposure testing included: the receptacle material, materials of the receptacle faceplate and box, terminal torque, and energized state of the receptacle. A portion of the receptacles in the fire exposure testing had overheated connections that were created in the laboratory testing. These receptacles were used to assess whether evidence of overheating would persist after a fire exposure. All receptacles were documented for damage to th

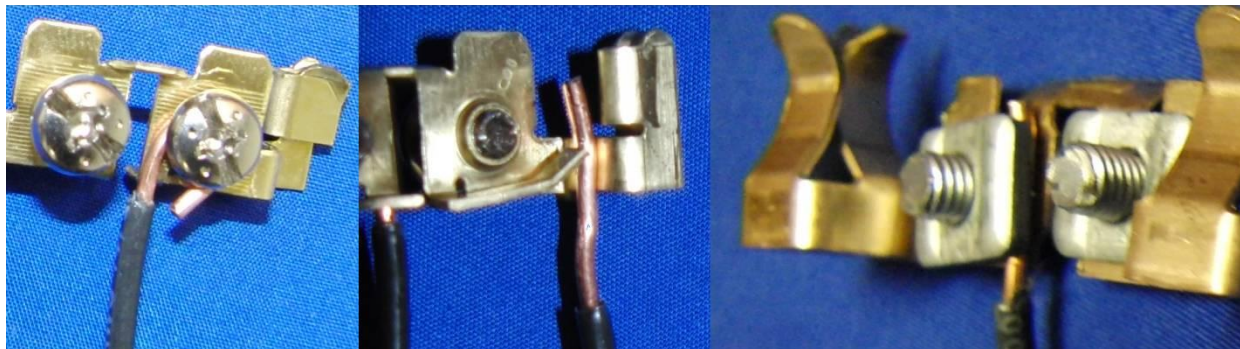
A common physical mechanism leading to receptacles fires is the occurrence of an overheating connection, formed as a result of a loose terminal connection. In a receptacle there are electrical connections between the plug blades and the receptacle as well as between the receptacle and branch circuit wiring. Connections between the receptacle and branch circuit wiring can be various types, including side wired screw terminals, back wired push-in terminals,

and back wired compression terminals, the latter being less common (see Figure 1-2). All types of connections have the potential to overheat if installed improperly. In addition, due to the practice of installing receptacles in series in some installations, a receptacle does not necessarily have to have a load plugged directly into it in order for there to be current passing through it and potentially creating an overheating connection.

Figure 1-2. Three types of receptacle terminals (from left to right: side wired screw terminal, back wired push-in terminal, and back wired compression terminal).

Back wired push-in receptacle connections rely on the spring force of the internal plug contact to retain the conductor in the receptacle (see Figure 1-2, center). This spring force can be reduced over time by the insertion of a conductor that is larger than intended or by repeated insertion and removal of a conductor [Aronstein, 1993].

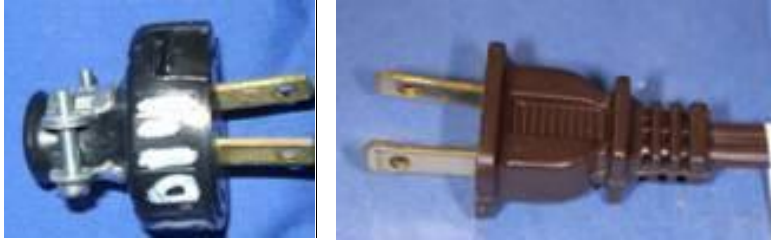
Figure 1-5. Solid brass (left), folded brass (right) plug blades.

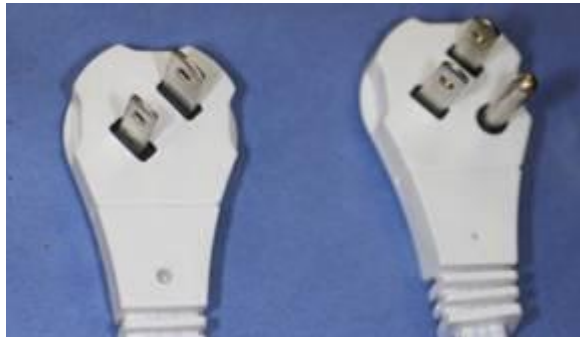
Figure 1-6. Plated plug blades: 2-prong (left) and 3-prong (right).

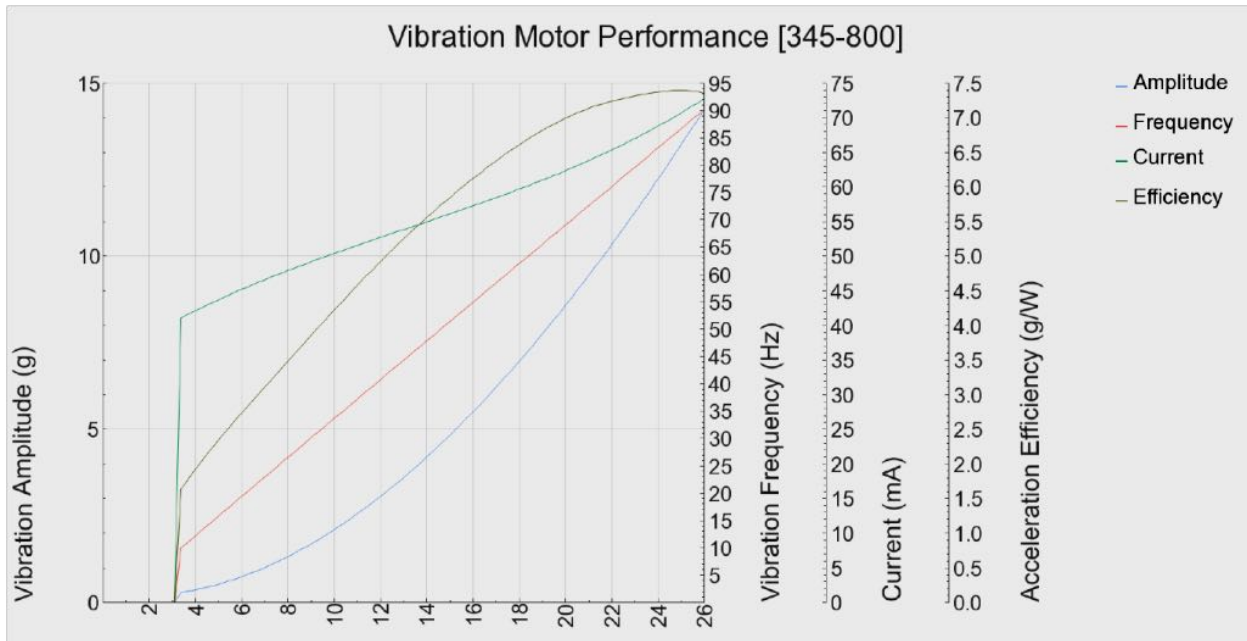
Figure 2-5. Vibration motor performance from manufacturer's datasheet; x-axis in Volts.

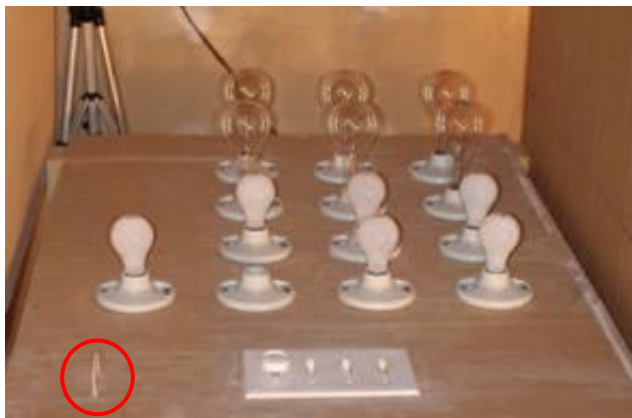
The electrical load for the test racks was provided by up to 18 tungsten-filament light bulbs, ranging in power from 25 W to 300 W. The light bulbs were arranged in a load bank (see Figure 2-6);

a separate load bank was used for each test rack. The loading circuit consisted of up to 18 light sockets connected in parallel. Up to four switches and one dimmer switch controlled the flow of electricity to groups of light bulbs. This allowed the total current draw to be varied from 0 to 20A. The electrical load was plugged into the “loaded receptacle” placed at one end of the daisy chain of receptacles (see Figure 2-1, Figure 2-2, and Figure 2-3). The loaded receptacles were 20A rated, heavy duty Leviton receptacles wired with the screw connections tightened to manufacturer’s specifications. A section of the neutral wire from the load bank to the loaded receptacle was routed outside of the load bank enclosure to facilitate current measurement (see Figure 2-6).

Figure 2-6. Photograph of light bulb load bank. Note: neutral wire circled.

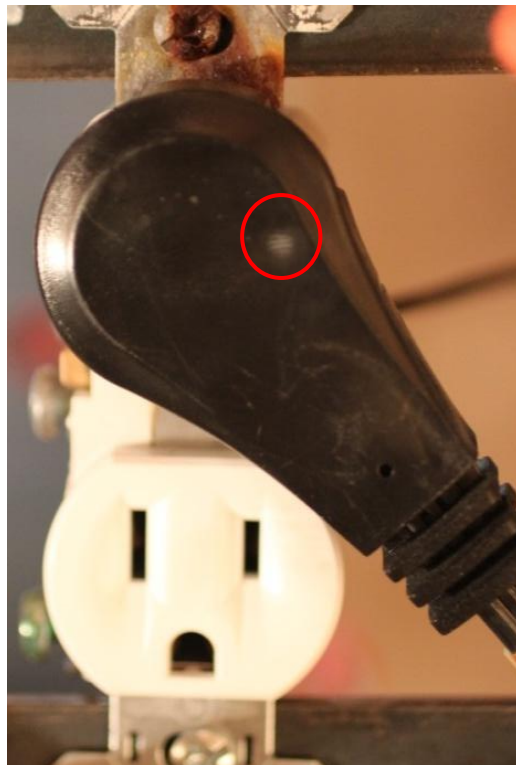
Figure 2-13. Overheating and discoloration of black plug with plated blade (PSE285; 0.01 kg).

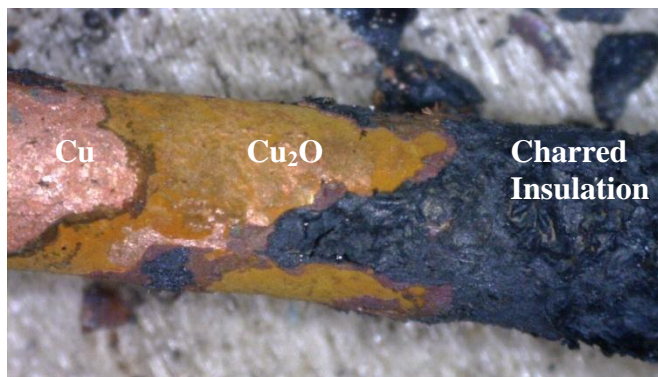
Figure 2-15. Oxidation of wire, showing layer of Cu₂O in center and underlying copper (PSE170).

The development of an overheating connection in a loose terminal connection is a rather straight-forward process. The process begins with a loose terminal connection having a reduced contact area between the wire and the terminal, and thus larger contact resistance, than a well tightened connection. The increased contact resistance will lead to resistive heating as the current flow is limited to the smaller contact area. Cupric oxide (CuO) will then be formed as the copper reacts with oxygen in the air at the elevated temperatures. Copper oxides, being semi-conductive, will further increase the resistance between the wire and terminal [Shea, 2006]. The increased resistance will cause additional heating and production of CuO and the cycle (heating>oxide formation>increased resistance>heating...) will continue until enough of an oxide layer is produced that a glowing connection is formed or the receptacle fails. Cuprous oxide (Cu_2O) may also form on the copper wire at elevated temperatures [Ferrino-McAllister et al., 2006] (see Figure 2-15).

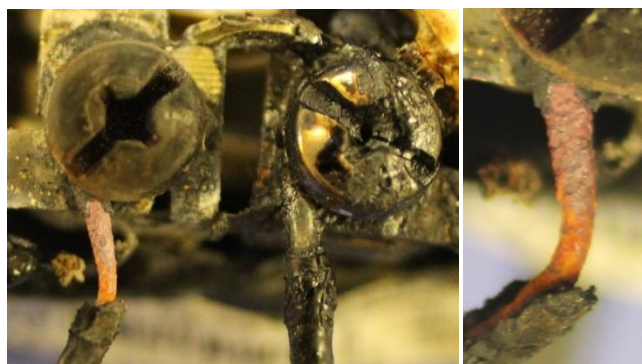
Figure 2-18. Thinned and pitted wire from oxidation (LEV009).

Some severe cases of oxidation of copper wiring as a result of glowing connections resulted in drastic thinning and tapering of the conductor. Figure 2-18, Figure 2-19, and Figure 2-20 are three instances where severe oxidation on the receptacle wiring near the screw connection was observed. In these cases, the wiring was severely pitted and the diameter of the wire was reduced by up to 1/2 of the original size. The wire insulation, in most of these cases, was charred and friable, which allowed more of the wire to be exposed to air. As the diameter of the wire was reduced, so was the current carrying capacity of the conductor. This further contributed to overheating of the connection. This thinning of the conductor is unique compared to necking of the conductor at a glow spot (see Section 2.3.3.3). The main difference is that the conductor thinning occurs gradually over a longer length whereas necking occurs suddenly at the glow spot.

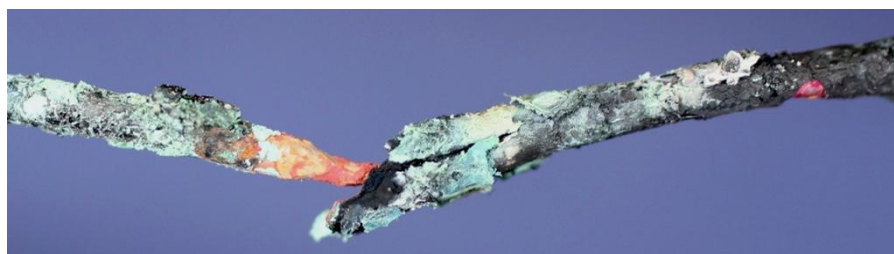
Figure 2-19. Thinned and pitted wire from oxidation (PSE263).

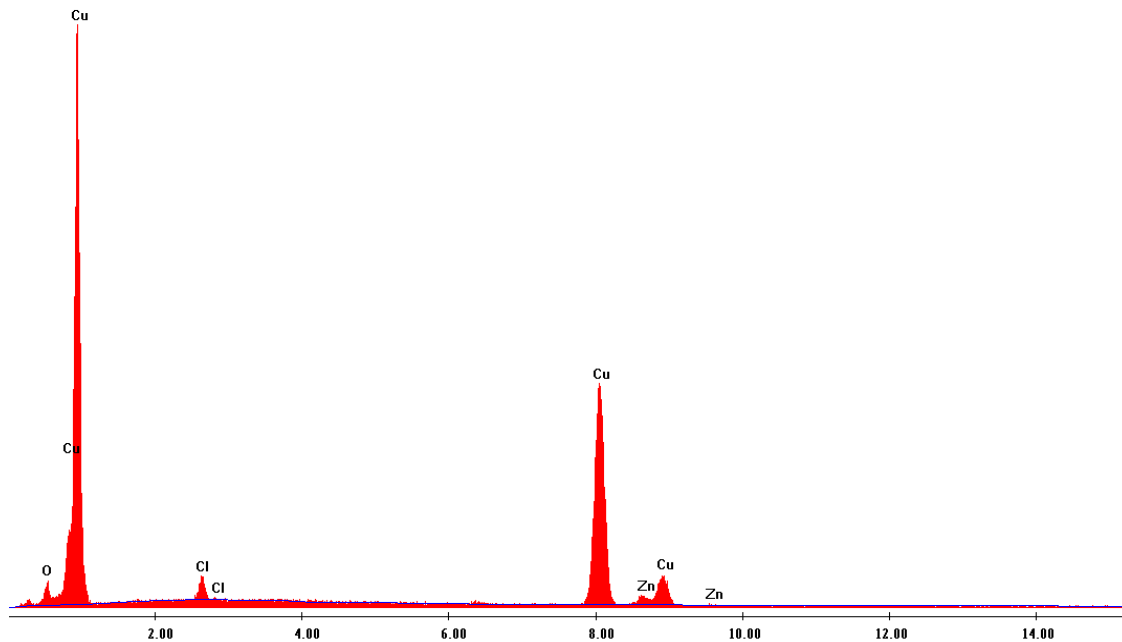
Figure 2-26. EDS Spectra for dendrite, “EDS1” in Figure 2-23 (right).

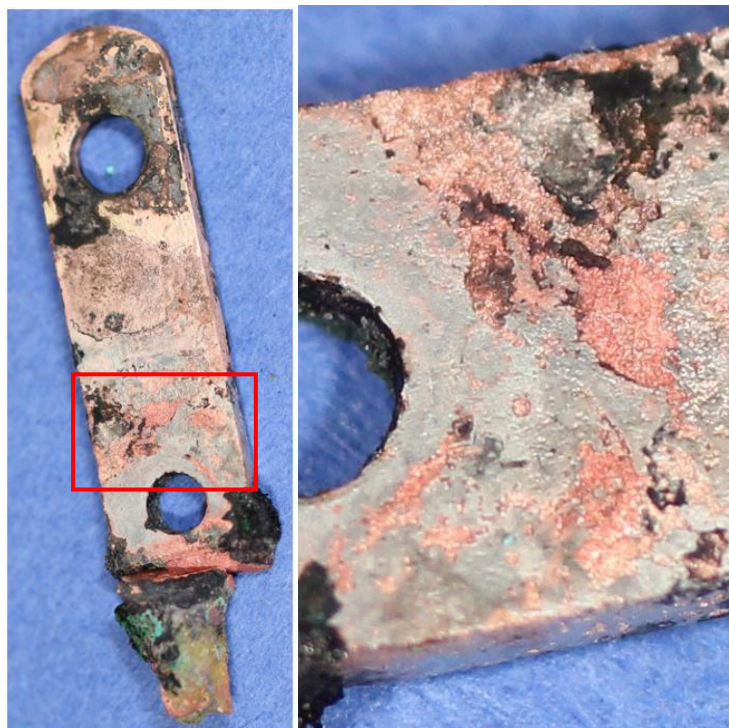
Figure 2-28. Loss of plating and dezincification of low profile plug blade; nominal retention force of 0.01 kg (LEV286).

Dezincification was also observed for nickel plated brass plug blades. The process of dezincification for plug blades, especially those plated with nickel is likely more complicated than that of the bare brass contacts. This is because the nickel plating provides a physical barrier that prevents dezincification of the underlying brass. Before dezincification of the underlying brass can occur, the nickel plating would need to be removed. A combination of corrosion from the plug material vapors and heating from the overheating connection is expected to cause the loss of nickel plating. Also, any nickel remaining would likely prevent dezincification on the underlying brass, creating less uniform dezincification across the area. Figure 2-28 shows loss of plating and dezincification for a low profile plug blade. The dezincification appears to be more localized as the nickel plating still remained over portions of the plug blade, but there was noticeable pitting on the plating and dezincified brass. This dezincification occurred in a polypropylene receptacle, but the plug material was likely PVC.

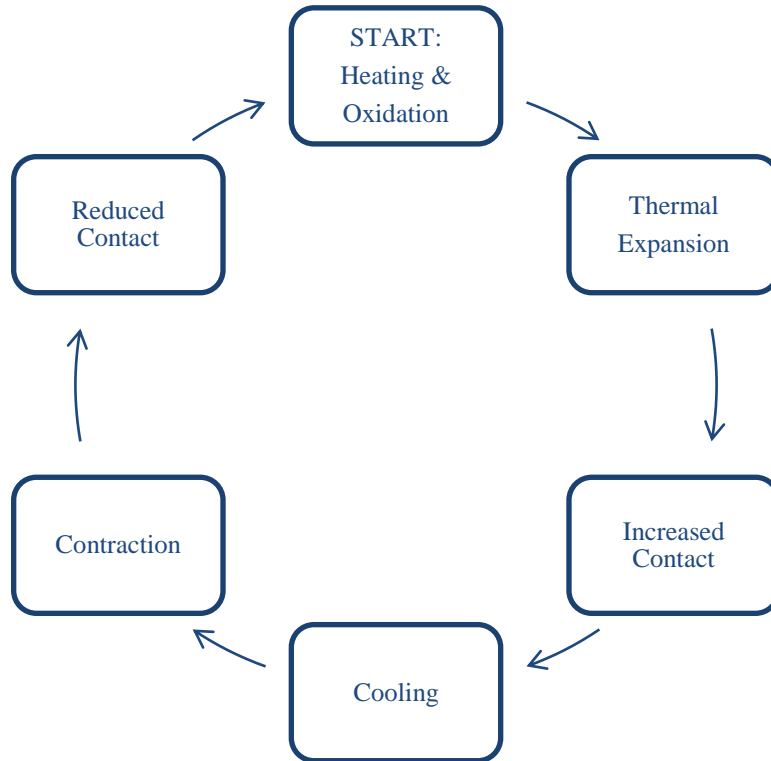
Figure 2-38. Potential heating and cooling cycle for a connection showing frequent oscillations in temperature.

While the temperatures and voltage drops are not significant compared to those reported for the failure events, the oscillating behavior may lend some insight into the formation and behavior of certain overheating connections. In the case where frequent oscillation of temperatures and voltage drops occur, it is possible that the cyclical heating and cooling is due to thermal expansion and contraction of the wiring combined with oxidation. A flow chart showing this cycle is shown in Figure 2-38.

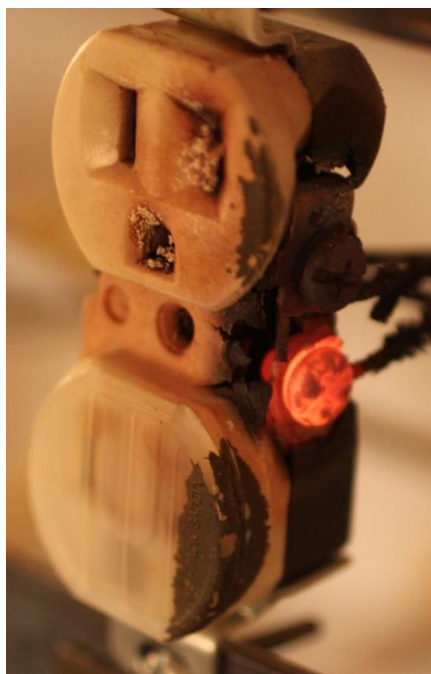
Figure 2-39. Thermoset receptacle with overall glow at ¼ turn loose connection (E010).

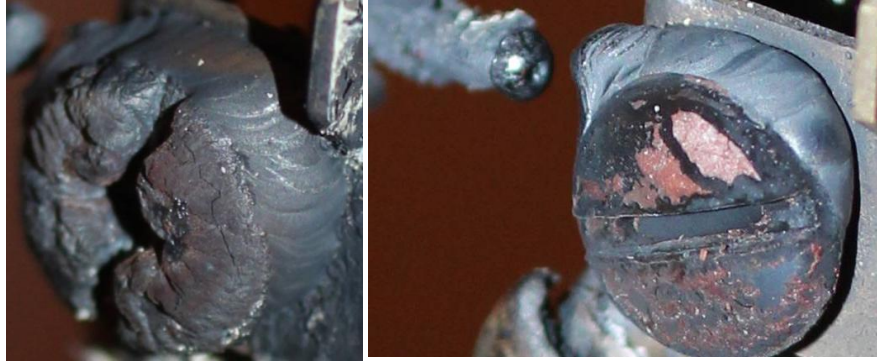
Figure 2-41. Curved striations from glow movement on receptacles, receptacle LEV275 (left) and E003 (right).

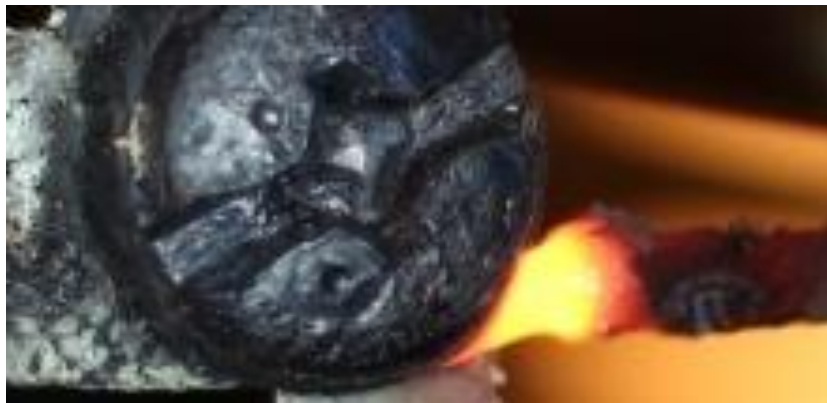
Figure 2-42. Necking of conductor at glow spot on receptacle LEV277.

For all failure events where the conductors severed, a bright glow spot developed at some point along the copper conductor at the loose connection. Once the glow spot had moved to the part of the conductor not underneath the screw head, the conductor would begin to neck (see Figure 2-42) as mechanical forces (weight and tension on the wire) stretched the wire at the glow spot (i.e., where the copper was molten). Korinek et al. [2013] also observed necking, but attributed it to surface tension forces in the molten material. As a result of the necking, the conductors typically severed, sometimes accompanied by a series parting arc. In no cases did the series arcing cause a circuit breaker to trip. The severing of the conductor at the glow spot produced various characteristic ends on the severed conductors (see Section 2.3.5.4).

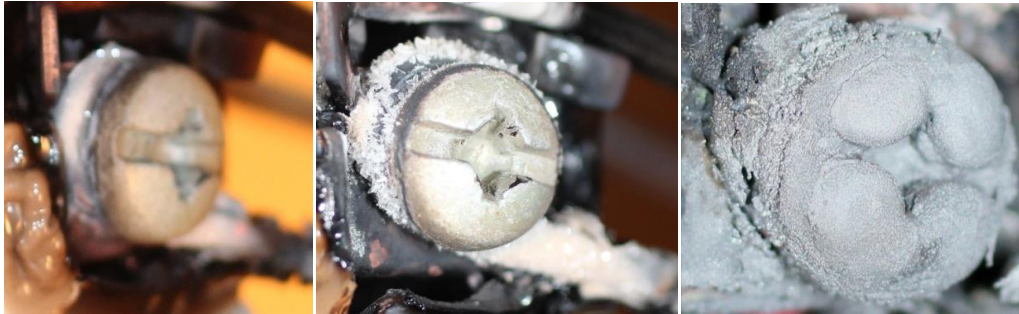
Figure 2-44. Development of enlarged screw head on receptacle PSE170 at T = 0 hours (left), T = 21.6 hours (center) and T = 29.2 hours (right).

Twenty-eight cases were observed where a heavy layer of corrosion was developed on the screw terminals of receptacles with failure events (see Table 2-10). This was termed an enlarged screw head (see Figure 2-44, right). The enlarged screw heads are characterized by a swollen appearance with narrowed screw slots due to the buildup of corrosion products. The enlarged screw heads had a black, grey, or reddish color, and fine surface porosity though the surface was relatively smooth. In these cases, rather than a dark oxidation of the copper conductor causing the overheating at the terminal, a layer of white corrosion was deposited on the conductor at some point during the testing (see Figure 2-44, left). This was quite common for the PVC receptacles, and twenty-eight cases were observed where the white corrosion developed into the enlarged screw head condition. Examination with a Scanning Electron Microscope (SEM) equipped with Energy-dispersive X-ray Spectroscopy (EDS) revealed that this corrosion was primarily chlorine, likely coming from the PVC. In one case where the enlarged screw head developed, after approximately 145 days of testing, it was observed that a crystalline deposit was formed on the conductor (see Figure 2-44, center). Over the course of approximately 29 hours, the initial chlorine corrosion developed into a crystalline deposit and then corroded the screw head ultimately leading to an overheating event and failure of the receptacle. Unfortunately, it was not possible to determine whether this specific series of events occurred for the other cases where an enlarged screw head was found. However, the enlarged screw heads appeared to be similar (see Section 2.3.5.3) and are a clear indication that a glowing connection and chlorine corrosion were present.

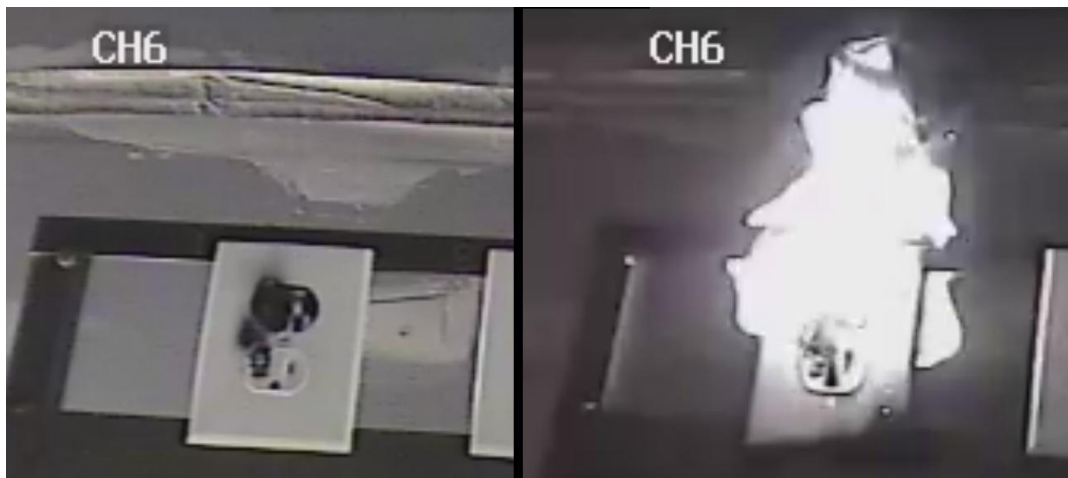
Figure 2-46. Flaming ignition of receptacle in box (before ignition (left) and 21 seconds after ignition (right)).

The flaming ignition events were very diverse in terms of the duration, size, and location of the flames. Table 2-6 and Table 2-7 summarize the key data for the flaming ignition events. In four cases, the video surveillance system did not capture the flaming ignition event. Flaming ignition was determined based on visual indicators of flaming (i.e., soot, charring of the receptacle and/or adjacent receptacles) or in-person observation of flaming. The duration of flaming ignition events ranged from as little as 4 seconds to over 6 minutes. In all cases, the receptacles and plugs self-extinguished and did not spread to adjacent receptacles. Maximum flame heights ranged from 2 inches to 24 inches. Often, for the larger flame heights (i.e., greater than or equal to 8 inches), the flames were largest during 10% or so of the total event duration, and diminished quite drastically for the rest of the event. In the case of the smaller flaming events, flame heights were more consistent throughout the duration of the event. Figure 2-45 and Figure 2-46 show two examples of flaming ignition events.

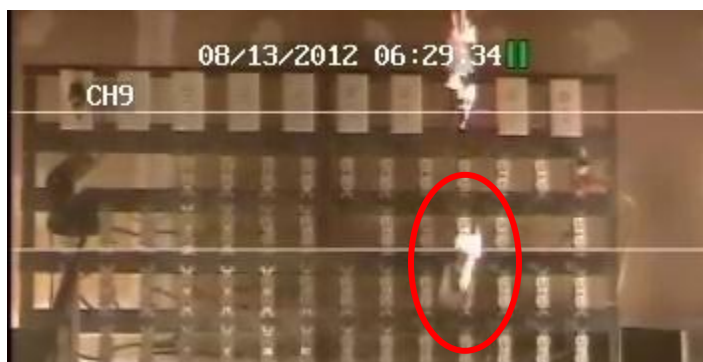
Figure 2-48. Flaming faceplate drops to ground (PSE166).

Six receptacles had melting plastic drip while flaming. PSE166 had most of the faceplate fall to the ground burning (see Figure 2-48), but it is unclear whether the faceplate continued to burn while on the floor as this is out of the video frame. Because the faceplate is constructed of Nylon, it is unlikely that it burned for very long while on the ground as these faceplates tend to self-extinguish without the application of an external flame. LEV269 had a flaming droplet, likely plastic from the faceplate, fall about 6 inches to the receptacle below and sustain flaming for about 5 seconds before it self-extinguished (see Figure 2-49). The receptacle below LEV269 did not ignite as a result of the flaming droplet. The other receptacles with flaming droplets behaved similar to LEV269. The PVC outlet boxes did appear to contribute to the size and duration of the flaming events.

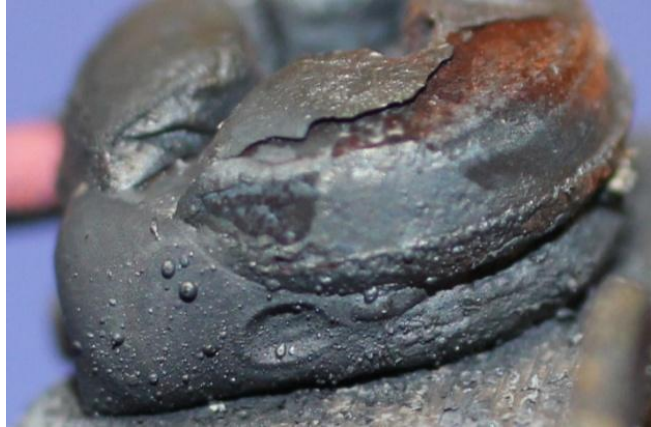
Figure 2-59. Partially welded conductor; no curved striations (LEV127).

Welded conductors were observed on a number of receptacles across the majority of failure events. Table 2-9 lists a summary of the receptacle failures, welded conductors, and welded conductors with curved striations observed for each type of failure; this table does not include the plug failure events. Welded conductors were divided into two types: those with curved striations and those without curved striations. As described in Section 2.3.3.3, curved striations are an indication that the glow spot moved along the conductor around the screw terminal. The curved striations could appear in a variety of ways. Both deep grooves and very shallow striations were observed. A typical example of curved striations is shown in Figure 2-58; the welded conductor fills the gap between the edge of the screw head and the brass internal contact plate. It is possible that the adhesion forces between the molten copper and the solid steel screw caused the molten copper to fill the gap. In the cases where distinct curved striations were not observed, it was for one of two reasons; the wire was only partially melted or there was an enlarged screw head (see discussion in Section 2.3.5.3). Partially welded conductors are a result of a failure event occurring before the glow spot could completely move around the screw. A photograph of a partially welded conductor with no distinct curved striations is shown in Figure 2-59.

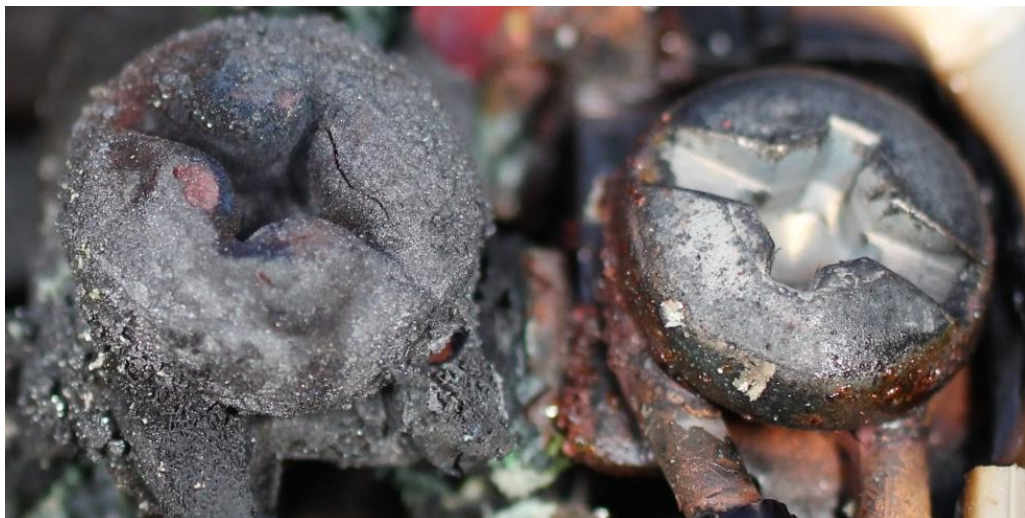
Figure 2-61. Enlarged screw head on receptacle PSE134.

The enlarged screw head is a phenomenon arising from the corrosion of the copper wire and steel screw on a receptacle by HCl gasses evolved from the thermal degradation of PVC receptacle materials (see Section 2.3.2.2). Table 2-10 provides a summary of the enlarged screw heads observed for each failure event, whether the conductor was melted, and whether curved striations appeared. The enlarged screw heads are characterized by a swollen appearance with narrowed screw slots due to the buildup of corrosion products. The corrosion deposits on the screw heads appear to be rather porous and grey, black, or dark red in color (see Figure 2-61, Figure 2-62 and Figure 2-63). All of the enlarged screw heads observed in the laboratory testing

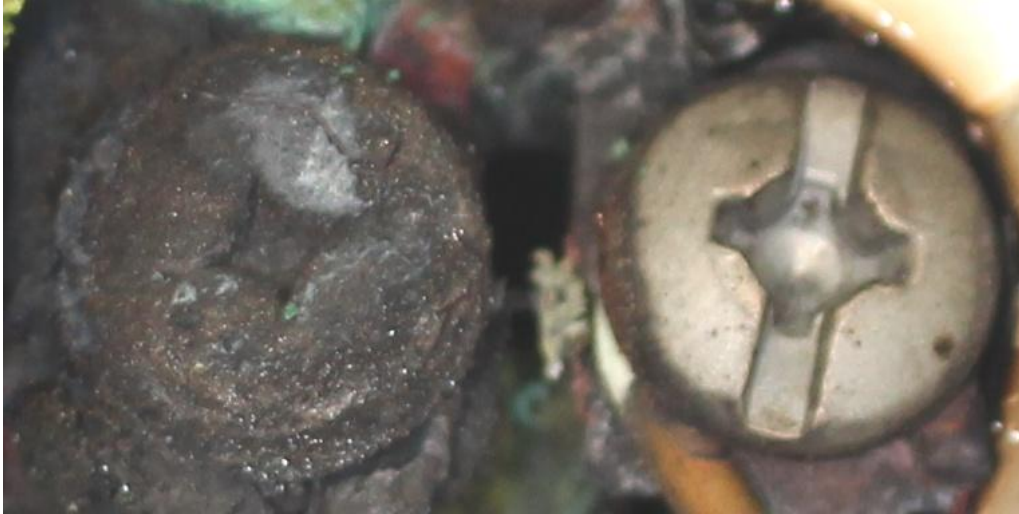
Figure 2-62. Enlarged screw head from receptacle PSE129.

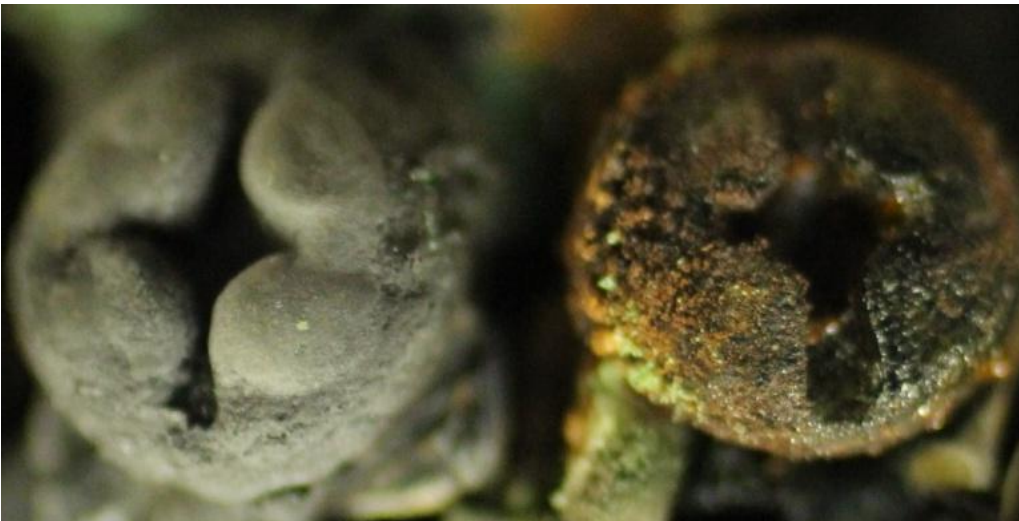
Figure 2-63. Enlarged screw head from receptacle PSE170.

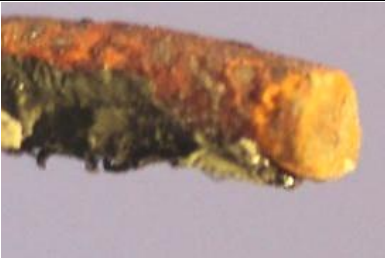
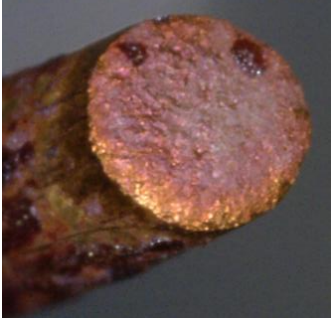
Table 2-13. Photographs of Wire Ends from Failure Events Severed by Glowing.

Round Ends	Flat	Irregular

<p data-bbox="207 562 570 632">E003 –with dimple <i>Conductor Severed w/o Arc</i></p>

<p data-bbox="630 562 992 632">LEV018 <i>Conductor Severed w/o Arc</i></p>

<p data-bbox="1052 562 1414 632">PSE170 <i>Conductor Severed w/ Arc</i></p>

<p data-bbox="207 894 570 963">LEV035 – shiny <i>Conductor Severed w/o Arc</i></p>

<p data-bbox="630 894 992 963">LEV013 <i>Conductor Severed w/ Arc</i></p>

<p data-bbox="1052 1388 1414 1457">PSE134 <i>Conductor Severed w/ Arc</i></p>

<p data-bbox="207 1318 570 1388">LEV267 <i>Conductor Severed w/o Arc</i></p>

<p data-bbox="630 1318 992 1430">LEV173 (initially observed as round) <i>Flaming Ignition</i></p>

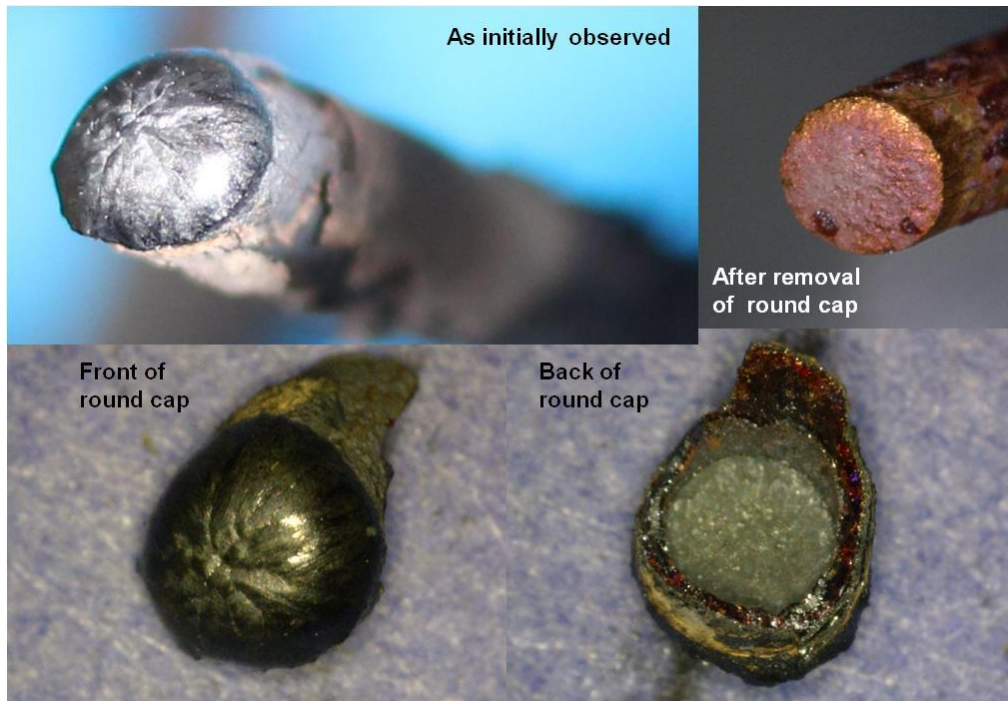
Figure 2-70. Round, shiny severed conductor end showing round cap and flat underneath (LEV173).

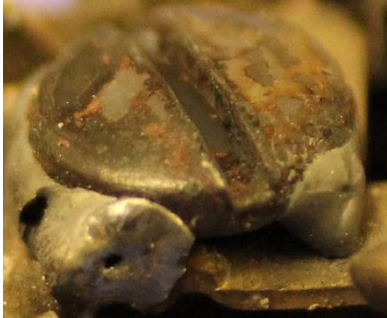
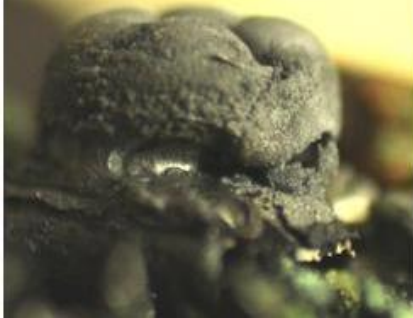
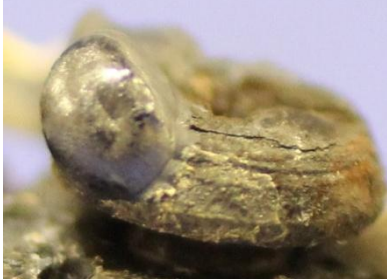
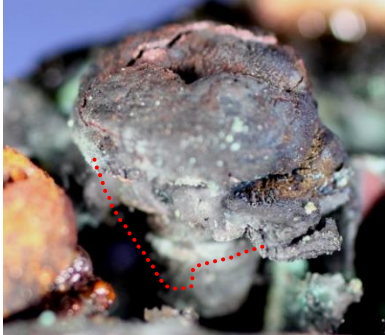
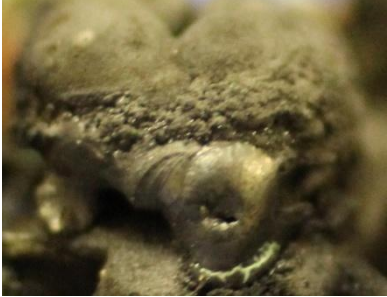
Table 2-14. Photographs of Severed Conductor Evidence on Screw Side Found in Receptacle Failures.

Round/Shiny Ends	Irregular	None

<p data-bbox="217 646 581 709">E003 <i>Conductor Severed w/o Arc</i></p>

<p data-bbox="639 646 1003 709">PSE170 <i>Conductor Severed w/o Arc</i></p>

<p data-bbox="217 1003 581 1066">LEV035 <i>Conductor Severed w/o Arc</i></p>

<p data-bbox="646 1207 993 1270">PSE134 – split <i>Conductor Severed w/ Arc</i></p>

<p data-bbox="1047 982 1429 1129">PSE263 <i>Conductor Severed w/ Arc (approximate area of missing material outlined)</i></p>

<p data-bbox="217 1377 581 1440">PSE133 <i>Conductor Severed w/o Arc</i></p>

The severed conductor ends on the screw side of the severed conductor were similar in form to the wire ends. Round and/or shiny and irregular shaped evidence was observed. Table 2-14 shows some examples of the various types of severed conductor ends observed on the screw side of the conductor. In most cases, the location of severing was directly adjacent to the screw head, but in some cases it occurred up to 1.2 cm (0.5 in.) from the screw head on the wire. In addition, for one receptacle (PSE263), it was found that part of the brass terminal was missing in the location of the severed conductor, possibly due to the arcing that occurred when the conductor was severed. The irregular shaped conductor from PSE134 was also quite interesting (see Table 2-14); it appeared that the wire split and splayed open into four pieces approximately 1.2 cm (0.5 in.) from the screw head. In most cases, the irregular shaped ends appeared for receptacle failure events having arcing. But, round and shiny ends were also observed for severed conductor failure events having arcing.

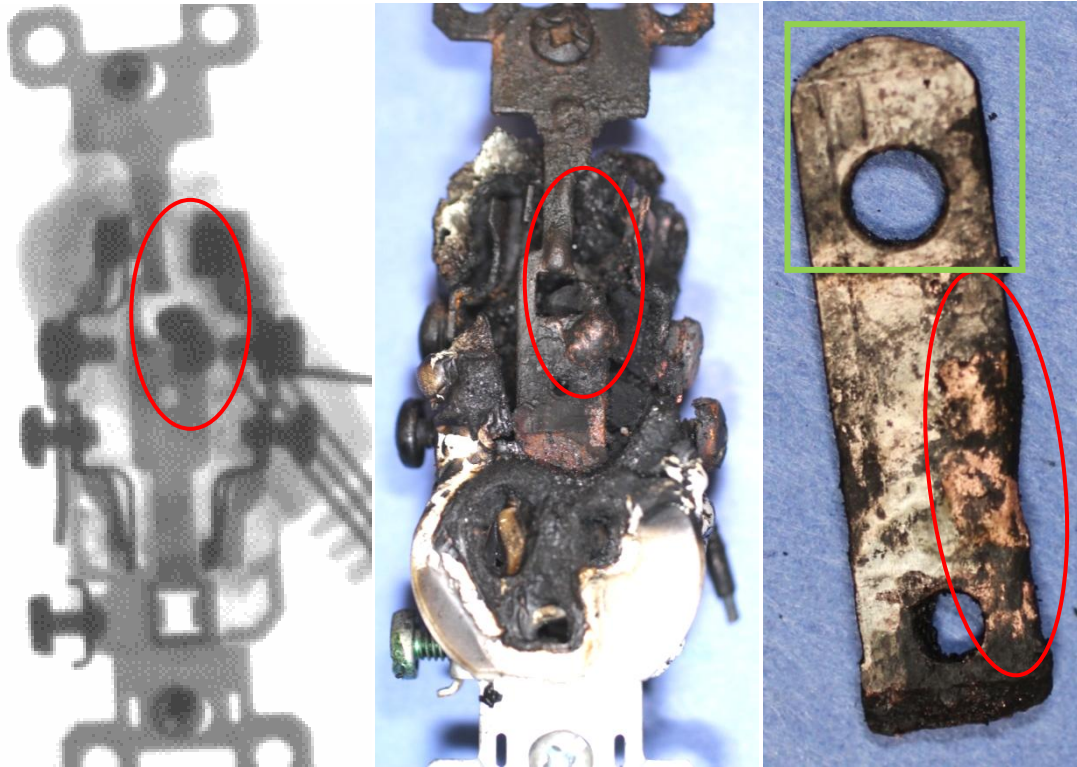
Figure 2-75. Arcing between grounding strap (left, center) and hot plug blade (right) from PSE285.

In all cases of flaming ignition in plug connections, evidence of arcing was found. Those receptacles (2 out of 5) that tripped circuit breakers (PSE285 and LEV063) showed signs of parallel arcing between a hot conductor and the ground strap. Those receptacles that did not trip circuit breakers showed evidence of series arcing between two hot conductors. Arcing evidence was determined using the characteristics presented in Section 2.3.5.1. Figure 2-75 shows the arcing damage between the hot plug blade and the grounding strap for PSE285. The green square in Figure 2-75 indicates the approximate area of contact between the internal plug contacts and the plug blade. The arcing damage is located on the plug blade behind this contact area (i.e., towards the interface between the receptacle and plug surfaces). Because the arcing damage is not located at the area of contact between the blade and internal plug contacts, it is likely that this occurred during the flaming ignition event and not during the overheating process. For receptacle LEV060, arcing occurred between the hot plug blade and internal plug contact. Some transfer of material is evident on both the plug blade and the receptacle contact (see Figure 2-76). It is unclear whether this arcing occurred during the failure event or prior to it. Arcing also occurred in the plug, away from the receptacle contacts for LEV286. In this case, arcing occurred at the base of the ground pin within the plug (see Figure 2-77). It is likely that the arcing occurred between the ground pin and the hot wire or base of the hot plug blade (see Figure 2-77). However, additional examination of the hot plug blade and hot plug wire did not yield any conclusive evidence to determine the corresponding arc location.

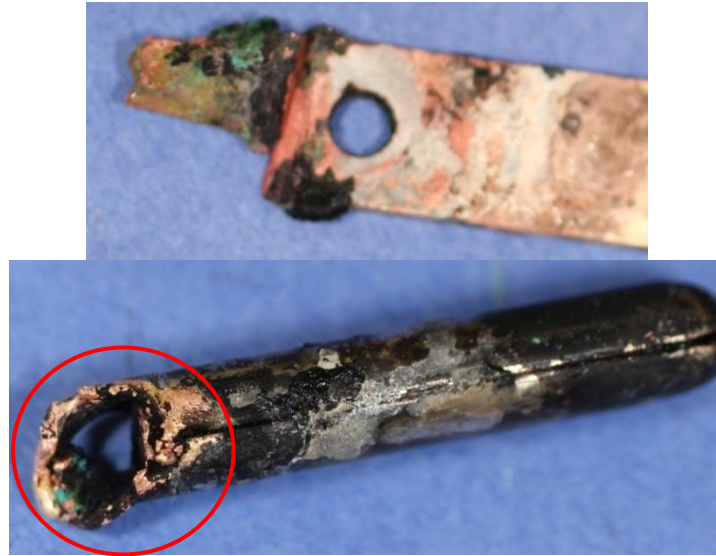
Figure 2-77. Arcing damage at back of ground pin (bottom); hot blade (top) from plug in receptacle LEV286.

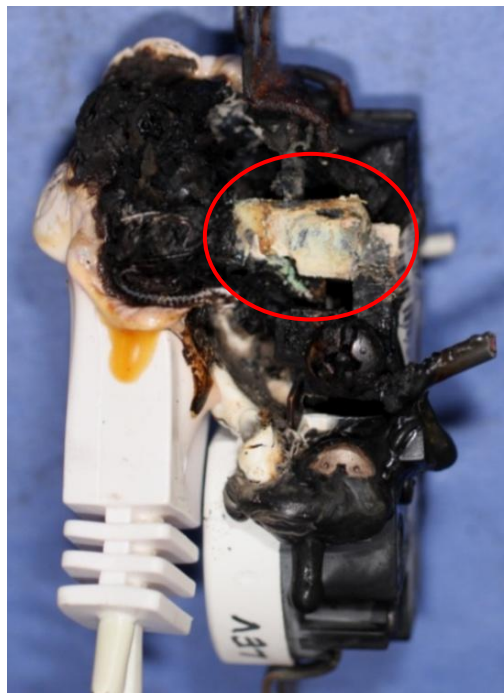
Figure 2-78. White residue (corrosion) at plug/receptacle connection (LEV060).

Corrosion was evident for the majority of the receptacles and plugs involved in flaming ignition failure events. Corrosion was observed in the form of a whitish deposit (see Figure 2-78) or dezincification (see Figure 2-79). The whitish deposit on the plug blade and internal plug contacts is likely due to the degradation of the PVC plug during overheating. This process would be similar to that described in Section 2.3.2.2. Dezincification was observed for 80% of the receptacle and plug failure events. Dezincification on both the brass plug blades (after loss of plating) and the brass internal plug contacts was found.

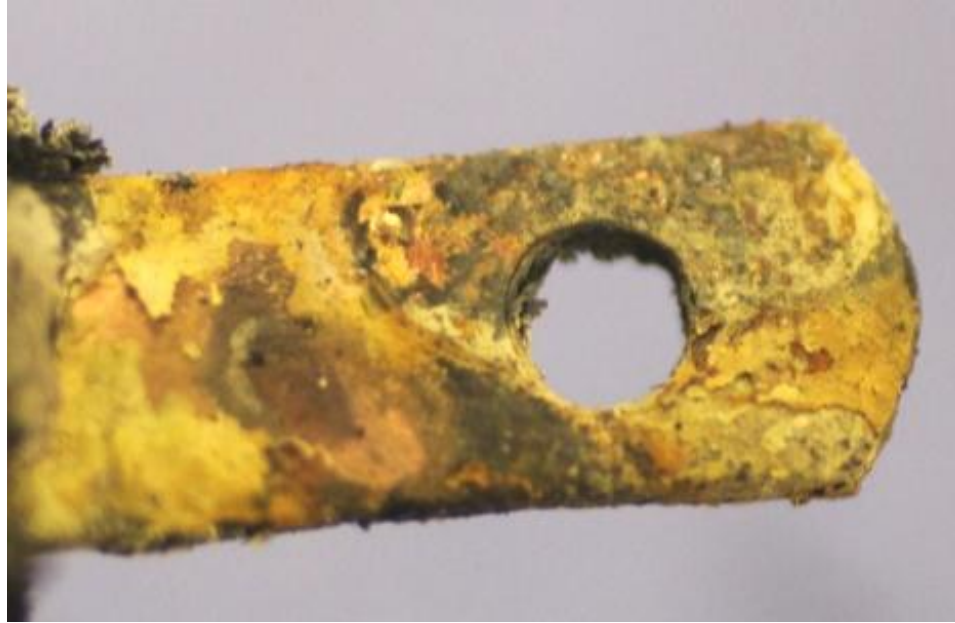
Figure 2-79. Loss of plating and dezincification on hot plug blade (LEV060).

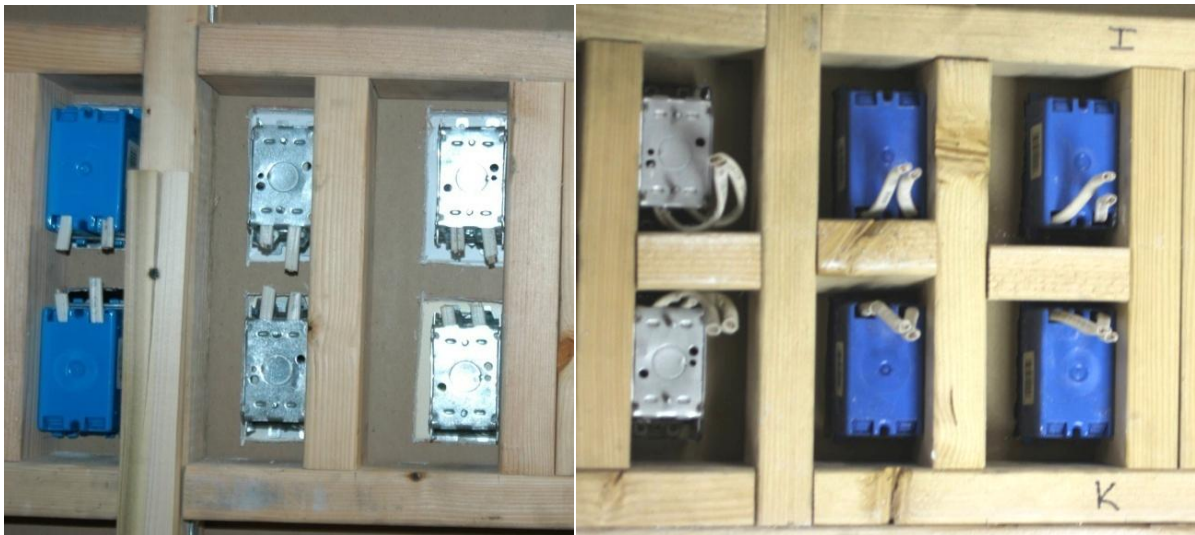
Figure 3-2. Typical outlet box installation for Test 1 (left) and Tests 2 through 8 (right).

The frame wall assemblies used for furnace testing were constructed in a similar manner as those used for the compartment fire testing. The wall assembly was constructed of 2 by 4 inch dimensional lumber (i.e., studs) with each receptacle enclosed with lumber on four sides, except as shown in Figure 3-2. The wall assembly was enclosed on the front and back surfaces with 15.9 mm (0.625 in.) thick gypsum wall board effectively isolating each receptacle. The wall assembly had overall dimensions of 1.2 m (4.0 ft) wide by 1.5 m (5.0 ft) tall. Holes in the non-exposed side of the wall assembly were the minimal size necessary for the passage of wiring and instrumentation. The receptacles were centered in the exposed portion of the wall assembly as shown in Figure 3-6. Bracing consisting of 2 by 4 nominal lumber was screwed to the top, middle, and bottom of the back of the wall assembly to facilitate securing the wall assembly to the furnace. No insulation inside of the wall cavity was used. A layer of 2.5 cm (1.0 inch) thick Fiberfrax ceramic fiber insulation was placed between the furnace and the wall assembly. The Fiberfrax was used to prevent smoke or flames from exiting at the interface of the furnace and wall assembly. The same load center that was used for the compartment fire testing (see Section 3.1.1.3) was used for the furnace fire testing.

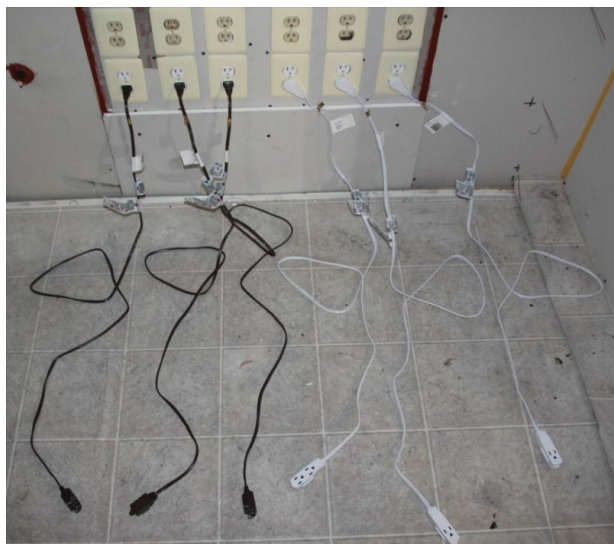
Figure 3-4. Location and arrangement of extension cords in compartment.

In Tests 6, 7, and 8 the bottom row of six receptacles was outfitted with extension cords plugged in to the bottom outlet of each receptacle. The extension cords were located inside of the compartment and arranged such that adjacent cords were not touching. The extension cords were placed on the floor of the compartment with a single loop in the wiring approximately 0.46 m (1.5 ft) down the length of the cord from the receptacle (see Figure 3-4). The loop was used to reduce the floor space taken up by the cords as well as to create a potential arcing location (i.e., where the cord overlaps itself).

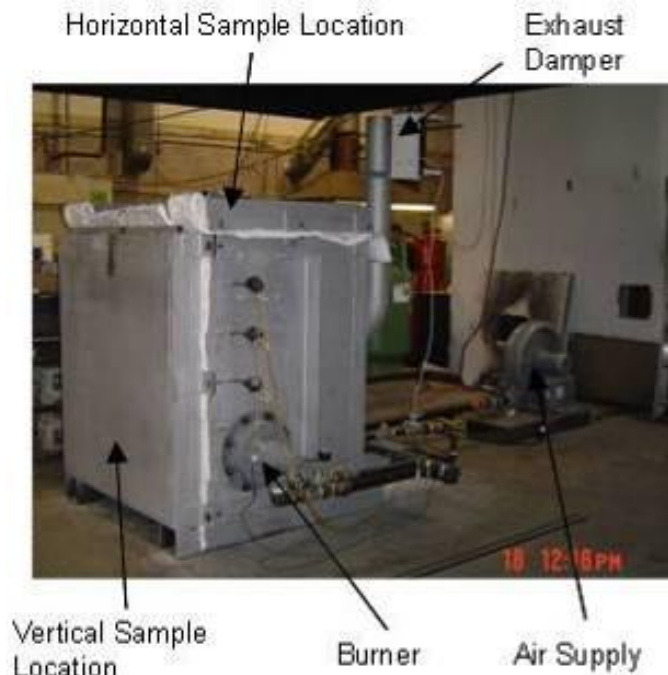
Figure 3-5. Photograph of intermediate scale furnace.

The HAI intermediate scale furnace is a premixed, natural gas fed, forced air furnace. Typically this furnace is used for standard fire exposures of structural elements. The outside of the furnace is constructed of 0.6 cm (0.25 in.) thick steel plate and angle iron pieces. The overall exterior dimensions are 1.2 m (4.0 ft) wide, by 1.5 m (5.0 ft) tall, by 1.06 m (3.5 ft) deep. The interior of the furnace is lined with 15.2 cm (6.0 in.) thick rigid ceramic fiber insulation. The overall interior dimensions are 0.9 m (3.0 ft) wide, by 1.2 m (4.0 ft) tall, by 0.9 m (3.0 ft) deep.

Two burners are used to create a nearly uniform temperature within the furnace. One burner is located at the bottom front of the right side of the furnace; the second burner is located at the bottom rear of the left side of the furnace. The furnace exhaust is located nominally in the center of the rear side of the furnace, opposite the vertical sample location. A negative pressure was generally maintained throughout operation of the furnace in order to limit the smoke emitting from the test sample into the laboratory space. A photograph of the furnace used in this test series is shown in Figure 3-5. The negative pressure within the furnace was kept low in order to minimize effects on combustion of the wall assembly.

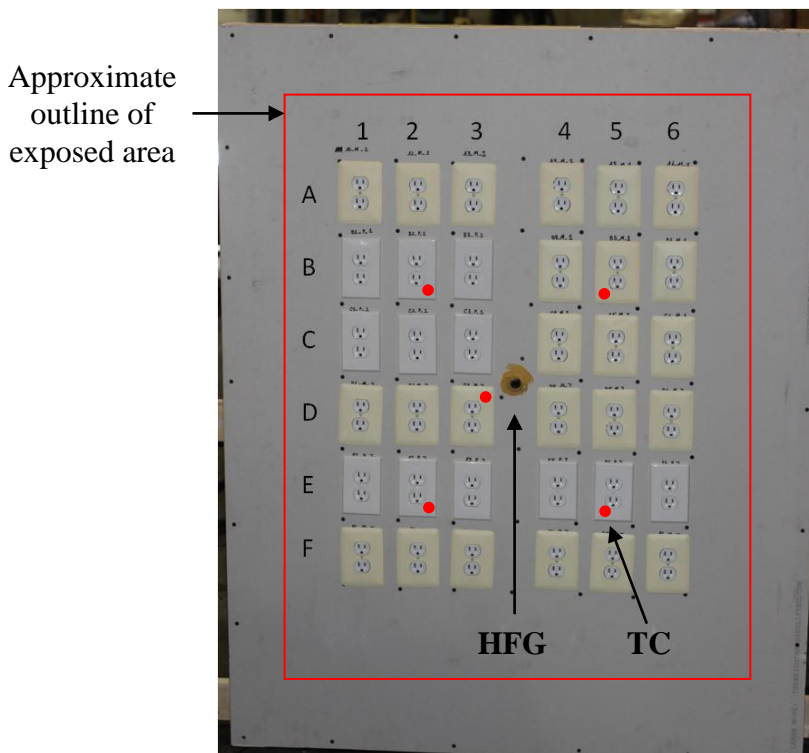
Figure 3-6. Photograph of wall assembly, elevation view, showing location of instrumentation and approximate outline of the exposed area.

Receptacles were placed in a grid such that they were spaced approximately 12.7 cm (5.0 in.) on center horizontally and approximately 15.2 cm (6.0 in.) on center vertically. Outlet boxes were attached to the vertical studs using two built-in nails. The receptacles were mounted to the outlet boxes using two machine screws supplied with the receptacle and oriented such that the grounding slot was at the bottom of each outlet. For the furnace fire testing, all of the receptacles were installed in metal boxes. Only metal boxes were used because at the elevated temperatures in these tests, it was assumed that using plastic boxes would make identification of the receptacle remains very difficult and possibly allow the receptacles to fall out of the wall assembly and into the furnace; the steel outlet boxes provided more robust mounting method for the receptacles. For convenience, a numbering scheme was used to identify the location of receptacles within the wall assembly. Rows were identified by letters and columns by numbers. Receptacles were referred to using a row-column ID (e.g., A1, A2... F5, and F6).

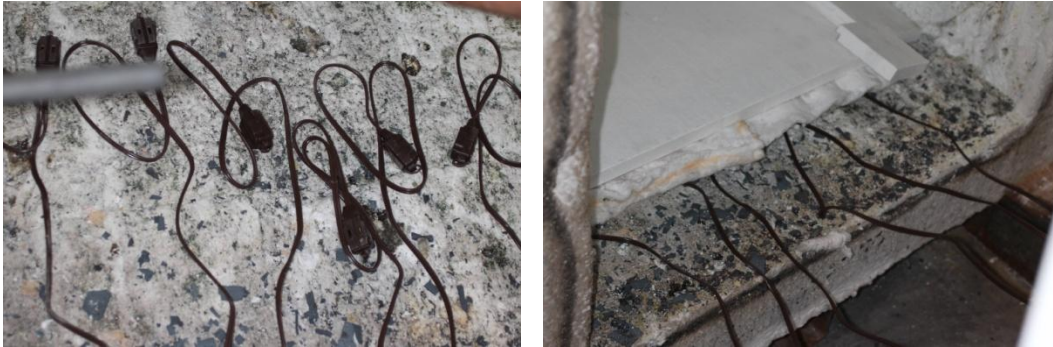
Figure 3-8. Location and arrangement of extension cords in furnace (left) and insulation placement (right).

insulation was placed over top of the cords inside of the furnace (see Figure 3-8). Because the furnace temperatures were expected to be above the melting point of copper for an extended period, the insulation was used to preserve a section of the wiring such that there would be something left to examine. Beneath the insulation, the cords were coiled and separated such that they were not touching. Approximately 0.6 m (2.0 ft) of the extension cord was left exposed.

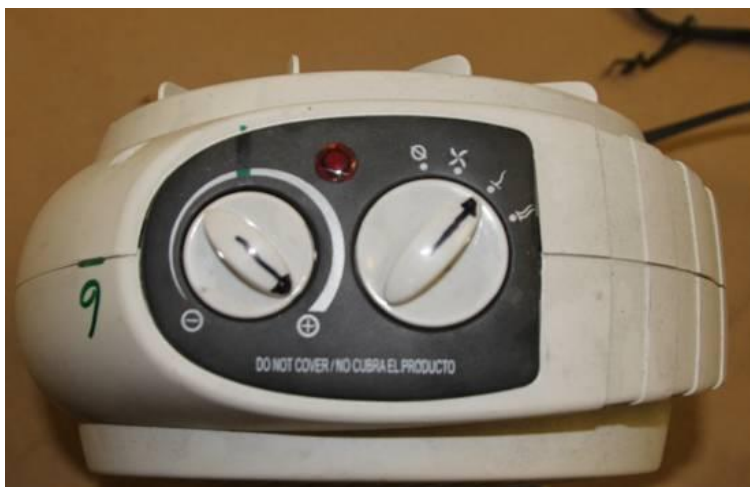
Figure 3-9. Heater setting for compartment fire tests.
