Document Title: Development and Analysis of Electrical Receptacle Fires

Author(s): Matthew E. Benfer, Daniel T. Gottuk

DEVELOPMENT AND ANALYSIS OF ELECTRICAL RECEPTACLE FIRES

Laboratory testing evaluated the impact of a wide range of variables on the formation of overheating connections in residential duplex receptacles. Two types of receptacle configurations have been evaluated: 1) those focused on terminal connections and 2) those focused on plug connections. Testing included 528 receptacle trials, 408 trials with various terminal connections and 120 trials with various plug connections. Thirteen pre-fabricated wall assemblies of 36 receptacles were placed in 8 compartment fire tests and 5 furnace fire tests. The variables evaluated in the fire exposure testing included: the receptacle material, materials of the receptacle faceplate and box, terminal torque, and energized state of the receptacle. A portion of the receptacles in the fire exposure testing had overheated connections that were created in the laboratory testing. These receptacles were used to assess whether evidence of overheating would persist after a fire exposure. All receptacles were documented for damage to th

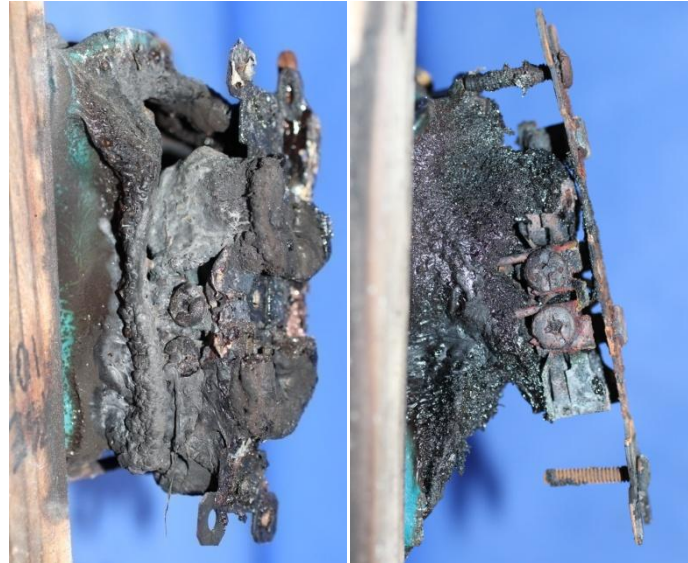
Figure 3-10. Thermal damage to PVC receptacles: mostly consumed (PSE101, left) and totally consumed (PSE137, right).

Figure 3-10 shows photographs of the thermal damage to two PVC receptacles exposed to two different fire scenarios but which have approximately equal integrated heat flux values. Both receptacles were installed in PVC outlet boxes with steel faceplates. Table 3-3 presents the integrated, maximum, and average heat flux values as well as the average and maximum temperature values measured for both receptacles. Visually, it is quite easy to see that the thermal damage to the two receptacles is different. Each measurement of thermal environment presented herein has its drawbacks. The integrated heat flux values do not illustrate the differences in thermal damage, but the average and maximum temperature and heat flux values do a better job. The differences between the maximum heat flux values and temperature values are more pronounced than for the averages. However, the maximum values do not account for duration of the exposure. Average values, on the other hand account for the exposure duration, but smooth out peak values.

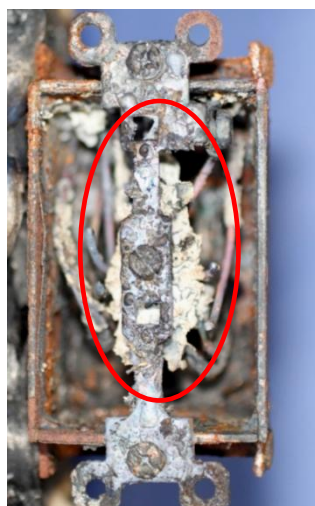
Figure 3-17. Photograph of totally consumed PVC receptacle with copper melting (PSE385) showing remaining char.

As PVC receptacles were heated by the fire exposures, they would brown, bubble, deform, and char. This was somewhat similar to the damage created by overheating (see Section 2.3.3.1). The six damage categories for PVC receptacles are defined in Table 3-6. Figure 3-16 shows the progression of fire damage for a series of PVC receptacles. The damage to the receptacles was relatively uniform across the face of the receptacle and progressed evenly from front to back. PVC receptacles heated by fire did not tend to exhibit sagging of the plastic materials which was seen for the overheating connections (see Figure 2-30, right). The body materials would deform such that straight edges would become wavy (see Figure 3-16, partially consumed), but no effects of gravity were apparent. This is possibly due to the relatively short time scale of the fire exposures (i.e., minutes) versus the longer time scales for overheating (i.e., days). Over shorter time periods, at temperatures above those that cause charring, the PVC does not have enough time to begin sagging because the receptacle will char. The PVC char is more rigid than the softened plastic. In all cases, some of the charred receptacle remained in the outlet box after the fire exposure and tended to retain a rectangular shape. When the receptacle was considered totally consumed or the brass or copper melted, the receptacle tended to be a clump of white char located behind the grounding strap (see Figure 3-17). The char was generally unrecognizable from the original receptacle.

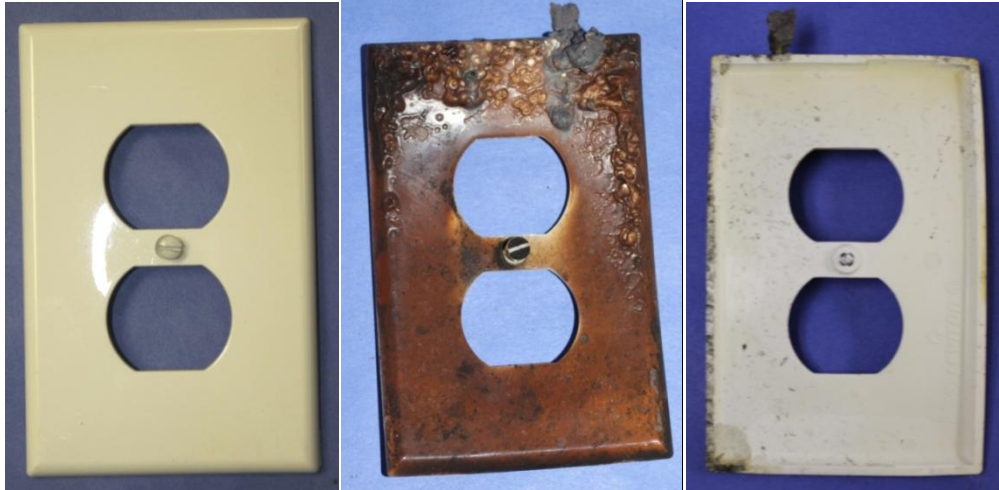
Figure 3-21. Photographs of damage progression in nylon faceplates, exemplar (left) and blistered/partially melted front (center) and back (right).

The damage to the nylon faceplates was relatively uniform across the face of the faceplate. The damage to the nylon faceplates included the plastic discoloring to brown, blistering on the surface, and curving of the faceplate away from the wall. The two damage categories for Nylon faceplates are defined in Table 3-10. As the thermal damage increased, the faceplates melted off of the receptacle, leaving nothing behind except the attaching screw. This would leave the receptacles directly exposed to the fire environment. None of the fallen faceplates were found in any discernible form from the plastic remains on the floor of the compartment or in the furnace. Even as the faceplate began to blister and discolor on the front surface, the back surface remained undamaged with minor discoloration beginning in the blistering areas on the front. Figure 3-21 shows a typical blistered/partially melted and an exemplar nylon faceplate. There were no remnants of the totally consumed faceplates.

The progression of damage to nylon faceplates from an external fire exposure was not similar to the damage created by overheating. Figure 3-22 shows the receptacle faceplates from two overheating connections, with one having had flaming ignition (right). In the center photo in Figure 3-21, there are some light areas where the faceplate remains somewhat white in color rather than brown. This was observed on all of the blistered/partially melted faceplates; this was the area of the faceplate where the receptacle behind was in contact. It is likely that the receptacle behind provided a heat sink for the faceplate. On the other hand, for faceplates used in the laboratory testing where an overheating connection was present, there was generally a darkened and charred area where the overheating receptacle would have been in contact with the faceplate (see Figure 3-22, left). This discoloration is from the heat produced by the loose connections and is much darker in color than the discoloration from the fire. It is likely that hotter local temperatures present for the overheating connections caused the dark discoloration, but because they were localized, they did not cause the faceplate to fall off.

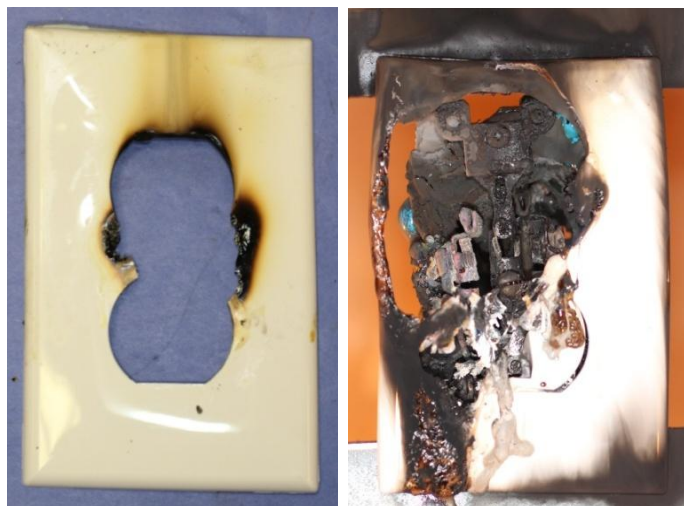
Figure 3-22. Photographs of typical faceplate damage from overheating connections: LEV171 (left) and LEV269 (right).

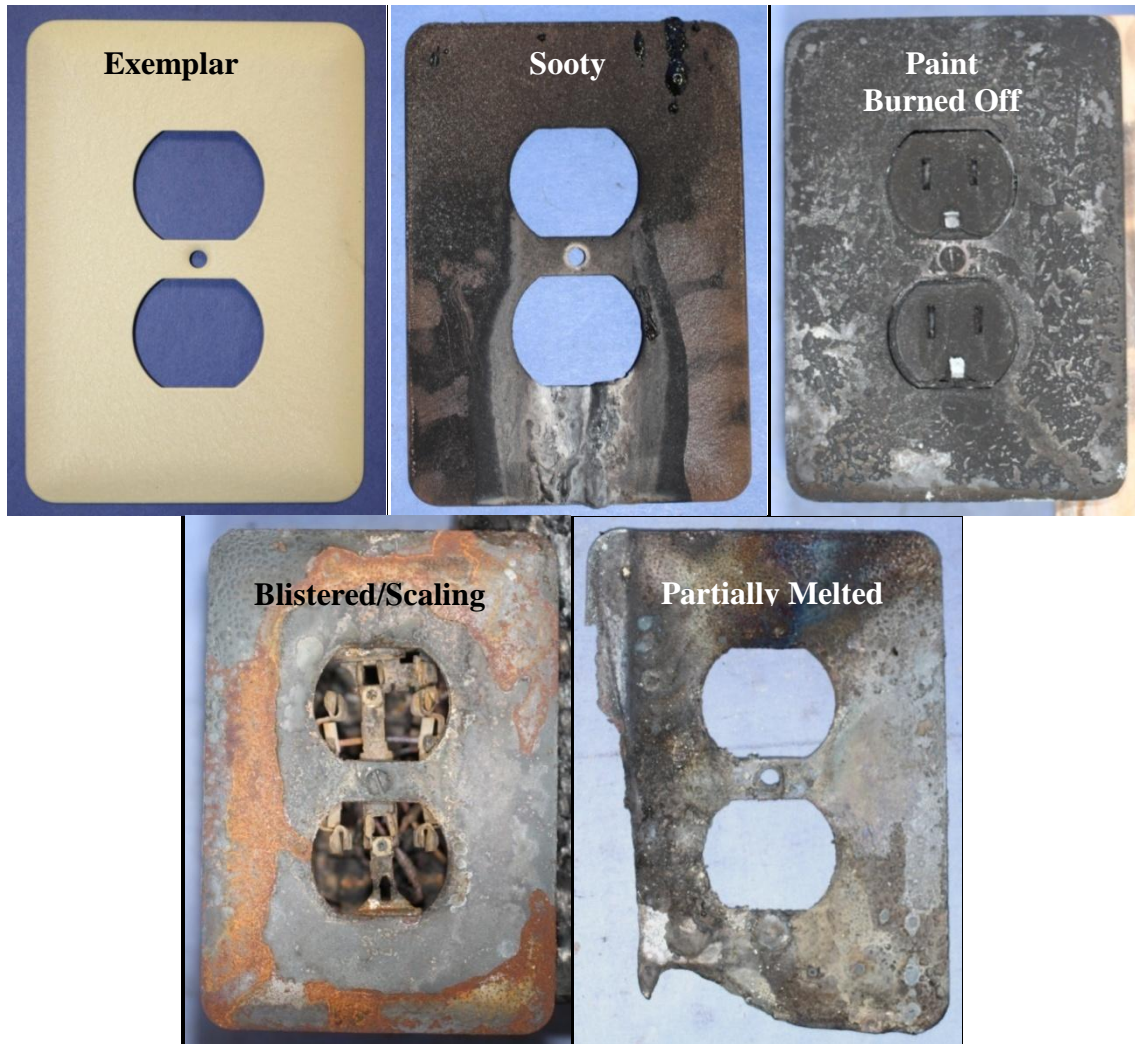
Figure 3-24. Photographs of damage progression in steel faceplates.

As steel faceplates were heated by the fire exposures, they would become covered with soot, paint decomposed (browned), paint would burn off, develop a blistered appearance and scaling, and melt. The four damage categories for steel faceplates are defined in Table 3-12. Steel faceplates were not evaluated in the laboratory testing. Figure 3-24 shows the progression of fire damage for a series of steel faceplates. The damage to the faceplates was relatively uniform across the front face of the faceplate. The damage to the steel faceplates did not progress from the front to the back in the same manner as the receptacles and outlet boxes. Since the steel faceplates were rather thin (1.06 mm (0.042 in)) compared to the other items (nylon faceplates: 0.25 cm (0.1 in.); receptacles: ~2.5 cm (1.0 in.); outlet boxes: ~7.5 cm (3.0 in.)), the damage on the front of the faceplate was often the same as on the back of the faceplate. Also, the melting of the steel faceplates occurred in localized areas rather than from front to back. The steel faceplates having blistering and scaling damage would often begin to rust after the fire exposure.

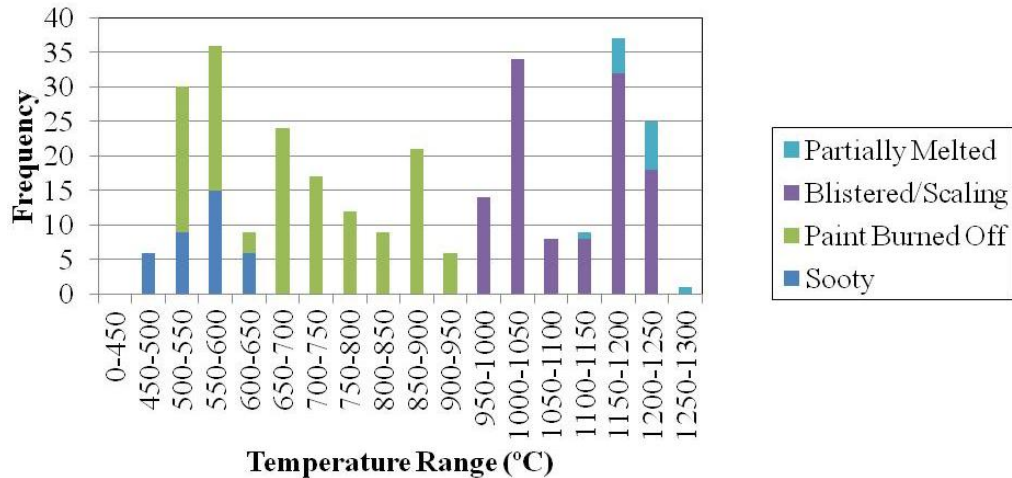
Figure 3-25. Histogram plot of damage category frequency for steel faceplates as a function of the maximum exposure temperature range.

Table 3-13 lists the minimums, maximums, averages and standard deviations for the maximum exposure temperatures for each damage category for steel faceplates. Figure 3-25 is a histogram plot of damage category frequency for steel faceplates as a function of the maximum exposure temperature range. This data is presented for all of the steel faceplates over all fire exposure testing, irrespective of the receptacle material, outlet box material, or energized state of the receptacle. In all cases some damage to the faceplate was present after the fire exposure. The average temperatures for each damage category are very distinct and increase as the damage gets more severe. There was minimal overlap between the range of maximum temperatures for the sooty/discolored and burned paint damage categories. The blistered/scaling and partially melted damage categories also overlapped somewhat. There was a distinct demarcation between the burned paint and blistered/scaling temperature ranges which corresponds to the differences in temperatures between the furnace fire exposures and the compartment fire exposures.

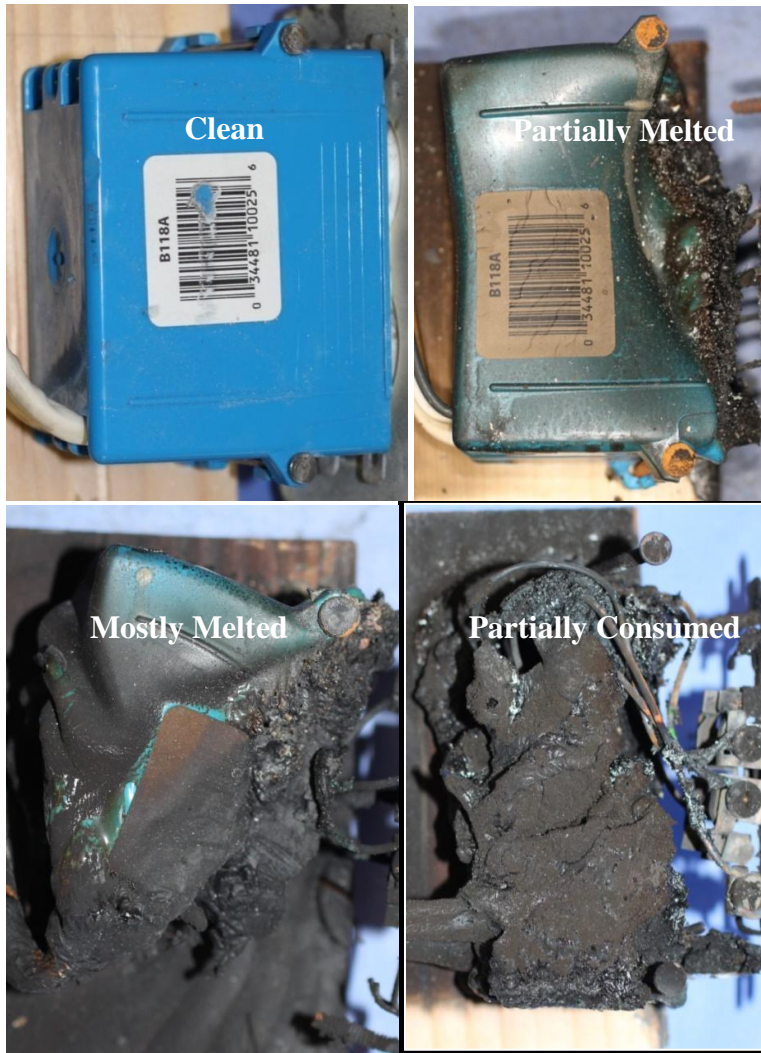
Figure 3-26. Photographs of damage progression in PVC outlet boxes (increasing thermal insult from top left to bottom right).

As the PVC outlet boxes were heated by the fire exposures, they discolored, deformed, sagged, and charred. This behavior is similar to the PVC receptacles observed in this test series (see Section 3.3.2.2). The four damage categories for PVC outlet boxes are defined in Table 3-14. Figure 3-26 shows the progression of fire damage for a series of PVC outlet boxes. Only six of the PVC outlet boxes were undamaged and free of soot deposits on the outside at the end of the fire exposure (compartment fire Test 2). These outlet boxes did have some soot inside, behind the receptacle. Three of these outlet boxes had steel faceplates (sooty) and three had plastic (blistered/partially melted); all of the receptacles were partially melted polypropylene receptacles.

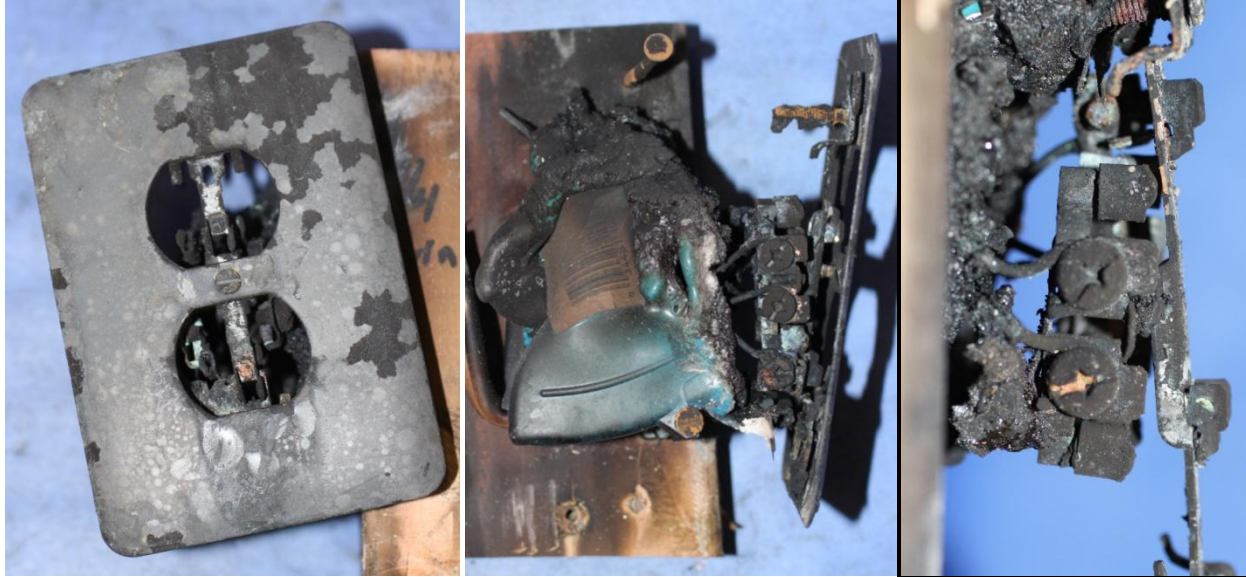
Figure 3-31. Photographs of steel faceplate (left), PVC outlet box (center) and poly propylene receptacle (LEV160, right).

A general process was developed to use the maximum exposure temperature data presented in the previous sections to assess the thermal environment based on the observed damage to the receptacle, faceplate, and outlet box. To demonstrate this process, a polypropylene receptacle will be evaluated in this section. Figure 3-31 shows the thermal damage to a steel faceplate, PVC outlet box, and polypropylene receptacle from compartment fire Test 4 (LEV160; location E-1).

The first part of this process was to classify the thermal damage to the receptacle, faceplate, and outlet box based on the definitions presented in the previous sections. The steel faceplate had the paint burned off and did not exhibit any blistering, scaling, or melting. The PVC outlet box had considerable melting and deformation, but some of the color was still visible and the box partially retained its shape. This level of damage would be considered mostly melted. The polypropylene receptacle had been totally consumed; no plastic from the receptacle remained attached to the brass contacts; and neither the brass contacts nor the copper wiring exhibited evidence of melting from the fire. The second part of this evaluation was to gather the maximum exposure temperature ranges (i.e., the average ± 1 standard deviation) for the damage categories determined for the receptacle, faceplate, and outlet box. This data is presented in Table 3-18 for the components making up the LEV160 receptacle installation.

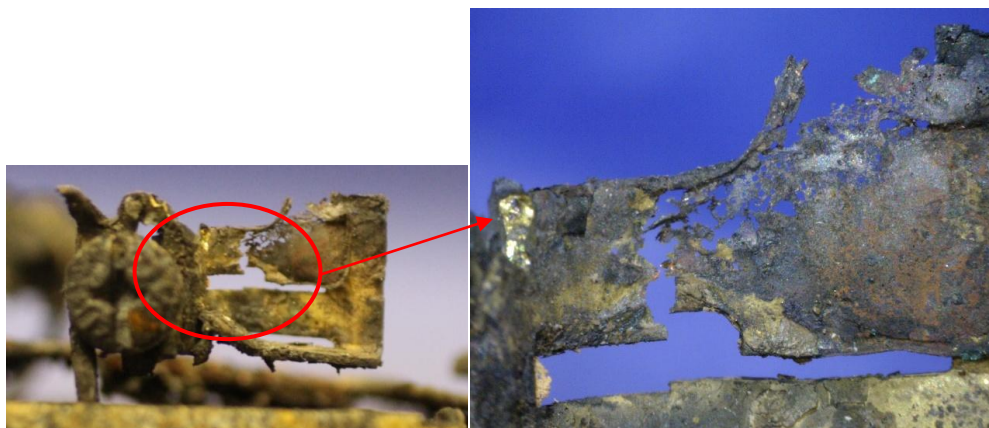
Figure 3-36. Photograph of melted brass receptacle contact showing thinning of contacts and holes (PSE373, non-energized).

The appearance of the thinned contacts from oxidation and overheating is different than the thinned contacts from melting (see Figure 3-33, Figure 3-36, and Figure 3-39). The thinned contacts from melting tend to be a result of the molten brass running down the contacts. As a result of this, internal contacts that have melted will also generally be thicker than original at some point. The thinned contacts were only viewed after the furnace exposure and as such it is unclear whether or not they had changed due to the furnace exposure. However, due to the lack of melting of the internal plug contacts in these three receptacles, it is unlikely that the appearance changed as a result of the furnace exposure. This thinning was also not in the vicinity of the locations where arcing was observed to occur.

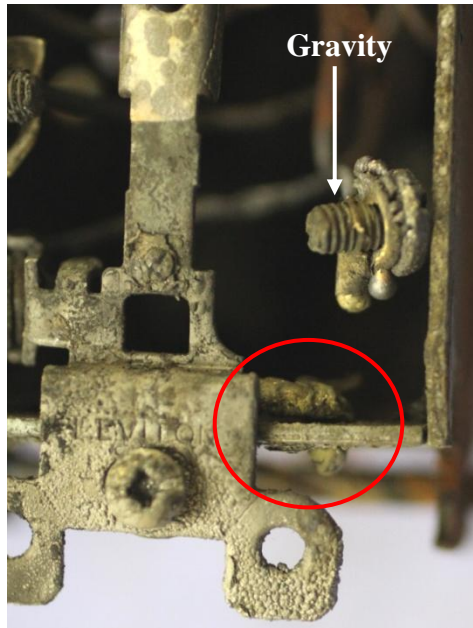
Figure 3-38. Photograph of melted brass receptacle contact showing round globules, effects of gravity and dripping brass (LEV363, non-energized).

Even when the brass contacts are mostly melted from around the screw terminal, there may still be effects of gravity evident. Figure 3-38 shows the effects of gravity on the melted brass receptacle contacts from a non-energized polypropylene receptacle. The brass that is remaining on the screw terminal is not recognizable from the un-melted contacts; there are only two globules hanging from the screw that remain. Below the original location of the brass contact a pool of solidified brass can be seen at the bottom of the outlet box (solid circle). During the test, it appears that the brass also began to flow and drip through a hole in the bottom of the outlet box. Figure 3-39 shows the flow of melted brass for a non-energized polypropylene receptacle; the brass around the top terminal is thinned, pitted, and has a hole, while the brass around the bottom terminal is thicker and forms a round globule. This globule is very rough in appearance and the melting of the brass extends over the majority brass contact.

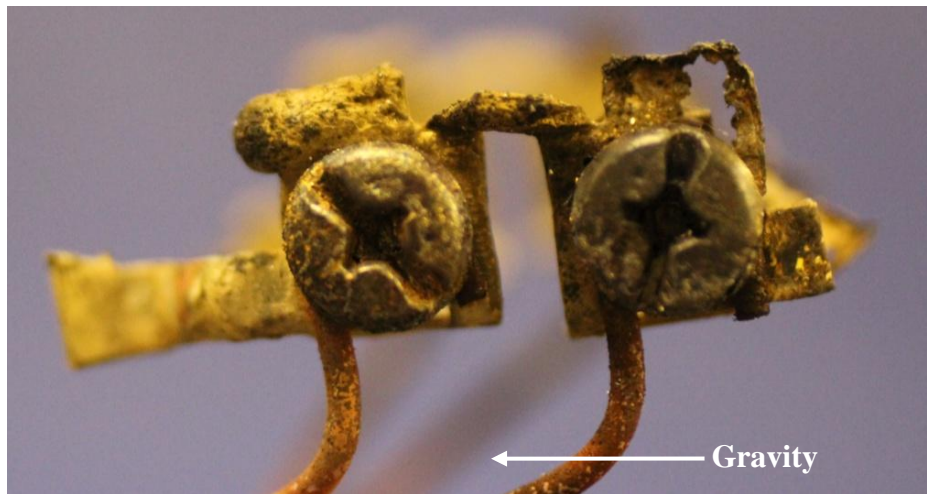
Figure 3-39. Photograph of melted brass receptacle contact showing round globule and effects of gravity (LEV354, non-energized).

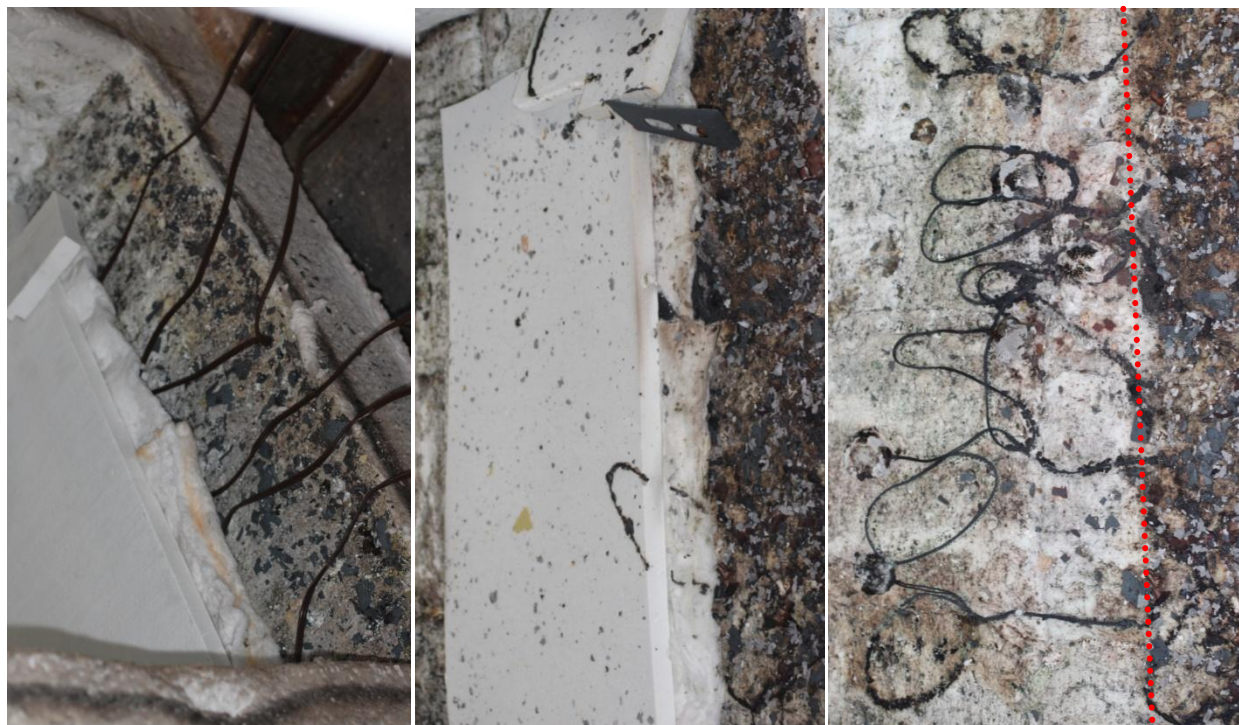
Figure 3-40. Extension cord wiring covered with insulation prior to test (left), with insulation after test (center) and with insulation removed (right) after furnace Test 4.

Melting of solid copper wiring attached to receptacles and stranded copper wiring from extension cords was observed in some of the furnace fire exposure tests. In general, the melting of solid copper wiring attached to receptacles occurred uniformly across the exposed area. Melting of stranded copper wiring was quite extensive in the furnace fire exposures. This was due to the location of the wiring in the direct pathway of the burner at the front of the furnace near the wall assembly (see Figure 3-8). As a result, the majority of extension cord wiring was completely melted up to the point where it went beneath the ceramic insulation (see Figure 3-40). Melted copper conductors had various appearances including tapered ends, flat ends, pointed

Due to the location of the extension cords in the path of the burner (see Figure 3-40), there was not much melted stranded wire remaining from the furnace fire tests. Melting of stranded

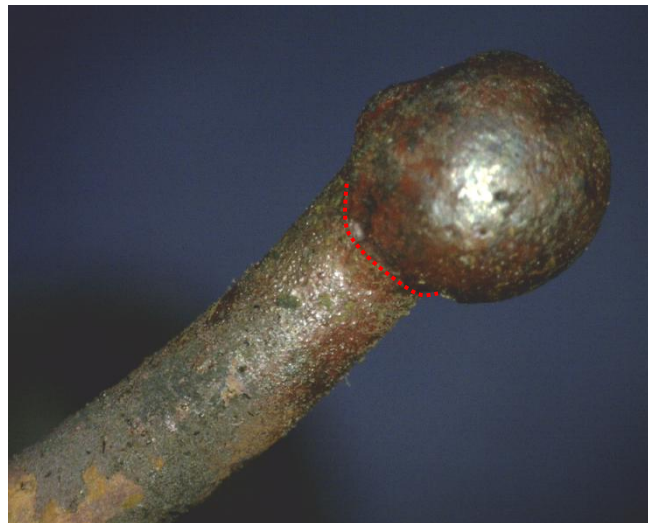
Figure 3-41. Melted copper wiring from a non-energized polypropylene receptacle showing line of demarcation (LEV389).

A clear line of demarcation between damaged and undamaged areas is an accepted indicator of arc melting. However, in a few cases this characteristic was observed in cases of melted copper. For instance, Figure 3-41 shows a wire from a non-energized polypropylene receptacle that has a round globule at one end. This globule has a rather distinct line of demarcation between it and the un-melted wire (shown as a dashed line). Evaluating this piece of evidence based on the clear line of demarcation alone could lead one to believe that the globule was from arcing. However, there was other clear evidence of copper melting due to fire exposure that was observed for this receptacle. Had the energized state of the receptacle been unknown during the evaluation, this piece of wire would have been a potential arcing location having extensive thermal damage. Figure 3-44 (left) shows another instance of a clear line of demarcation between the damaged site (i.e., the flat end) and the undamaged conductor. Also, faint copper drawing lines can be seen extending from the damaged area. Again, additional evidence (see Figure 3-44 center and right) from the receptacle and knowledge that the receptacle was non-energized, clearly indicates that melting of copper conductors from the fire has occurred and not arcing. These pieces of evidence do not suggest that the characteristics of a clear line of demarcation and copper drawing lines extending from the area of damage are not indicators of arcing. But, they

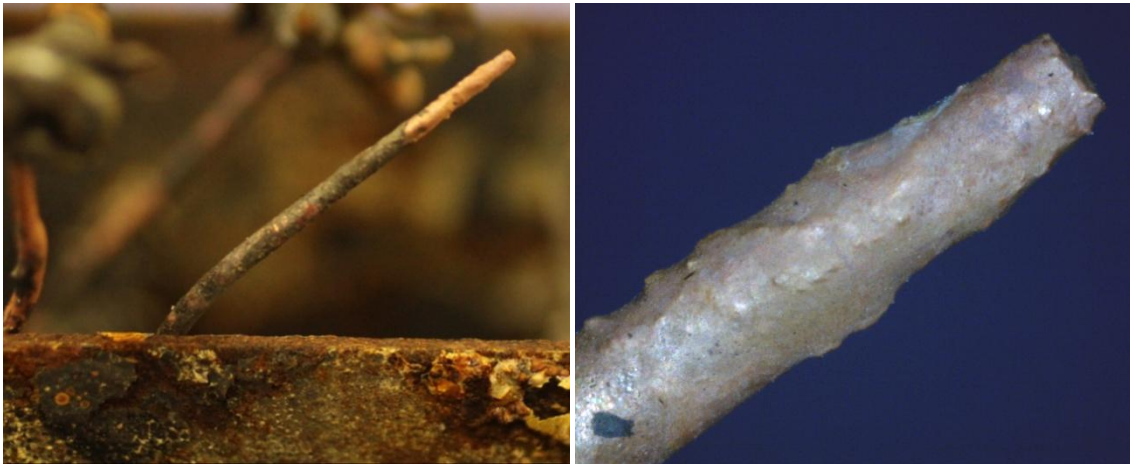
Figure 3-43. Photographs of melted copper wiring from a PVC receptacle showing tapered shape, irregular surface, and flat end (energized, PSE369).

Figure 3-43 shows an irregular, bumpy, and slightly tapered copper wire with a relatively flat surface at the end. Figure 3-44 shows three different examples of melted copper wiring were found from a single non-energized polypropylene receptacle (LEV371). The left image shows a wire with a flat end. This wire has a rather distinct line of demarcation between the melted area and the un-melted wire, with the copper drawing lines somewhat visible. The flat side of the wire is rough and with many divots; Figure 3-45 shows another example of this. The center photograph in Figure 3-44 shows a wire with a pointed end having a clear line of demarcation between the un-melted wire and the melted area. The surface of the end of the wire is rather smooth and rounded. The third melted copper wire from LEV371 has the more typical appearance of a melted copper wire with the irregular tapered end that has some pitting. The fourth conductor from LEV371 was located at the bottom of the outlet box, partially melted but still attached to the screw with a melted brass globule.

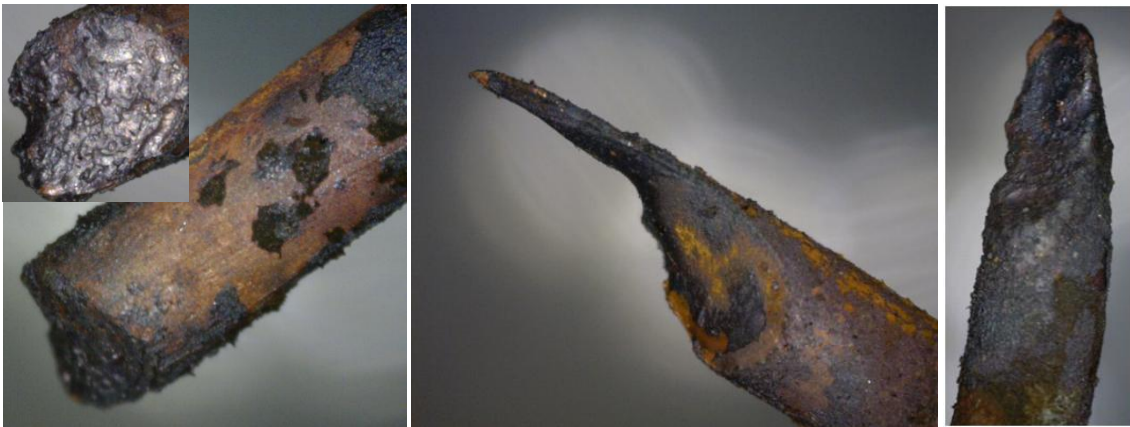
Figure 3-44. Photographs of three melted copper wire ends from a single non-energized polypropylene receptacle (LEV371): flat (left with blowup of flat face), pointed (center), and tapered (right).

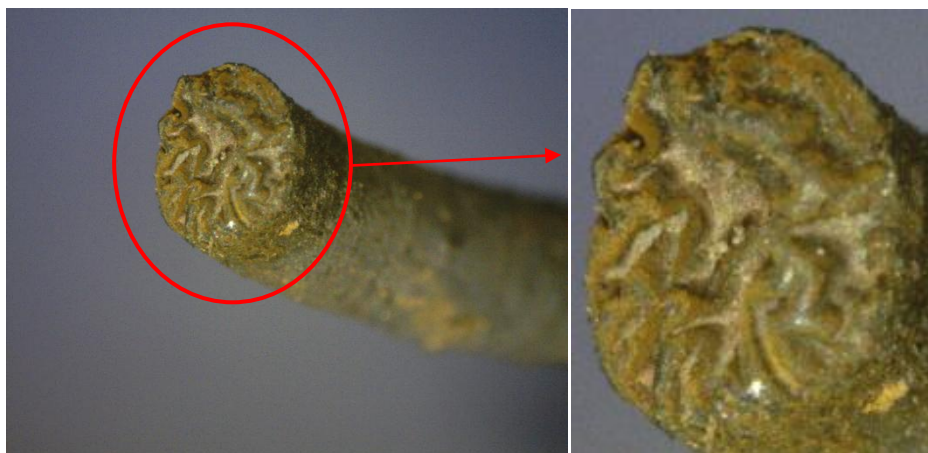
Figure 3-45. Photograph of melted copper wiring showing a flat end with pitting from a non-energized PVC receptacle (PSE384).

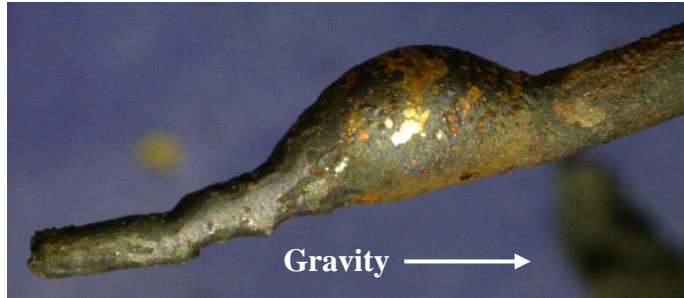
Figure 3-48. Photograph of melted copper wiring showing irregular end and effects of gravity from a non-energized PVC receptacle (PSE386).

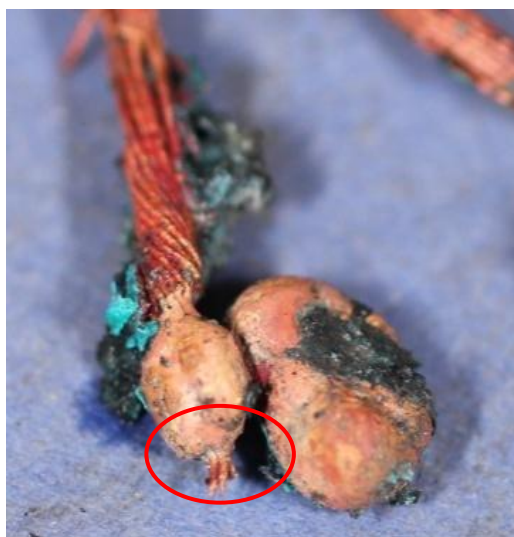
Figure 3-50. Photograph of melted stranded copper wiring for an energized extension cord from a thermoset receptacle; wire strands running through melt globule circled in red (E098).

wiring was observed with some similar characteristics as melted solid wiring. However, the difference in configurations between the solid (in an outlet box) and stranded (in the open) wiring meant that some of the unique melted copper evidence shown for the solid copper wiring did not appear for the stranded wiring. For example, the flat wire ends, severe pitting, clear line of demarcation, and copper drawing lines visible outside the damage area were generally not observed for the stranded wiring. The majority of melted stranded wiring had rough round globules at the end of the wire such as the one pictured in Figure 3-50. The two globules are rather large compared to the size of the wire and the wire strands actually run through the smaller of the globules. Some of the melted stranded wiring exhibited partially fused strands in the vicinity of the melted globule (see Figure 3-51). This is also an indication that the damage is not localized and that there is not a clear line of demarcation between the un-melted and melted sections of wiring.

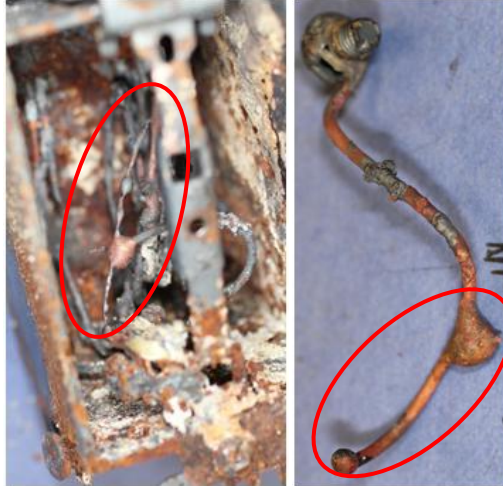
Figure 3-53. Photographs of melted copper wiring from energized polypropylene receptacles LEV398 (left) and LEV400 (right).

Pitting of copper conductors ranged from small divots over the surface of the melted conductor to extensive pitting that left the wiring very porous. Figure 3-46 shows an irregular shaped end of a melted copper wire attached to the terminal screw. The melted conductor has an area of small pits and large overall divots that give the irregular appearance. Severe pitting of the melted copper conductors was observed in only a few cases. In these cases, the majority of copper wiring in the outlet box was melted. Figure 3-47 shows a photograph of an outlet box that with the melted wire contained inside (left) as well as a blown up photograph of the severely pitted copper wiring (right). This outlet box had an energized polypropylene receptacle installed. The photograph of the outlet box also shows the effects of gravity on the melted copper that has been deposited and pooled in the bottom right of the outlet box. The severely pitted wiring retained its original shape, but became very porous. It is unclear exactly what conditions would cause this to happen, but the surface of this wire does appear to have a significant layer of cuprous oxide (rust/orange color). Effects of gravity in copper wiring were observed as round globules extended down the copper wiring and pools of copper deposited in the bottom of outlet boxes. Figure 3-48 and the right photo in Figure 3-53 show two instances of round globules of melted copper on un-melted wire.

All but two receptacles that had brass or copper melting had fire exposure temperatures greater than the melting point of the brass or copper, respectively. These two receptacles, LEV398 and LEV400, had significant copper melting but had maximum exposure temperatures of 1000 and 1055°C, respectively (see Figure 3-53). Melting of steel faceplates at temperatures lower than the melting points was also observed (see Section 3.3.3.2). Both receptacles were energized polypropylene receptacles, installed in steel outlet boxes with steel faceplates. Also, both receptacles had solid, plated plugs installed. Maximum exposure temperatures were calculated using the furnace characterization tests (see Section 3.3.1.1.1). However, the furnace characterization was conducted with an inert wall assembly that did not burn, while the furnace fire tests, on the other hand, were conducted with receptacles, wood studs, and wiring insulation that did burn. It is possible that the contribution of the burning receptacles, wiring, and/or faceplate materials produced higher temperatures within the outlet boxes for some receptacles causing the copper to melt. The differences between the maximum exposure temperatures in these two cases and the melting point of copper were 25°C and 80°C; these differences are not that large.

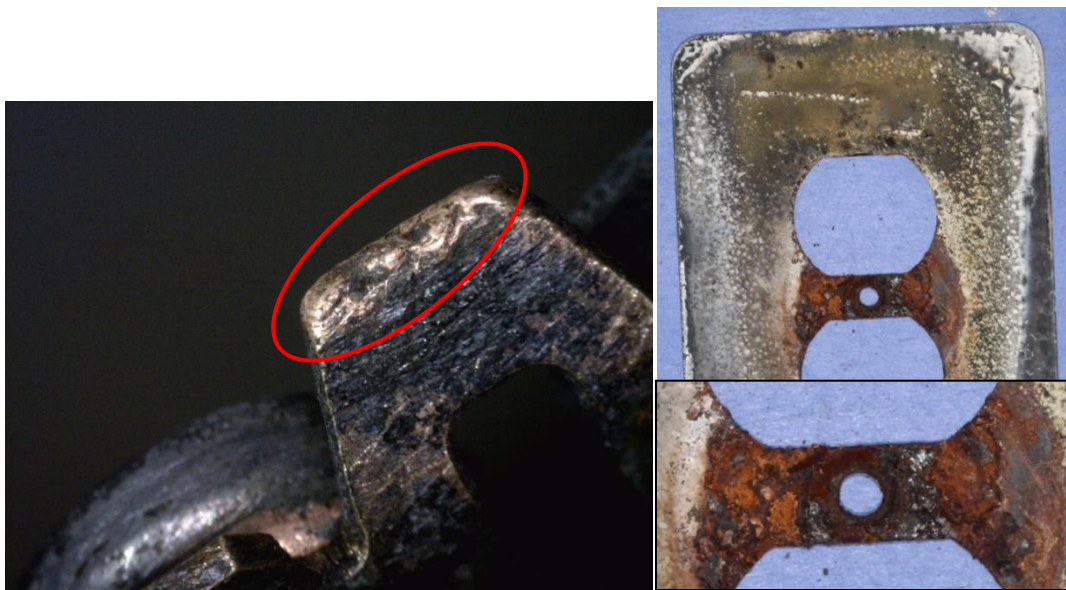
Figure 3-56. Photos of possible arcing damage on break off tab of energized PVC receptacle (PSE251, left) and rusted steel faceplate (right).

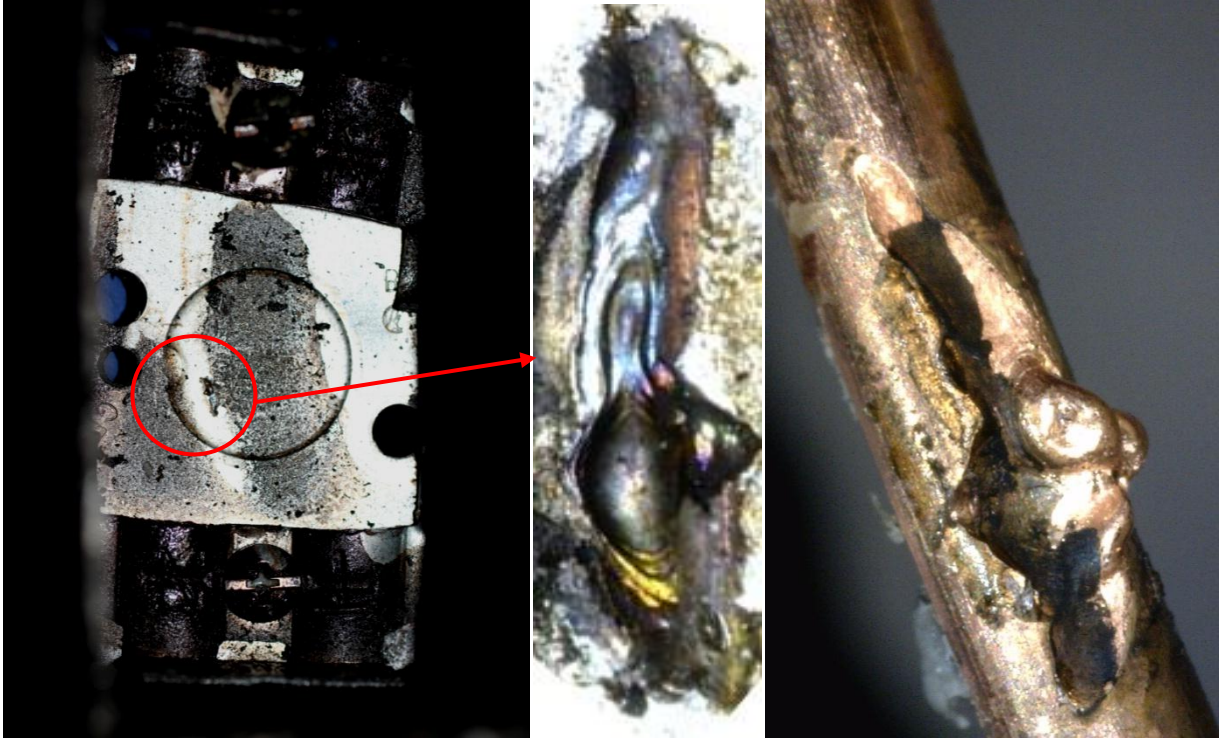
Figure 3-64. Photographs of damage from arcing between the hot copper conductor (right) and grounded steel outlet box (left and center) for a thermoset receptacle (D012).

Recognizing that the damage from fire melting of brass and copper tends to be spread somewhat uniformly over the conductors, it becomes important to establish that arcing evidence exhibits a localized area of damage where the conductors have contacted. The brass and steel components of receptacles are stamped and bent during manufacturing, which leads to rather sharp and defined edges being present on the components. Sometimes these components will also be stamped with lettering. When an arc occurs in the vicinity of these edges or lettering, the edges and lettering will remain defined and undamaged outside of the arcing location. The grounding straps and female contacts shown with arcing damage in Figure 3-61 and Figure 3-62 all have clearly defined edges of the metal components immediately outside of the arc location. This is also exhibited for the lettering on the brass break off tab in Figure 3-59, the steel outlet box in Figure 3-64, and the plug contacts and faceplate in Figure 3-60. A similar indicator of the lack of melting on copper wiring is the visibility of the copper drawing lines immediately outside of the arc location. These lines are formed as a result of the extrusion process used to manufacture copper wiring. These lines or striations are visible on the copper wiring in Figure 3-64.

The interior and exterior surfaces of the steel outlet boxes used in this testing were plated with zinc for corrosion resistance. At fire exposure temperatures up to 883°C, this plating will remain (see Table 3-17). This would suggest that if the zinc plating remains on the steel, the exposure temperatures would have likely been below the melting point of brass and copper (i.e., 930°C and 1080°C, respectively). This metric can also be helpful in assessing whether melting likely produced the evidence at hand. Figure 3-64 shows arcing damage from the contact between the hot copper conductor and the steel outlet box. The outlet box has damage (i.e., a shallow notch with a bead) quite similar to shape and position as the damage on the copper wire (i.e., a shallow notch with a bead). The plating on the outlet box is still intact as evidenced by its overall shiny appearance.

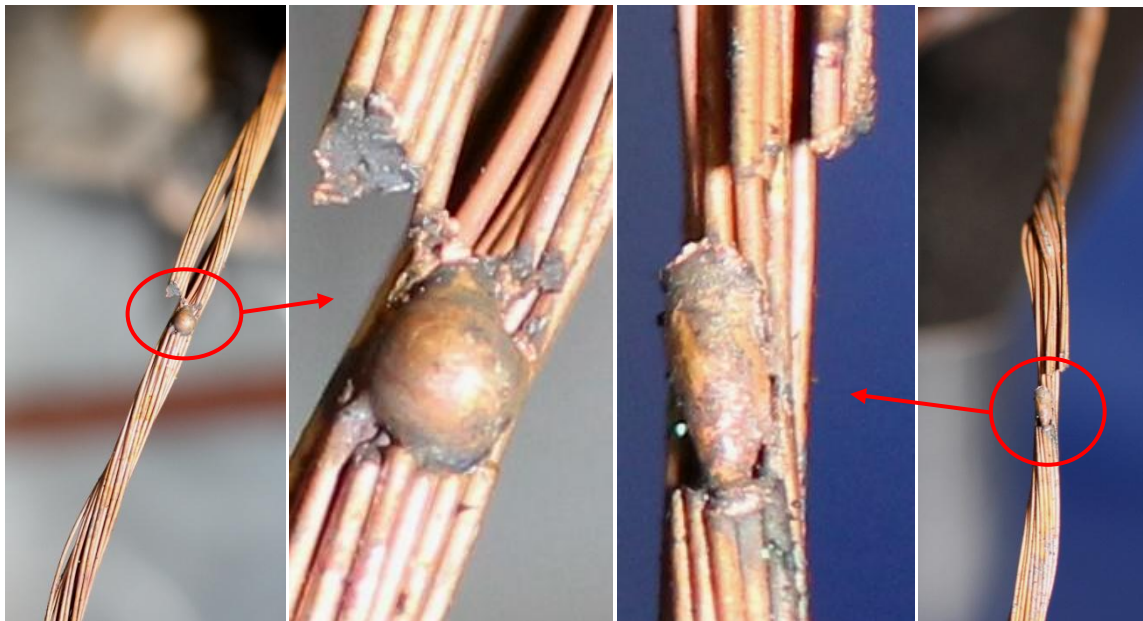
Figure 3-68. Photographs of arcing between stranded hot and ground wires from an extension cord attached to a polypropylene receptacle (LEV340).

Arcing in stranded copper extension cords produced much the same characteristic traits as the solid copper wiring, brass receptacle components, and steel items. Three cases of arcing in stranded wiring are shown in Figure 3-66, Figure 3-67, and Figure 3-68. All of these arcing instances exhibit corresponding damage on both conductors as well as clear lines of demarcation between the damaged and undamaged areas. None of these extension cords show signs of melting. Severing of some or all of the wire strands was observed in arcing for stranded extension cords. The severed strands also exhibited clear lines of demarcation and mechanical breakage and melting could be ruled out as the cause of severing based on the appearance of the strands. The beads within the notches of the stranded wires were round and relatively smooth. Figure 3-69 shows the two ends of a severed neutral wire from a stranded extension cord. There is a rather large bead on one end but more of a notch on the other. The scanning electron microscope (SEM) images of the two sections of wire accentuate the lines of demarcation between the arc location and the undamaged strands, which is difficult to visualize in the photographs due to some debris.

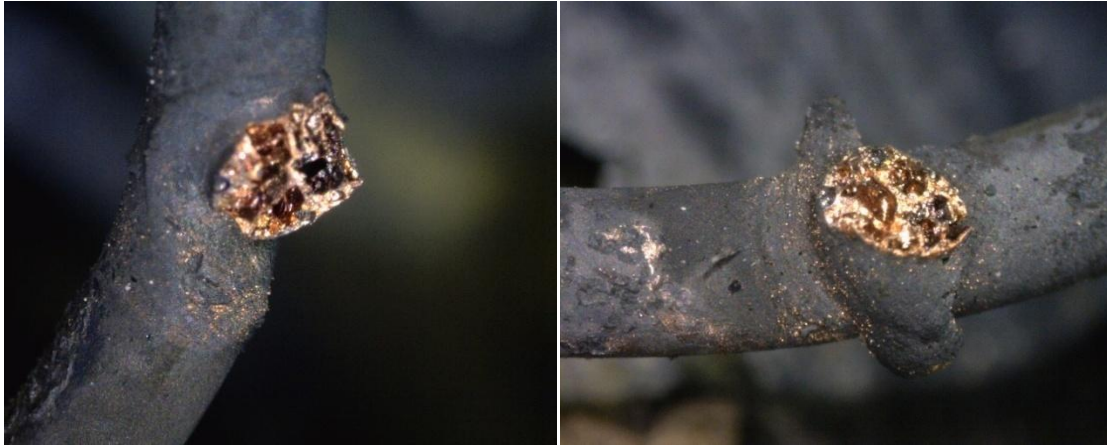
Figure 3-70. Photograph of arcing in receptacle hot and neutral wires showing internal porosity from a thermoset receptacle (B020).

Some of the arcing locations in receptacle and extension cord wiring had the two wires fused together by the arcing such as those shown in Figure 3-66. During the examination of some of these wire pairs, the two wires broke apart, revealing the internal structure of the arc bead. Two cases of arcing in receptacle wiring with fused beads that separated are shown in Figure 3-70 and Figure 3-71. Both of these instances show rather large voids within the bead that connected the two wires. The presence of high internal porosity within copper arc beads compared to low internal porosity in melted copper has been studied in the literature (see Section 1.1.5), but there have not been any studies which attempt to quantify this difference. In addition, there has been no systematic study of whether arcing damage in brass or steel exhibits similar porosity characteristics as those proposed by some researchers for copper. Internal porosity in arcing damage produced in testing was further examined in Section 4.6.

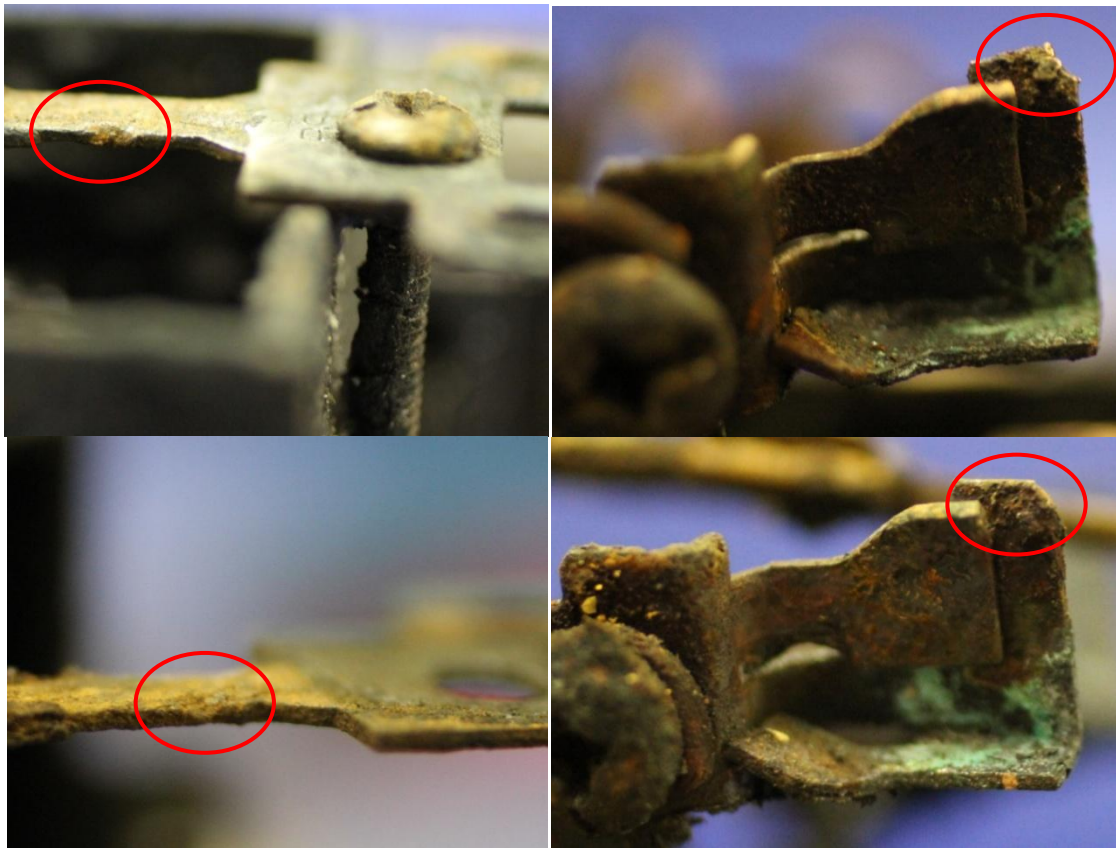
Figure 3-75. Arcing damage from PVC receptacles PSE248 (top left and right) and PSE249 (bottom left and right).

There was only one direct comparison between a receptacle having two faults before tripping and one having only one fault before tripping where the arcing occurred in the same location. The arcing damage for PSE248 (2 faults) and PSE249 (1 fault) is shown in Figure 3-75. Both receptacles have a small notch on the ground strap and on the top inside of the internal plug contacts. The damage for the two receptacles looks remarkably similar although the damage on the ground strap for PSE249 is difficult to see due to the presence of some rust. Based on these two receptacles, there does not seem to be any indication that the occurrence of two faults before the circuit breaker tripped versus only one fault occurring has any impact on the visual evidence of arcing. However, this is only one case.

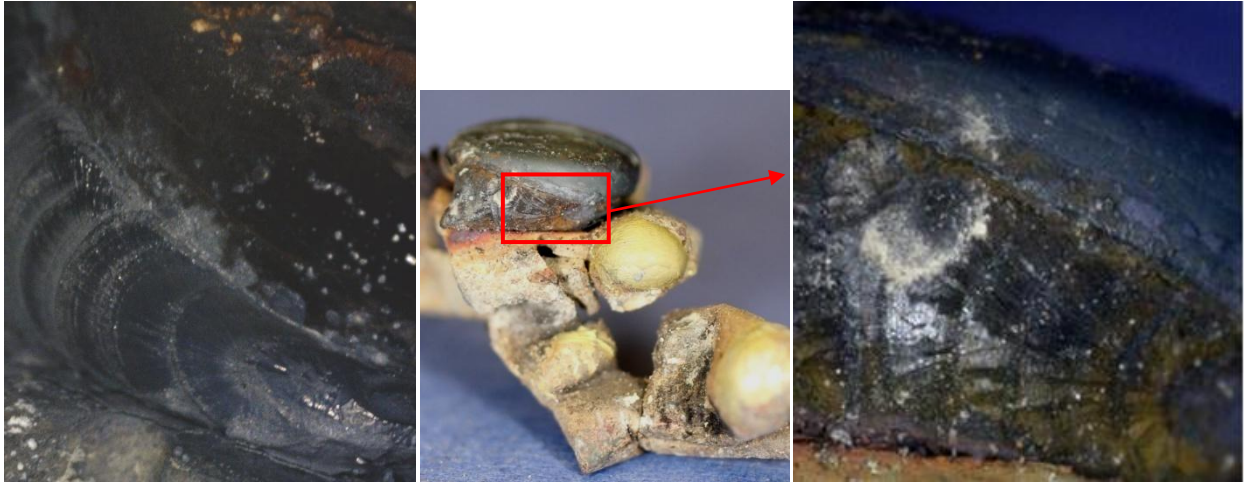
Figure 3-76. Welded conductor with curved striations from a thermoset receptacle before (left) and after (center, right) furnace fire exposure (E002); melting of brass contacts (center).

Twelve receptacles with a total of thirteen combined welded conductors were exposed to furnace fire Test 5. Of these thirteen welded conductors, 11 had curved striations visible prior to furnace exposure. After the furnace fire exposure, all of the welded conductors remained identifiable. However, the curved striations could only be identified on nine out of the 11 welded conductors that previously had curved striations. In general, the curved striations became more difficult to see after the furnace exposure. Figure 3-76 and Figure 3-77 show two welded conductors with curved striations before and after the furnace exposure. Even though the brass contacts had begun to melt beneath the melted copper conductor in Figure 3-76, the welded conductor did not show any visual damage. There was some surface discoloration and the welded conductor became somewhat shinier. The welded conductor in Figure 3-77 appears to be redder in color and the curved striations became somewhat more dulled. It is possible that the red discoloration is copper oxides produced by the fire heating.

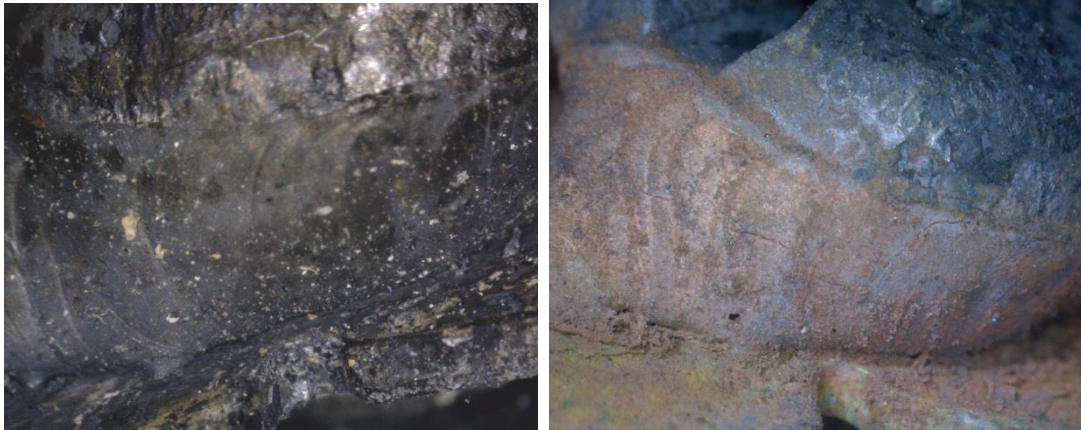
Figure 3-77. Welded conductor with curved striations before (left) and after (right) furnace fire exposure (LEV272)

The welded conductor after the furnace exposure in Figure 3-78 (center) appears to be rather similar to the one shown in Figure 3-77 (right) in terms of the red surface appearance. This
