Document Title: Development and Analysis of Electrical Receptacle Fires

Author(s): Matthew E. Benfer, Daniel T. Gottuk

DEVELOPMENT AND ANALYSIS OF ELECTRICAL RECEPTACLE FIRES

Laboratory testing evaluated the impact of a wide range of variables on the formation of overheating connections in residential duplex receptacles. Two types of receptacle configurations have been evaluated: 1) those focused on terminal connections and 2) those focused on plug connections. Testing included 528 receptacle trials, 408 trials with various terminal connections and 120 trials with various plug connections. Thirteen pre-fabricated wall assemblies of 36 receptacles were placed in 8 compartment fire tests and 5 furnace fire tests. The variables evaluated in the fire exposure testing included: the receptacle material, materials of the receptacle faceplate and box, terminal torque, and energized state of the receptacle. A portion of the receptacles in the fire exposure testing had overheated connections that were created in the laboratory testing. These receptacles were used to assess whether evidence of overheating would persist after a fire exposure. All receptacles were documented for damage to th

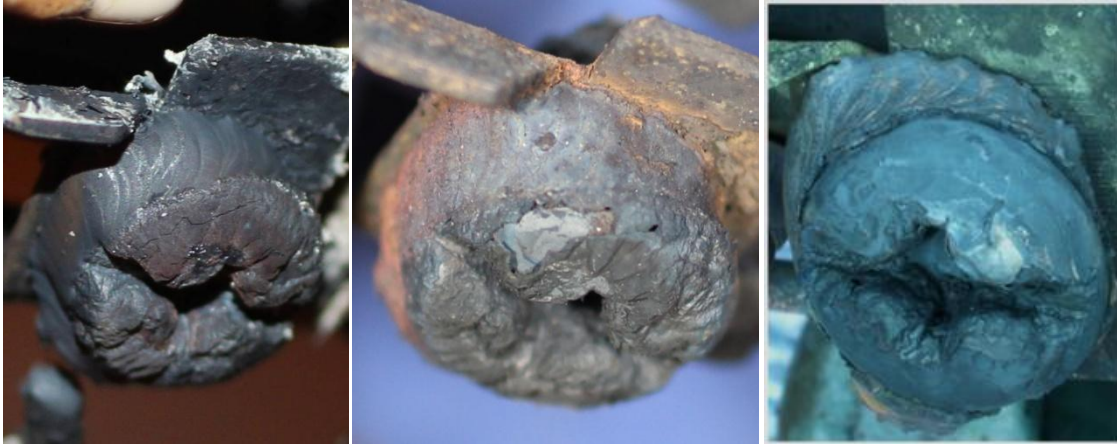
Figure 3-78. Welded conductor with curved striations before furnace exposure (left), after furnace exposure (center), and after furnace exposure with ultrasonic cleaning (right), (LEV275).

The welded conductor after the furnace exposure in Figure 3-78 (center) appears to be rather similar to the one shown in Figure 3-77 (right) in terms of the red surface appearance. This

welded conductor (LEV275) was ultrasonically cleaned in a mild detergent and re-examined. The image of the cleaned conductor in Figure 3-78 (right) shows that underneath the surface coating the welded conductor is a dull grey color similar to the appearance of the welded conductor before the furnace exposure. Also, the curved striations stand out more and appear to be somewhat copper in color in comparison to the rest of the welded conductor.

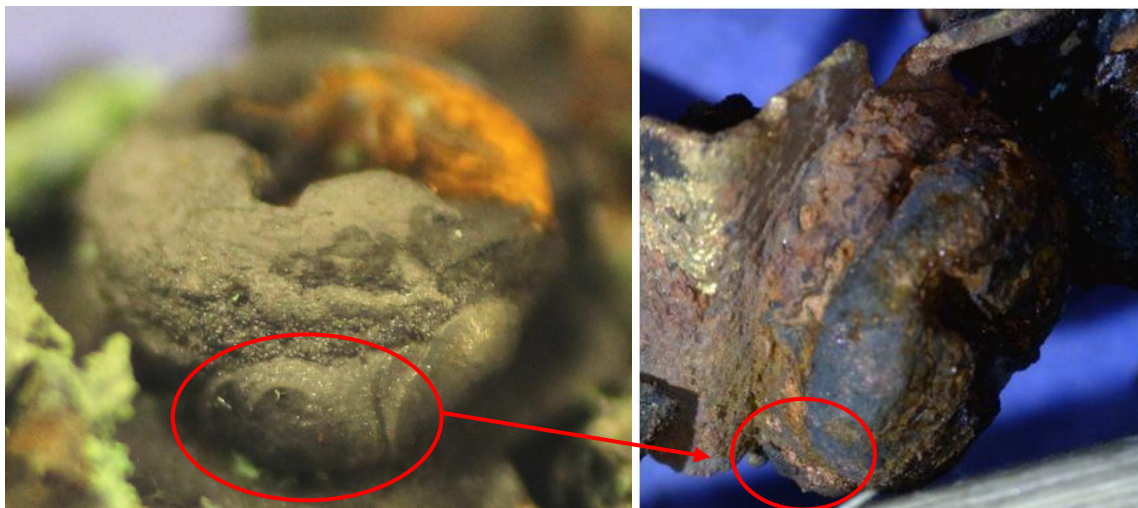
Figure 3-79. Welded conductor with curved striations before (left) and after (right) furnace fire exposure (PSE021).

One of the two welded conductors that had visible curved striations prior to the furnace exposure, but where those curved striations were not present after the furnace exposure is shown in Figure 3-79. For both of these receptacles, the welded conductor was confirmed to be present after the furnace fire exposure. The image of the curved striations prior to the furnace exposure (Figure 3-79, left) shows a few faint curved striations, but the image after the fire exposure shows only an irregular welded conductor. The other instance where the curved striations were not observed after the furnace exposure was similar in appearance both before and after the furnace exposure to the conductor and screw shown in Figure 3-79. In general, both the presence and appearance of welded conductors persisted even after an intense fire exposure. This evidence remained unique when compared to fire melting of copper components (see Figure 3-42 and Figure 3-49).

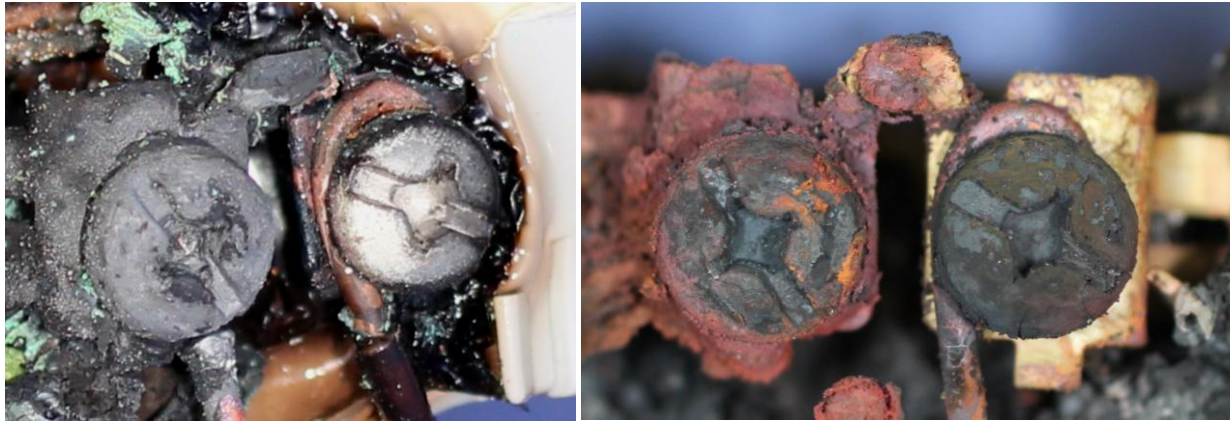
Figure 3-80. Enlarged screw head from PVC receptacle before (left) and after (right) furnace exposure (PSE023).

Five receptacles with enlarged screw heads were exposed to furnace fire Test 5. After the furnace fire exposure, four out of five of the enlarged screw heads remained identifiable. In general, the shape of the enlarged screw heads remained, but the color changed. The one case where the enlarged screw head was not identifiable after the furnace exposure is shown in Figure 3-80. Prior to the furnace exposure, this enlarged screw head only had a partial surface buildup (see Figure 3-80, left). After the furnace fire exposure, the buildup on the enlarged screw head was not distinctly different from the normal screw head (see Figure 3-80, right). However, the enlarged screw head did exhibit extensive red oxidation products compared to the normal screw head after the furnace.

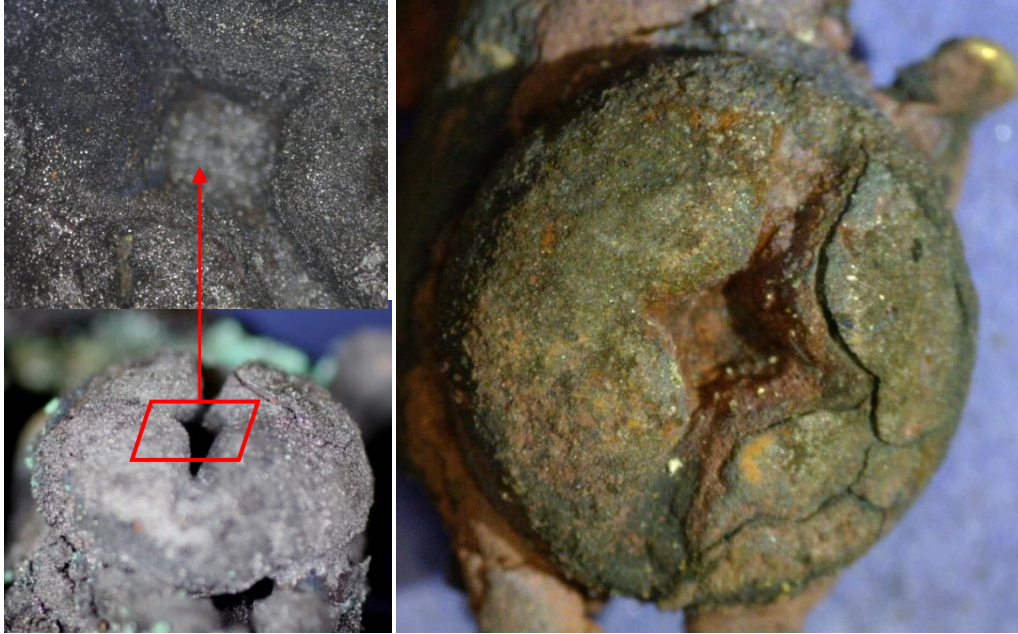
Figure 3-81. Enlarged screw head from PVC receptacle before (left) and after (right) the furnace exposure (PSE132).

Figure 3-81 and Figure 3-82 show two examples of enlarged screw heads before and after the furnace exposure. Both of these enlarged screw heads were grey in color before the furnace exposure, but changed slightly after the exposure. The enlarged screw head from PSE132 (Figure 3-81) changed to a brownish red color after the furnace exposure and the enlarged screw head from PSE133 (Figure 3-82) changed to a dark black color. Even with the majority of the PVC receptacle consumed by the furnace exposure, both of these enlarged screw heads persisted and remained unique compared to fire effects. This was also true for the other two enlarged screw heads.

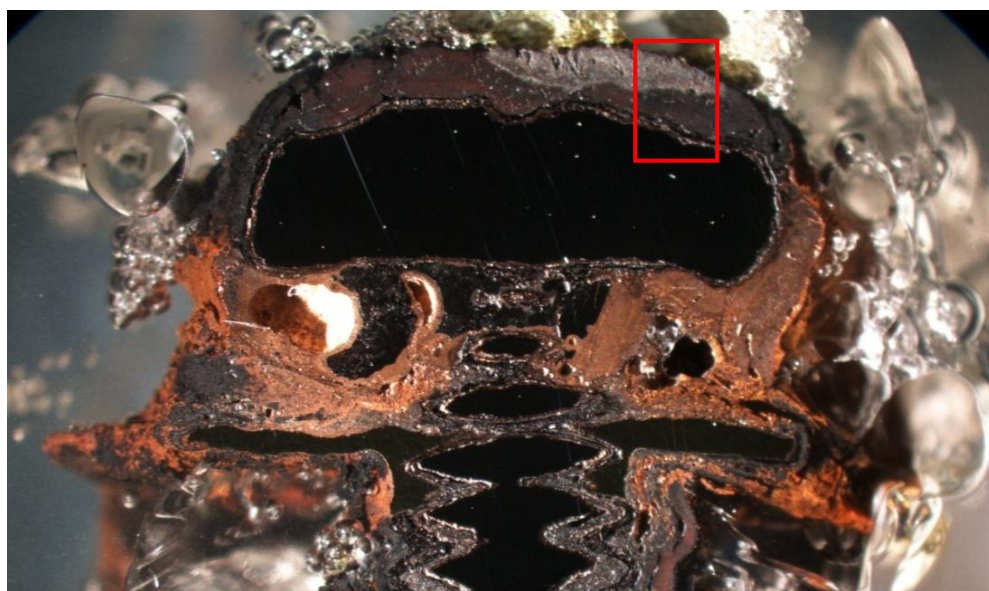
sectioning and polishing methodology. A photograph of the cross-sectioned and polished screw in the brass receptacle contact is shown in Figure 3-83. The thickness of the corrosion layer atop the screw was approximately 1.1 mm (0.043 inches) at the thickest point. The corrosion covered almost the whole surface of the screw and threads but was not a constant thickness over the entire surface. It can be seen that the corrosion byproducts are primarily surface growth with some loss of volume of bulk steel. An exemplar cross-sectioned screw is shown for reference in Figure 2-65. The plating overtop the steel screw was approximately 4-5 μm thick.

Figure 3-83. Sectioned and polished enlarged screw head from PSE133 after fire exposure.
Note: square indicates area of EDS mapping.

A SEM examination was conducted of the cross-sectioned screw. Figure 3-84 shows a back-scatter image of the corrosion layer atop the steel (a red square in Figure 3-83 indicates the approximate location of the SEM image). There appears to be a boundary (indicated by a dotted red line) between two layers of the corroded material indicated by the difference in color. Unlike the corrosion layers in Figure 2-66, these two layers do not appear to be different densities. However, both layers do appear to be porous, much like the other sectioned screw. In order to determine the chemical makeup of the corrosion, an EDS mapping of the area shown in Figure 3-83 was conducted. Carbon, chlorine, copper, iron, manganese, oxygen and silicone were mapped, with the results shown in Figure 3-85. Each element is plotted as a relative concentration.

2-68 and Figure 3-83). Another indication that the screw from PSE362 has not undergone overheating and corrosion similar to the enlarged screw heads is that the copper wire and brass contact show no evidence of severe overheating or glowing (i.e., reduction in thickness, heavy oxidation, or dezincification) compared to what would be expected for an enlarged screw head. No brass conductor or copper wire segments were found with Furnace Screw X.

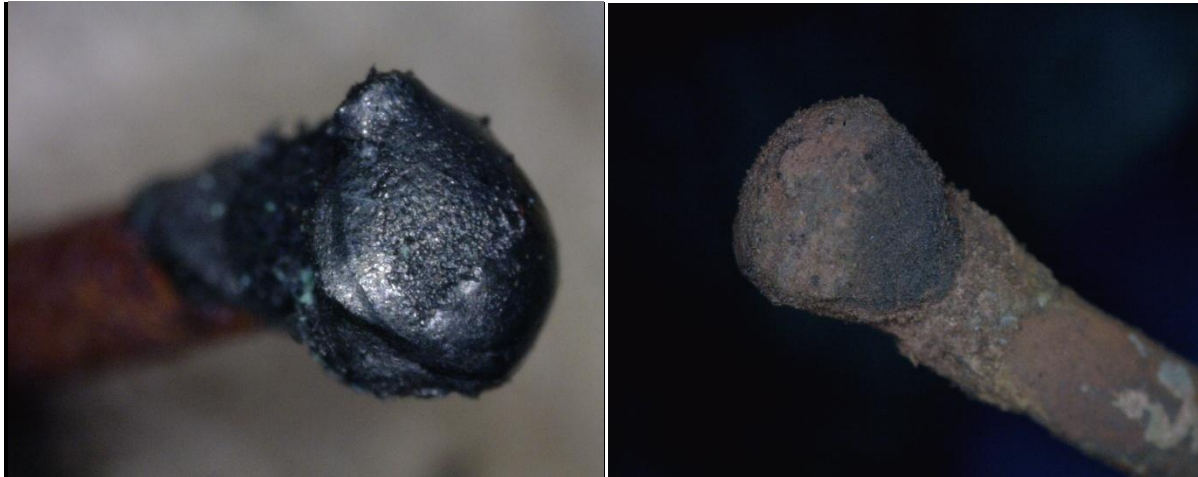
Fourteen receptacles that had overheating, severed conductor failure events were exposed to furnace fire Test 5. The severed wire ends from five of the receptacles were not included in this test. Of the nine wire ends from severed conductors that were exposed to the furnace, all nine samples were identifiable as conductors severed by glowing after the exposure. One example of a rounded wire end from a severed conductor is shown before and after the fire exposure in Figure 3-97. Much like the welded conductors with curved striations, the only change in the appearance of the severed conductor ends was a color change from shiny grey to dark and red. The red is probably from a surface coating of copper oxides. The general shape of the severed conductors did not change due to the furnace exposure, which reached temperatures of 1000°C for 10 minutes. This change in appearance was typical for the rest of the wire sides of the severed conductors after the furnace fire exposure regardless of their original shape (i.e., round or irregular).

Figure 3-97. Photographs of severed conductor end on wire from PVC (PSE023) receptacle before (left) and after (right) furnace exposure.

conductor near the overheating (see Figures 3-97, 3-98, and 3-99) and the pits were uniformly shallow. For the brass conductors, when pits grew to a large enough depth on the conductor, they would eventually form holes. These holes were typically accompanied by thinning of the conductor. Thinning was defined as a relatively uniform reduction in thickness of the conductor; this is different from gradual necking. Table 4-28 and 4-29 list the presence of pitting and thinning and holes for conductors with melting damage, respectively.

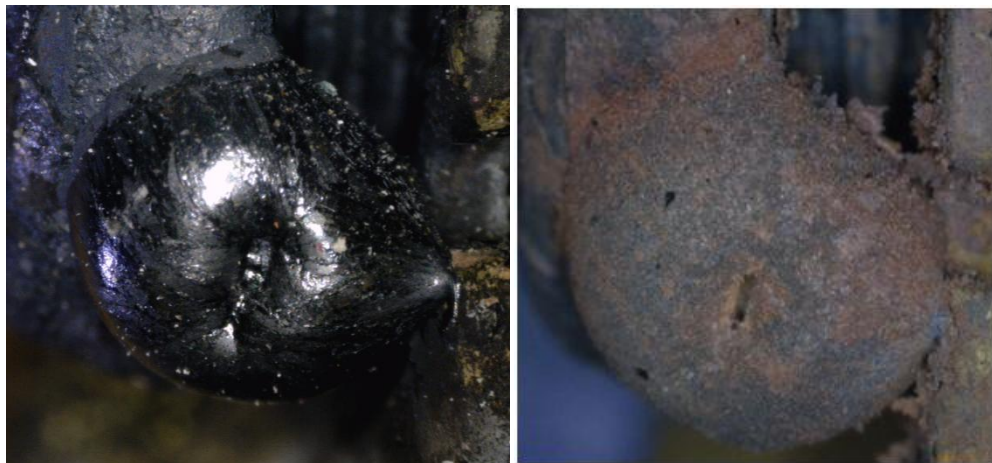
Thirteen of the fourteen screw sides of the severed conductor ends had characteristic shapes that persisted after the fire exposure. The only screw side of the severed conductor that did not persist after the furnace exposure showed some signs of melting of the copper conductor at the location where the conductor severed. Figure 3-98 shows the screw side of the severed conductor from a PVC receptacle. The shape, including the dimple at the center of the severed conductor, did not change due to the furnace exposure. The shiny, smooth appearance changed to a dull black-reddish (from copper oxides) color after the furnace exposure. These changes in appearance were typical for the rest of the screw-side severed conductors after the furnace fire exposure regardless of their original shape (i.e., round or irregular).

Figure 3-98. Severed conductor end on screw side from polypropylene (LEV272) receptacle before (left) and after (right) furnace exposure.

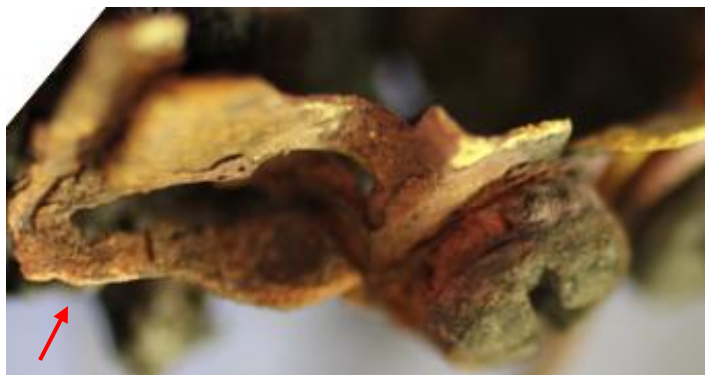
contacts could not be seen in their entirety prior to the furnace exposure. Three examples of the thinned contacts are shown in Figure 3-99, Figure 3-100, and Figure 3-101. Two of the three receptacles had enlarged screw heads (PSE023 and PSE021) and all three receptacles had welded conductors with curved striations. The thinning of the contacts occurred in the vicinity of the screw connection that was overheating and was relatively uniform over the contacts. In general, the thickness of the contacts was reduced to about half of the original thickness. Both Figure 3-100 and Figure 3-101 show the thinned part of the contacts and the non-thinned part.

Figure 3-99. Photograph of internal plug contacts thinned by oxidation and overheating from PVC receptacle (PSE023).

The appearance of the thinned contacts from oxidation and overheating is different than the thinned contacts from melting (see Figure 3-33, Figure 3-36, and Figure 3-39). The thinned contacts from melting tend to be a result of the molten brass running down the contacts. As a result of this, internal contacts that have melted will also generally be thicker than original at some point. The thinned contacts were only viewed after the furnace exposure and as such it is unclear whether or not they had changed due to the furnace exposure. However, due to the lack of melting of the internal plug contacts in these three receptacles, it is unlikely that the appearance changed as a result of the furnace exposure. This thinning was also not in the vicinity of the locations where arcing was observed to occur.

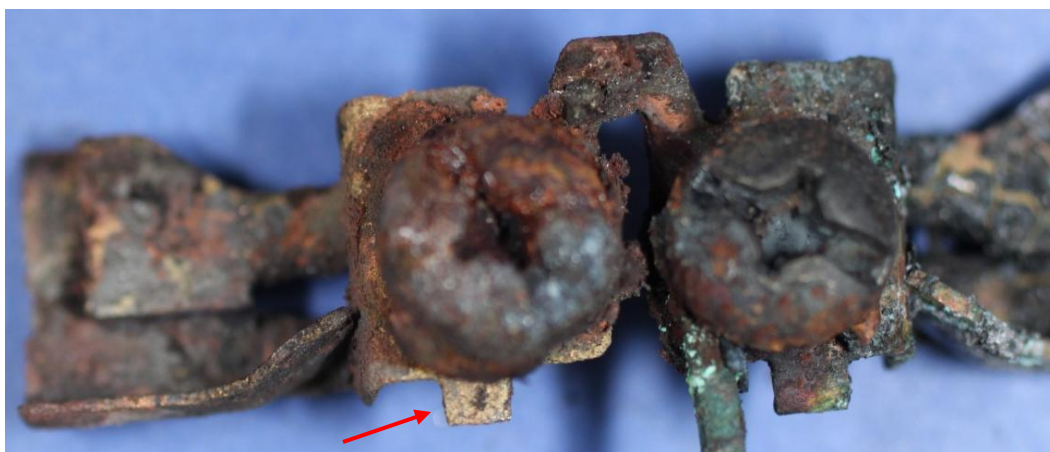
Figure 3-100. Photograph of internal plug contacts thinned by oxidation and overheating from PVC receptacle (PSE021).

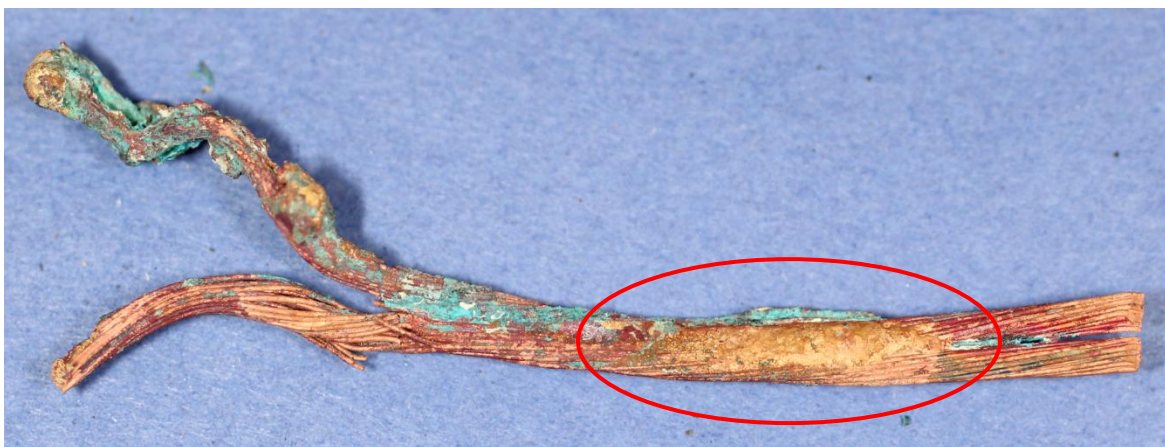
Only four (7%) of the conductors with fire melting had corresponding damage on the opposing conductor. These four conductors (two pairs of stranded copper wires) were fused together as a result of the fire exposure. A photograph showing two of the fused wires is shown in Figure 4-1. While these two instances of melting were not visually similar to any of the arcing damage observed in this test series, it is important to note that there is a possibility that melted conductors can exhibit corresponding damage, particularly for conductors that fuse over a small contact area, which could break apart later. The results demonstrate that corresponding damage on conductors is highly correlated to arcing events and only occurred in melting events with stranded copper wire. Consequently, this trait is a reliable indicator of arcing.

Figure 4-1. Corresponding damage on opposing conductor(s) for receptacle with melting (LEV397).

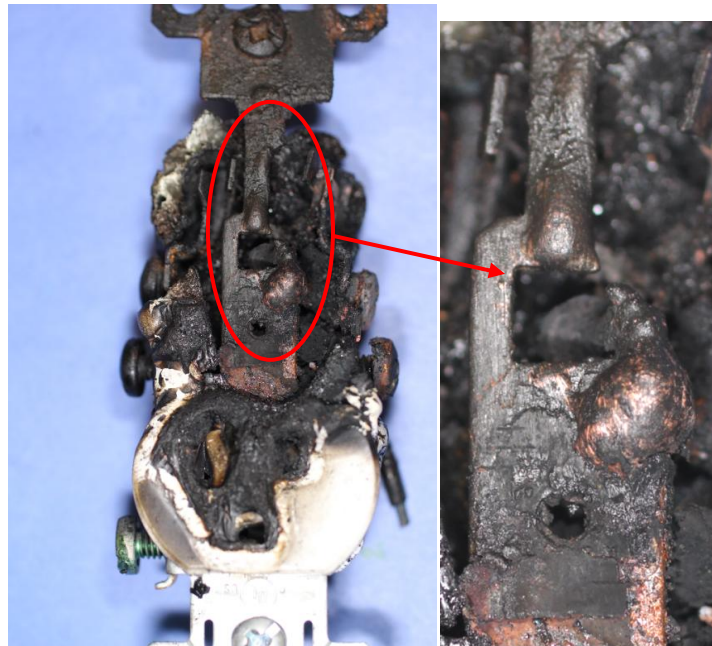
A large portion of conductors from fire induced arcing (95%) and arcing in receptacle failures (90%) had a positive identification of localized damage with a sharp line of demarcation. Those few conductors without localized damage with a sharp line of demarcation were brass and steel only. Figure 4-3 shows an example of arcing damage that is localized in the vicinity of the top-hot side of the grounding strap without a sharp line of demarcation. The presence of various degrees of damage and globules over the large area of arcing does not indicate a sharp line of demarcation.

Figure 4-3. Localized point of contact without a sharp line of demarcation (PSE 285).

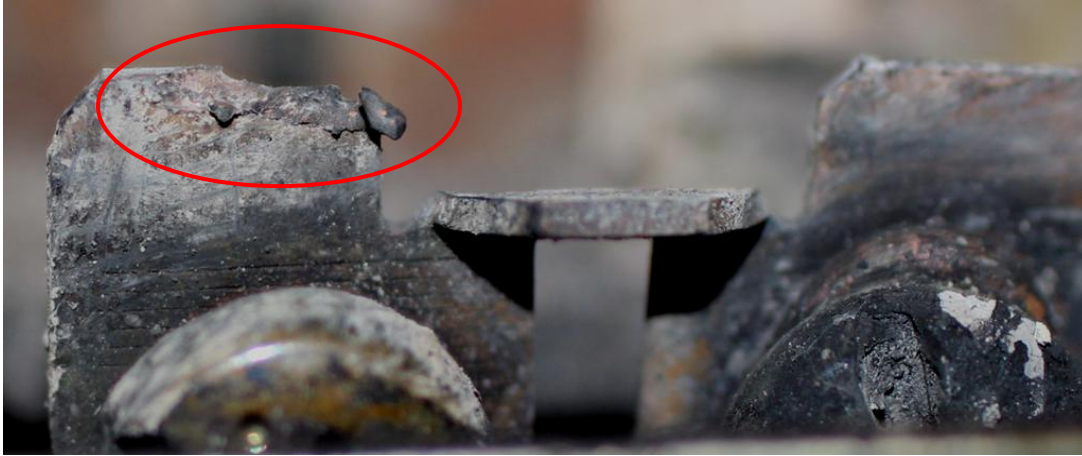
For the purpose of this evaluation, arcing and melting damage was considered to be round and smooth if some (e.g., a round globule in a notch) or all of the damage was rounded without jagged or rough surfaces and edges. For example, a shallow notch in a conductor was only considered to be round if the notch had a round globule in it or if the notch was without irregular depressions. Figure 4-5 shows an example of a notch in a brass plug contact which was not round and smooth; in this receptacle, arcing occurred between the steel faceplate and brass plug contact. Figure 4-6 shows an example of a notch in a steel faceplate which was round and smooth; where arcing occurred between the brass plug contact and the faceplate. Tables 4-7, 4-8, and 4-9 list the presence of a round smooth shape for receptacle failures, fire induced arcing, and receptacles with melting, respectively.

Figure 4-5. Notch in brass plug contact which is not round and smooth (LEV144).

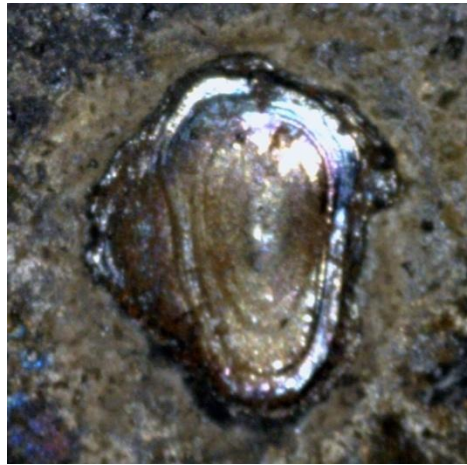
Figure 4-6. Notch in steel faceplate which is round and smooth (PSE331).

Only a small portion (21%) of conductors with arcing damage from receptacle failures and a single conductor (1.1%) with fire induced arcing damage (see Figure 4-6) exhibited resolidification waves. Resolidification waves were observed on steel, brass, and copper conductors, but were most often on the steel receptacle components than the copper wires and brass components. Murray and Ajersch [2009] observed resolidification waves on copper and steel; these researchers also tested brass and aluminum conductors but did not state whether resolidification waves were observed on these metals. The resolidification waves observed in this work were similar in appearance to those observed by Murray and Ajersch [2009].

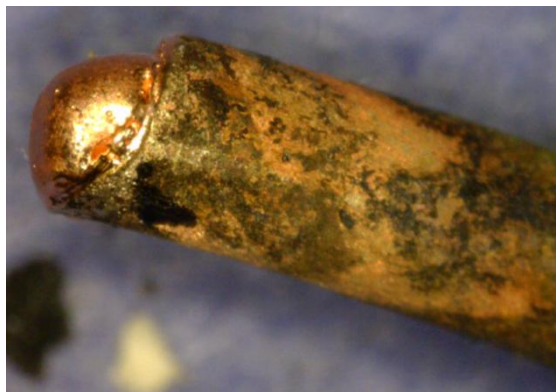
Figure 4-7. Round and smooth bead on end of wire severed by arcing (E001).

Due to surface tension, small suspended volumes of liquids tend to form round or spherical drops or beads with relatively uniform surfaces. Both arcing and fire-melting can produce molten drops of brass or copper conductors; when these re-solidify, they can form round and smooth shapes. However, because melting and resolidification occurs much quicker for arcing than fire-melting, arcing may be more likely to form spherical beads (see Figure 4-7) than fire melting beads which can be affected by gravity (see Section 4.9)

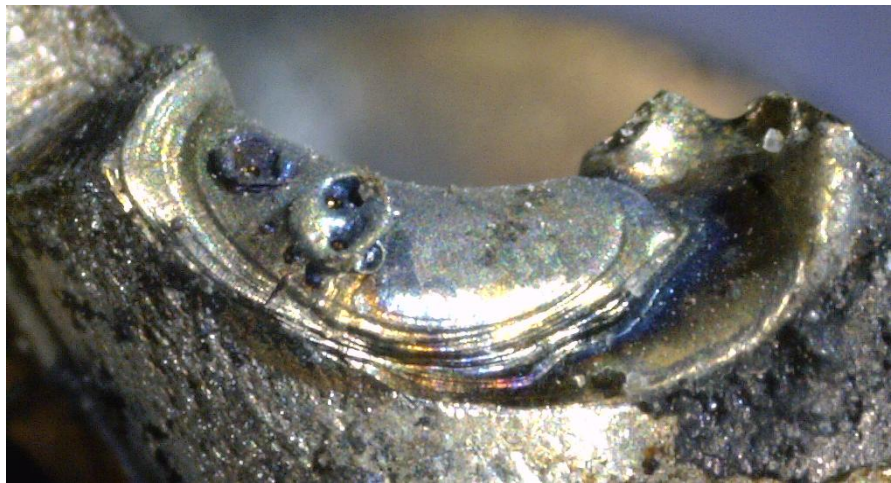
Figure 4-9. Arcing damage on grounding strap showing resolidification waves that are more pronounced on the major axis (LEV174).

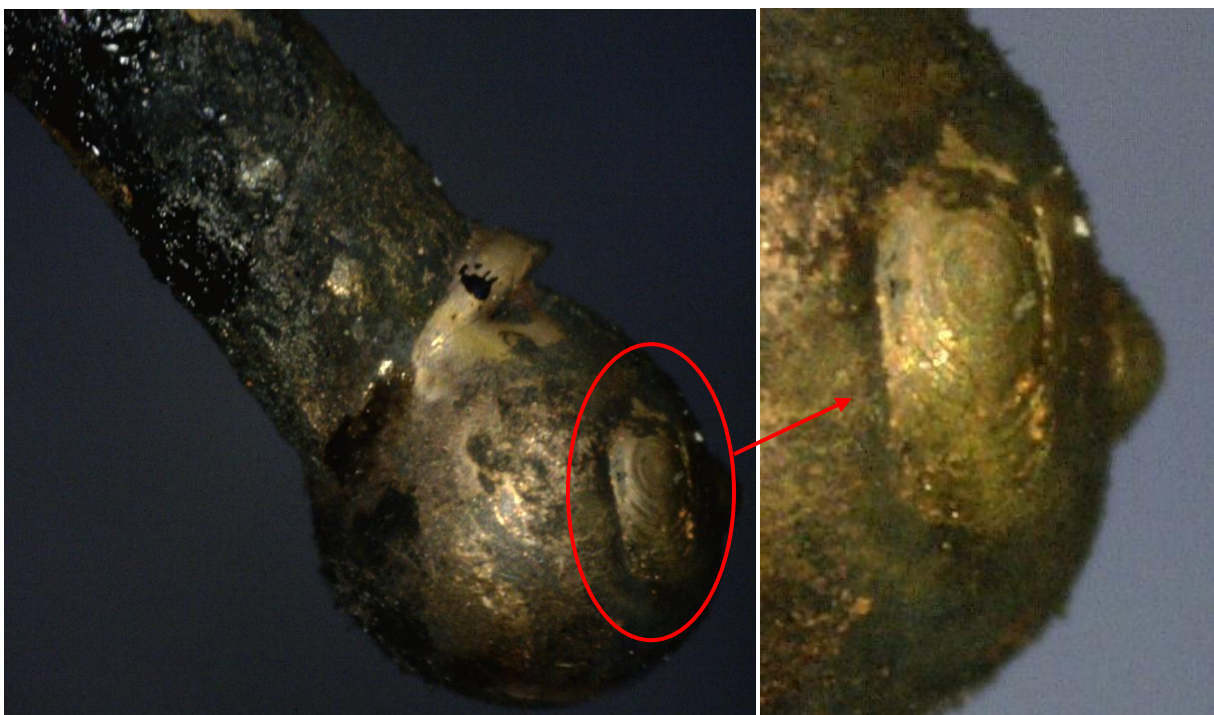
Figure 4-10. Arcing damage on copper wire showing resolidification waves (LEV172).

One instance of resolidification waves is shown in Figure 4-10 where the waves are located on only a portion of the copper arc bead. It is possible that this wire, from a receptacle failure event, had multiple arcs: one to create the bead and another to cause the resolidification waves in a localized spot on the bead. None of the conductors with melting damage were observed with resolidification waves. Despite the low percentages of arc damaged conductors with resolidification waves present, this characteristic trait is a strong indicator that arcing occurred. The resolidification waves themselves are unique compared to the visual appearance of melting. The regular, concentric rings are not able to be produced by fire melting due to the relatively slow process of fire-melting and cooling compared to arcing.

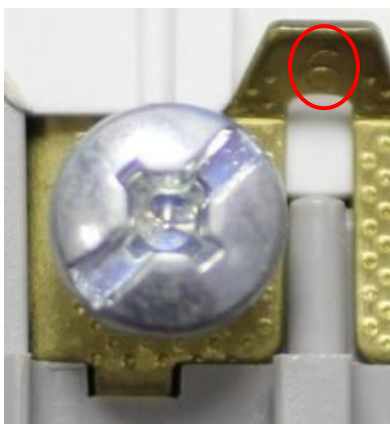
Figure 4-11. Typical stamped number (circled), bent brass plug contact with crisp edges from an exemplar PVC receptacle.

Tooling marks come from the manufacturing process of metal components of receptacles and wiring. These processes mar the surface with a regular pattern or form a distinct shape (see Figure 4-11). Tooling marks include defined edges and lettering for stamped and bent brass and steel receptacle components and copper drawing lines for copper wires. When exposed to temperatures on the order of the melting temperature of the conductor, these tooling marks can begin to be destroyed. In addition, oxidation of copper, dezincification, and rusting can also destroy these tooling marks. Tables 4-13, 4-14, and 4-15 list the presence of tooling marks visible outside the area of damage for receptacle failures, fire induced arcing, and receptacles with melting, respectively.

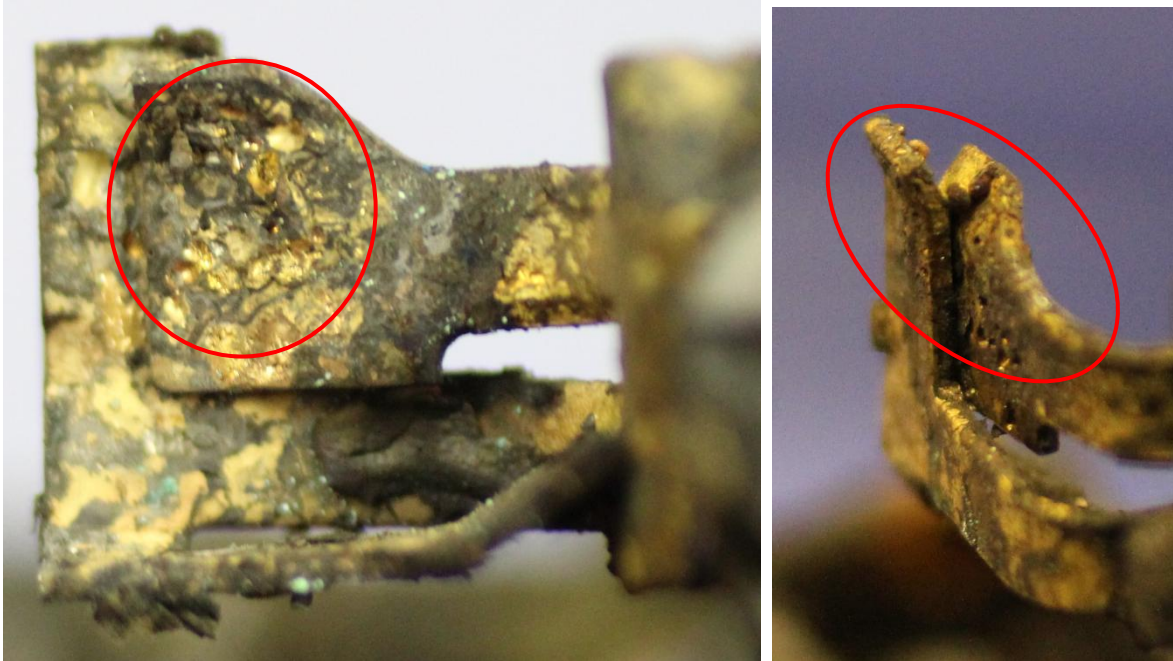
Figure 4-12. Photos of melting damage on non-energized plug contact which has tooling marks (sharp edges) visible outside the damaged areas (PSE359).

Only one non-energized conductor (1.7%) with melting damage had tooling marks visible outside the damage area. This brass contact is shown in Figure 4-12, with the damage circled. This melting damage was localized on the plug contacts and the sharp edges of the conductor are visible adjacent to the damage. Though it is possible that tooling marks outside of the damage area can be present on damage after minimal fire-melting, the presence of this trait is a fair indicator that arcing occurred at the damage site.

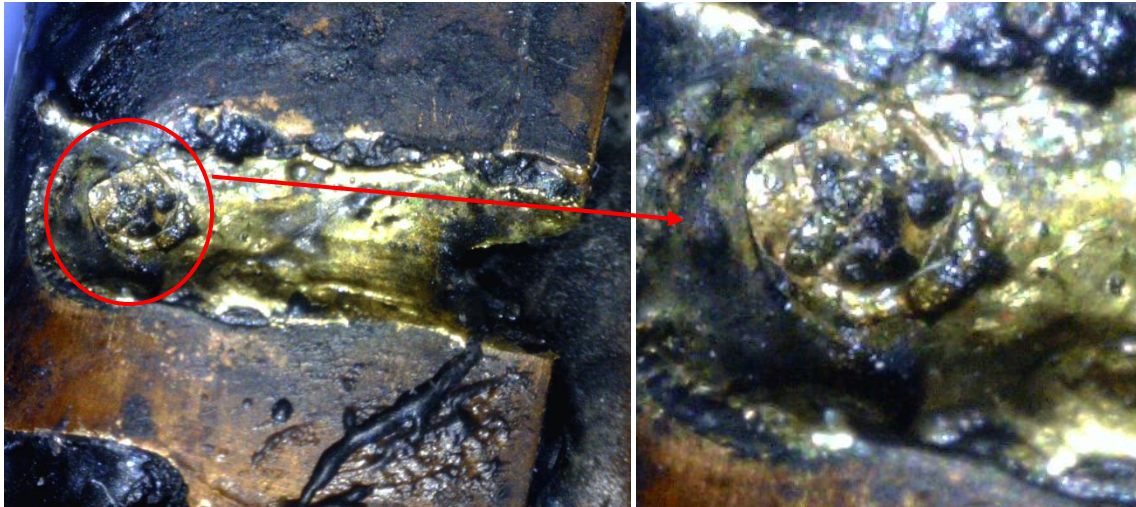
Figure 4-13. Arcing damage on brass plug contact showing large voids (LEV266).

In general, the evaluations of arcing and melting damage were external evaluations of the conductors; the internal structure of the damaged material was not systematically evaluated. However, some of the arcing locations examined had two conductors fused together by arcing. During the examination, these conductors were pulled apart to reveal the internal structure of the connecting arc bead. In 21 conductors, large voids were observed inside the arc bead. An example of a brass conductor with large internal voids (i.e., the dark areas) in the arc damaged area is shown in Figure 4-13. This conductor arced to the steel grounding strap and only partially fused along the damaged area (circled in Figure 4-13).

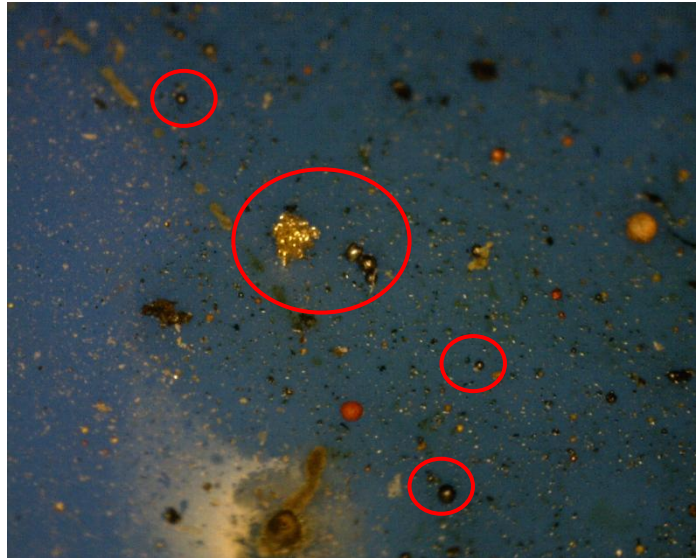
Figure 4-15. Spatter from arcing, deposited on PVC outlet box (LEV172).

Spatter, or sprayed molten material, is often ejected outward in all directions from the arc location when arcing occurs. This material is then deposited on surfaces up to inches away from the arcing location. Spatter consists of very small spherical particles of the metal(s) which were involved in arcing. Since the particles cool very quickly, they generally retain their spherical shape when they impact a surface. These spheres are typically on the order of 0.1 mm or less, but some can be larger. Two examples of spatter from receptacle failure events are shown in Figure 4-15 and Figure 4-16. While fire melting can produce molten metal that falls (in the direction of gravity) onto surfaces, these do not tend to cool rapidly and can deform when striking the surface. Therefore, the very small spherical spatter particles from arcing are generally unique compared to the deposits produced by melting. SEM/EDS analysis of the particles may be useful in determining the chemical makeup of particles to differentiate metals and from other spherical solids. Tables 4-16, 4-17, and 4-18 list the presence of spatter deposits for receptacle failures, fire induced arcing, and receptacles with melting, respectively. The process of locating and identifying spatter is the most difficult of the arcing characteristics

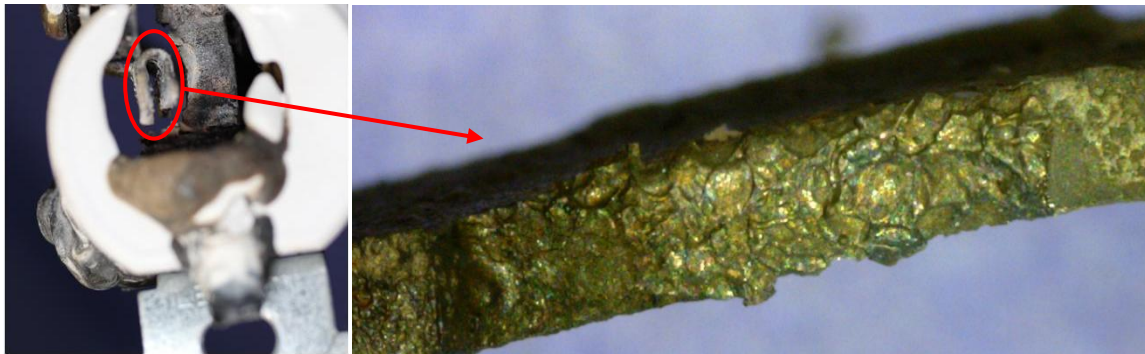
Figure 4-17. Small divots (and localized round depressions) on a grounding strap from a neutral to ground arc during receptacle failure (LEV008).

A small portion of conductors with arcing damage had small beads and divots (3%) and localized round depressions (2%); only 5.3% of conductors with melting damage had blisters on the surface. Figure 4-17 shows an example of small divots over a limited area on the grounding strap of a receptacle (LEV008). This conductor was also classified as having localized round depressions. This damage was from neutral-to-ground arcing that occurred during the receptacle failure event. Since series arcs are limited by the current in the circuit, these arcs were not high enough in current to create larger notches that were observed for hot-to-ground or hot-to-neutral shorts. The prolonged arcing, which occurred over minutes, caused the formation of multiple divots. Figure 4-18 shows an example of a stranded copper wire exposed to fire which had localized round depressions on one of the globules at the end of the wire. Figure 4-19 shows an example of blisters on the surface of a melted conductor. This conductor was wired to a PVC receptacle subjected to the furnace fire exposure.

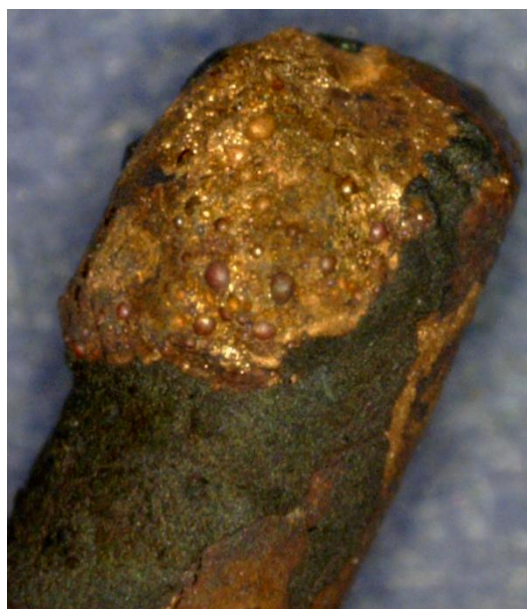
Figure 4-19. Solid copper conductor with blisters on the surface (PSE385).

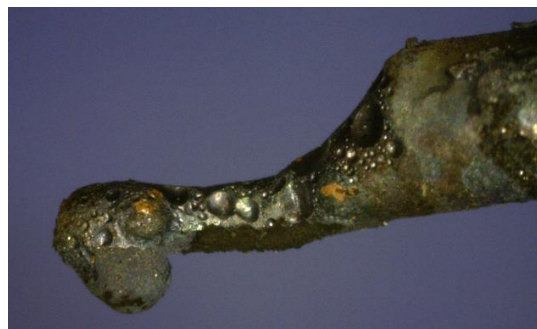
Figure 4-22. Pitting of copper wire due to fire-melting (LEV391).

Surface pitting was present on a notable portion (44%) of conductors with melting damage. Figure 4-22 shows pitting on a solid copper wire with melting damage. This pitting was localized at the end of the copper wire where melting had occurred; beyond this damage area no pitting was observed. The majority of brass conductors with melting damage had pitting present, whereas the majority of solid copper wires and all stranded copper wires with melting damage did not. It is possible that the larger surface area and lower melting temperature for the brass conductors preferentially allowed pitting to occur on the brass conductors compared to the copper conductors. The small diameter of the individual strands of the stranded copper wires likely prevented surface pitting from occurring. Figure 4-23 shows pitting, thinning, and holes present on a brass plug contact.

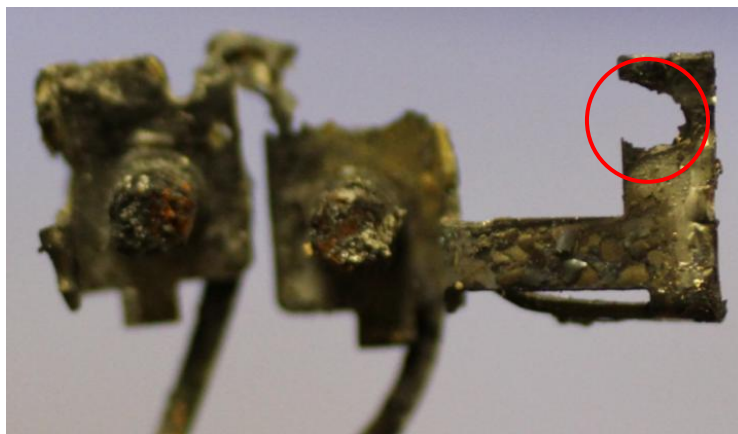
Figure 4-24. Holes formed on brass plug contacts due to fire-melting (PSE381).

Thinning and holes were present on a notable portion (40%) of conductors with melting damage, but was only observed on the brass conductors. The shape of the brass conductors (i.e., flat and bent) was most likely the reason why thinning and holes were able to form on the conductors compared to the copper wiring. Because one dimension of the brass conductors was much smaller (i.e., the thickness) than the other dimensions, pitting could progress to the point where a hole was formed. The cylindrical shape (i.e., same thickness in two dimensions) of the conductors would prohibit melting from causing localized holes to form, instead the conductors would sever. Figure 4-24 shows a hole that formed in a brass conductor which eventually opened on one side. Although a notable portion of the fire-melted conductors exhibited pitting, thinning, and holes, these characteristic traits are not strong indicators of fire-melting in all conductors. However, because a much larger portion of brass conductors exhibited pitting, thinning, and holes, these are stronger indicators of fire melting for brass conductors. Thinning and pitting due to fire melting could be differentiated from thinning and pitting due to overheating based on its location, uniformity, and size, shape, and depth of the pits. Thinning, pitting, and holes were not typically observed on the damage to conductors from arcing.

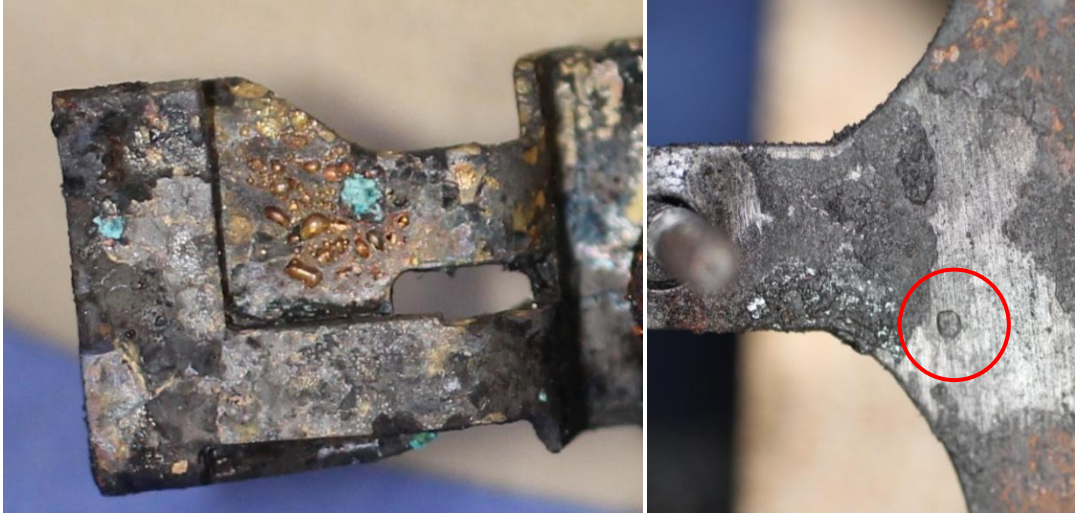
Figure 4-26. Surface pitting on brass contacts from PSE358 (left) and corresponding arcing damage on faceplate from PSE323 (right).

A Scanning Electron Microscope (SEM) was used to document some of the forensic evidence gathered in the laboratory testing and fire exposure testing. In particular, the SEM was used to image two break-off tabs from PVC receptacles. Both of the break-off tabs are shown in Figure 4-24. The damage on one of these break-off tabs is from melting of a non-energized receptacle (PSE358 – Figure 4-25, left) and the other is from arcing between the break off tab and a steel faceplate (PSE323 – Figure 4-25, right). A cursory examination of both of the break-off tabs appears to show that the notches in the top of the break off tabs exhibit rather clear lines of demarcation between the area of damage and the undamaged area. This type of notch was frequently observed for arcing between break-off tabs and steel faceplates. In the case of PSE358, there was no corresponding damage on the faceplate indicative of arcing and there was some pitting of the brass contacts indicating melting had begun (see Figure 4-26, left). In the case of PSE323 receptacle, there was no indication of melting in the internal plug contacts and there was evidence of a corresponding arcing location on the faceplate (see Figure 4-26, right).
