# FAÇADE CONDITIONS

An Illustrated Glossary  
of Visual Symptoms

**Edited by Dan Eschenasy, PE**  
Chief Structural Engineer  
NYC Department of Buildings

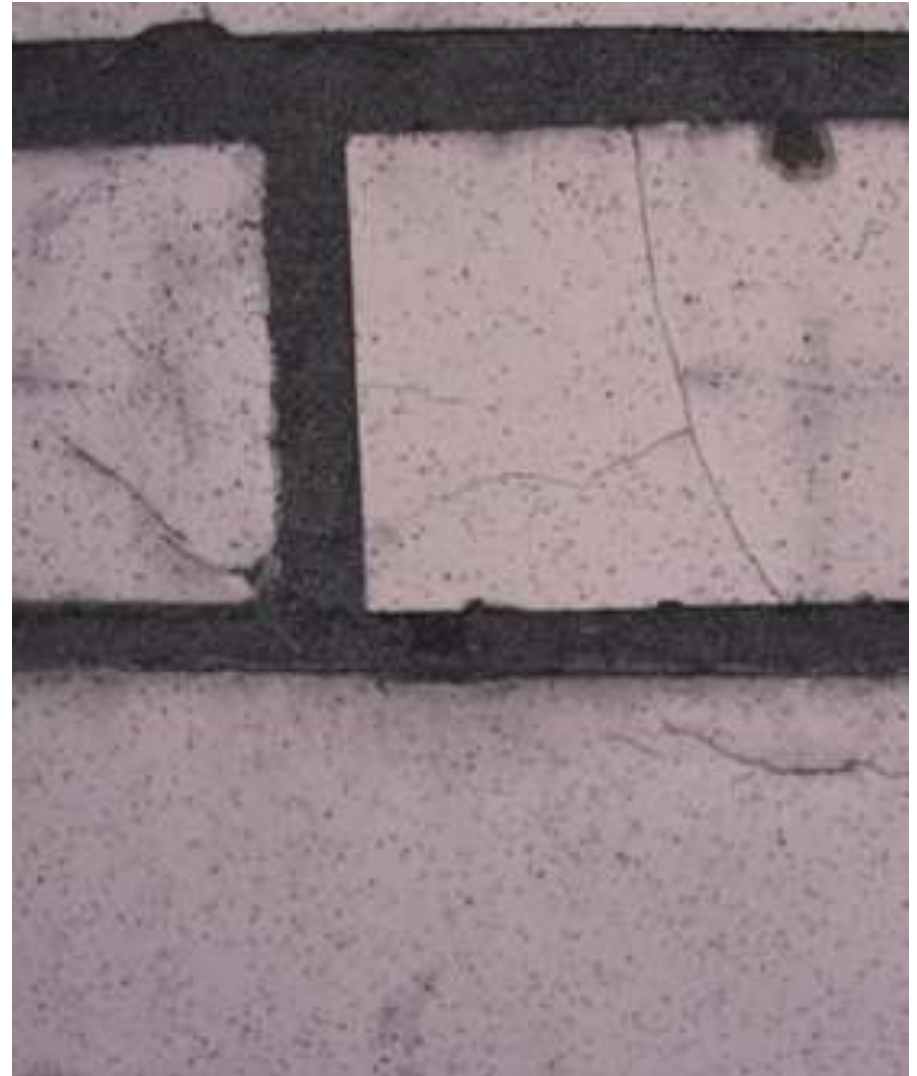
Fine surface cracks without clear directional pattern.

***Probable Causes/Deficiencies:***

Improper brick manufacture and quality.  
Freeze/thaw. Usually in glazed brick.

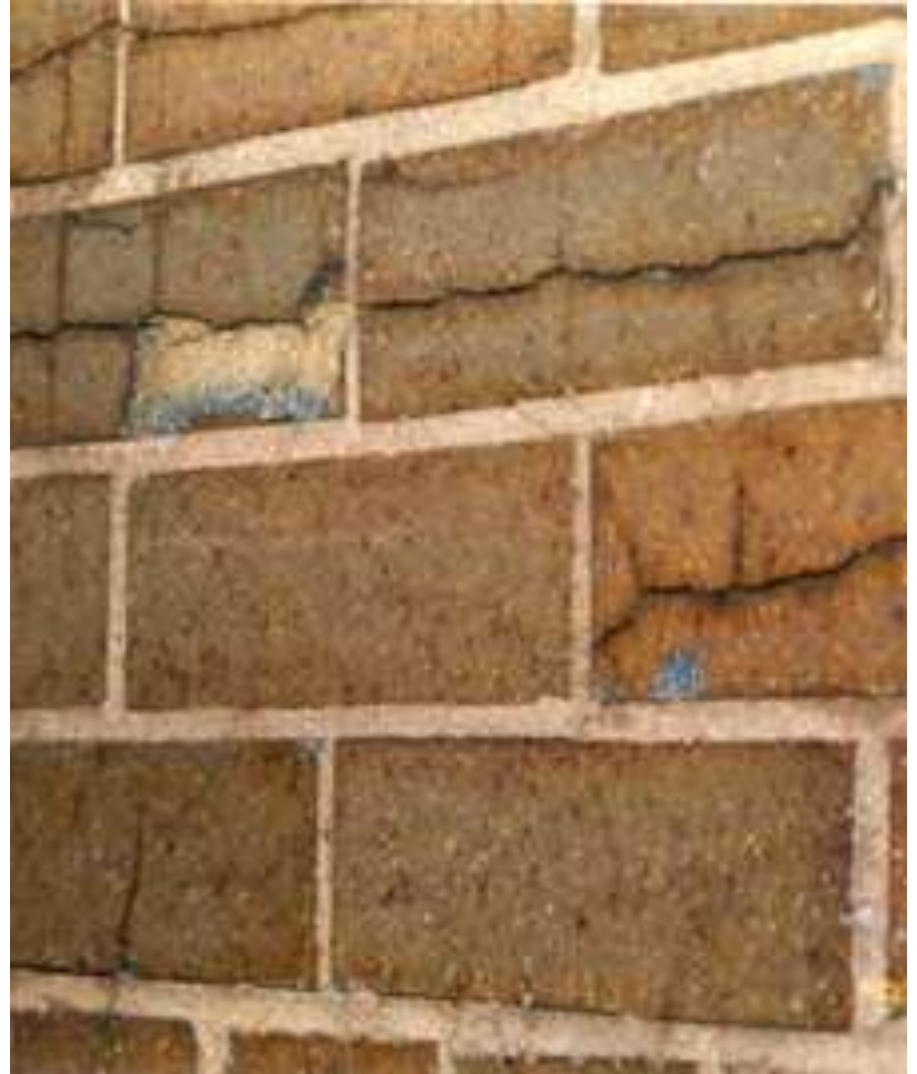
## 3.1.2 Cracks in Brick Surface

Cracks in brick surface that do not continue in mortar. Some spalling.

Freeze/thaw. Ice lensing. Usually in glazed brick. Constrained ceramic expansion. Brick with high saturation rate.

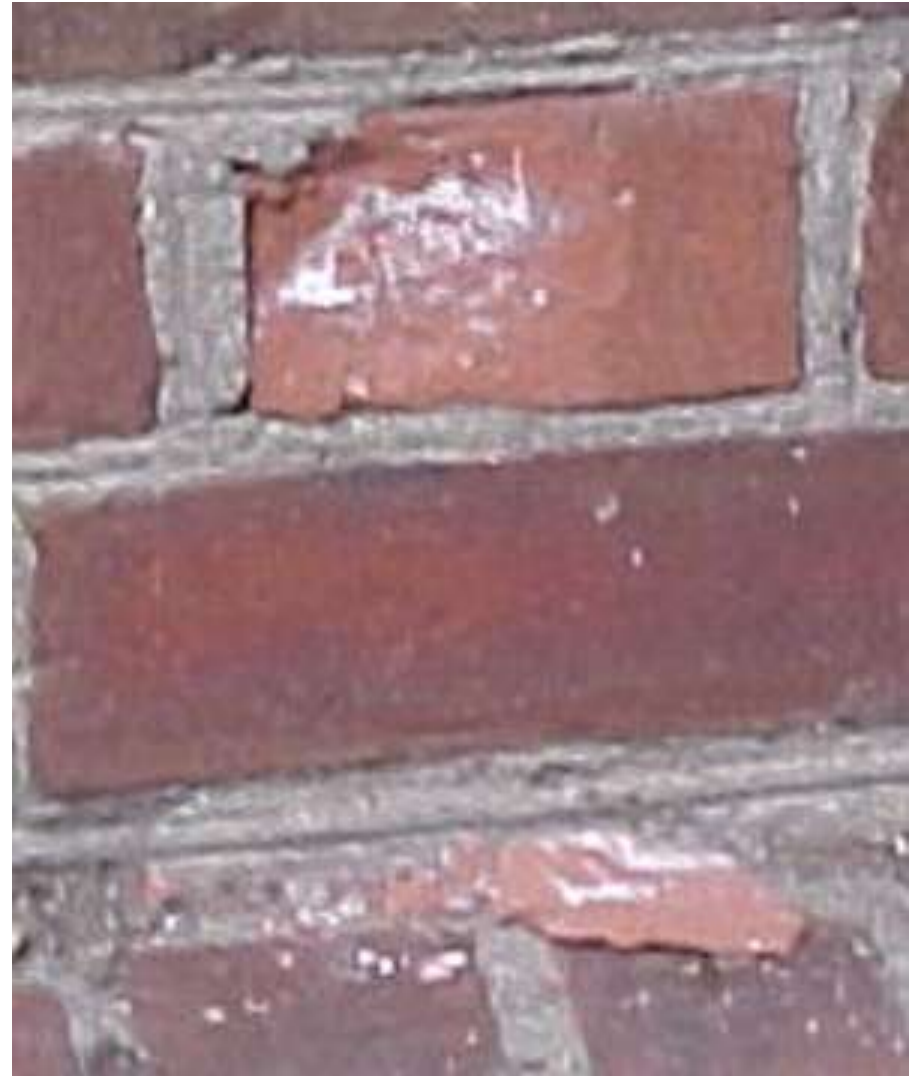
# 3.1.7 Cryptoefflorescence Spall

Migration of water thru porous brick. Soluble salts that are deposited in the mass of the brick. Cryptoefflorescence (subflorescence) increases volume from crystallization adding pressure on the brick internal structure or on the brick skin.

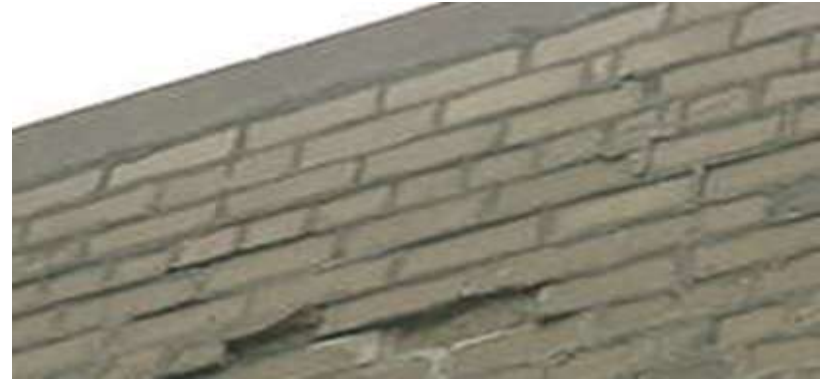
# 3.1.8 Brick Spalling/Delaminating

More common in glazed brick and coated brick where migration of water out of the brick unit is severely blocked by lack of permeability of outer layer. Freeze/thaw of entrapped water.

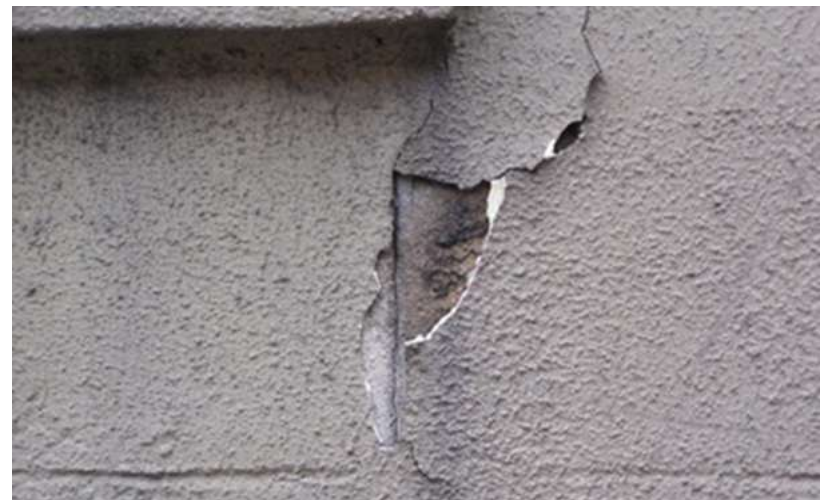
# 3.1.10 Peeling of Paint or Stucco

Moisture accumulation due to presence of coating with limited vapor permeability leads to the separation of paint or stucco layer. Also disintegration of brick (following several freeze thaw cycles).

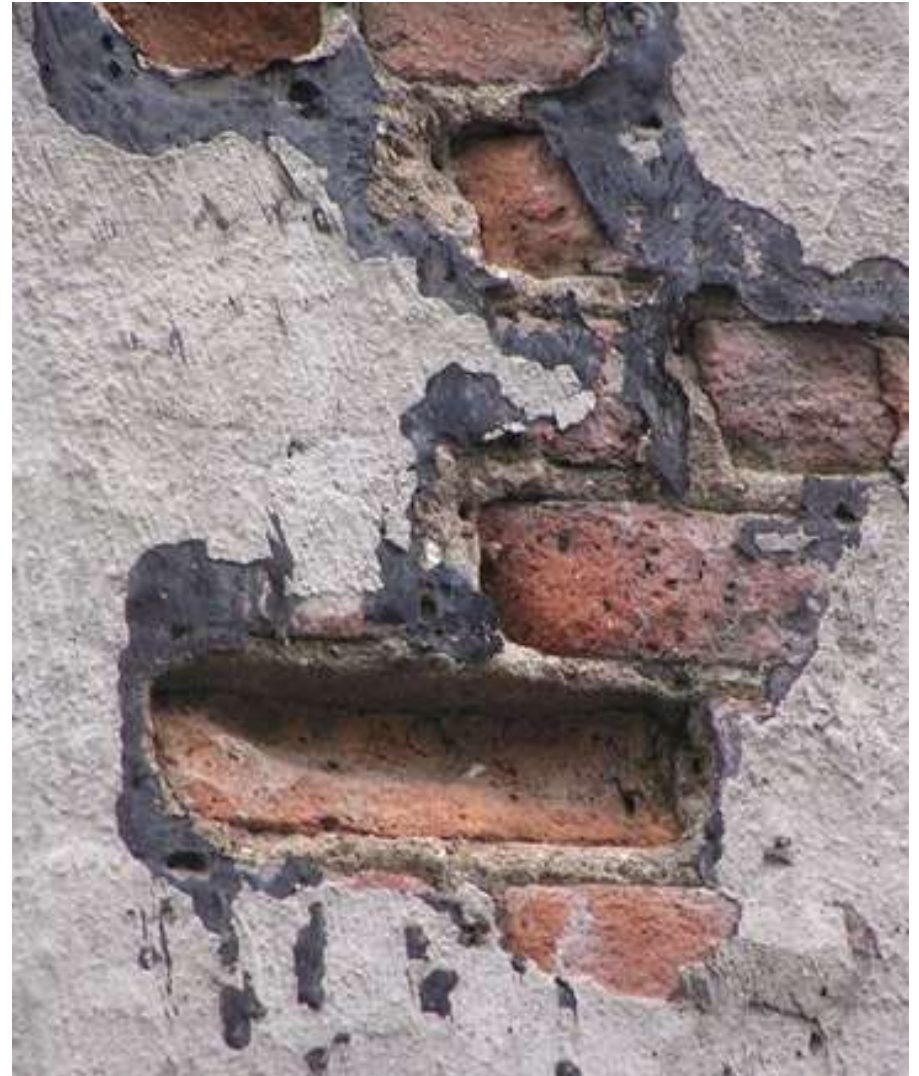
# 3.1.11 Brick Coving

Loss of material due to presence of standing water.

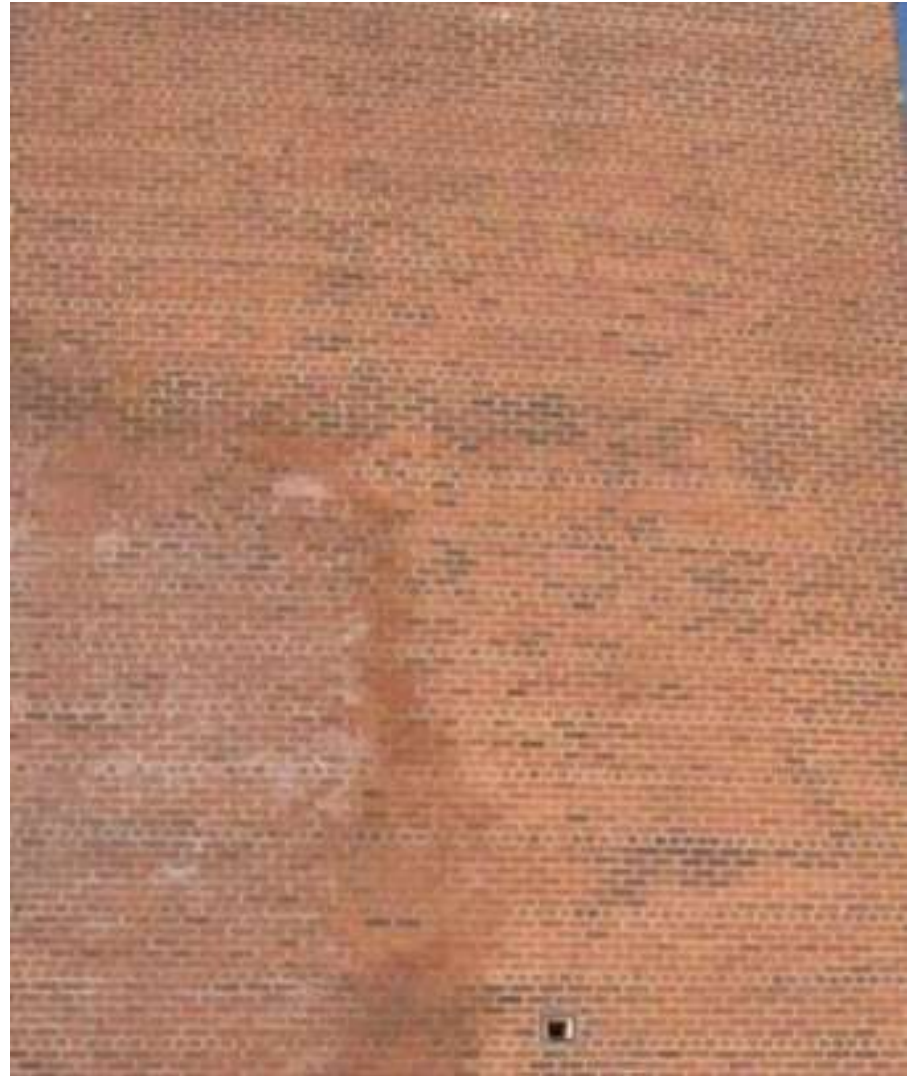
## 3.1.12 Wet Wall

Dampness rising from foundations.  
Problems with the mechanical or plumbing systems.

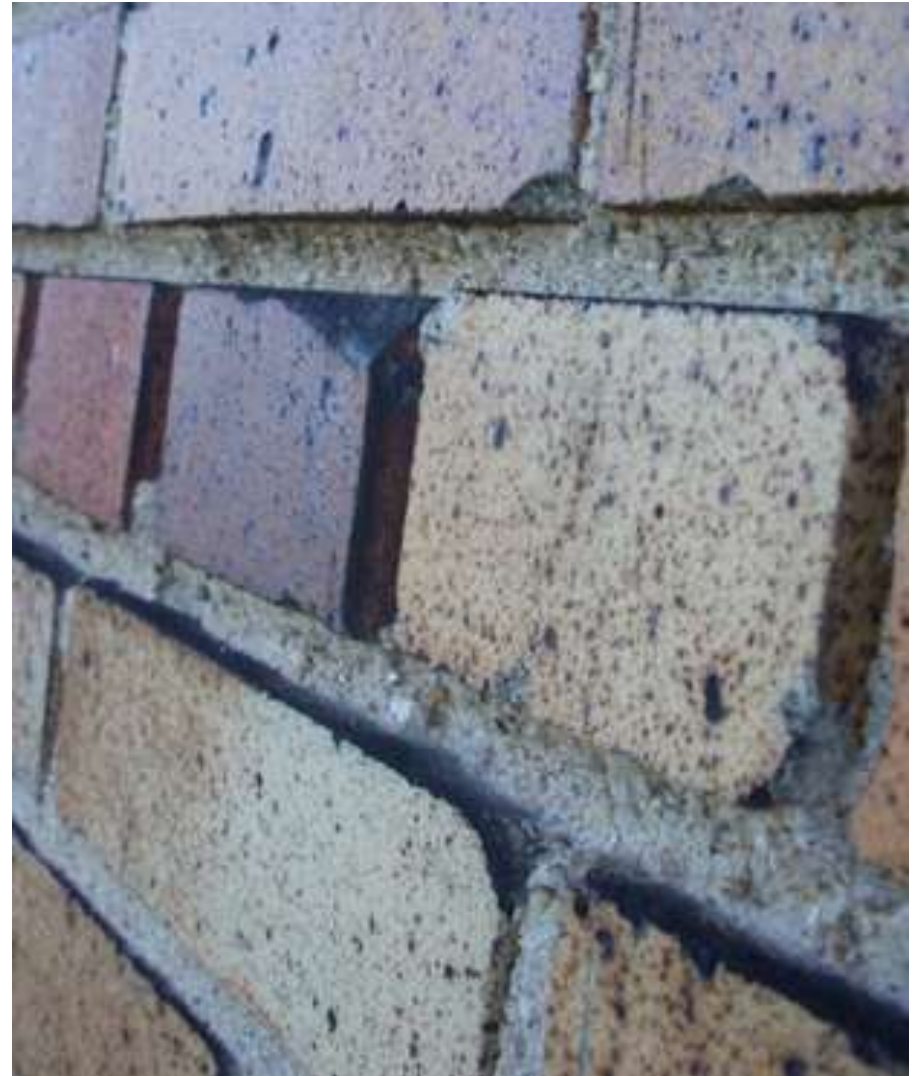
# 3.1.15 Open/Eroded Mortar Joint

Erosion due to wind or frost cycles.  
Disaggregating of lime component of the binder.

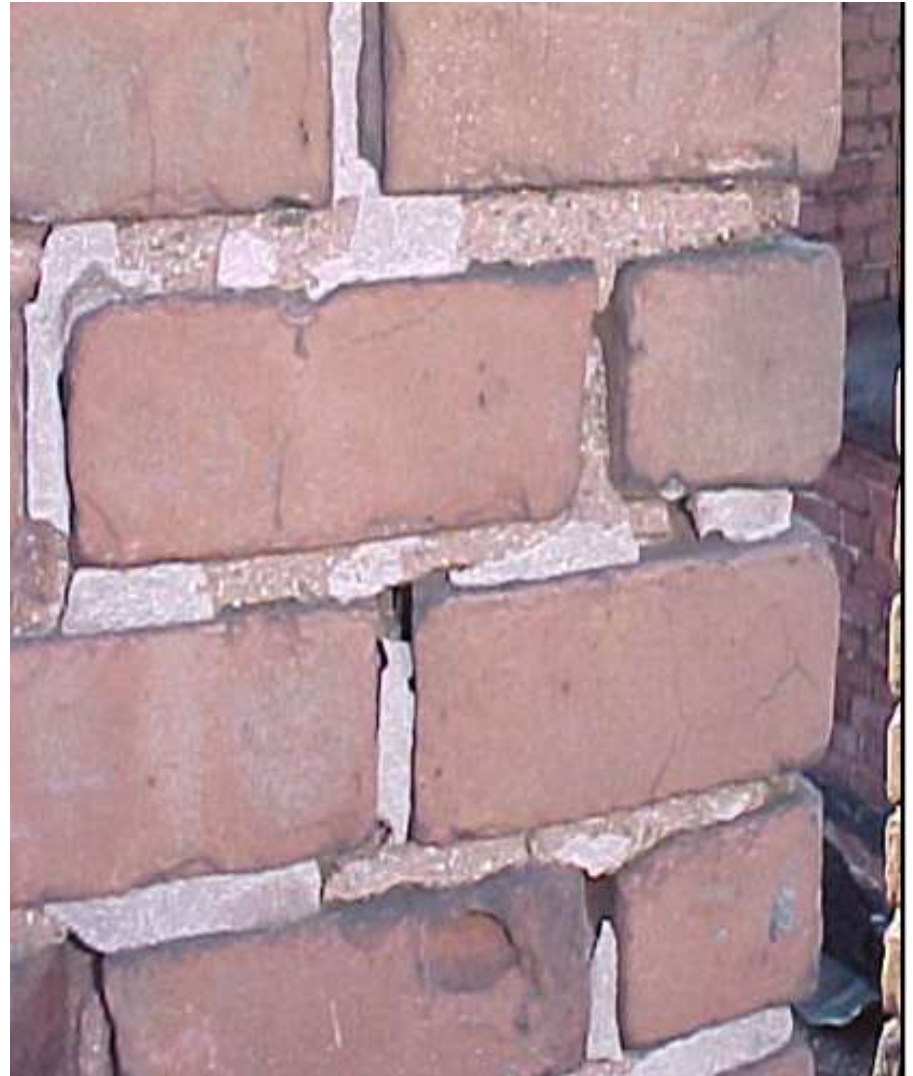
# 3.1.21 Improper Joint Repair (Pointing)

Lack of compatibility of existing and  
repair mortar, lack of sufficient depth  
of repointing.

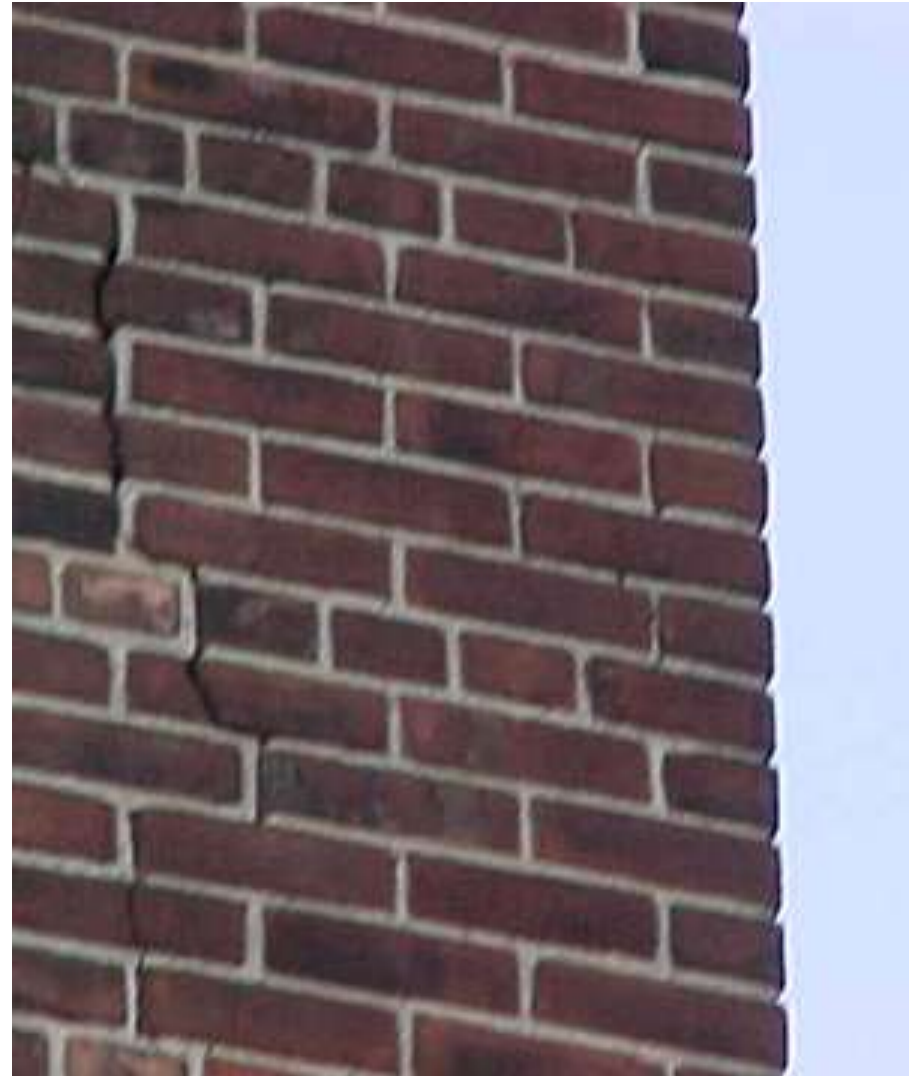
## 3.1.25.b Slight Vertical Crack in Masonry

Cracks are always the result of stresses in masonry that exceed resistance of brick or mortar or both. See various type of wall construction for specifics.

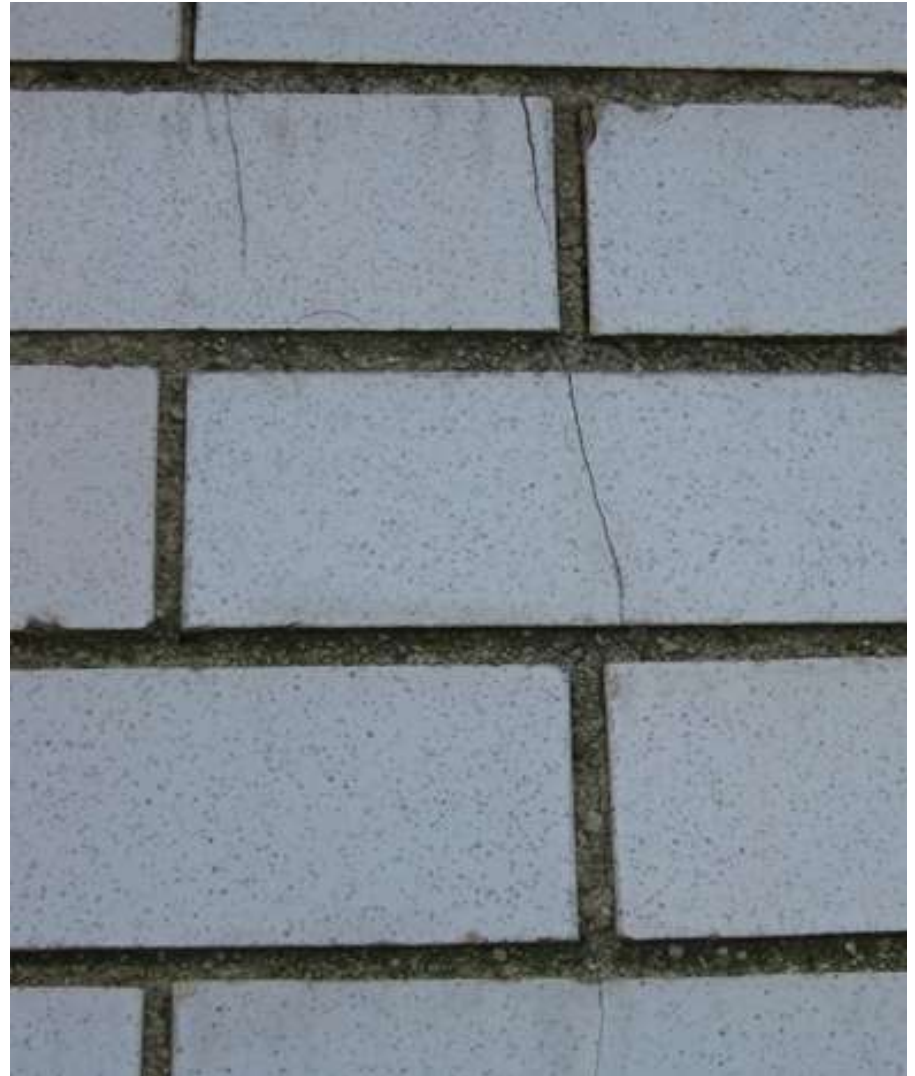
# 3.1.25.d Crack in Masonry Unit Only

Might represent an incipient condition at the surface of the masonry unit due to composition of brick. Significant difference between properties of brick and mortar.

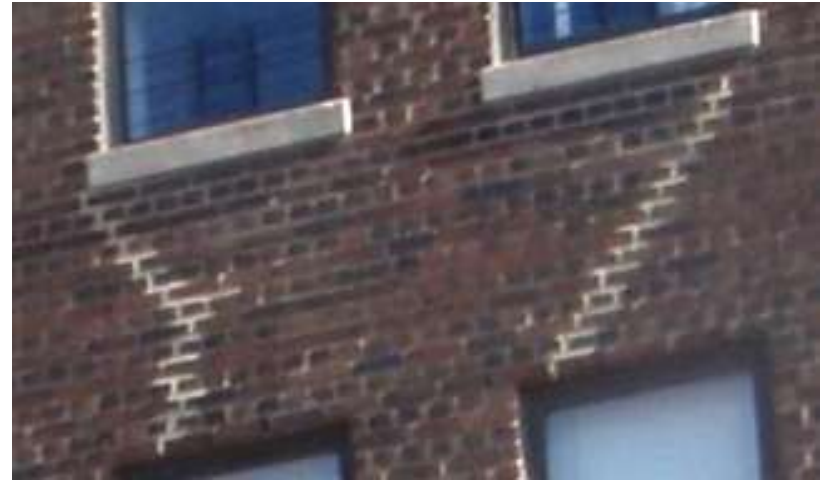
Cracks are always the result of stresses in masonry that exceed resistance of brick or mortar or both. See various type of wall construction for specifics.

Repaired Stepped Crack

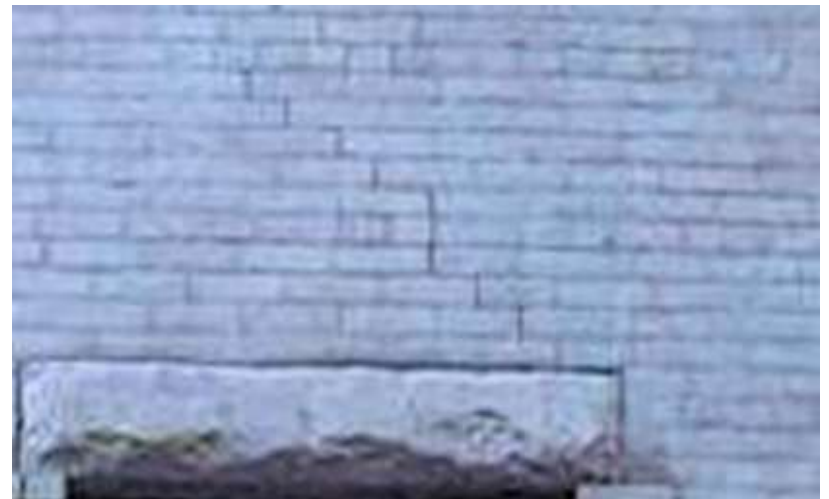
Unrepaired Stepped Crack

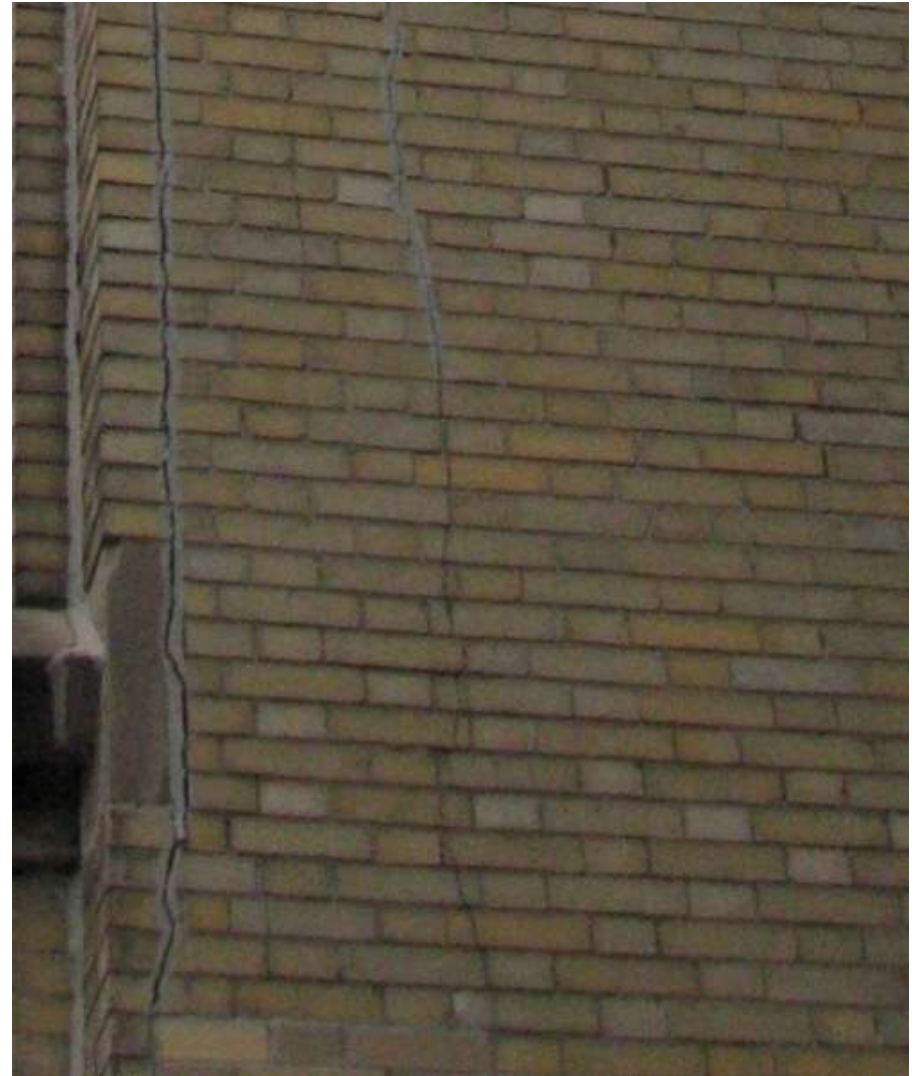
# 3.1.28 Improperly Repaired Crack

Improper workmanship and detailing of repair. Original cause of cracking was not eliminated. Proper repair usually requires replacement of cracked bricks.

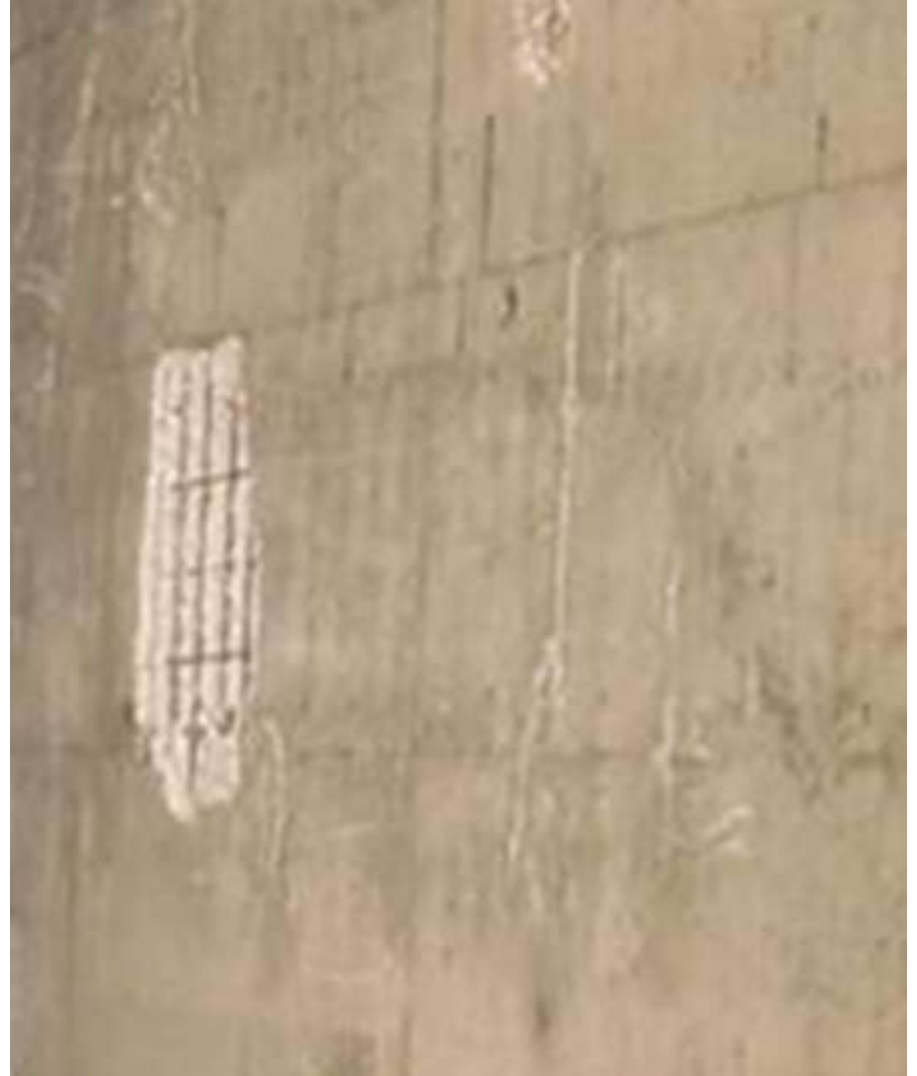
## 3.2.3 Delaminating Concrete Over Reinforcement

Splitting/separation of concrete surface exposing reinforcing steel. Cracking of concrete surfaces in an isolated area with defined borders.

“Rust jacking”. Excessive local corrosion of reinforcing or embedded steel. Lack of sufficient protection against corrosion. Poor quality concrete and/or concrete or rebar placement (insufficient cover).

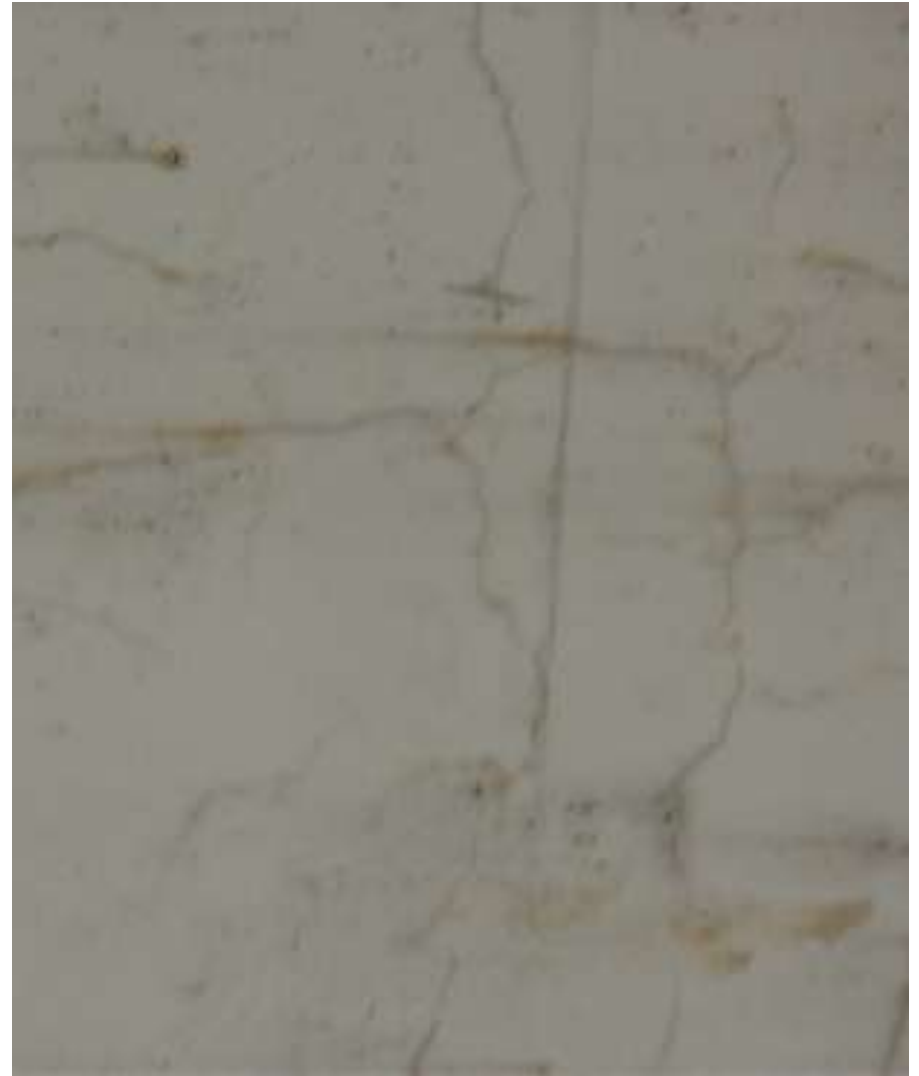
## 3.2.4 Pattern Cracking/Crazing of Concrete

Very fine crack with no clear direction.

***Probable Causes/Deficiencies:*** Differential change in volume between surface of concrete and interior. Poor quality concrete and/or placement. When crazing forms during first year after pour - poor vibrations or curing Alkali- silica reaction.

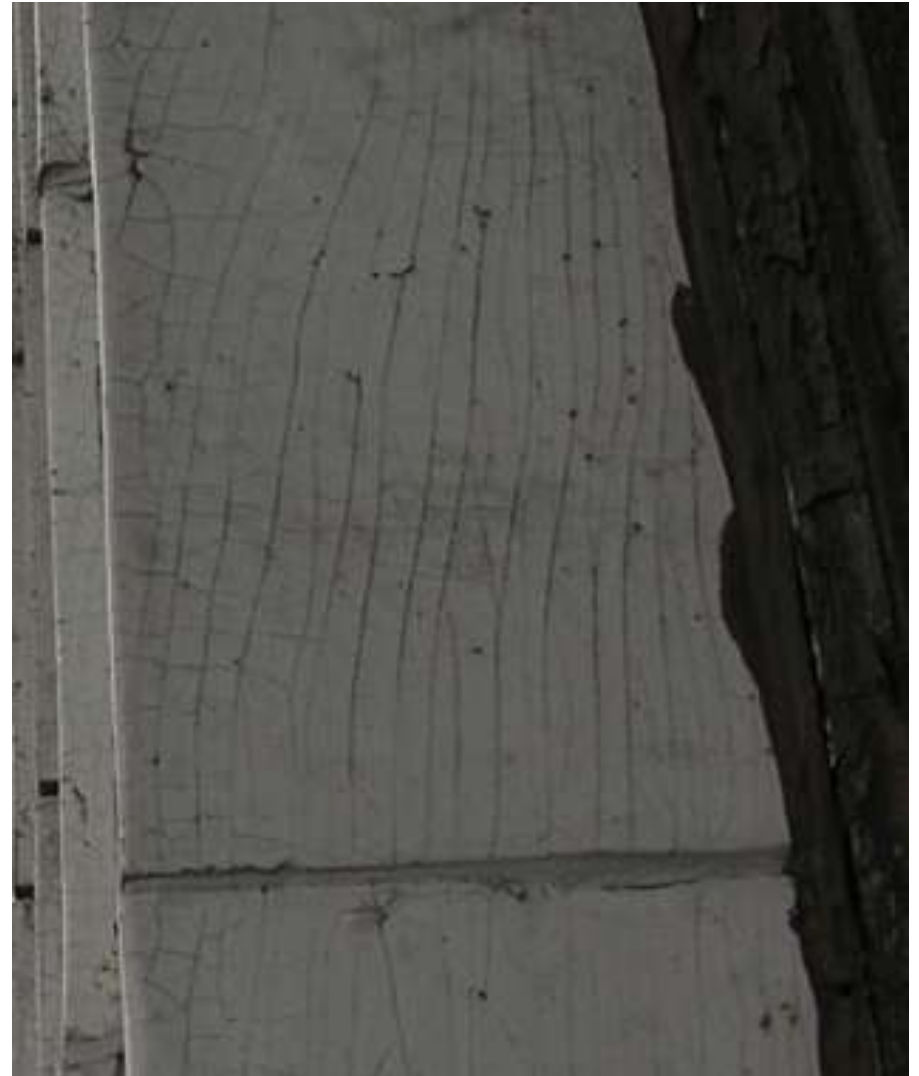
# 3.3.3 Directional Fine Cracking of Terra-cotta Surface

Surface cracking favoring a certain direction.

Manufacture process. The pattern of the surface cracks may be caused by stresses produced by a specific loading of the terra-cotta unit.

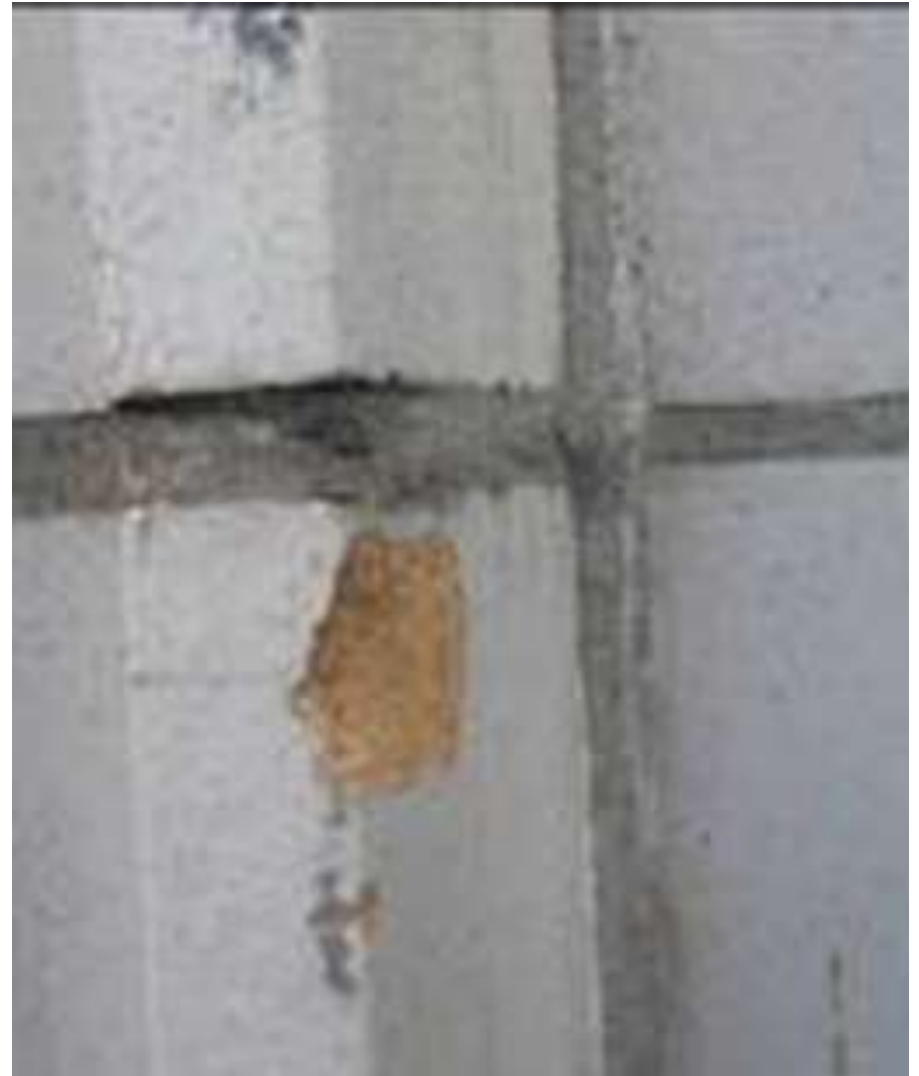
## 3.3.4 Glaze/Surface Chip - Terra-cotta

Trapped water inside the masonry tends to migrate outward. Water penetration through joints or surface cracks. Impact damage (construction equipment).

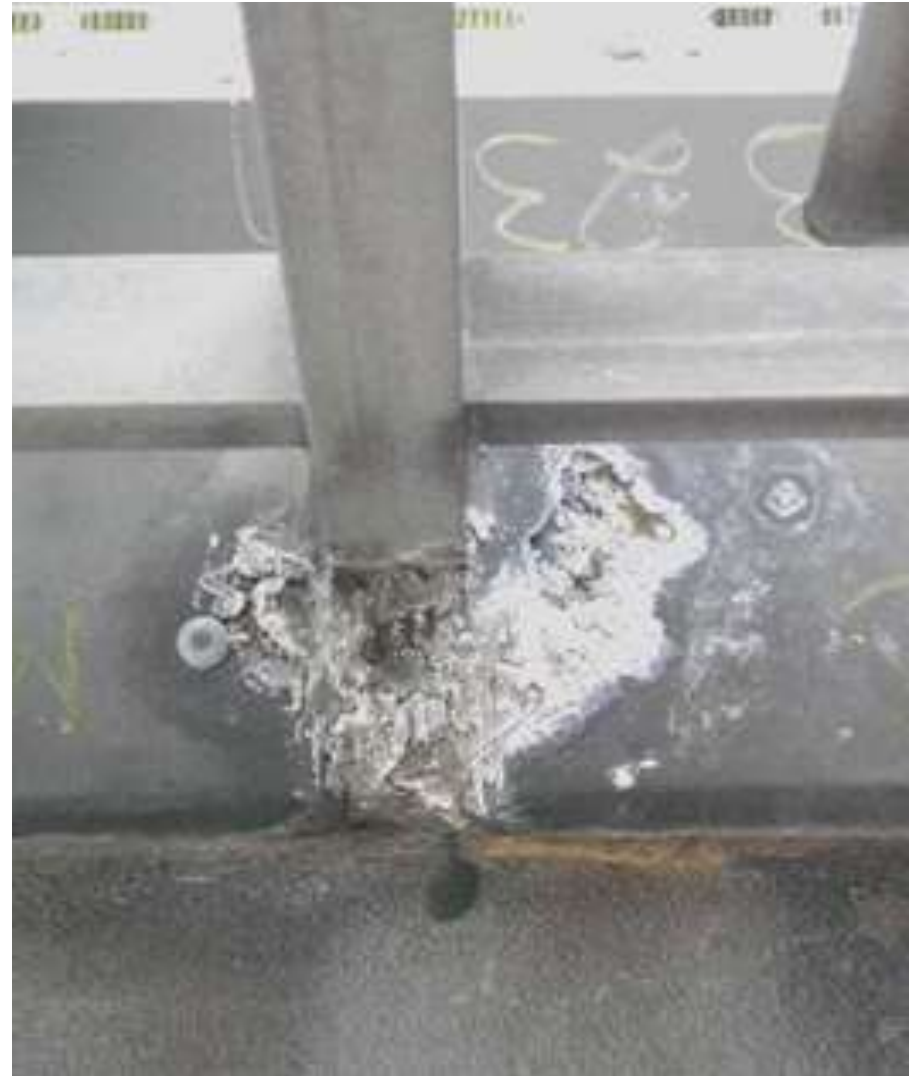
## 3.6.4 Pitting / Crevice Corrosion

Corrosion occurring due to stagnant chloride solution in holes. Can affect aluminum and stainless steel as well.

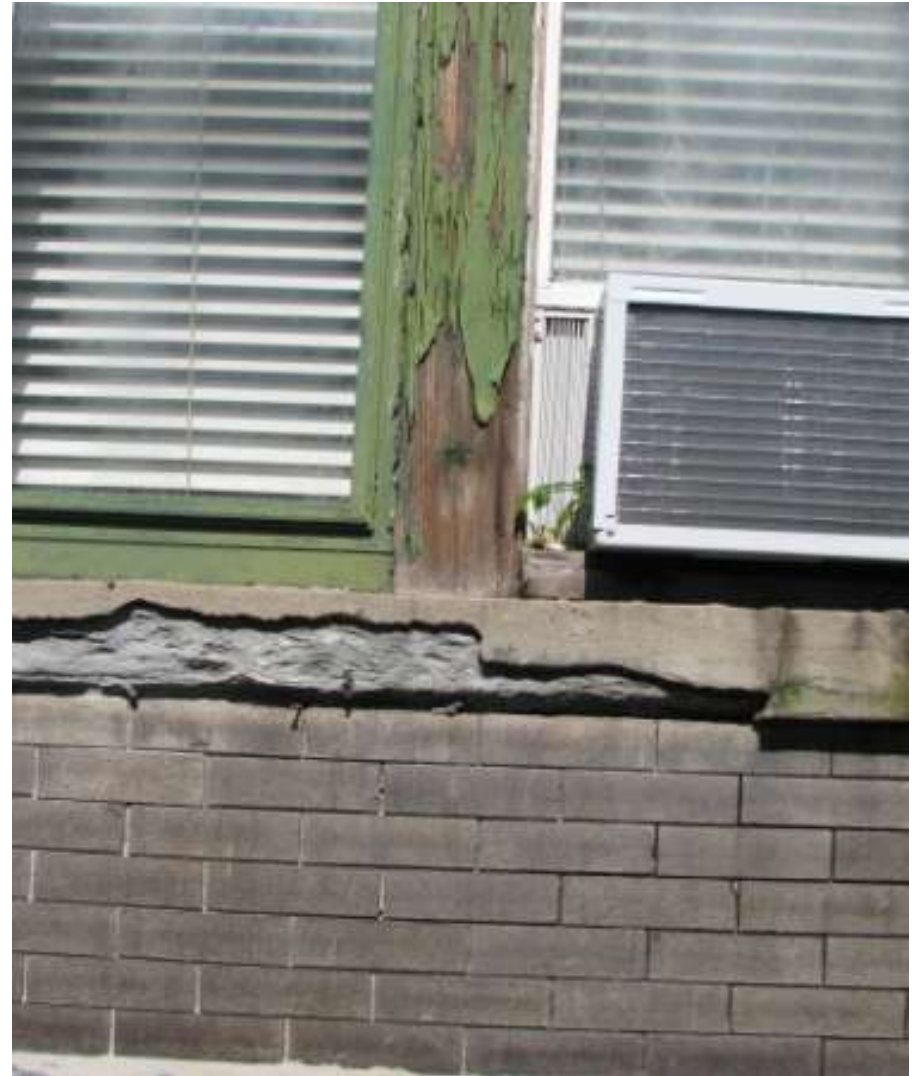
# 4.1 Fenestration Framing

Section 4.1 covers condition of framing and sealants around the glass panels or around other exterior openings in facades (e.g. HVAC).

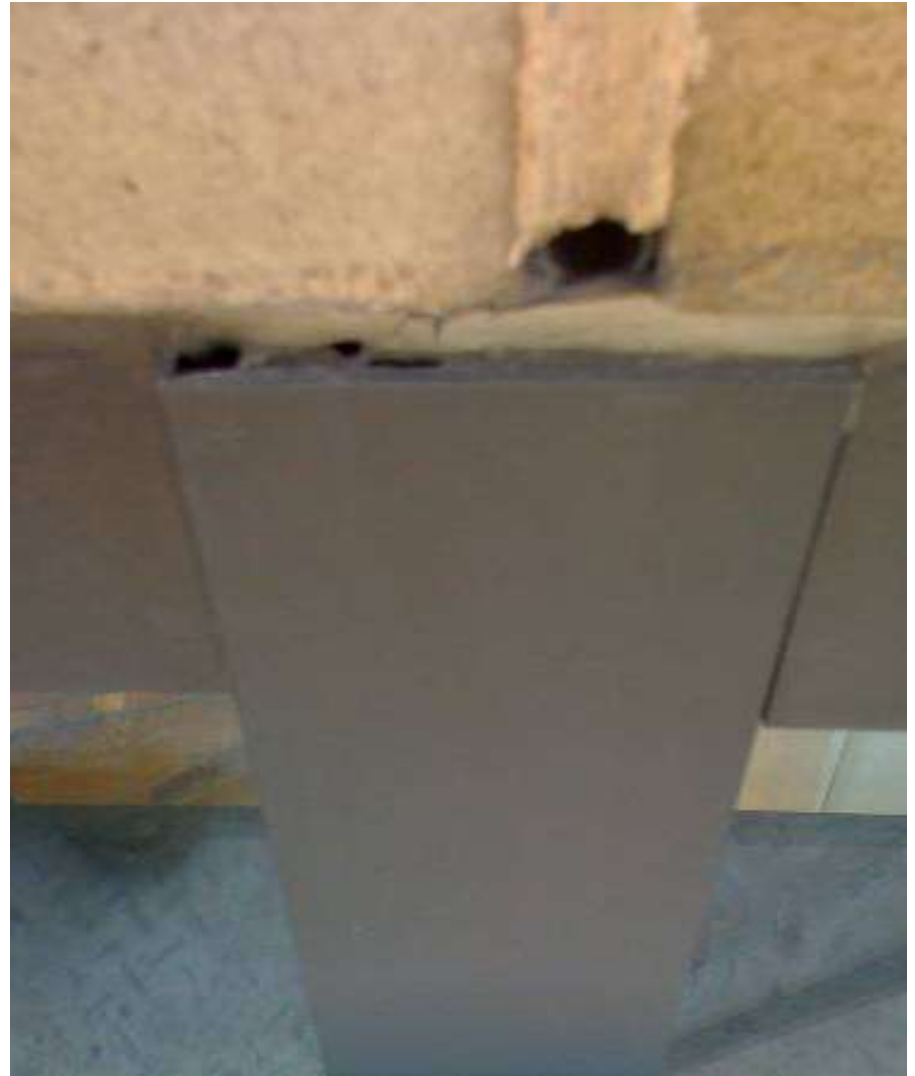
## 4.1.2 Gap in Sealant (Window Frame and Masonry)

Continuity of sealant. Condition of sealant.  
Signs of water infiltration.

Improper installation/application of sealant.  
Improper curing of sealant. Loss of elasticity  
of sealant due to aging. Adhesive failure.  
Loss of cohesion of sealant. Local rust of  
frame material. Organic growth.

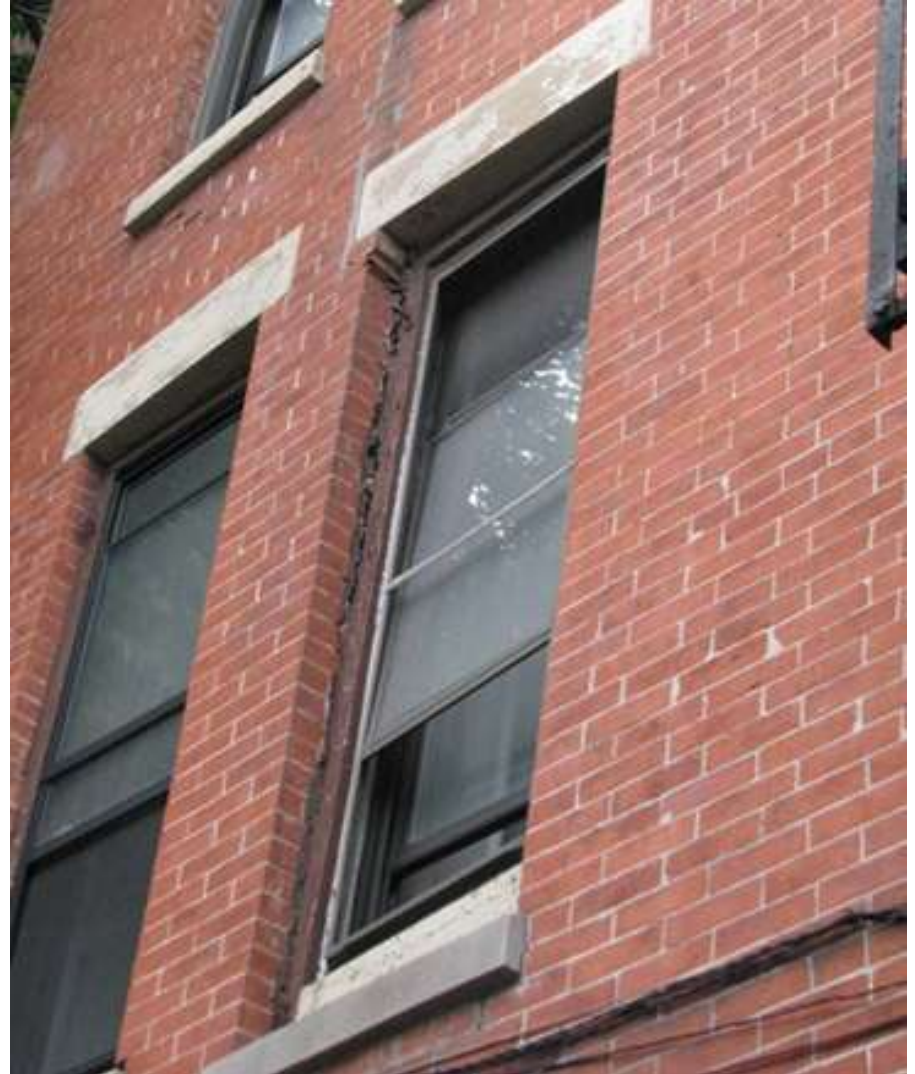
# 4.1.10 Wood Frame Separated From Brick and Displaced

Condition of frame. Frame alignment. Cracks, voids around frame.

Decay of wood. Shrinkage of wood.  
Inadequacy of frame attachment to masonry.

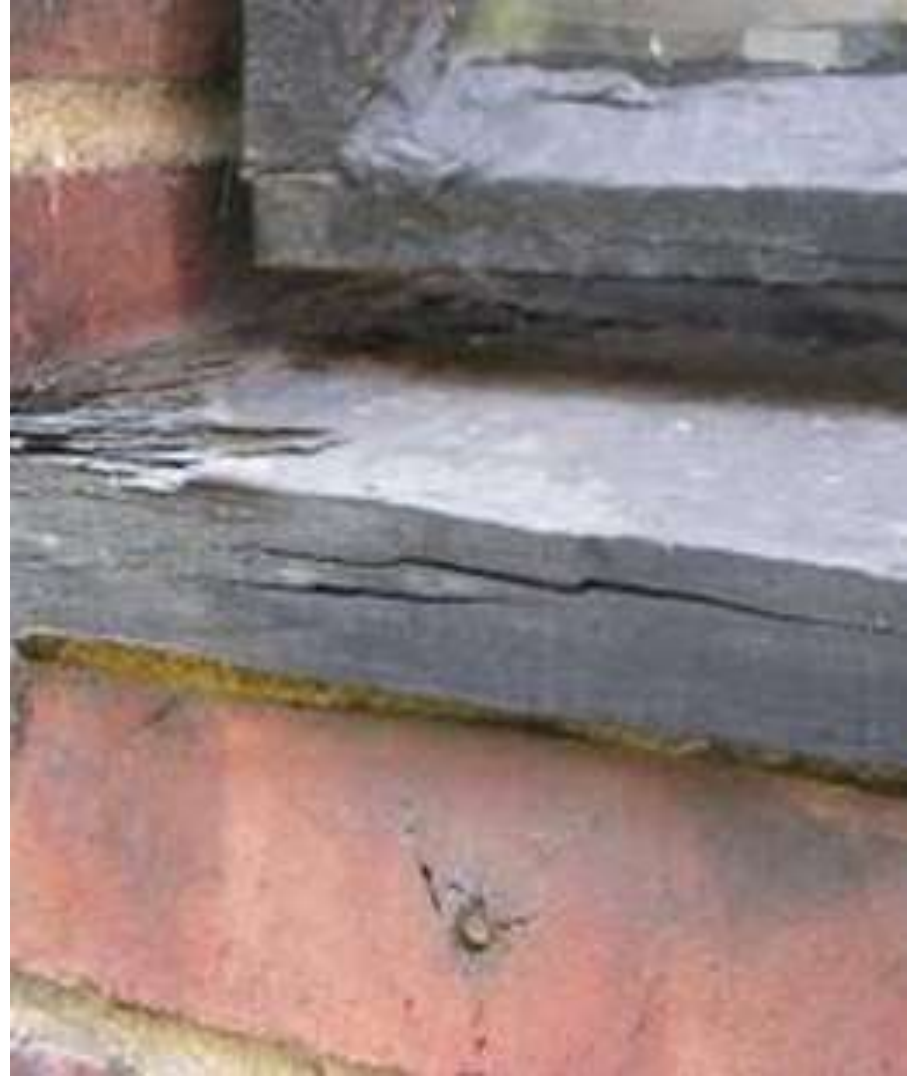
## 4.2.1 Exfoliating of Slate Window Sill

Loose shards, horizontal separation along stone layers.

Poor stone quality. Water infiltration and freeze/thaw cycles separate the bedding planes of the stone.

Additional water penetration and icing.

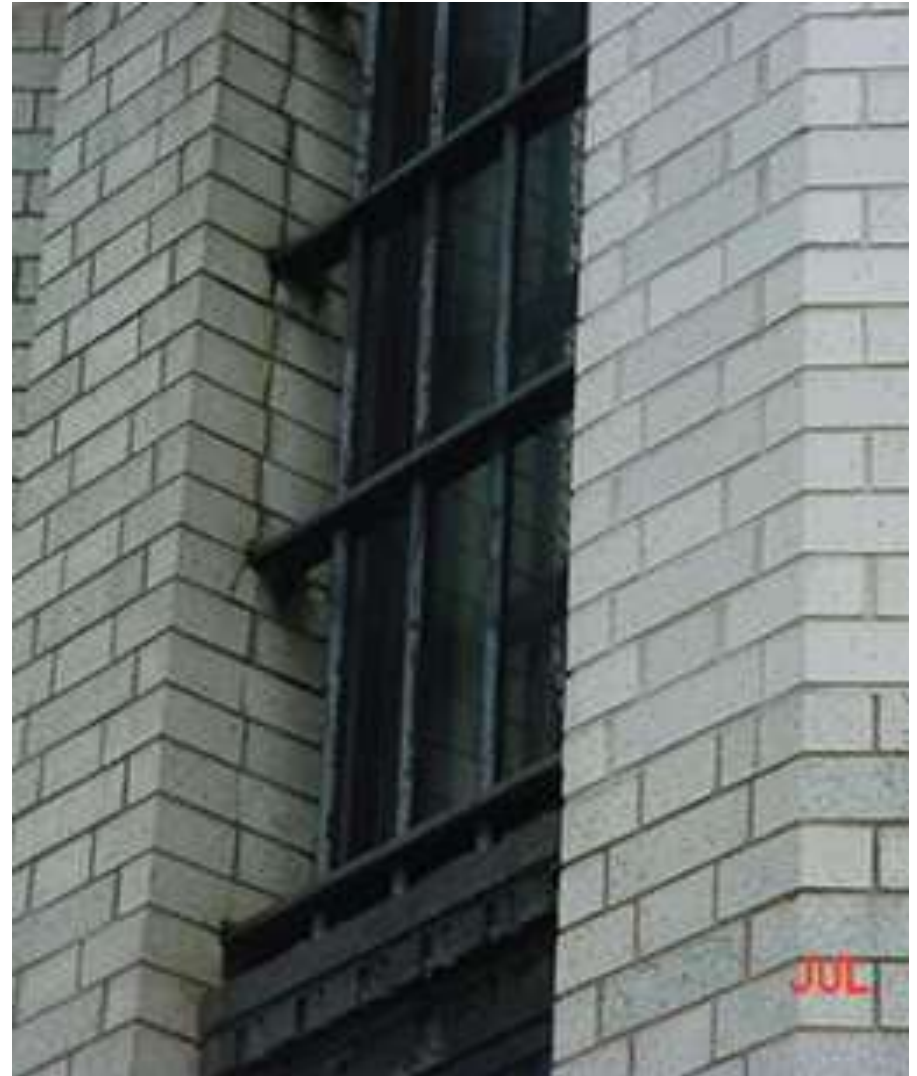
# 4.2.10 Crack of Masonry Jamb at Inserts

Condition of jamb, presence of cracks originating at embedded bars and/or anchorages. Condition of window frame.

Rust jacking.
