# FAÇADE CONDITIONS

An Illustrated Glossary  
of Visual Symptoms

**Edited by Dan Eschenasy, PE**  
Chief Structural Engineer  
NYC Department of Buildings

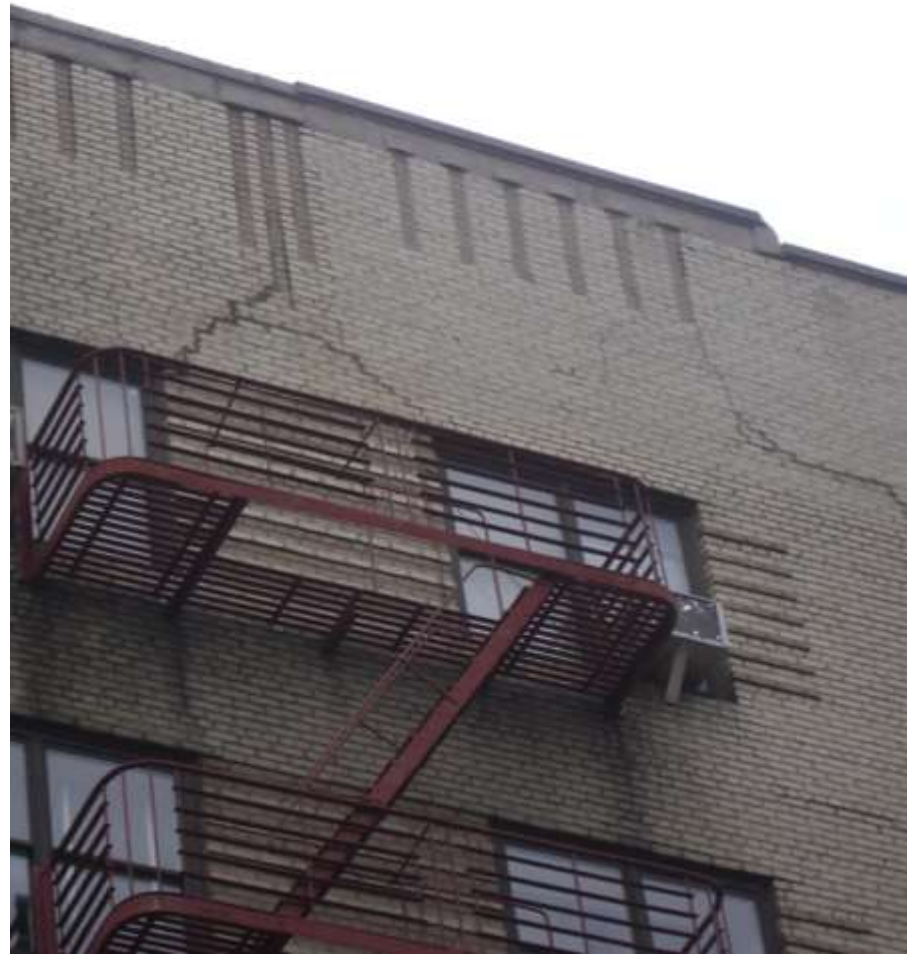
## 4.3 Parapets / Cornices

Parapets are the building element most exposed to the action of rain, wind or thermal variation. Sometimes the parapet condition might be worsened by the detailing and construction of the joining to the roofing system.

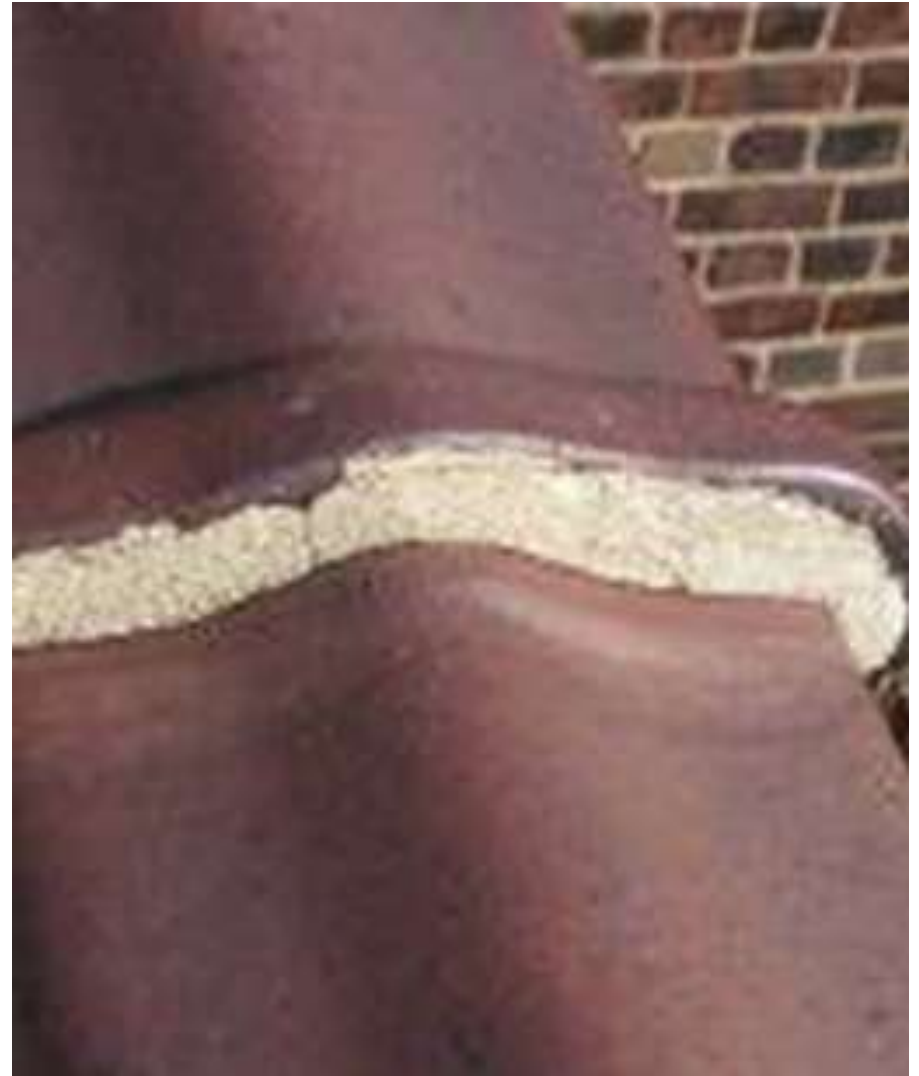
## 4.3.2 Open Cross Joints - Coping

Mortar condition. Loose, cracked mortar.

Water penetration and freeze/thaw cycles

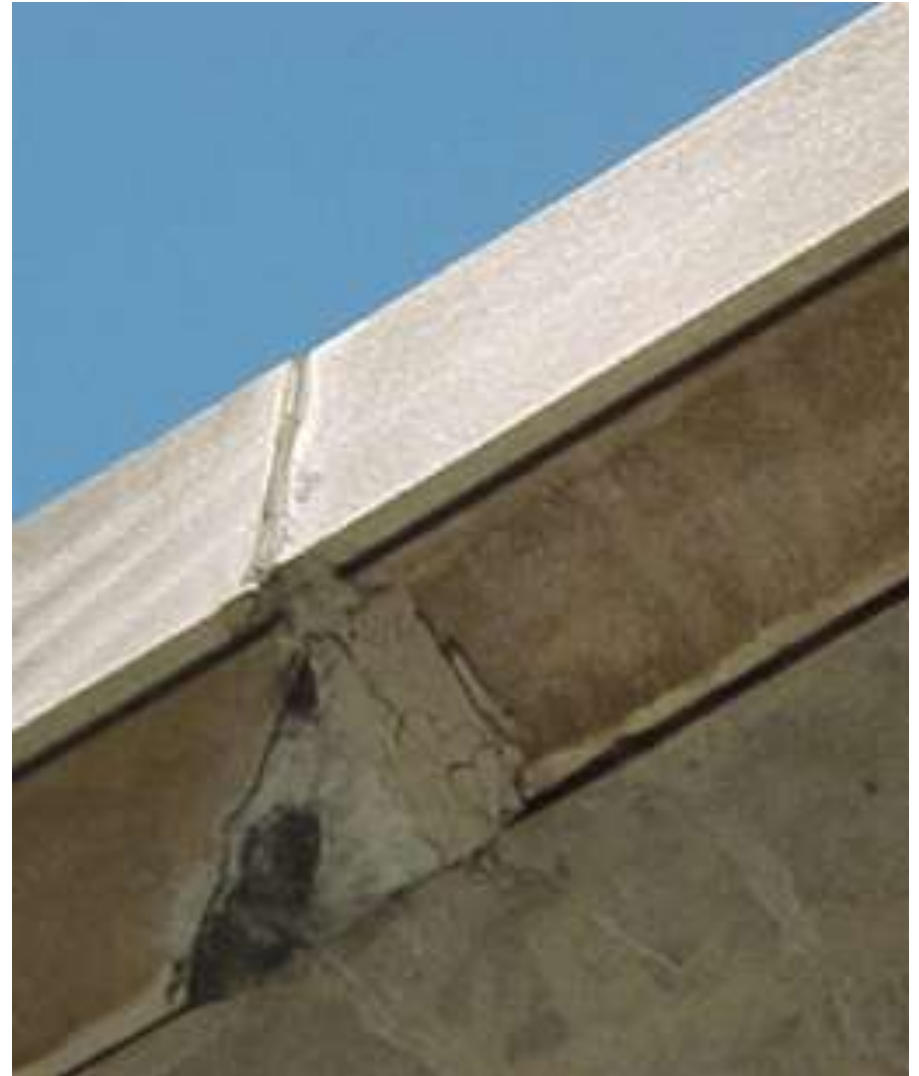
# 4.3.14 Deterioration of Underside Cornice

Cracks/deterioration of decorative elements (stone, concrete, cast stone).

Excessive water accumulation followed by icing/ thaw cycles. Stresses due to blocked thermal expansion

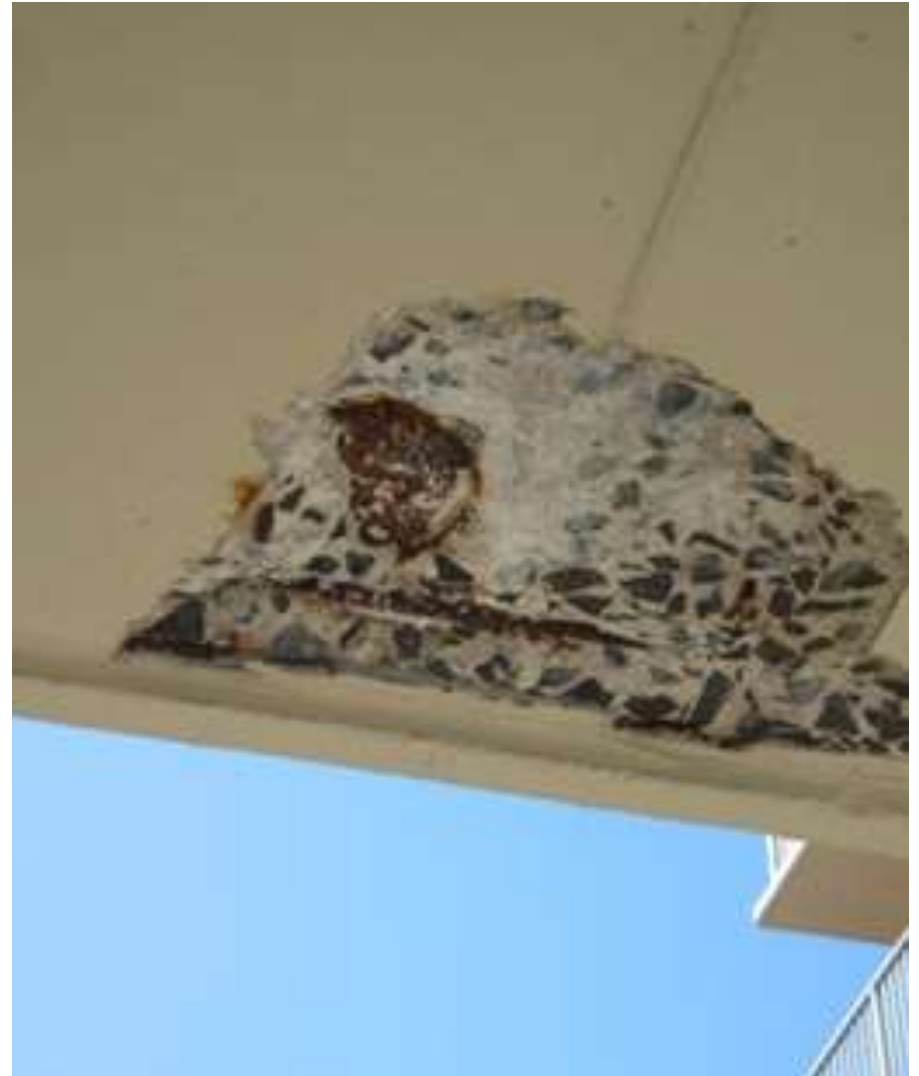
## 4.4.5 Spall in Concrete Slab at Underside of Post

Spalling/deterioration of concrete underneath rail post.

Improperly waterproofed insert (post base) above. Crevice corrosion of aluminum base post.

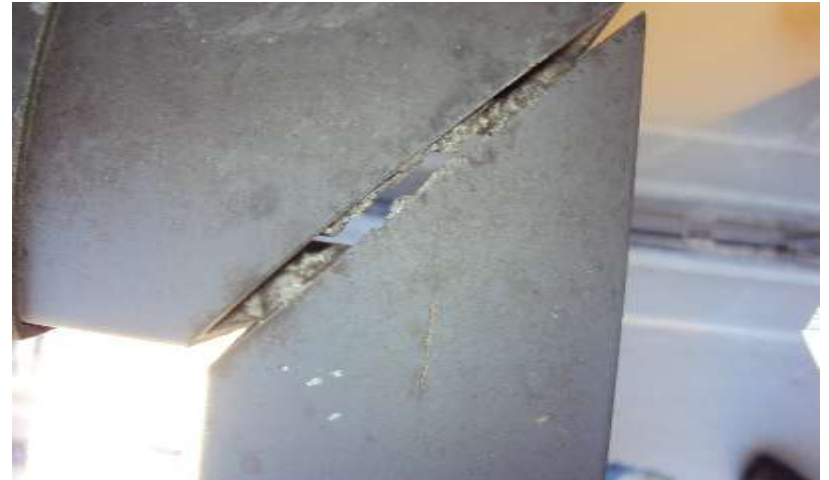
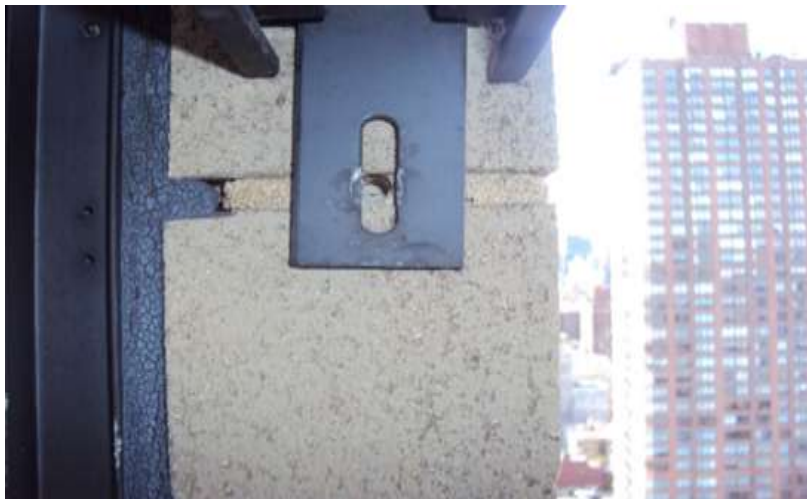
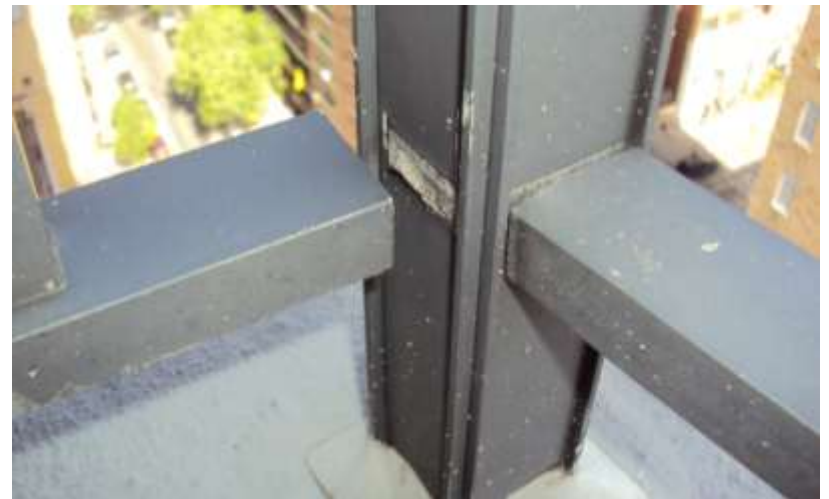
# 4.4.9 Handrail Connection Failures

Deterioration and failure of connections.

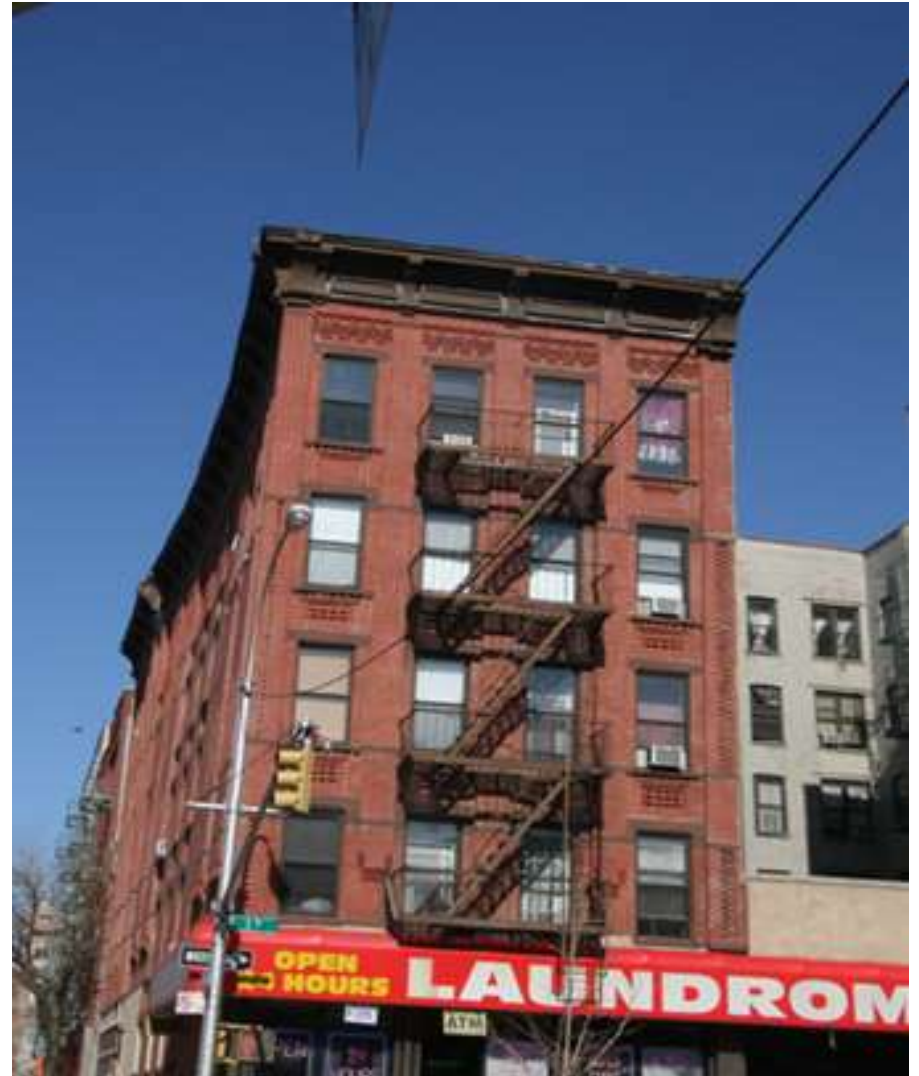
# 5.1.1 Façade Bowing Inwards (or Outwards)

Requires structural engineering analysis.

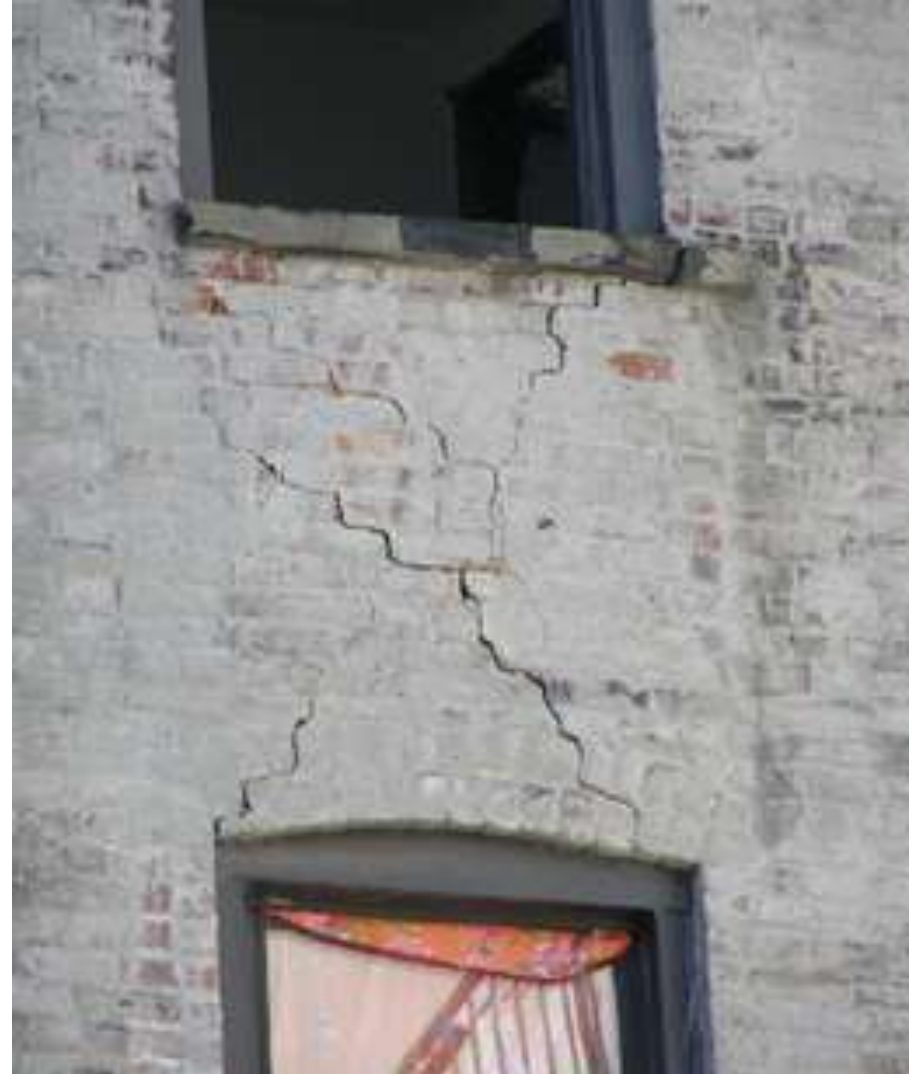
# 5.1.5 Intersecting Diagonal Cracks – Connecting Opening

Intersecting diagonal cracks in spandrels.  
More common near corners.

May require engineering analysis.

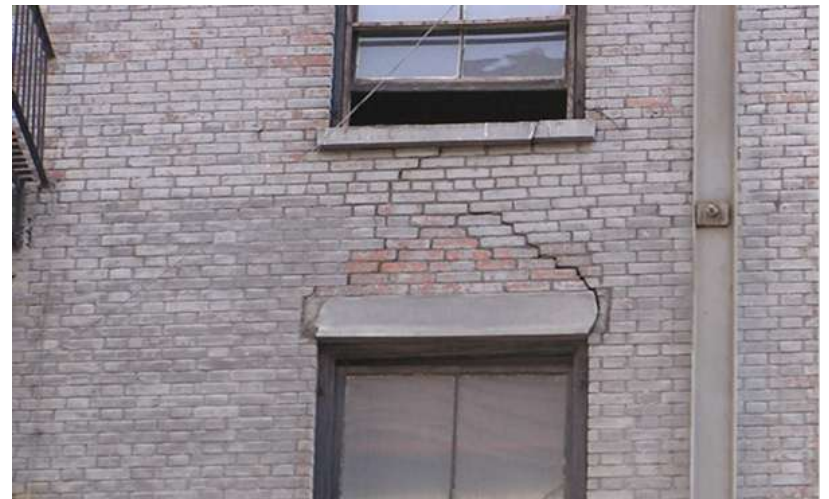
# 5.1.6 Inverted “V” Crack at Lintels

Inverted V shaped stepped cracks. More commonly originating at lintel.

Deflection of lintel. Crack forms along the lines of the *relieving masonry arch*  
Condition might have appeared soon after erection. Differential settlement under load (spandrel/pilaster)

Presence, condition of steel lintel needs to be investigated.

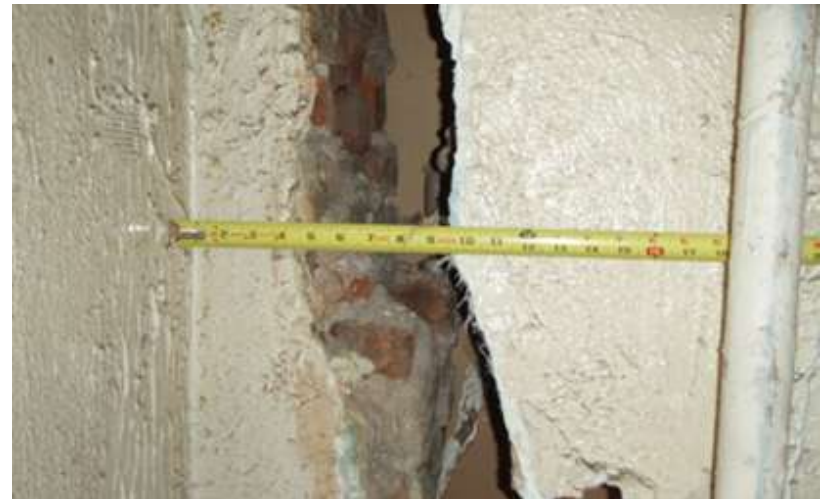
# 5.1.10 Bulging of Bearing Masonry

Bulging in outside wythe might indicate improper/insufficient bonding between wythes. Bulging of the entire masonry might be caused by the expansion of the floor structure.

*Requires structural engineering analysis.*

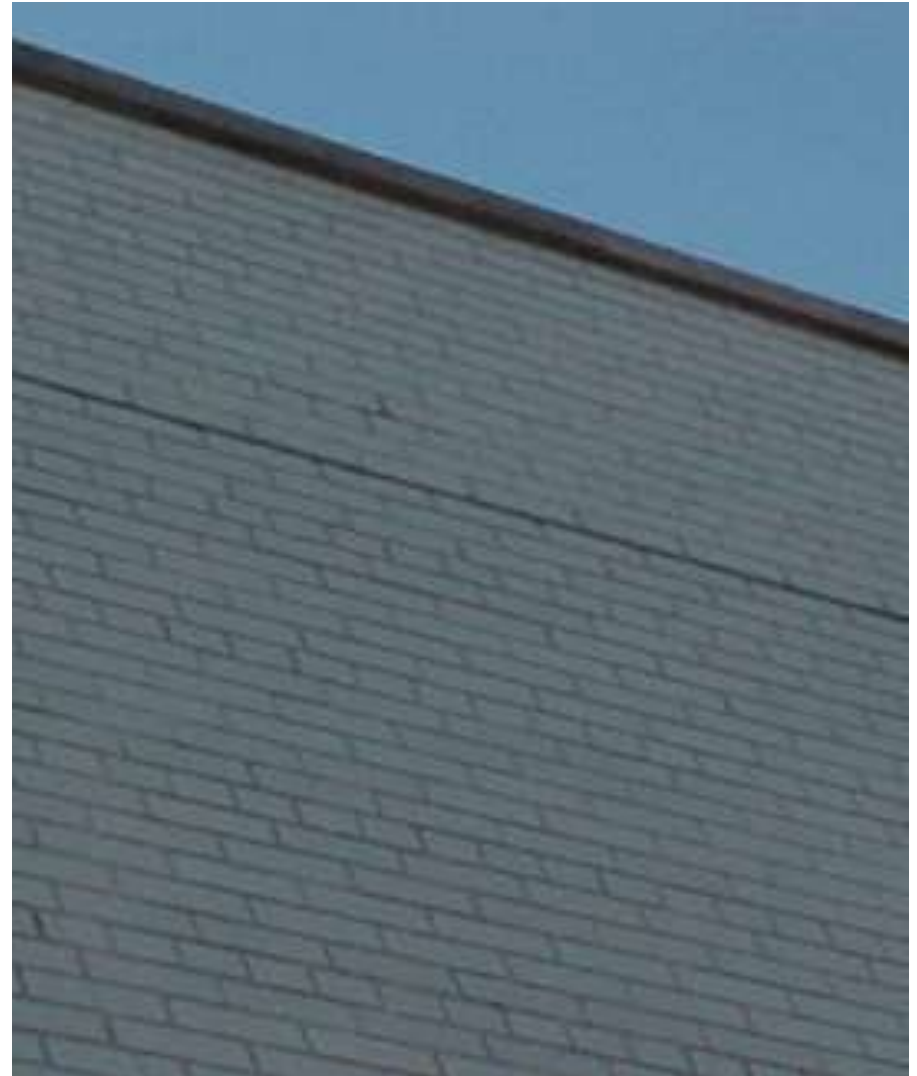
## 5.2.3 Crack At Parapet Along Spandrel Beam

Position of crack relative to the structural supporting elements, verticality of parapet. Alignment of parapet. Separation of parapet from masonry below. Condition of back-up masonry.

***Probable Causes/Deficiencies:*** Corrosion of supporting steel, thermal movement of parapet, creep and deflection of parapet under wind loads, possible water penetration due to failed roof flashings.

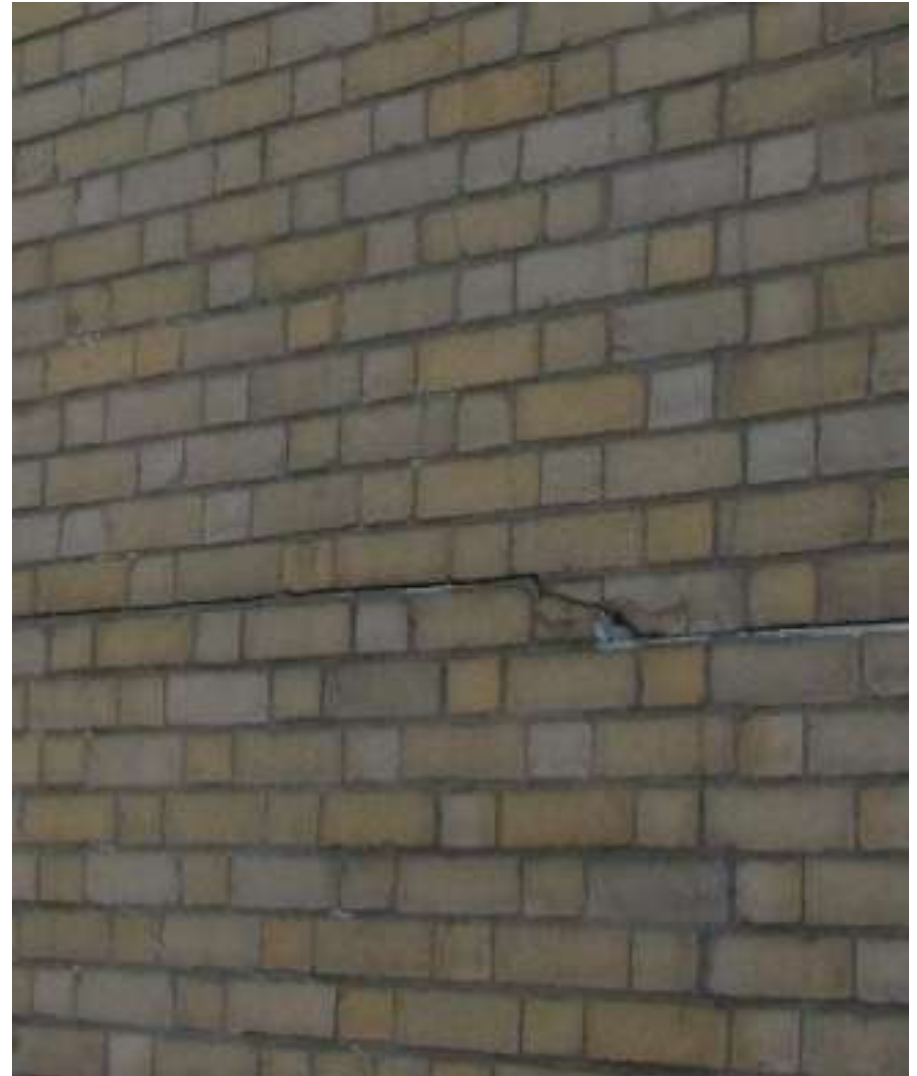
# 5.2.7 Bulge and Crack at Face Masonry

Presence of cracks.

Corrosion of steel spandrels. Shearing of brick headers at steel support. Freezing of water trapped (ice buildup) in the crack space.

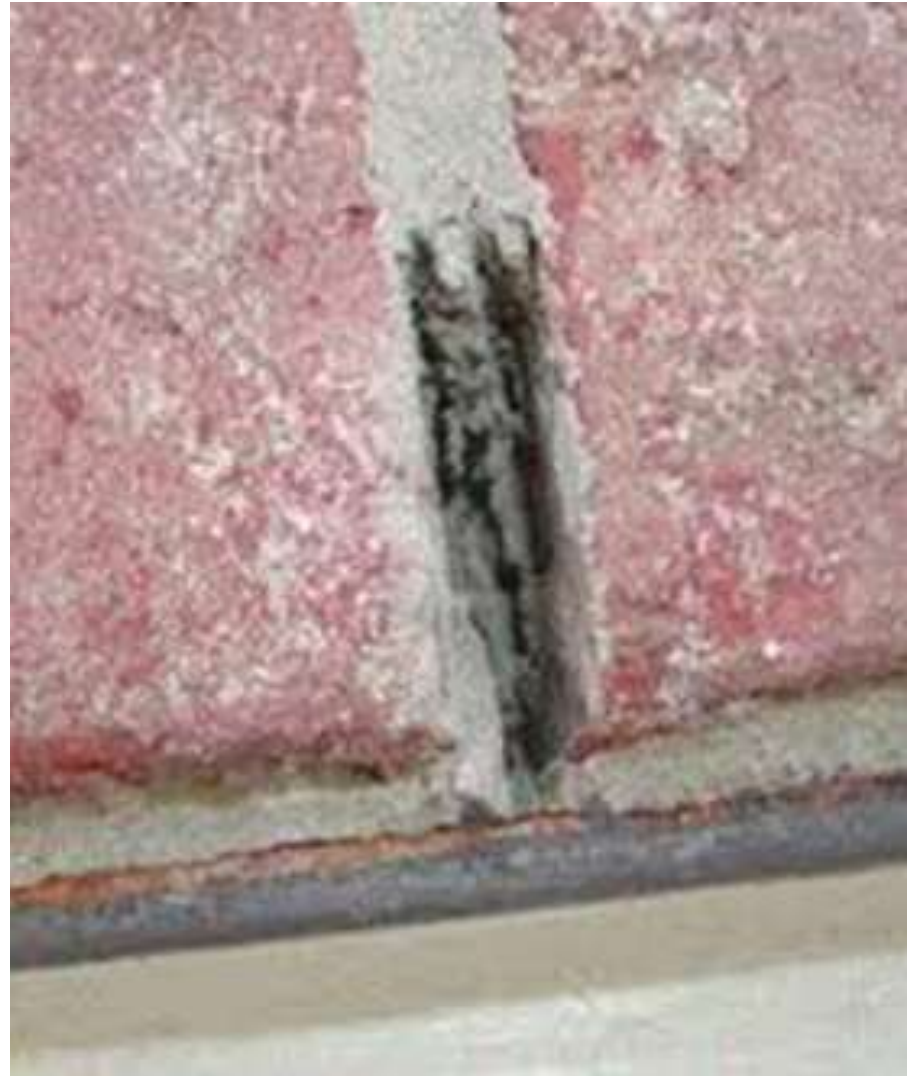
Accumulation of dirt. Mortar droppings blocking the cavity or the hole. Might allow water buildup.

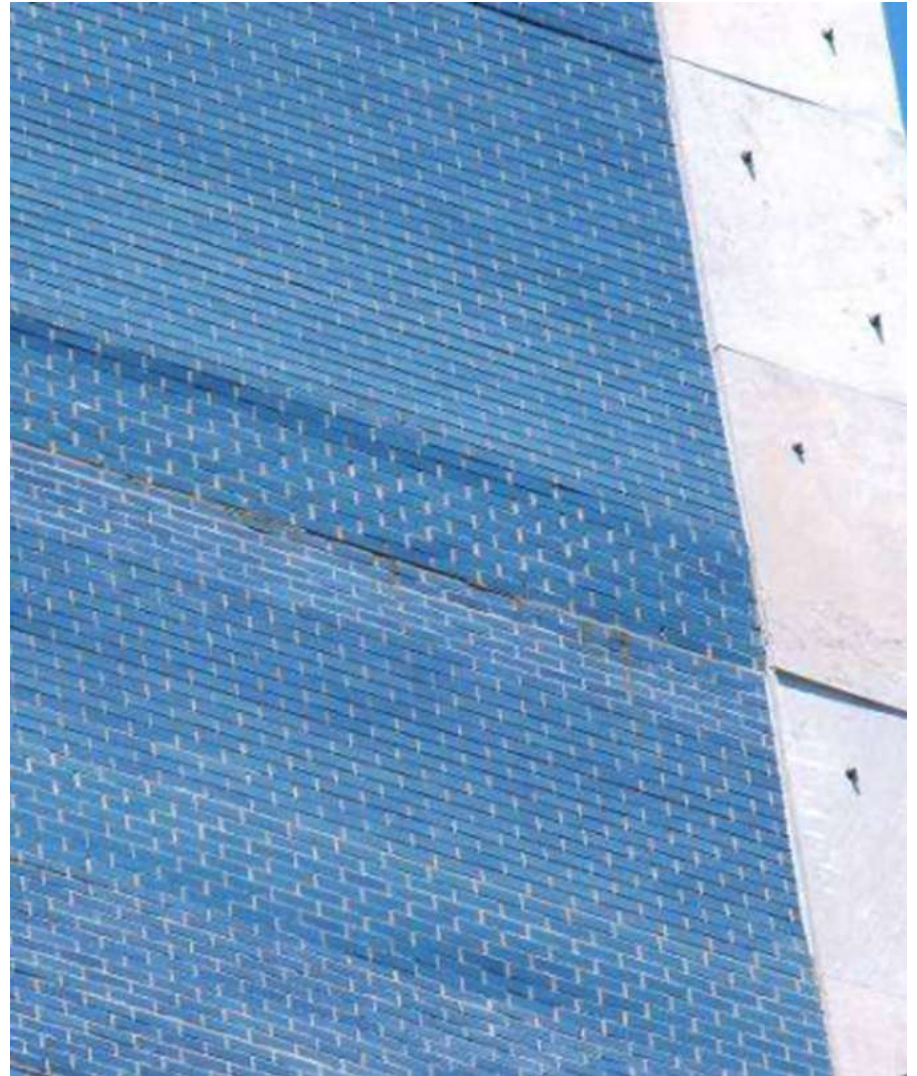
## 5.3.2 Rolling Block in Brick Veneer

Insufficient bearing of brick on shelf angle; shelf angle rotation (due to excessive shims) transfers load to lower facade veneer (contrary to design intent) ; construction tolerance issues; insufficient or rusted wall ties. Loss of wall ties anchorage.

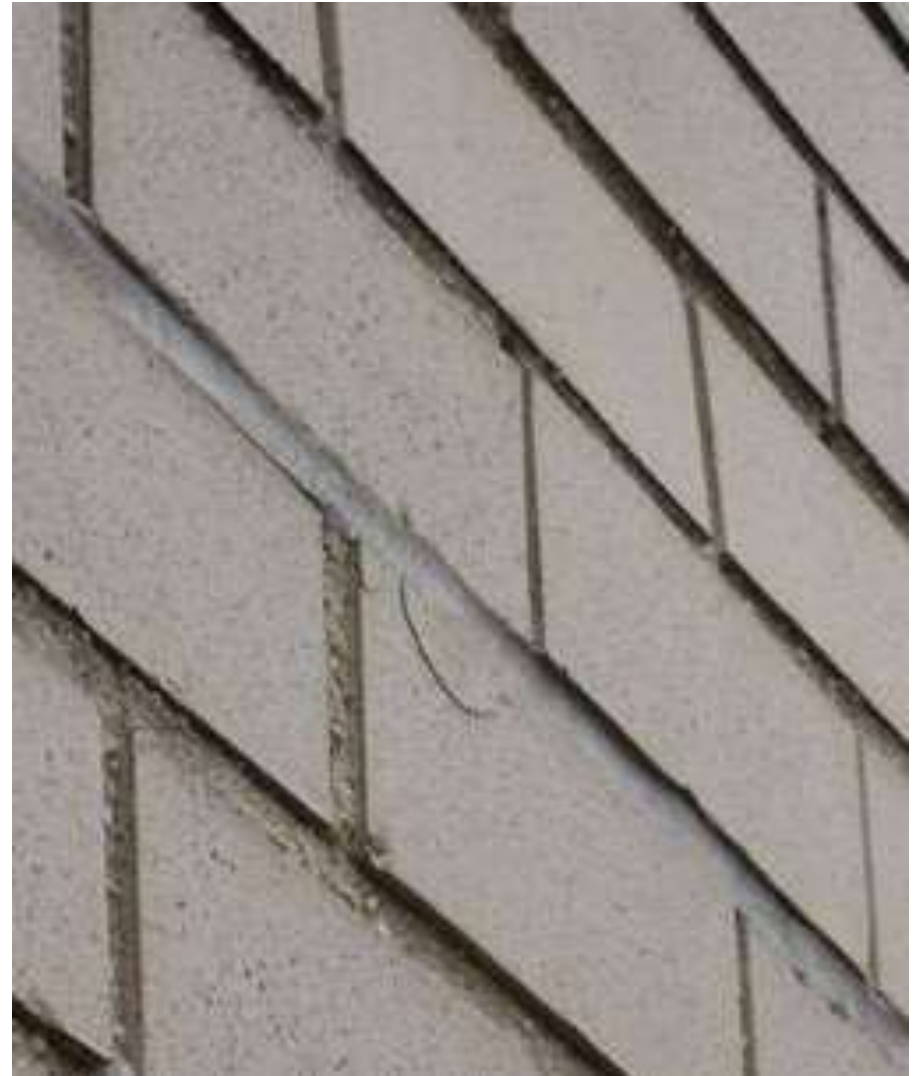
## 5.3.6 Incipient Brick Spalling at Shelf Support of Veneer

Spall of brick located at shelf angle joint.  
Cracked mortar at joint above spall,  
incipient bowing.

Additional spalling of brick course below shelf should be anticipated; load transfer to veneer below may result in bowing, buckling of veneer; confirm placement/extent of soft joint in veneer.

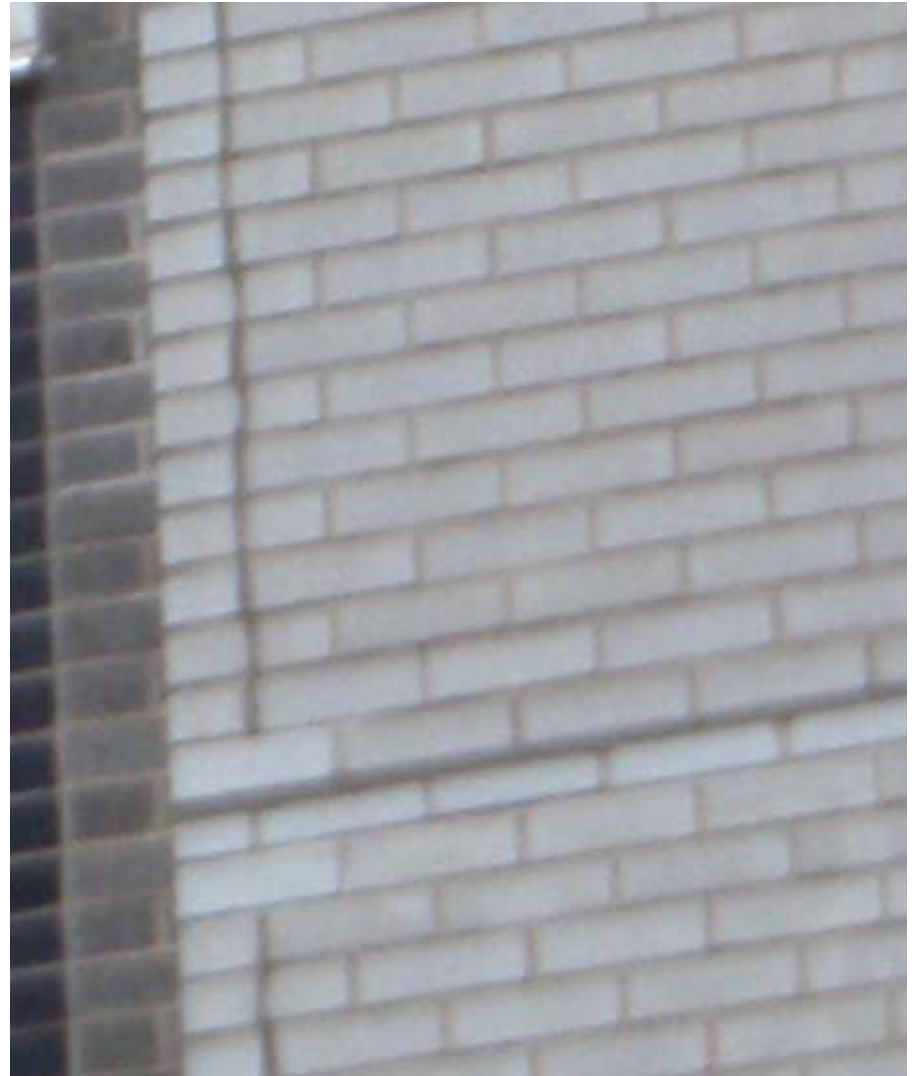
## 5.3.8 Vertical Cracks in Veneer at Corner

Size and direction of cracks.

Horizontal expansion in the plane of the veneer is not accommodated at the vertical control/expansion joints. Joint dimension is insufficient. Lack or improper placement of joints.

The thermal expansion develops forces that crack the brick veneer.

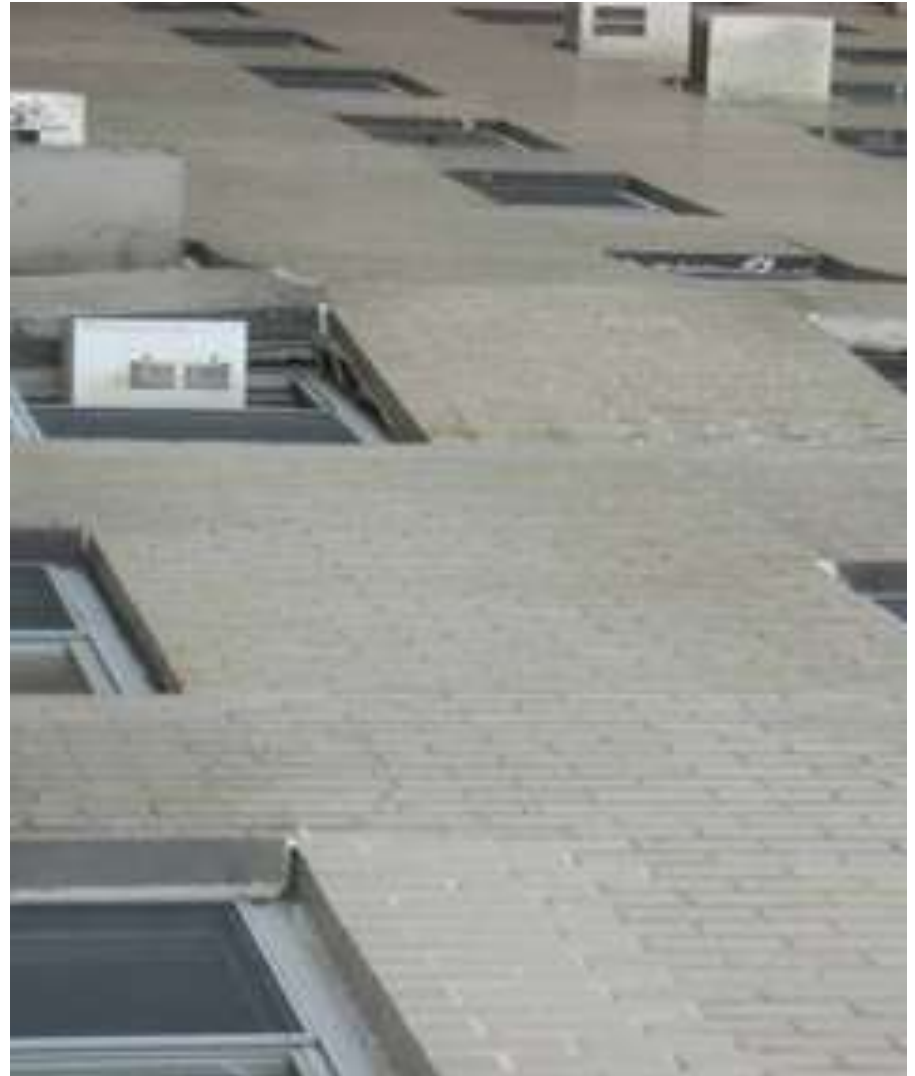
## 5.3.9 Bowing Brick Veneer

Insufficient drainage of water (clogged weep holes) or rust jacking pushing veneer off the shelf angle. Insufficient or rusted wall ties.

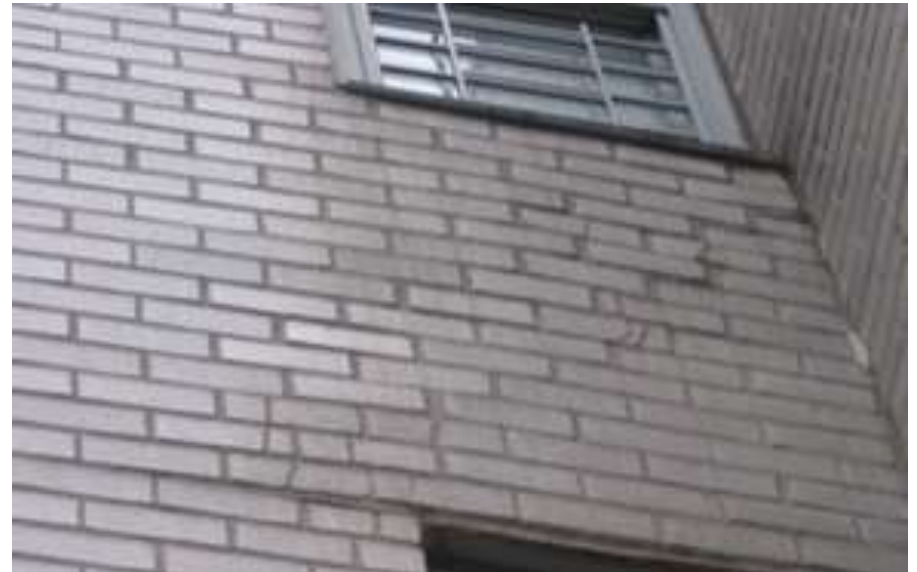
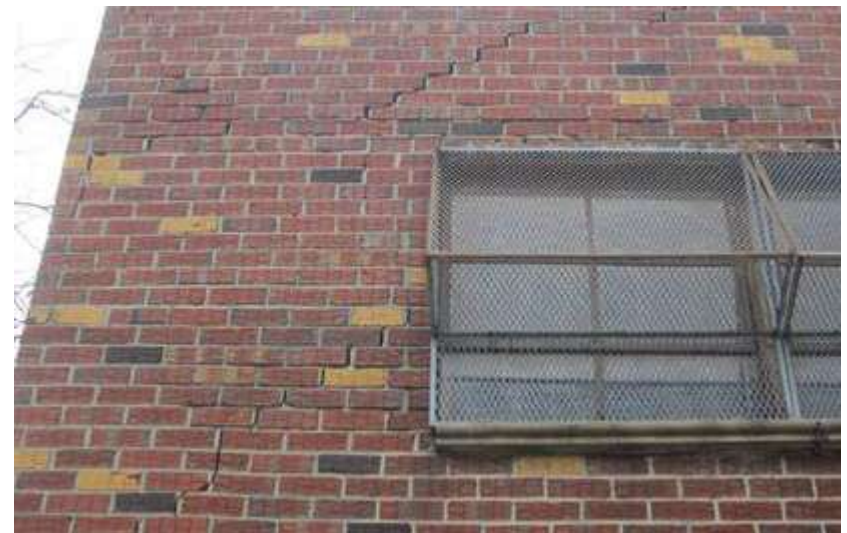
# 5.3.12 Stepped Crack in Brick Veneer

Stepped crack into mortar joints or into brick and mortar joints, downward bowing of shelf support. Verticality of wall elements.

Weakening of shelf support due to corrosion or due to movement of G-locks. Movement of veneer over shelf. Lack of joints. Movement of supporting frame.

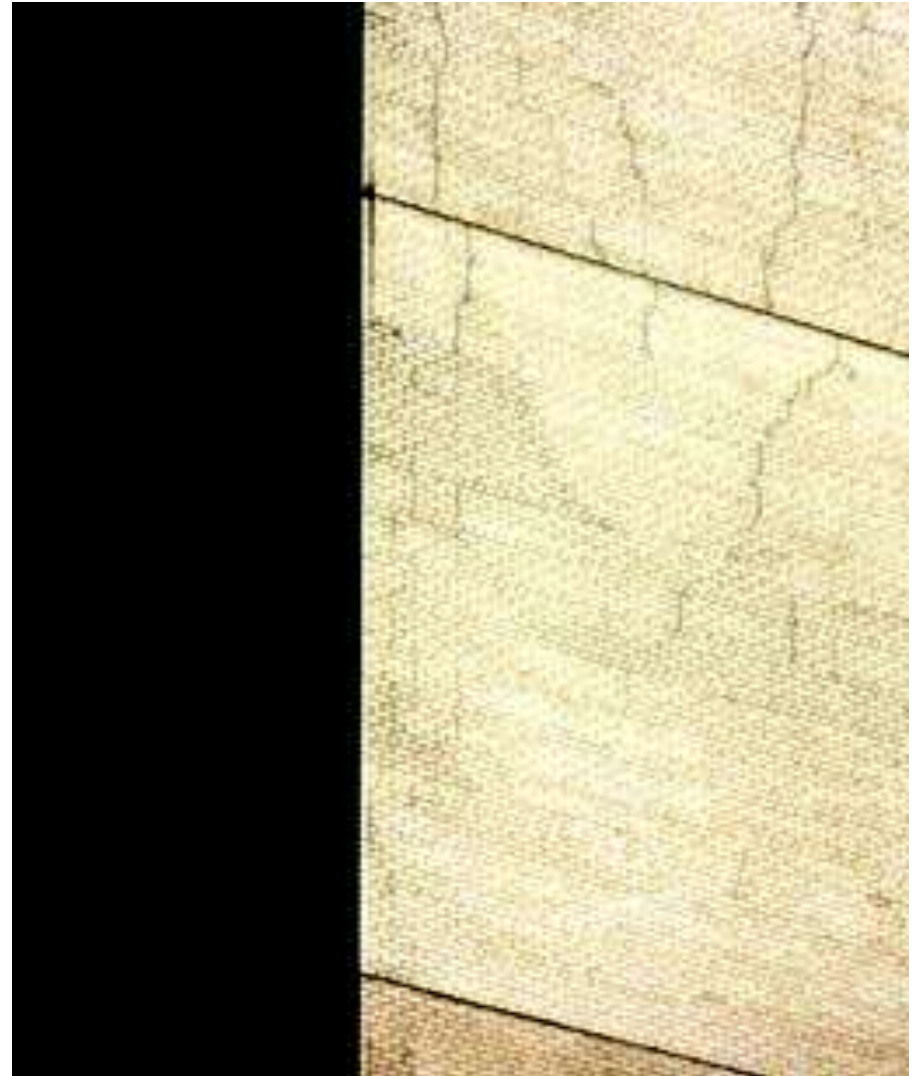
# 5.3.14 Vertical Cracks (distributed) in Brick Veneer

Vertical cracks, size and number of cracks, presence and condition of soft joints.

Brick undergoing ceramic or thermal expansion becomes compressed between shelf angles top and bottom, large distance between horizontal joints.

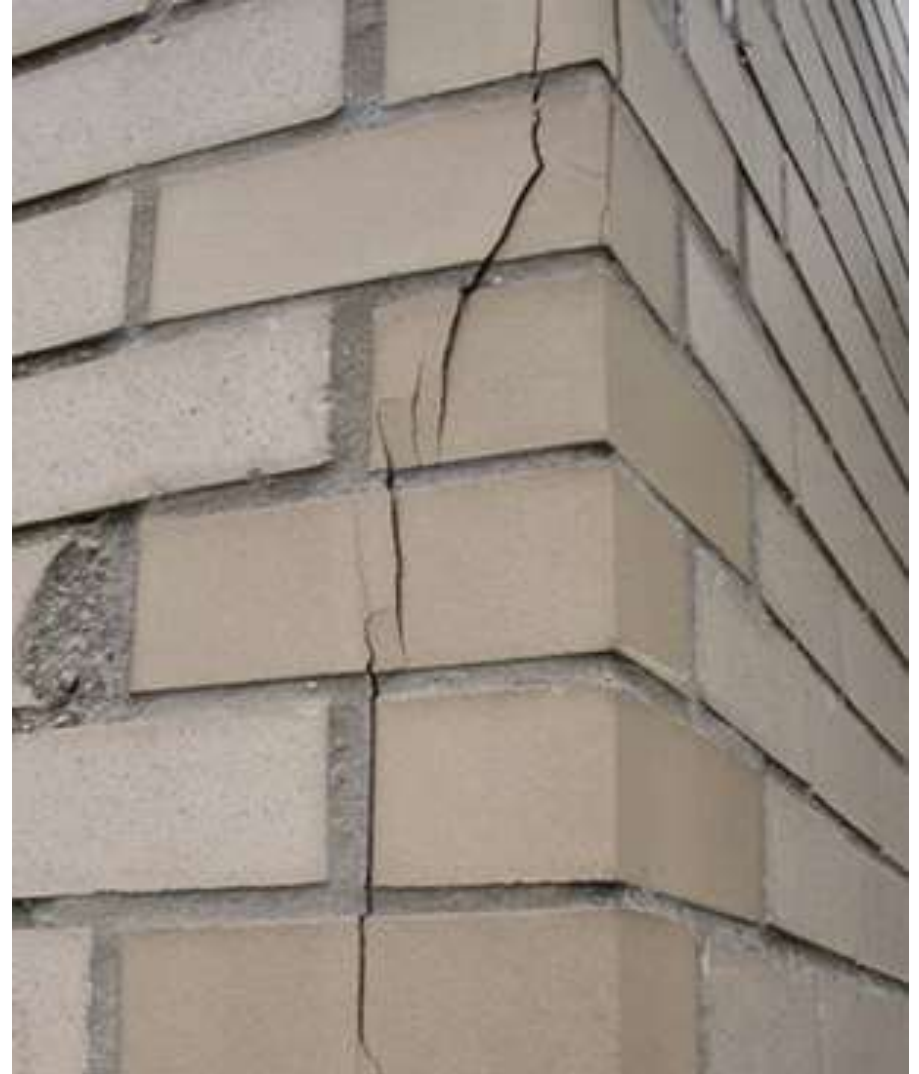
## 5.3.16 Improper Repair of Veneer at Corner

Vertical cracks formed following the replacement of the bricks at corner. The repair did not allow for the ceramic expansion of the newly installed brick.

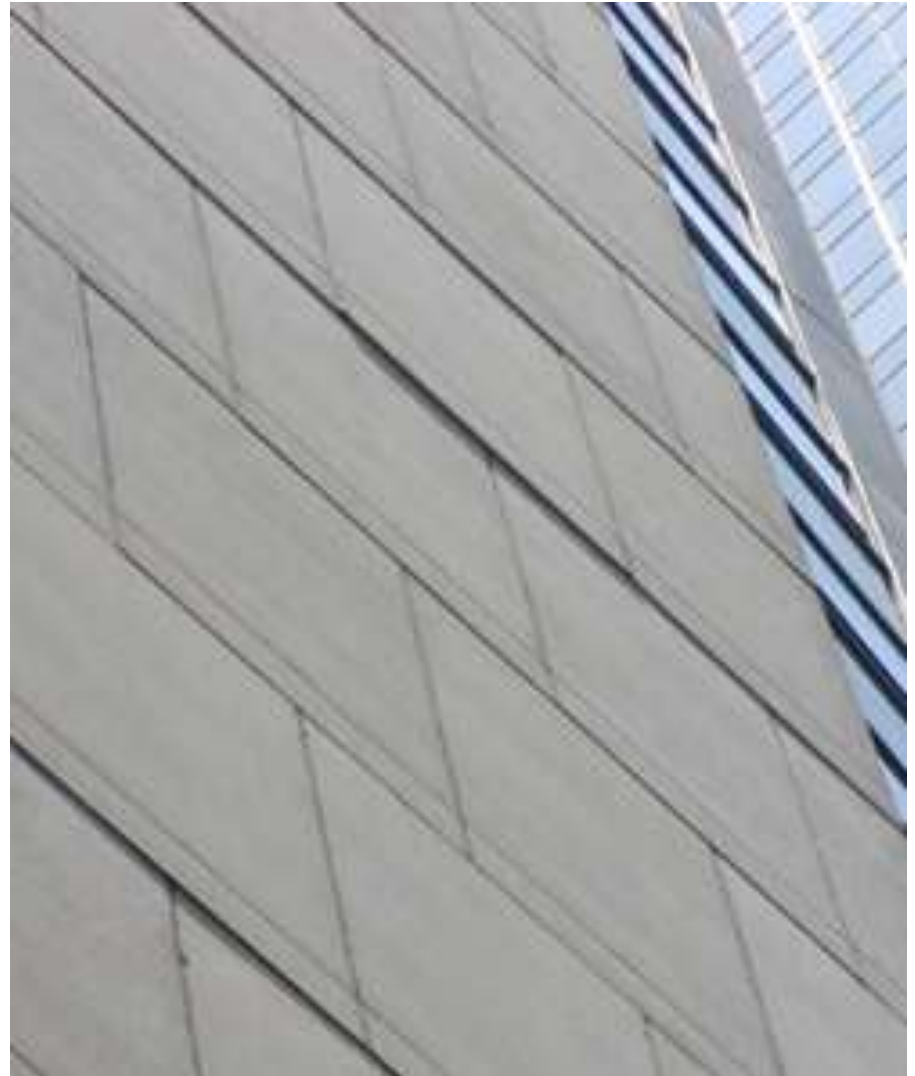
## 5.4.2 Slippage Precast Concrete Panel

Failure of the stone anchoring system; Rust build-up on the shelf angle; Use of non-galvanized anchoring system.

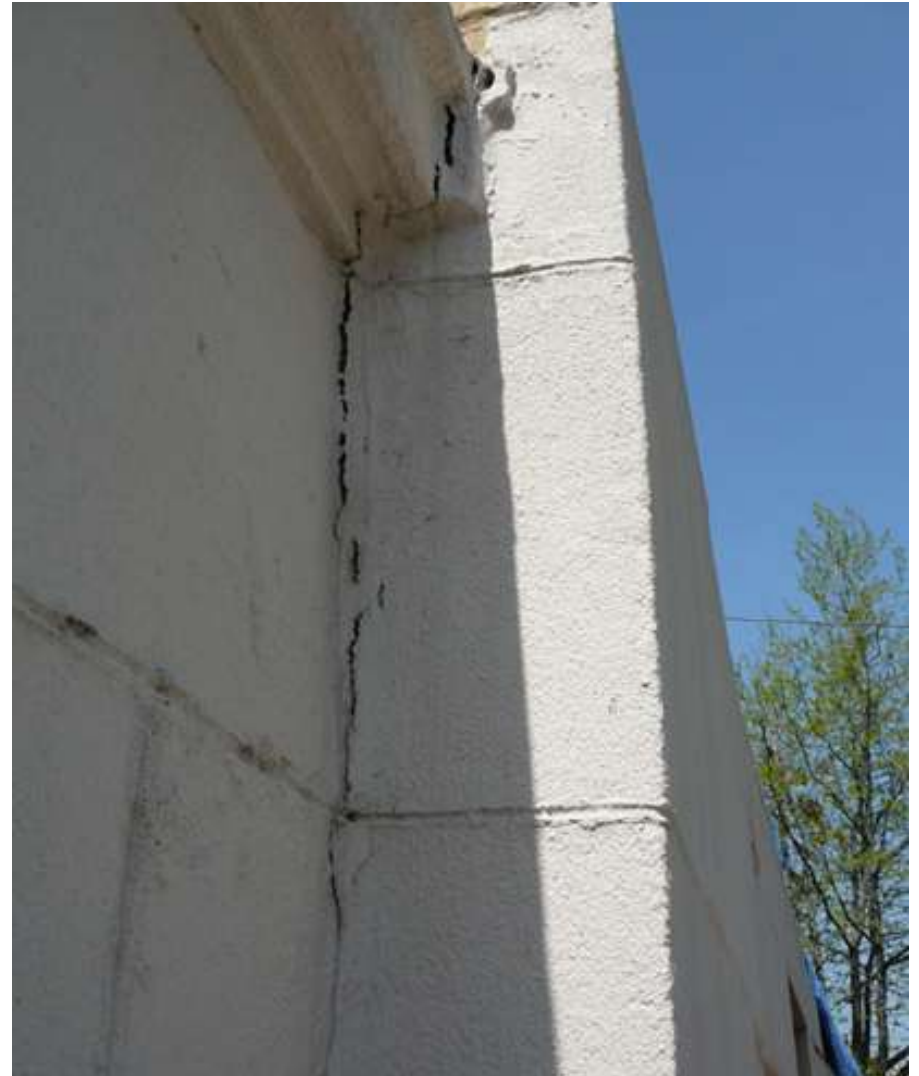
# 5.4.5 Crack at Joints of Precast Panels

Bulging of stone not related to shelf angle location; Cracking associated with bulging.

Insufficient number of stone anchors provided. Defective Precast Concrete Panel Attachment.

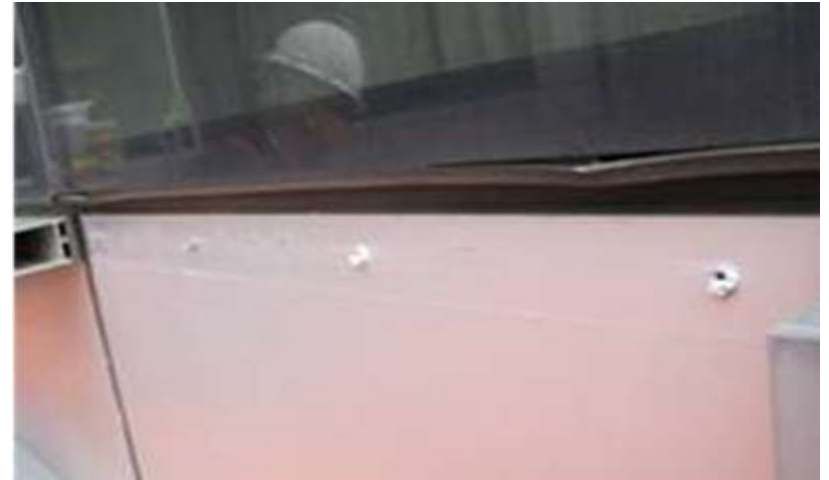
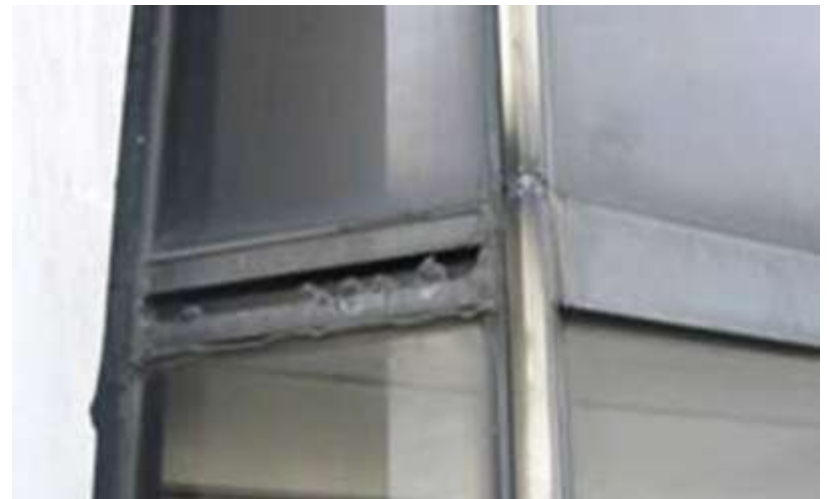
# 6.1.4 Missing Decorative Trim of Curtain Wall

Exposed underlying construction, condition of architectural hardware.

Design failure – excessive deflection, movement of metal element, and metal fatigue due to repeat wind load. Excessive story drift. Fastener fatigue failure.
