The Hazards of Fire Retardant Treated (FRT) Wood

By Bradish J. Waring

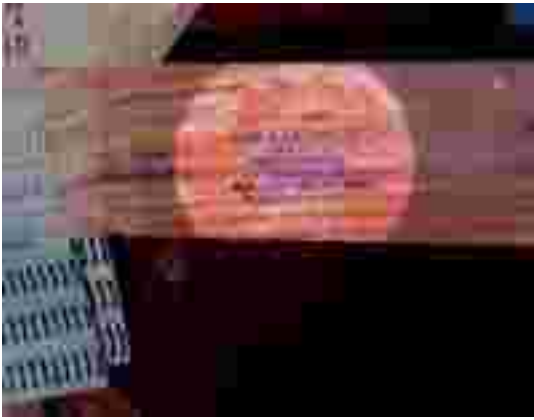
- Look for identification stamps which are typically located on visible portions of the plywood deck or dimensional lumber. The stamps can be ink stamps or paper stickers. The stamps may also identify the proprietary name of the FRT, the manufacturer or the applicator. Additionally, if an Underwriters Laboratories (U.L.) stamp is found, more than likely the lumber contains FRT. (see photo)

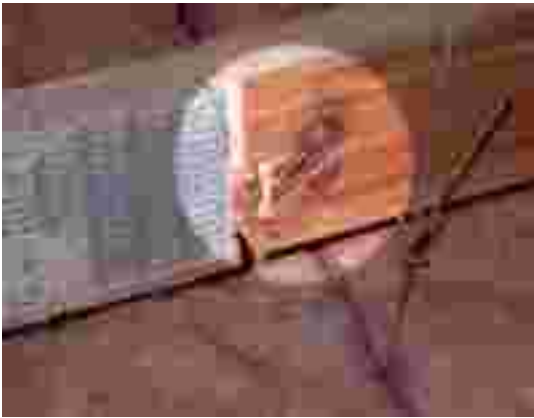
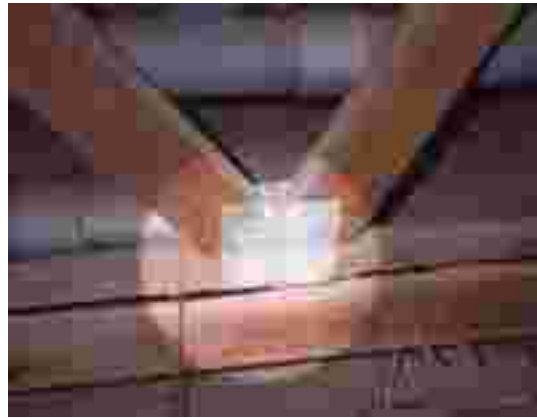
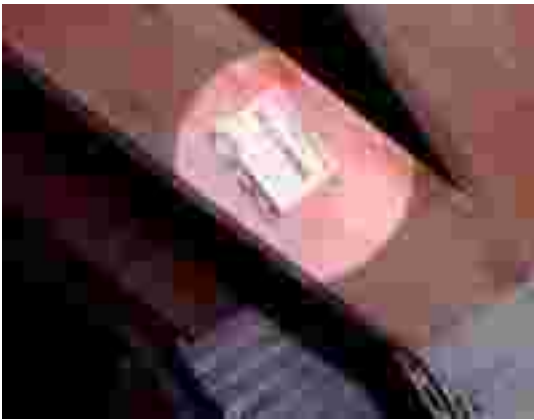
- Look for cracks, splits, or breaks in the dimensional lumber. These types of damages can be most extensive in the bottom chord of a truss (the horizontal member at the bottom of the truss which often supports the finished ceiling) and web members closest to the middle of the roof (vertical or diagonal framing members located below the roof ridge). (see photos)

- Look at the color of the wood components. FRT is typically darker in color. A reddish-brown color is typical.
- Look at the surface of plywood. FRT plywood can degrade and can cause the surface to be "fuzzy" in appearance. This occurs often where the wood has been subjected to direct water intrusion near eaves and roof penetrations.

- Look at the surface of the dimensional lumber. Light checking (cracks) along the length of the wood is normal. Heavy checking perpendicular to the grain of the wood can be associated with the use of FRT.

- Look at metal fasteners and metal plates on pre-fabricated trusses. Corrosion of the metal truss plates and/or the presence of white residue may be associated with the salts from FRT.
