ASEA REPORTS

Case studies of
asbestos water pipe
management practices

Case studies of asbestos water pipe management practices

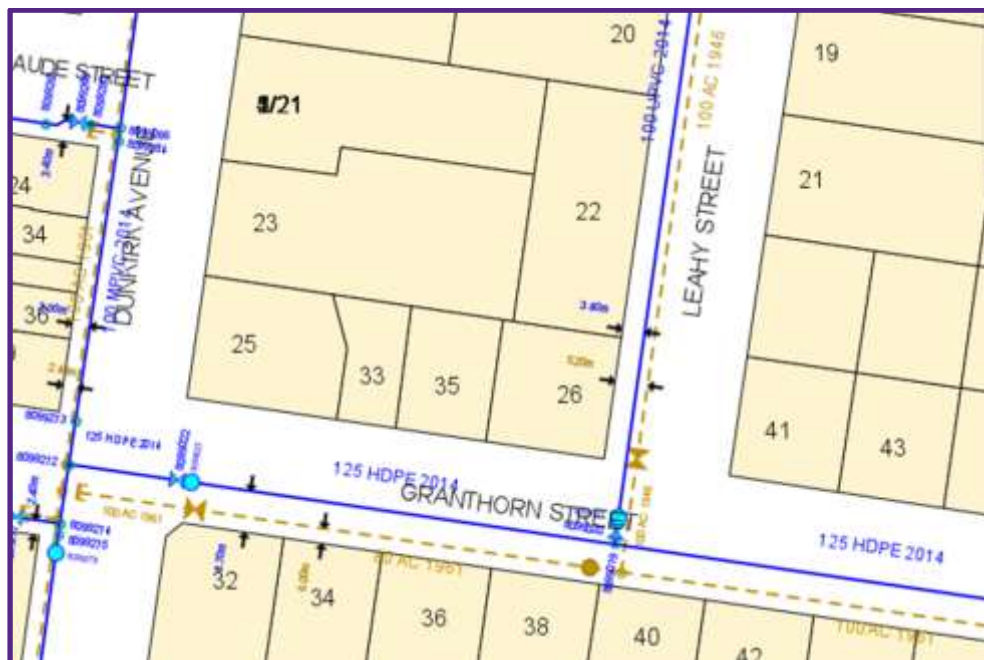
Figure 1.4: An example of a GIS snapshot of a replaced water main (note the blue line is the replacement main, and the gold/brown dotted line is the old AC main)

A representative from GVW attended the site with the contractor to review clean-up activities and ensure that all reinstatement works were completed to a satisfactory level. Information of the old main location is recorded on the GVW geographic information system (GIS). An example of the GIS snapshot of replaced water mains is provided in Figure 1.4 below.

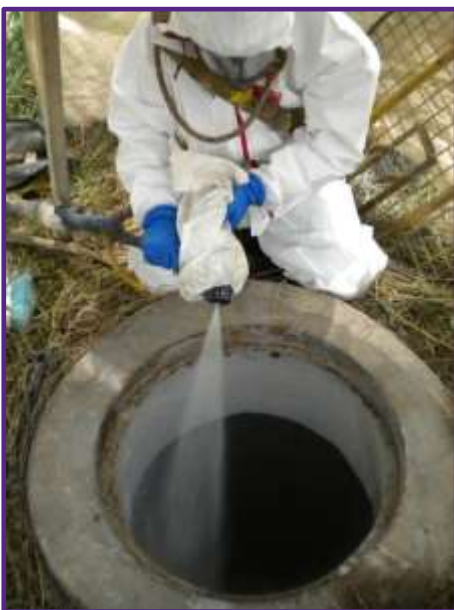
Figure 2.3: Manholes showing signs of deterioration being repaired. A special coating is applied to restore them to original condition.

The remediation work is then undertaken across two phases. Firstly, manholes showing signs of deterioration are sprayed with a special coating that looks to restore them to their prior level of performance. This technique can be done directly into the manhole without the need for excavation and removal. Figure 2.3 shows a manhole being repaired using the relining technology.

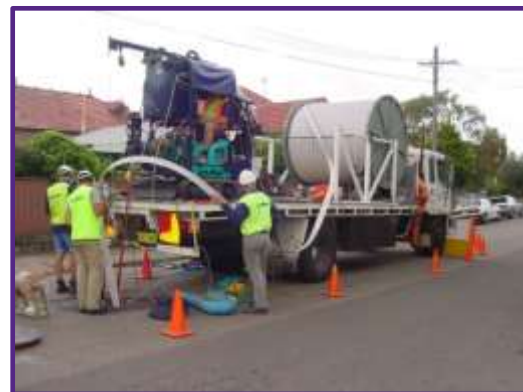
Figure 2.3: Pipes being repaired via trenchless technology

Secondly, pipe areas targeted through the camera investigation are repaired using innovative trenchless relining techniques to correct faults, rather than being replaced. This is a ‘no-dig’ and cost-effective way of renewing the pipe. In most cases, the new pipes are formed on site by taking a continuous strip of profile and spirally winding it inside the damaged pipe, forming a new, water-tight structural pipe within the host pipe (see Figure 2.4).

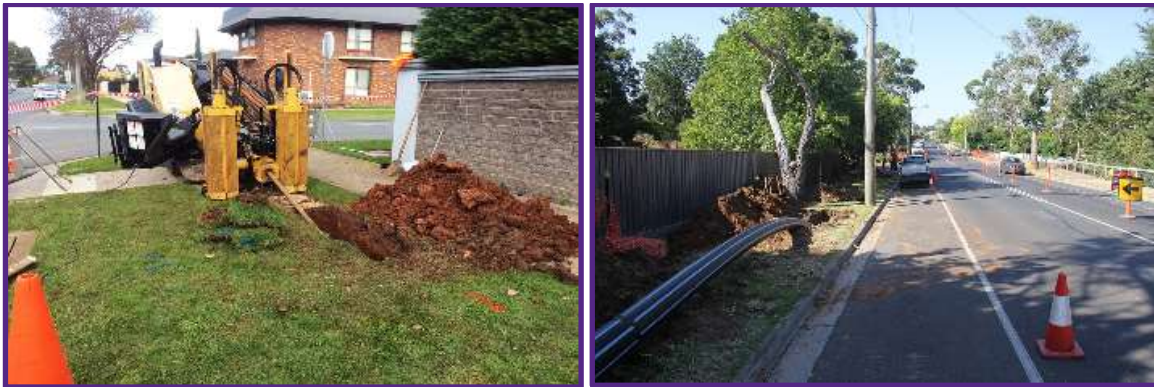
Figure 3.3: SE Water using the realign and leave technique for pipe renewal

In response to the release of WorkSafe Victoria's guidelines in March 2015, SE Water now favours the 'realign and leave' technique (often referred to as "by-passing")¹⁵. This was decided after consideration of the risks and benefits associated with each technique, OHS requirements and approval by the SE Water Board. There is an expectation that SE Water will continue extensive customer engagement as well as exploring emerging alternatives (see next section). Figure 3.3 shows SE Water conducting pipe renewal using the realign and leave technique.

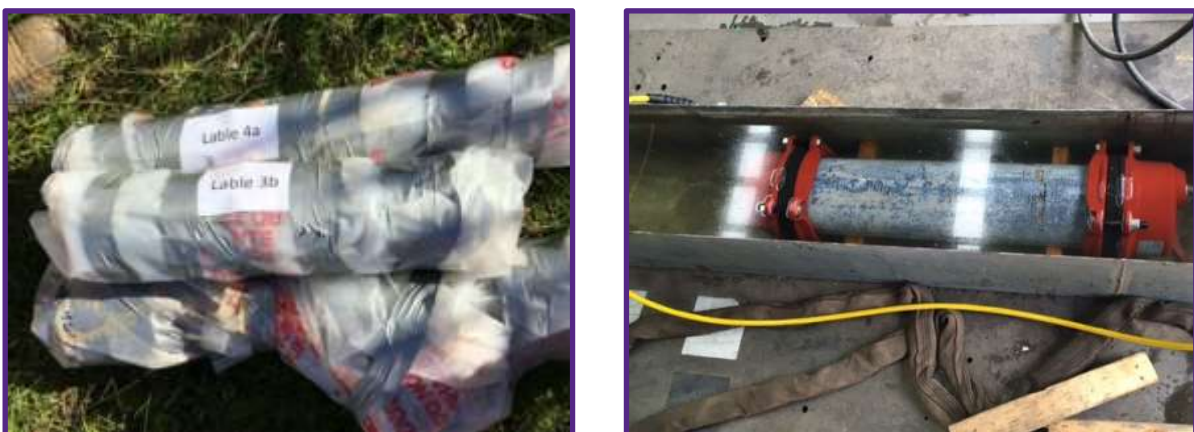
Figure 3.4: Example AC pipe renewal techniques that have been considered (left image is exhumed cured in place samples that were extracted to be laboratory tested, right is cured in place break test apparatus being tested)

SE Water's strategic approach to AC water pipe renewal includes consideration of new and emerging techniques that may be safer and more cost effective. These are outlined below (and presented in Figure 3.4):

- Non-Structural liners, where an organic polymer is sprayed on the internal pipe wall. This can span gaps and prevent leakage.
- Semi-Structural Spray on linings, which is a thicker layer of organic polymer that provides some structural properties.
- Cured in place semi-structural liners, where an inflated hose is placed in the pipe and cured or sealed in place using steam/hot air.
- Cured in place structural liners, which is the same as the cured in place semi-structural liners but the lining is reinforced with fibreglass to provide structural strength (the liner does not rely on the host pipe)¹⁶.

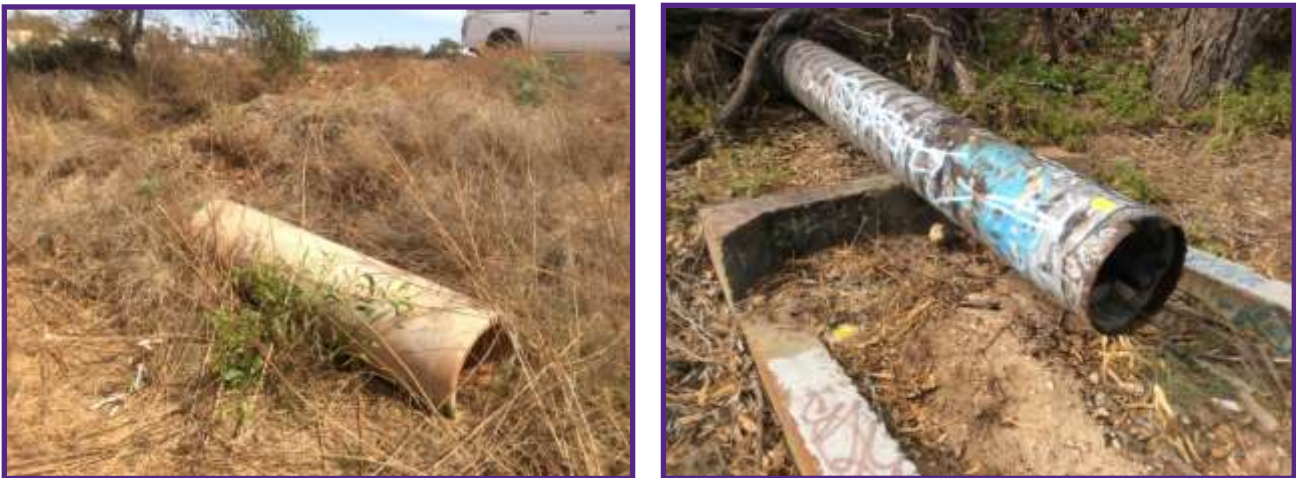
Figure 4.1: Common asbestos pipes found at Water Corporation (left image - AC Pipe Exterior of Compound in Karratha, right image – asbestos bitumen coated pipe in Karrinyup

Water Corporation's *Working with Asbestos* policy outlines the management and removal process for all ACM on or in the company's assets. This includes AC pipes and bitumen coated steel pipes (see Figure 4.1). This document indicates that these pipes "should be removed from the ground when decommissioned unless operational or safety constraints would it [sic] unfeasible". If asbestos pipes are left in the ground, this is tracked through data management programs such as LiteSpatial and MyWorld.

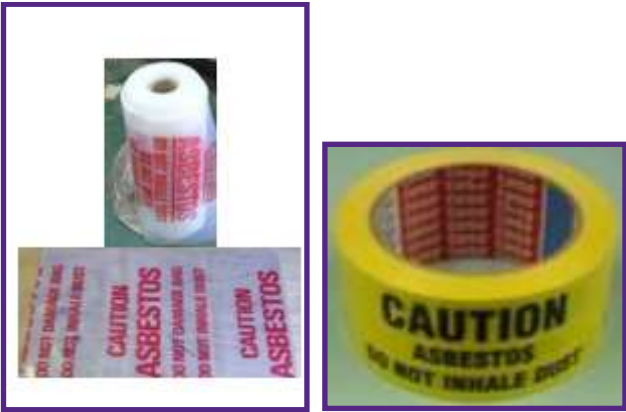
Figure 4.2: Equipment used by Water Corporation for asbestos removal (left image – disposal sheets (200 nm) or bags, right image – duct tape used to seal bags/wrapping)

- vi. The ACM is double-wrapped in plastic sheeting, fully sealed with duct tape and labelled. Water Corporation has asbestos disposal bags for the asbestos pipe (see Figure 4.2);

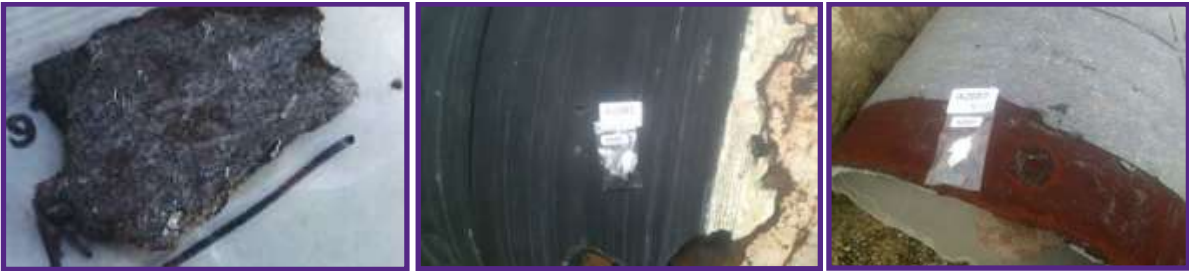
Figure 4.3: Coal tar or bituminous wrapped pipe pieces (on Water Corporation’s assets, these may contain asbestos and as such is treated as though it contains asbestos)

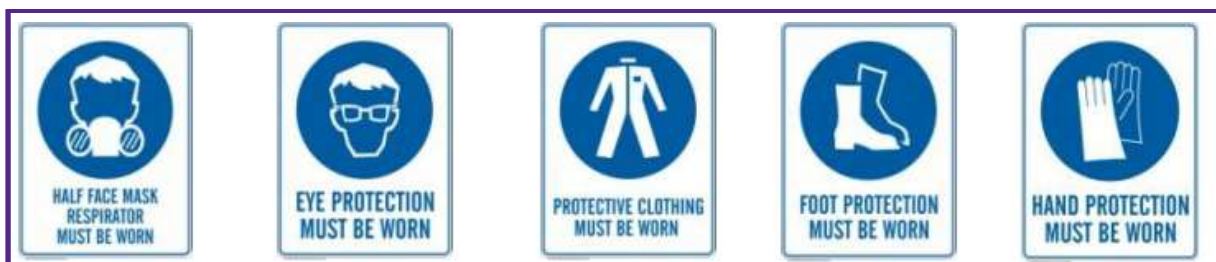
Figure 5.2: PPE that employees and contractors must wear when cutting or in the vicinity of cutting asbestos pipes (including the special requirements)

- P2 Mask Respirator - Fit check before use.
- Disposable overalls - tight cuffs (or taped to gloves and boots) and fitted with hood. Legs of overalls must be outside of gum boots.
- Nyllex gloves
- Safety glasses
- Safety signage

- **Personal Protective Equipment (PPE)**
 - The operator and anyone assisting with the cutting or in the vicinity of the cutting operation must (see Figure 5.2 for further details):

1. Wear appropriate PPE (see Figure 5.2);
2. Excavate to the depth of pipe, expose length of pipe using hand dig methods;
3. Barricade area;
4. Where pipes must be cut, the removalists use a hand saw or chain cutters. If unable to cut, removalists place a wet rag around the collar, wet the area down and hit the collar with a mash hammer and chisel away the collar. Power tools are never used;

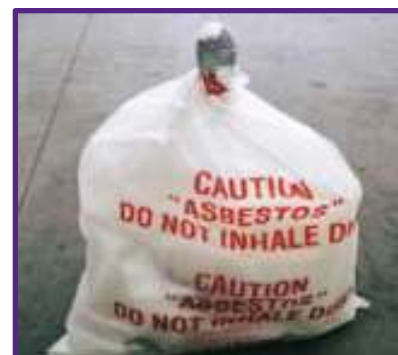
Figure 5.3: AC disposal bag, goose necked and sealed

6. Replace the pipe;
7. Wash down tools, equipment and PPE (if for re-use);
8. When complete, place PPE in AC disposal bag (see Figure 5.3 below), which is taken to a licenced landfill.

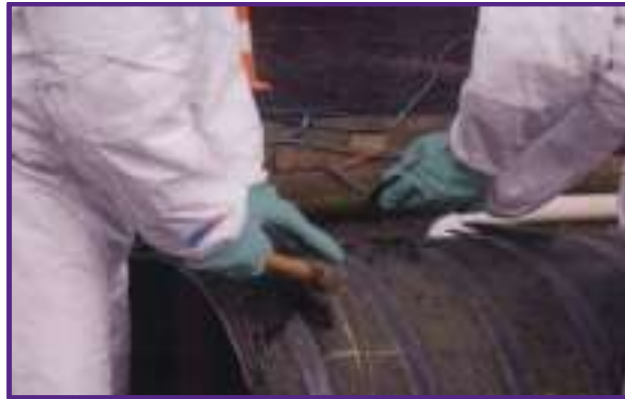
Figure 5.4: The hammer and chisel method used to remove asbestos from MSCL pipes

1. The pipe is taken out of the ground and removalists coat the area on the pipe to be removed with a mix of water/PVA or water based paint;
2. They then barricade the area and place a 200 micron sheet or bag under section of the pipe to be removed to capture waste as it is chipped away from the pipe;
3. The asbestos is then removed by chipping it away using a hammer and chisel (see Figure 5.4). If the wrapping is not totally removed from the pipe, the area is rasped to ensure all wrapping material is removed;

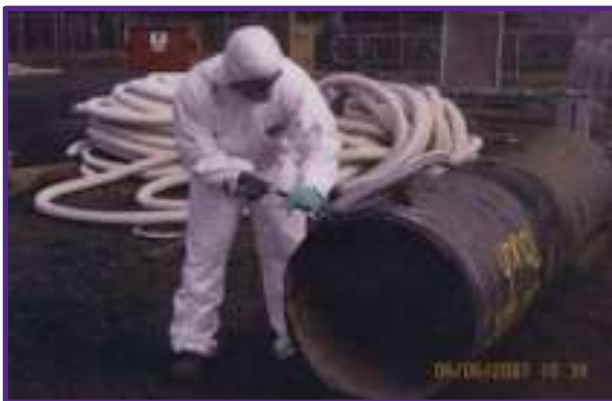
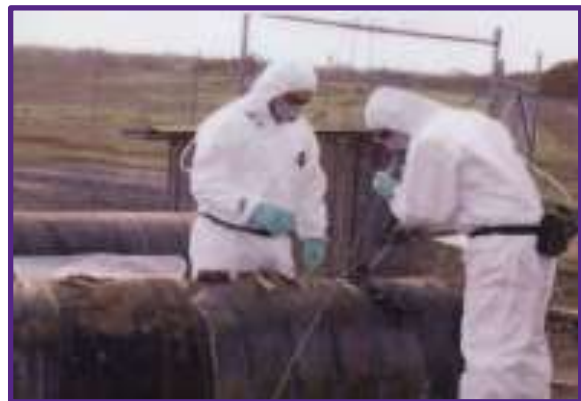
Figure 5.5: Asbestos pipe removalists undertaking removal works

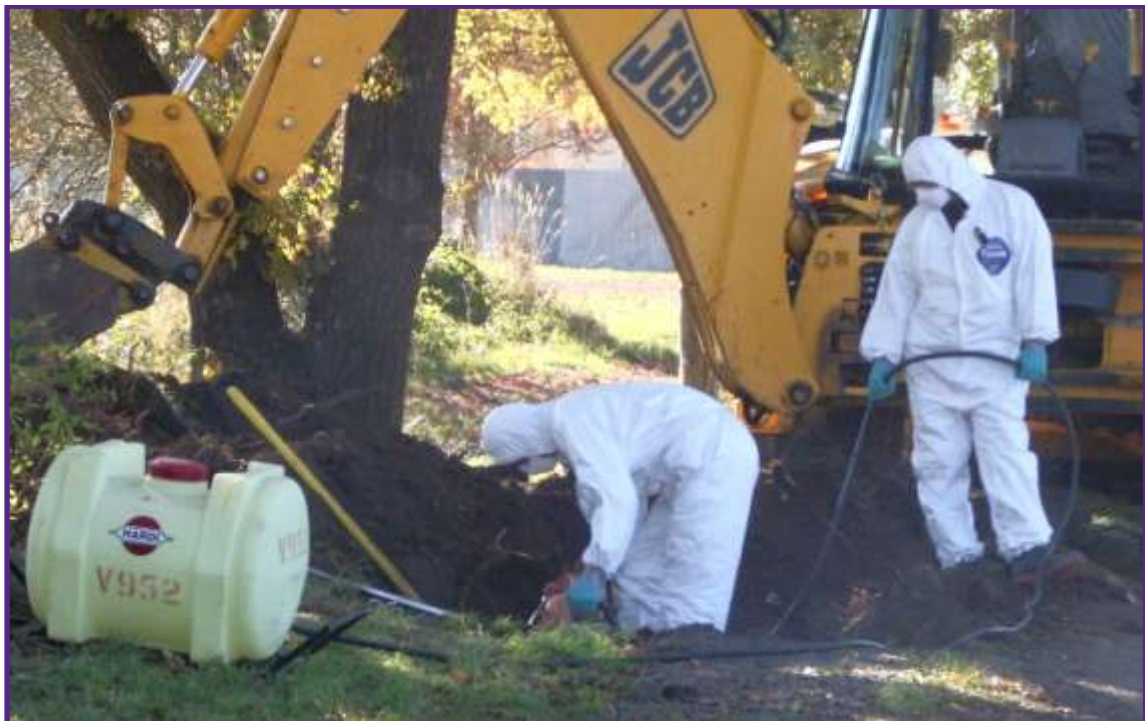
Figure 6.3: AC water main pipe removal using a demolition saw and with water continuously running

8. Use manually operated compression chain cutters or handsaws to cut pipes if possible (although note that a demolition saw²⁶ stored in Central Highland Water's asbestos removal trailer (see Figure 6.3) is permitted if water is continuously running on the blade and is pumped using the electronic pump located on the asbestos removal trailer);

Central Highlands Water staff removed 6 metres of AC pipe on East Street in Daylesford (see Figure 6.2). Class B trained removalists from Central Highland Water used a demolition saw with water tank and pump to cut the pipe, with water continuously running on the blade (see Figure 6.3). This task took approximately three hours and required two staff members. Labour and equipment costs to repair the AC water main were estimated to be \$500 (this does not include training costs for staff).
