Journal of Cultural Heritage

Assessment of preservation coatings for fiber-cement panels used in XX century mural paintings in Mexico

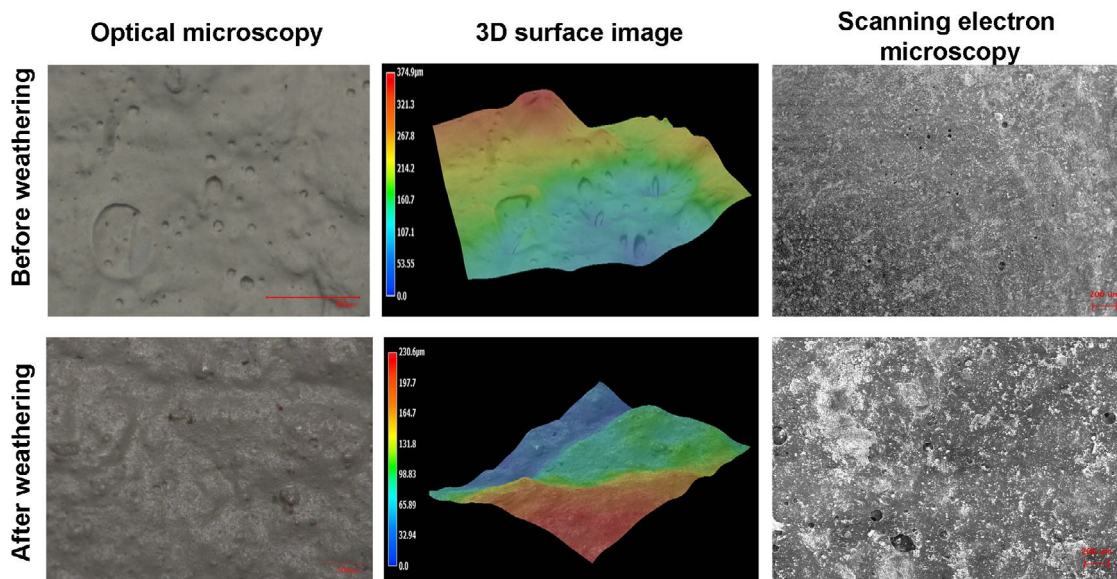
Fig. 4. Microscopic examination of the AR coating surface before and after weathering.

Microscopic examination (Fig. 4) showed that the AR coating formed surface bubbles of different sizes, therefore allowing the formation of pores. After weathering, the surface changed from a matte to a glossy finish, but no specific local roughness transformation was observed. The SEM images allowed to determine that the coating's aggregates formed agglomerations on the surface. Despite the pores observed before and after weathering on the coatings, the FCP fibers were never observed.

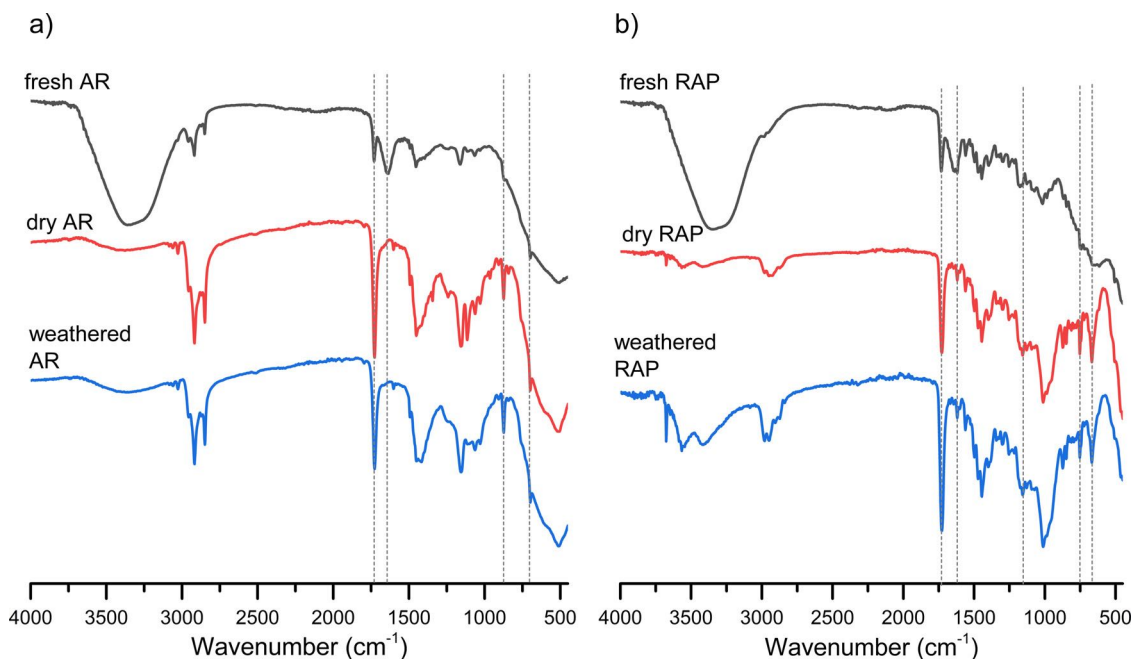
Fig. 8. Infrared ATR spectra comparison of the fresh, dry and weathered a) AR coating b) RAP (arbitrary units on the Y-axis).

Spectra of the AR sample were analyzed in each of three stages: when the layer was fresh, after the drying process and after the weathering process (Fig. 8a). In the FTIR-ATR spectrum of the fresh sample, the broad bands observed at $3400\text{--}3250\text{ cm}^{-1}$ and 1635 cm^{-1} (νOH , H_2O) were related to the large amount of water which causes attenuation of the other signals. FTIR-ATR spectrum of the AR sample after the drying process shows the corresponding signals of the NMR identified components, and after the induced weathering a decrease was observed in the signals at 1343 cm^{-1} ($\delta\text{as C-H, -CH}_2\text{-}$), 1113 cm^{-1} ($\nu\text{C-O}$) and 964 cm^{-1} (C-O str.) that were related to the surfactant Triton X-100. In the case of the RAP samples (Fig. 8b), the same effect of the presence of water was observed, just as in the AR sample. In the dry and in the aged samples no apparent changes in signal intensity were observed. The weathered sample of this material was analyzed by ^1H NMR and it was confirmed that the surfactant Triton X-100 was the compound that was lost after aging process [18].
