**BUILDING  
MATERIALS  
AND  
STRUCTURES**

REPORT BMS31

Structural Properties of  
"Insulite" Wall and "Insulite"  
Partition Constructions  
Sponsored by The Insulite Co.

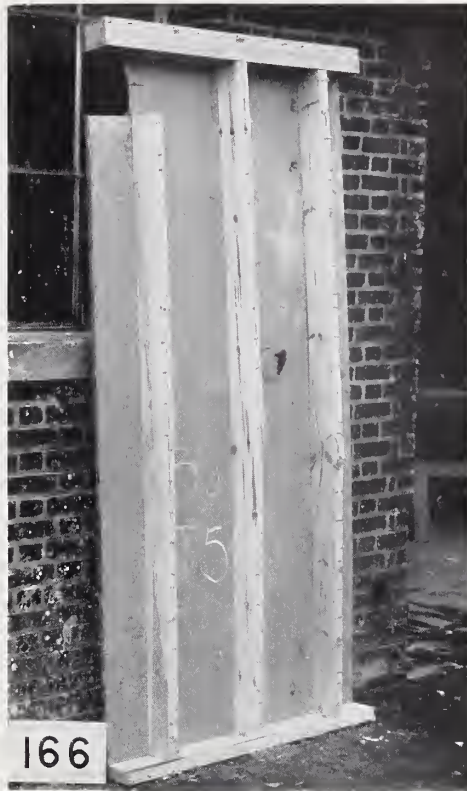
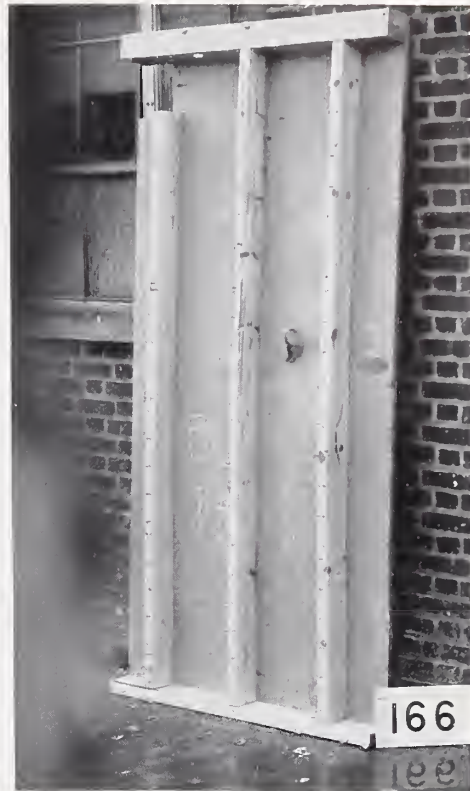
FIGURE 2.—Frame of wall specimen BJ-T5.

Many knots.

*Forest Products Laboratory.*—After each specimen was tested, one face was removed to expose the studs and photographs were taken showing the knots and failures. The grade of the wood framing was determined from these photographs. The studs ranged from almost straight grain with few knots, as shown in figure 1, to many knots, as shown in figure 2. A typical frame is shown in figure 3.

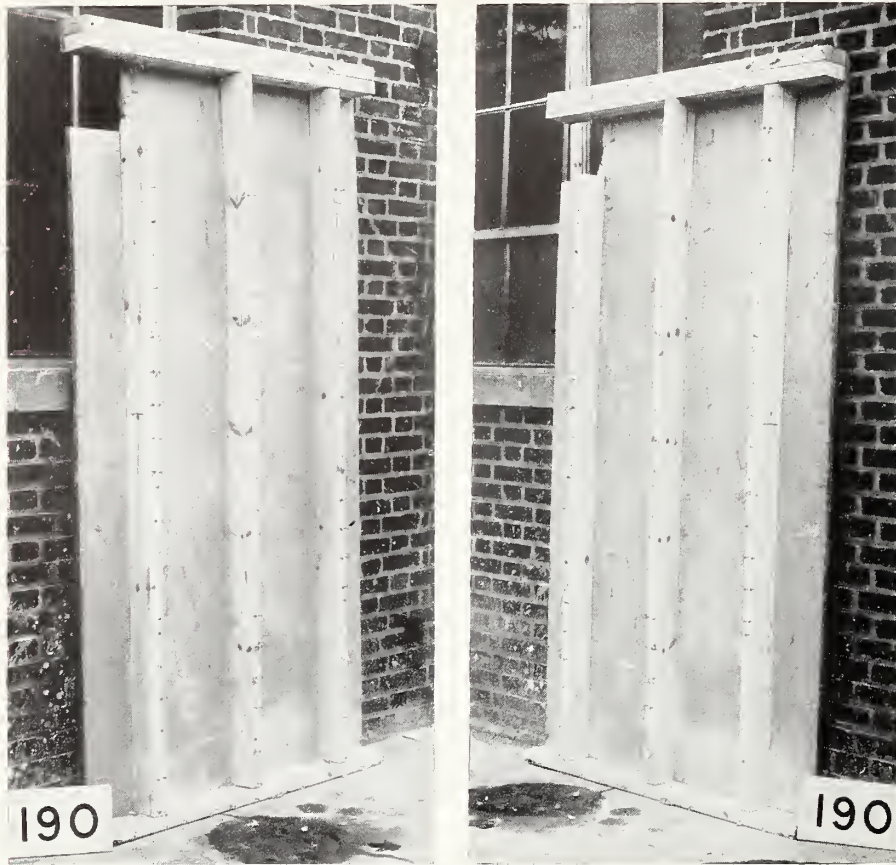
FIGURE 3.—Frame of wall specimen BK-T5.

A typical frame.

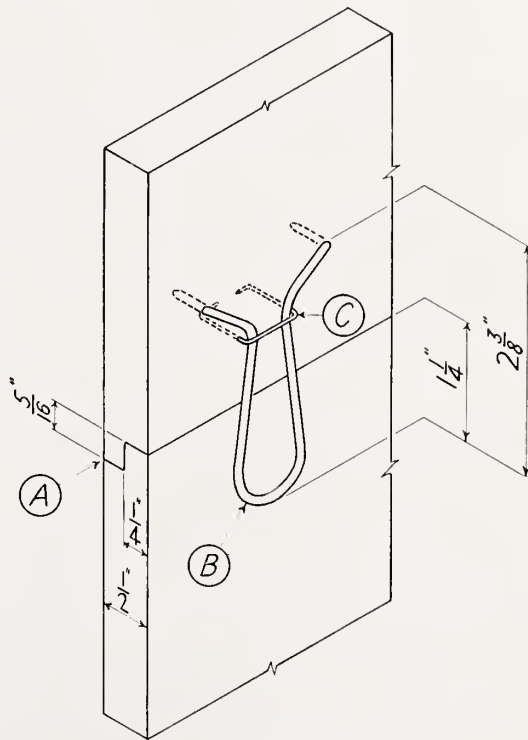
FIGURE 4.—"Lok-Joint" lath.

A, shiplapped joint; B, "Lok" with prongs projecting into the lath; C, staple passing through the lath and clinched.

Rigid insulation board made as described under (a), 1/2 in. thick, 1 ft 6 in. by 4 ft 0 in., shiplapped along each of the longer edges as shown at A, figure 4. There were three "Loks," spaced about 1 ft 4 in. on one shiplapped edge of each lath. The "Lok," B, was a loop of galvanized steel wire, No. 12 (0.1055-in. diam before galvanizing), reinforced by a staple, C, of steel wire No. 19 (0.041-in. diam). The "Loks" were attached to the lath to prevent lateral displacement with respect to the adjacent lath, particularly when the plaster was applied.

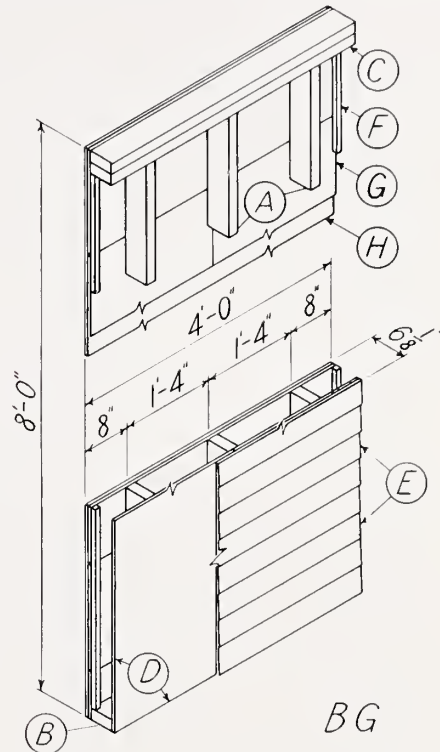
FIGURE 5.—Four-foot wall specimen BG.

A, stud; B, floor plate; C, top plate; D, sheathing; E, bevel siding; F, nailing strip; G, lath; H, plaster.

The 4-ft wall specimens were 8 ft 0 in. high, 4 ft 0 in. wide, and  $6\frac{1}{8}$  in. thick. Each specimen consisted of a wood frame to which the faces were fastened. The frame consisted of three studs, A, shown in figure 5, fastened to a floor plate, B, and a top plate, C, by nails. The outside face consisted of insulating-board sheathing, D, and wood bevel siding, E. The inside face

consisted of wood nailing strips, F, insulating-board lath, G, and plaster, H. The specimens were not painted.

*Studs.*—The studs, A, were red pine,  $1\frac{5}{8}$  by  $3\frac{5}{8}$  in. (nominal 2 by 4 in.), 7 ft  $7\frac{1}{8}$  in. long, spaced 1 ft 4 in. on centers. The lower end of each stud was fastened to the floor plate by two 16d common nails driven from the bottom of the plate (not toenailed), and the upper end of

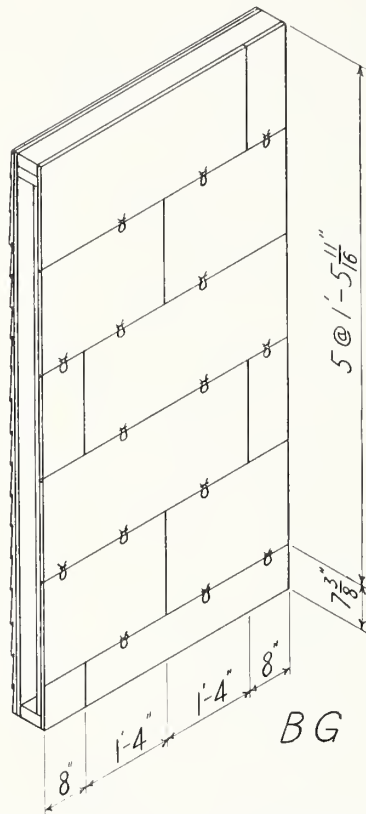
FIGURE 6.—Four-foot wall specimen BG.

Inside face, showing “Lok-Joint” lath.

*Lath.*—The lath, *G*, consisted of “Lok-Joint” lath, five full courses and one course cut to a height of  $7\frac{3}{8}$  in., as shown in figure 6. The plaster was on the burlap-textured sur-

*Lath.*—The lath, *I*, was “Lok-Joint” lath, five full courses and one course cut to a height of  $7\frac{3}{8}$  in., as shown in figure 6. The plaster was applied to the burlap-textured surface. There was a vertical joint in each course, centered on a stud, with  $\frac{3}{16}$ -in. clearance between the ends of the lath. The horizontal joints (shiplapped) were reinforced by “Loks”, three at each joint. The lath was fastened to the studs, floor plates, top plate, and nailing strips by plaster board nails spaced 4 in., about  $\frac{1}{2}$  in. from the edges of the lath.

*Lath.*—The lath, *G*, consisted of "Lok-Joint" lath, five full courses and one course cut to a height of  $7\frac{3}{8}$  in., as shown in figure 6. The plaster was on the burlap-textured surface. There was a vertical joint in each course, centered on a stud, with  $\frac{3}{16}$ -in. clearance between

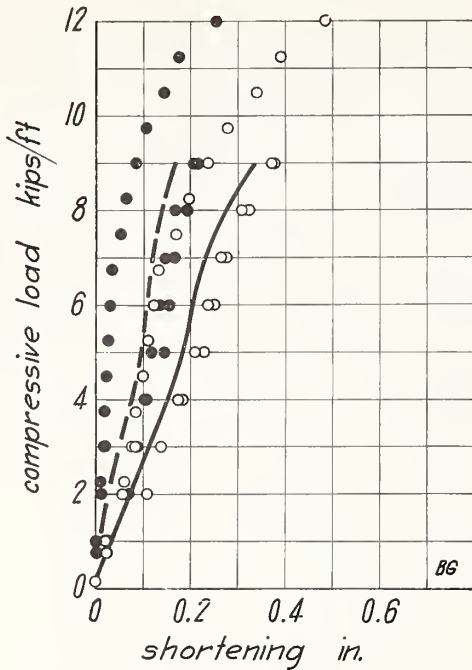
FIGURE 7.—Compressive load on wall BG.

Load-shortening (open circles) and load-set (solid circles) results for specimens BG-C1, C2, and C3. Load applied one-third the thickness (1.21 in.) from the inside surface of the studs. The loads are in kips per foot of actual width of specimen.

The results for wall specimens BG-C1, C2, and C3 are shown in table 13 and in figures 7 and 8.

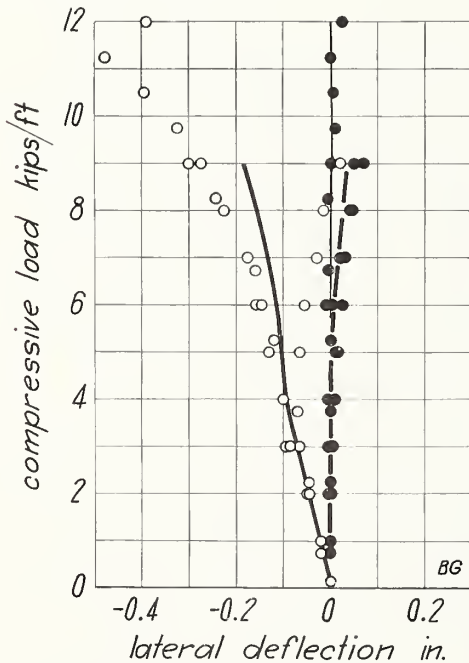
FIGURE 8.—Compressive load on wall BG.

Load-lateral deflection (open circles) and load-lateral set (solid circles) results for specimens BG-C1, C2, and C3. Load applied one-third the thickness (1.21 in.) from the inside surface of the studs. The loads are in kips per foot of actual width of specimen.

The lateral deflections shown in figure 8 were plotted to the right of the vertical axis for deflections of the specimens toward the outside face (positive deflection) and to the left for deflections toward the inside face (negative deflection).

the maximum load the deflection of specimen C1 was zero and the deflection of specimens C2 and C3 was toward the outside face. These deflections are not shown in figure 8. The change in the direction of the deflection curve probably indicates progressive local failure of the inside face.

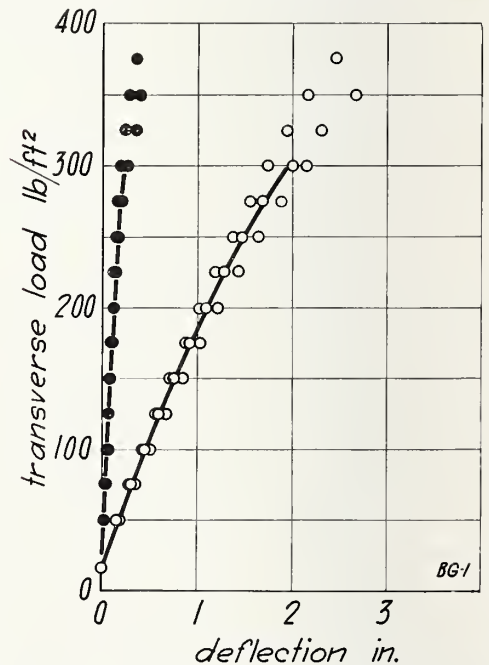
FIGURE 9. Transverse load on wall BG, load applied to inside face.

Load-deflection (open circles) and load-set (solid circles) results for specimens BG-T1, T2, and T3 on the span 7 ft 6 in.

The results are shown in table 13 and in figure 9 for wall specimens BG-T1, T2, and T3, loaded on the inside face, and in figure 10 for wall specimens BG-T4, T5, and T6, loaded on the outside face.

In each of the specimens T1, T2, and T3, loaded on the inside (plastered) face, the plaster cracked longitudinally along each outer stud and transversely across the specimen in several

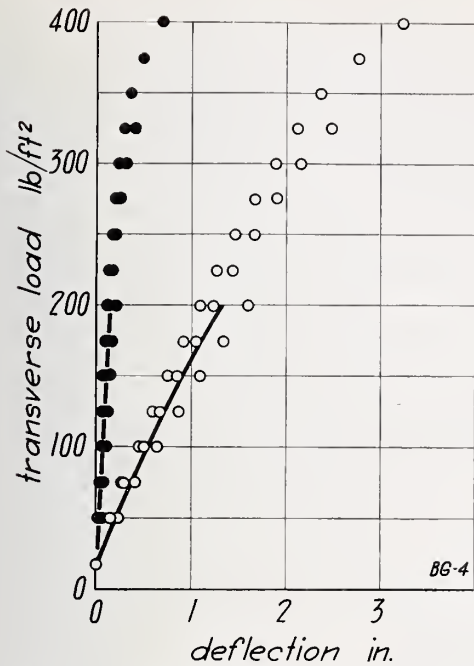
FIGURE 10—Transverse load on wall BG, load applied to outside face.

Load-deflection (open circles) and load-set (solid circles) results for specimens BG-T4, T5, and T6 on the span 7 ft 6 in.

In each of the specimens T4, T5, and T6, loaded on the outside (bevel siding) face, the plaster cracked transversely across the speci-

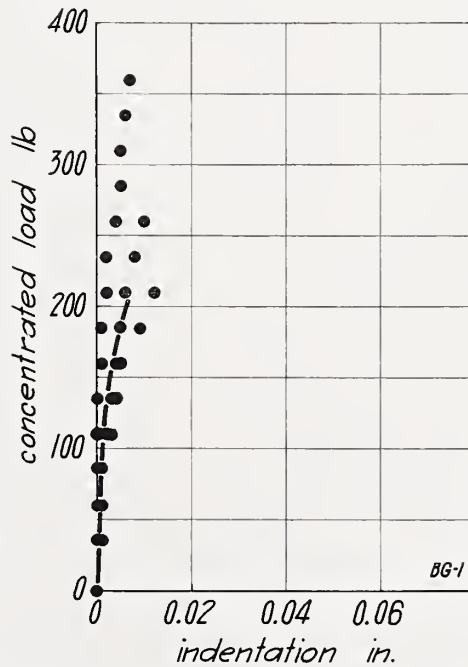
FIGURE 11.—Concentrated load on wall BG, load applied to inside face.

Load-indentation results for specimens BG-P1, P2, and P3.

The results are shown in table 13 and in figure 11 for wall specimens BG-P1, P2, and

The concentrated loads were applied to the inside face of specimens *P1*, *P2*, and *P3* on the plaster midway between two studs and about 1 ft 8 in. from the upper end of the specimen. On *P1* the load was applied over a lath joint. Each of the specimens failed by punch-

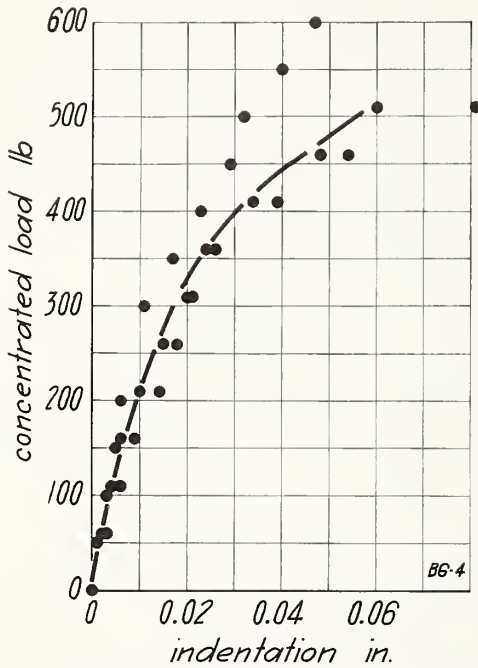
FIGURE 12.—Concentrated load on wall *BG*, load applied to outside face.

Load-indentation results for specimens *BG-P4*, *P5*, and *P6*.

*P3*, loaded on the inside face, and in figure 12 for wall specimens *BG-P4*, *P5*, and *P6*, loaded on the outside face.

The concentrated loads were applied to the outside face of specimens *P4*, *P5*, and *P6* on the wood bevel siding  $3\frac{1}{2}$ ,  $2\frac{1}{2}$ , and  $1\frac{1}{2}$  in., respectively, from the edge of a strip of siding midway between two studs and about 2 ft 2 in. from the upper end of the specimen. In specimen *P4*, at a load of 435 lb, and in specimen *P5*, at a load of 210 lb, the siding split along the grain at one edge of the disk. At the maximum loads each of the specimens failed by splitting of the siding along the grain at opposite edges of the disk and rupture across the grain under the disk.

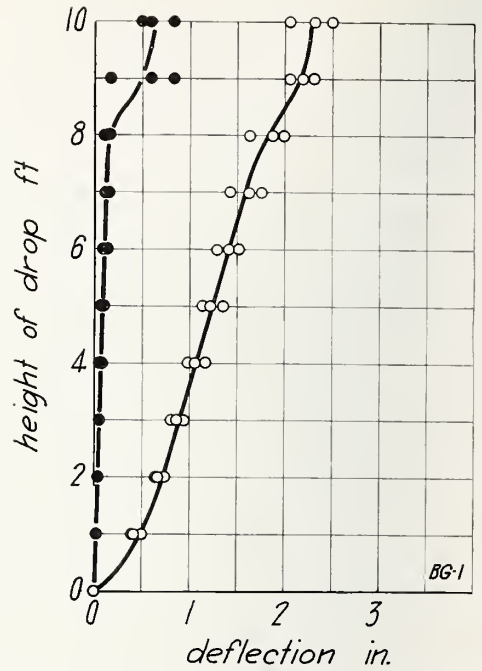
FIGURE 13.—Impact load on wall *BG*, load applied to inside face.

Height of drop-deflection (open circles) and height of drop-set (solid circles) results for specimens *BG-I1*, *I2*, and *I3* on the span 7 ft 6 in.

The results are shown in table 13 and in figure 13 for wall specimens *BG-I1*, *I2*, and *I3*, loaded on the inside face, and in figure 14 for wall specimens *BG-I4*, *I5*, and *I6*, loaded on the outside face.

1.5, 2.5, and 2.5 ft for specimens *I1*, *I2*, and *I3*, respectively, the inside face of each specimen failed by rupture of the plaster at the outer studs. After a drop of 10 ft the sets were 0.49, 0.83, and 0.59 in., respectively; the plaster and lath were broken where the sandbag struck, but the outside face and the studs did not fail.

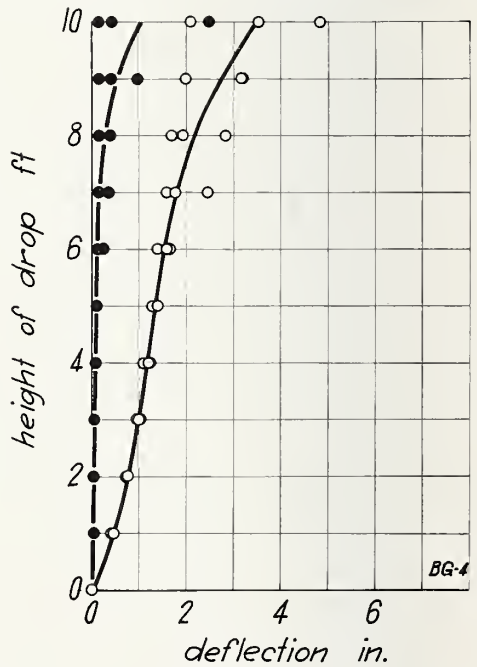
FIGURE 14.—Impact load on wall *BG*, load applied to outside face.

Height of drop-deflection (open circles) and height of drop-set (solid circles) results for specimens *BG-I4*, *I5*, and *I6* on the span 7 ft 6 in.

The impact loads were applied to the center of the outside face of specimens *I4*, *I5*, and *I6*, the sandbag striking the bevel siding directly over the center stud. In each of the specimens *I4*, *I5*, and *I6* at drops of 2.5, 1, and 1 ft and deflections of 0.85, 0.50, and 0.49 in., respectively, the plaster cracked transversely across each specimen at a lath joint near midspan. At drops of 4, 3, and 3 ft for specimens *I4*,

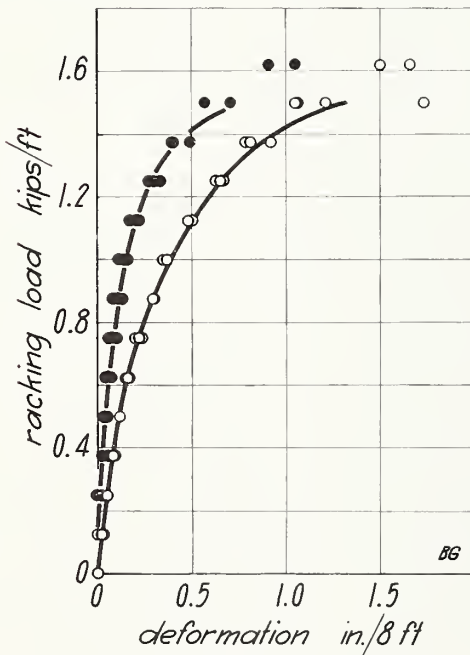
FIGURE 16.—Racking load on wall *BG*.

Load-deformation (open circles) and load-set (solid circles) results for specimens *BG-R1*, *R2*, and *R3*. The loads are in kips per foot of the face width of specimen (8 ft 0 in.).

specimens *BG-R1*, *R2*, and *R3* are shown in table 13 and in figure 16.

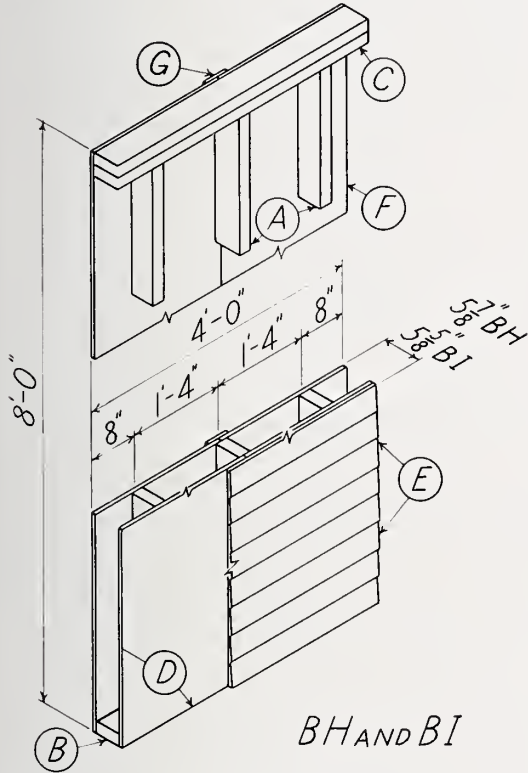
FIGURE 17.—Four-foot wall specimens BH and BI.

A, stud; B, floor plate; C, top plate; D, sheathing; E, bevel siding; F, interior board; G, batten strip.

The 4-ft wall specimens were 8 ft 0 in. high, 4 ft 0 in. wide, and  $5\frac{1}{2}$  in. thick. Each specimen consisted of a wood frame to which the faces were fastened. The frame consisted of three studs, *A*, shown in figure 17, fastened to a floor plate, *B*, and a top plate, *C*, by nails. The outside face consisted of insulating-board sheathing, *D*, and wood bevel siding, *E*. The inside face was interior board, *F*, with a vertical joint at midwidth covered by a batten strip, *G*. The specimens were not painted.

The 4-ft wall specimens were 8 ft 0 in. high, 4 ft 0 in. wide, and  $5\frac{5}{8}$  in. thick. Each specimen consisted of a wood frame to which the faces were fastened. The frame consisted of three studs, A, shown in figure 17, fastened to a floor plate, B, and a top plate, C, by nails. The outside face consisted of insulating-board sheathing, D, and wood bevel siding, E. The

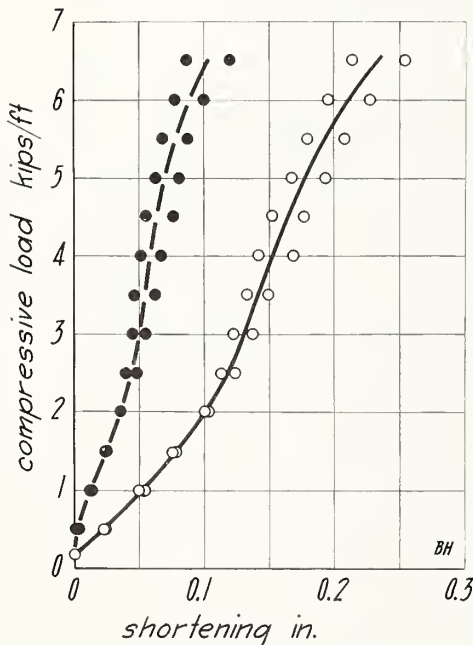
FIGURE 18.—Compressive load on wall *BH*.

Load-shortening (open circles) and load-set (solid circles) results for specimens *BH-C2* and *C3*. Load applied one-third the thickness (1.21 in.) from the inside surface of the studs. The loads are in kips per foot of actual width of specimen.

The results for wall specimens *BH-C2* and *C3* are shown in table 13 and in figures 18 and 19. The results for specimen *C1* are not reported because the compressometers were attached to the studs and did not measure the local crushing of the floor plate and the top plate. The maximum load for this specimen is not given in table 13 because the clearance for eccentric loading was not sufficient and the loading plates came into contact with the platen of the testing machine before the maximum load could be definitely ascertained. With the loading plate in contact with the platen, the load was increased to a maximum of 11.0 kips/ft. At this load one outer stud broke at midheight.

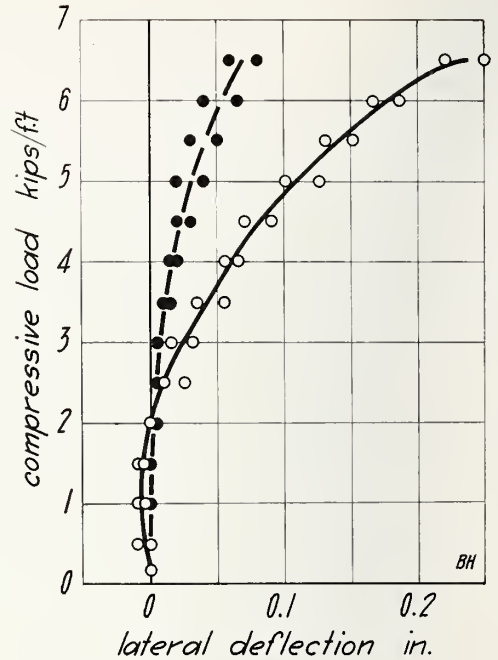
FIGURE 19.—Compressive load on wall *BH*.

Load-lateral deflection (open circles) and load-lateral set (solid circles) results for specimens *BH-C2* and *C3*. Load applied one-third the thickness (1.21 in.) from the inside surface of the studs. The loads are in kips per foot of actual width of specimen.

The lateral deflections shown in figure 19 were plotted to the right of the vertical axis for

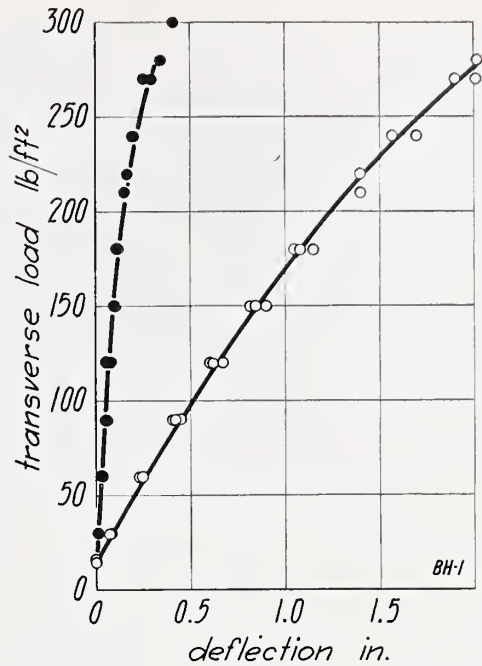
FIGURE 20.—Transverse load on wall BH-I, load applied to inside face.

Load-deflection (open circles) and load-set (solid circles) results for specimens BH-I-1, *T2*, and *T3* on the span 7 ft 6 in.

The results are shown in table 13 and in figure 20 for wall specimens *BH-T1*, *T2*, and *T3*, loaded on the inside face, and in figure 21 for wall specimens *BH-T4*, *T5*, and *T6*, loaded on the outside face.

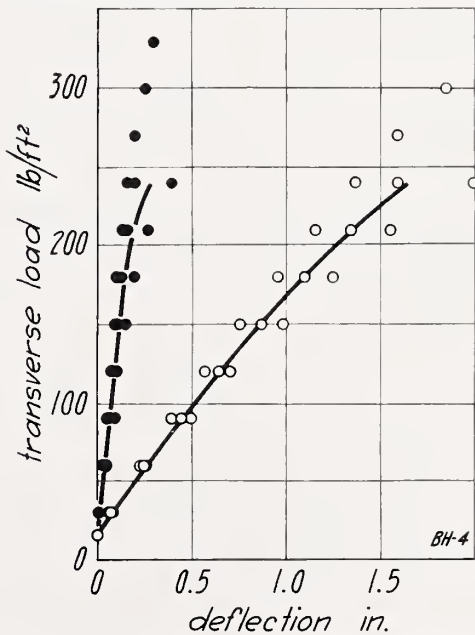
FIGURE 21.—Transverse load on wall BH-4, load applied to outside face.

Load-deflection (open circles) and load-set (solid circles) results for specimens BH-I-4, *T5*, and *T6* on the span 7 ft 6 in.

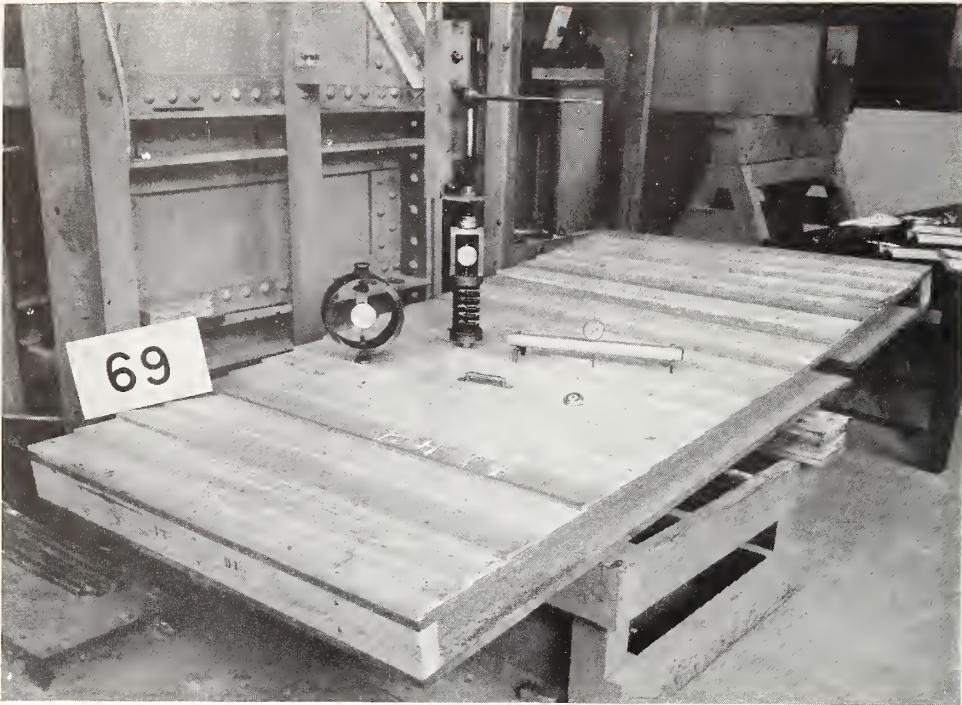
FIGURE 22.—Wall specimen BH-P<sub>4</sub> under concentrated load.

This specimen was an undamaged portion of specimen BH-T<sub>4</sub>.

Wall specimen *BH-P4* under concentrated load is shown in figure 22. The results are shown in table 13 and in figure 23 for wall specimens *BH-P1*, *P2*, and *P3*, loaded on the inside face, and in figure 24 for wall specimens *BH-P4*, *P5*, and *P6*, loaded on the outside face.

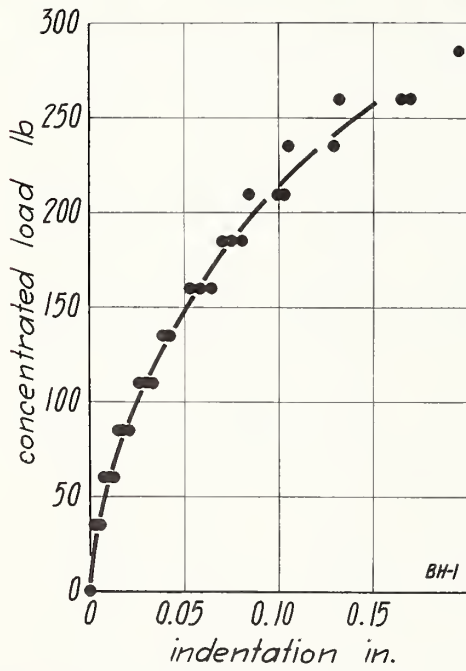
FIGURE 23.—Concentrated load on wall BH, load applied to inside face.

Load-indentation results for specimens BH-P<sub>1</sub>, P<sub>2</sub>, and P<sub>3</sub>.

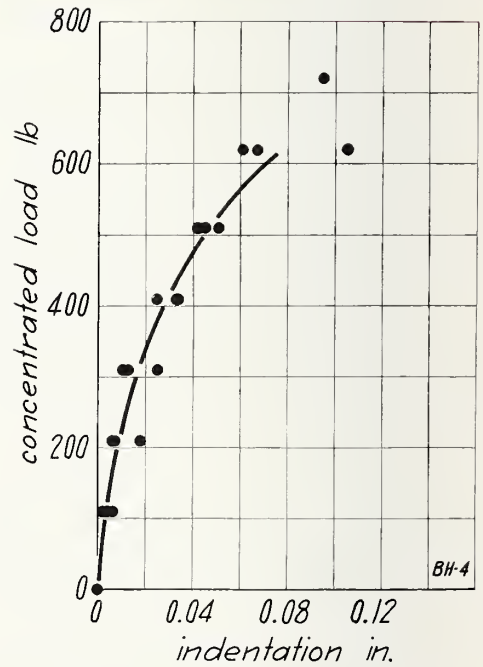
FIGURE 24.—Concentrated load on wall BH, load applied to outside face.

Load-indentation results for specimens BH-P<sub>4</sub>, P<sub>5</sub>, and P<sub>6</sub>.

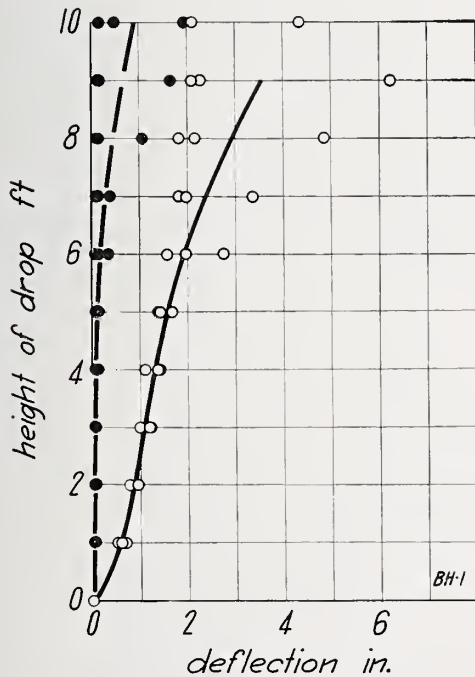
FIGURE 25.—Impact load on wall BH, load applied to inside face.

Height of drop-deflection (open circles) and height of drop-set (solid circles) results for specimens BH-11, 12, and 13 on the span 7 ft 6 in.

The results are shown in table 13 and in figure 25 for wall specimens *BH-I1*, *I2*, and *I3*, loaded on the inside face, and in figure 26 for wall specimens *BH-I4*, *I5*, and *I6*, loaded on the outside face.

The impact loads were applied to the center of the inside face of specimens *I1*, *I2*, and *I3*, the sandbag striking the batten strip and interior board directly over the center stud. In specimen *I1* the center stud broke at midspan at a drop of 9.5 ft. The set after a drop of 10 ft was 0.49 in., the interior board was dented

where the edge of the sandbag struck, and the sheathing on the opposite face was ruptured transversely across the specimen at midspan. In specimen *I2* the inside face failed at a drop of 9.5 ft by rupture of the interior board where the edge of the sandbag struck. The set after a drop of 10 ft was 0.16 in.; the studs and outside face were undamaged. In specimen *I3* the center stud broke at midspan at a drop of 5.5 ft. At a drop of 7.5 ft one outer stud broke at midspan and the outside face failed by splitting of the siding and rupture of the sheathing transversely across the specimen at midspan. The set after a drop of 10 ft was 1.95 in., and the interior board was cracked but not ruptured where the edge of the sandbag struck.

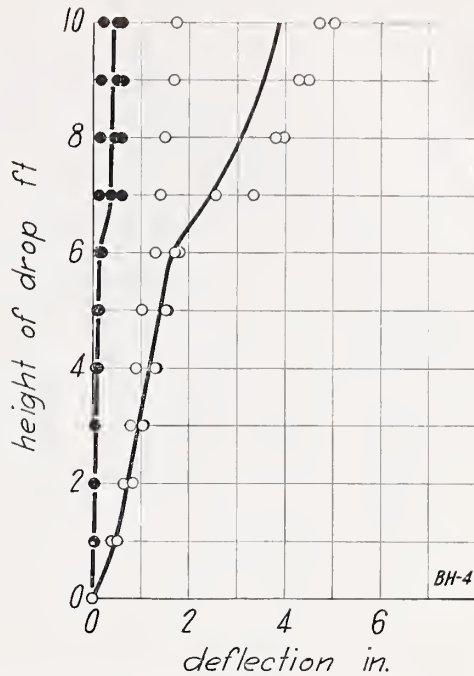
FIGURE 26.—Impact load on wall BH, load applied to outside face.

Height of drop-deflection (open circles) and height of drop-set (solid circles) results for specimens BH-14, 15, and 16 on the span 7 ft 6 in.

The impact loads were applied to the center of the outside face of specimens *I4*, *I5*, and *I6*, the sandbag striking the bevel siding directly over the center stud. At drops of 6, 6, and 5 ft for specimens *I4*, *I5*, and *I6*, respectively, the interior board of each specimen started to separate from the outer studs at midspan. In each of the specimens *I4* and *I6* the center stud broke at midspan and the inside face failed

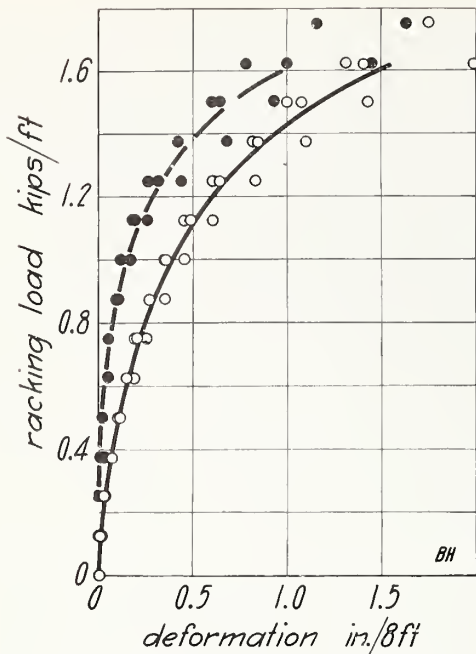
FIGURE 27.—Racking load on wall BH.

Load-deformation (open circles) and load-set (solid circles) results for specimens BH-R1, R2, and R3. The loads are in kips per foot of the face width of specimen (8 ft 0 in.).

The results for wall specimens BH-R1, R2, and R3 are shown in table 13 and in figure 27.

The racking loads were applied to the top plate only, and the stop was in contact with the floor plate only. At loads of 1.625, 1.726 (maximum load), and 1.375 kips/ft there was noticeable vertical displacement between the two sheathing boards at the joint. At the maximum load each of the specimens failed by the top plate pulling the nails from the studs and through the edges of the sheathing and interior board.

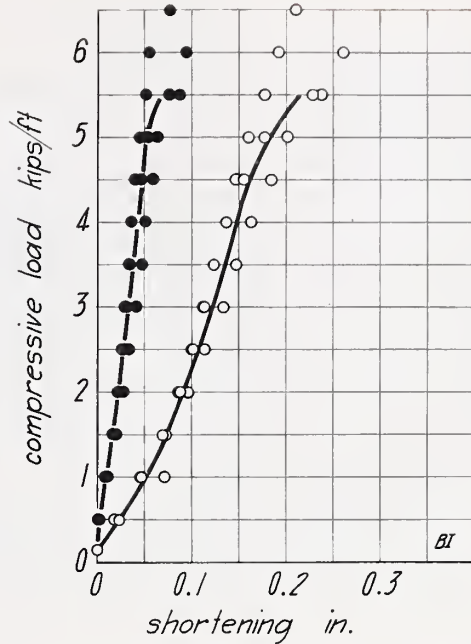
FIGURE 28.—Compressive load on wall *BI*.

Load-shortening (open circles) and load-set (solid circles) results for specimens *BI-C1*, *C2*, and *C3*. Load applied one-third the thickness (1.21 in.) from the inside surface of the studs. The loads are in kips per foot of actual width of specimen.

The results for wall specimens *BI-C1*, *C2*, and *C3* are shown in table 13 and in figures 28 and 29.

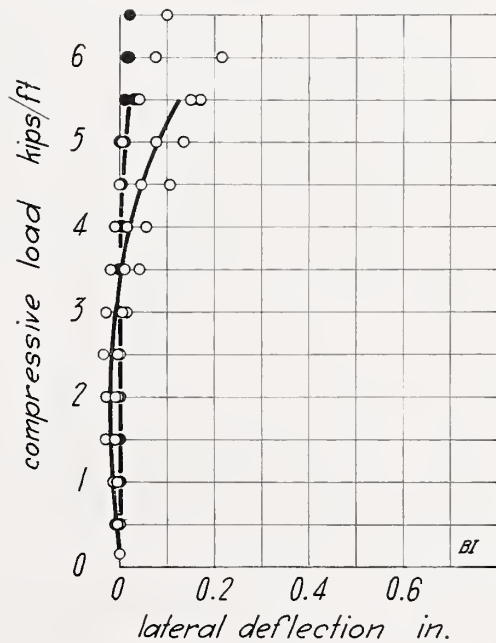
FIGURE 29.—Compressive load on wall *BI*.

Load-lateral deflection (open circles) and load-lateral set (solid circles) results for specimens *BI-C1*, *C2*, and *C3*. Load applied one-third the thickness (1.21 in.) from the inside surface of the studs. The loads are in kips per foot of actual width of specimen.

The lateral deflections shown in figure 29 are plotted to the right of the vertical axis for deflections of the specimens toward the outside face and to the left for deflections toward the inside face. No explanation was found for the deflection of the specimens toward the inside face under loads less than 4 kips/ft.

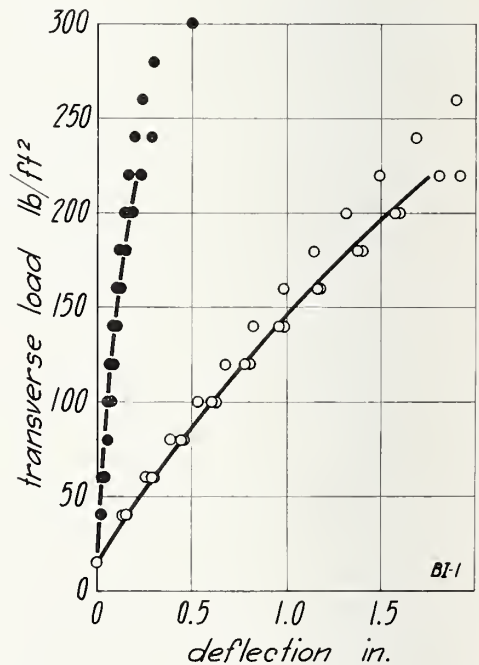
FIGURE 31.—Transverse load on wall *BI*, load applied to inside face.

Load-deflection (open circles) and load-set (solid circles) results for specimens *BI-T1*, *T2*, and *T3* on the span 7 ft 6 in.

Specimen *T1* failed by rupture of the center stud and one outer stud at a loading roller and rupture of both the interior board and the sheathing halfway across the specimen at the same place. Specimen *T2* failed by rupture of all three studs under a loading roller and rupture of the sheathing and siding at the same

place. Specimen *T3* failed by rupture of the center stud and one outer stud at a loading roller and rupture of the sheathing and siding transversely across the specimen at the same place.

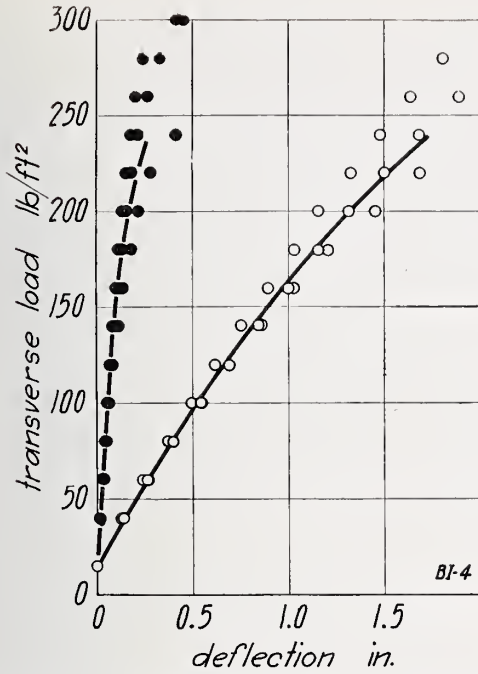
FIGURE 32.—Transverse load on wall BI, load applied to outside face.

Load-deflection (open circles) and load-set (solid circles) results for specimens BI-T4, T5, and T6 on the span 7 ft 6 in.

Specimens T4 and T5 failed by rupture of the center stud, one outer stud, and the interior board between the loading rollers. Specimen T6 failed by rupture of one outer stud at midspan, splitting of the center stud along the grain from midspan to the top plate, and rupture of the interior board at midspan.

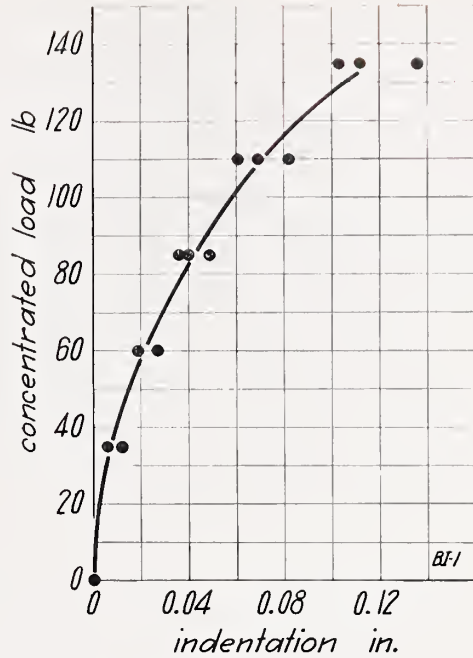
FIGURE 33.—Concentrated load on wall BI, load applied to inside face.

Load-indentation results for specimens BI-P1, P2, and P3.

The results are shown in table 13 and in figure 33 for wall specimens BI-P1, P2, and P3, loaded on the inside face, and in figure 34 for wall specimens BI-P4, P5, and P6, loaded on the outside face.

The concentrated loads were applied to the inside face of specimens P1, P2, and P3 on the interior board midway between two studs and 3 to 3½ ft from one end. Each of the specimens failed by punching of the disk through the interior board.

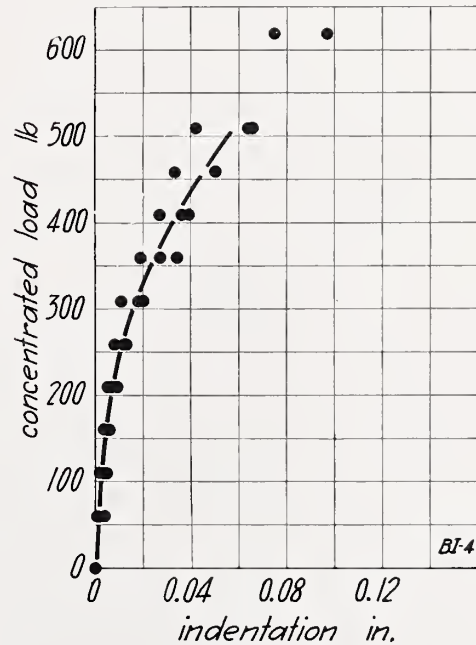
FIGURE 34.—Concentrated load on wall BI, load applied to outside face.

Load indentation results for specimens BI-P4, P5, and P6.

The concentrated loads were applied to the outside face of specimens P4, P5, and P6 on the bevel siding 1½ in. from the edge of a strip of siding midway between two studs and 2½ to

3½ ft from one end. Each of the specimens failed by splitting of the siding for about 8 in. along the grain on opposite edges of the disk.

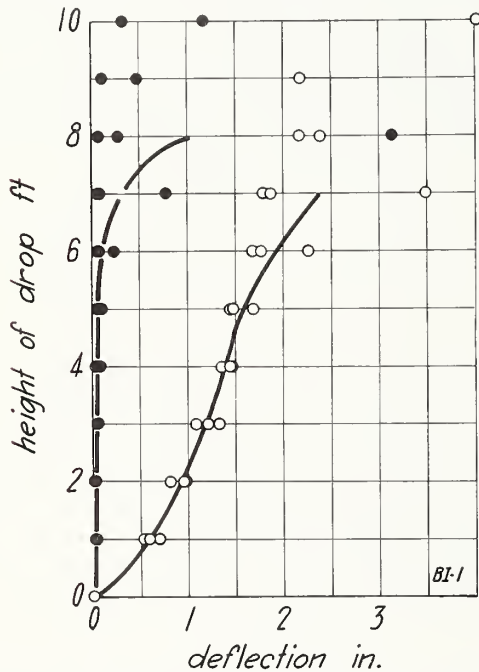
FIGURE 35.—Impact load on wall *BI*, load applied to inside face.

Height of drop-deflection (open circles) and height of drop-set (solid circles) results for specimens *BI-11*, *I2*, and *I3* on the span 7 ft 6 in.

The results are shown in table 13 and in figure 35 for wall specimens *BI-11*, *I2*, and *I3*, loaded on the inside face, and in figure 36 for wall specimens *BI-14*, *I5*, and *I6*, loaded on the outside face.

The impact loads were applied to the center of the inside face of specimens *I1*, *I2*, and *I3*, the sandbag striking the batten strip and interior board directly over the center stud.

In specimen *I1* at a drop of 5.5 ft the interior board separated from the outer studs at midspan; at 8.5 ft the siding on the opposite face cracked at midspan; at 9 ft both faces failed, the inside face by rupture of the interior board where the sandbag struck, the outside face by cracking of both the siding and sheathing at midspan. At 9.5 ft one outer stud broke at midspan. At 10 ft the set was 1.19 in. and the center stud was broken. In specimen *I2* at

a drop of 5.5 ft the interior board started to separate from the studs at midspan; at 7 ft one outer stud broke and both faces failed, the inside face by breaking of the interior board where the sandbag struck, the outside face by rupture of the sheathing. At 7.5 ft all three studs were broken, and at 9 ft the specimen broke in two pieces at midspan. In specimen *I3* at a drop of 6.5 ft the interior board separated from the outer studs near midspan, and at 9 ft the interior board cracked where the edge of the sandbag struck. At 10 ft the inside face failed by rupture of the interior board where the sandbag struck; the center stud broke at midspan, but the outside face did not fail.

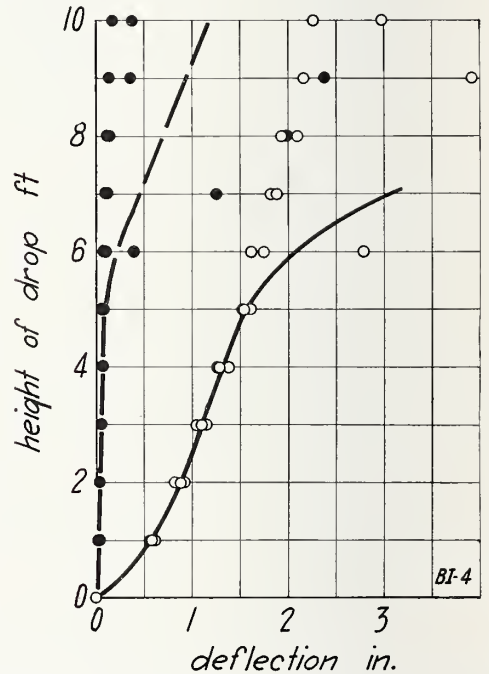
FIGURE 36.—Impact load on wall *BI*, load applied to outside face.

Height of drop-deflection (open circles) and height of drop-set (solid circles) results for specimens *BI-14*, *I5*, and *I6* on the span 7 ft 6 in.

The impact loads were applied to the center of the outside face of specimens *I4*, *I5*, and *I6*, the sandbag striking the wood bevel siding directly over the center stud. In specimen *I4* at a drop of 4 ft the interior board on the opposite face separated from the studs at midspan, at 5.5 ft the center stud broke at midspan, and at 6 ft the inside face failed by rupture of the interior board transversely across the specimen. At 6.5 ft one outer stud broke at mid-

span and at 7 ft the outside face failed by opening of the siding at midspan. After a drop of 10 ft the set was 2.98 in., three siding strips were cracked, and the sheathing was ruptured halfway across the specimen. In specimen *I5* at a drop of 3 ft the interior board separated from one outer stud at midspan and at 9.5 ft the siding cracked where the sandbag struck. After a drop of 10 ft the set was 0.16 in. and neither the faces nor the studs had failed. In specimen *I6* at a drop of 2.5 ft the interior board separated from the studs at midspan, at 8.5 ft the center stud failed at midspan, and at 9 ft the inside face failed by rupture of the interior board transversely across the specimen at midspan. The set after a drop of 10 ft was 0.38 in., and the outside face was undamaged.

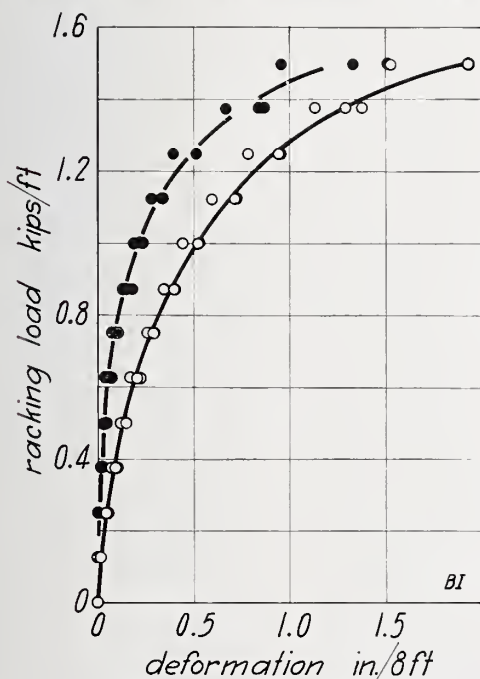
FIGURE 37.—Racking load on wall *BI*.

Load-deformation (open circles) and load-set (solid circles) results for specimens *BI-R1*, *R2*, and *R3*. The loads are in kips per foot of the face width of specimen (8 ft 0 in.).

The results for wall specimens *BI-R1*, *R2*, and *R3* are shown in table 13 and in figure 37.

The racking loads were applied to the top plate only, and the stop was in contact with the floor plate only. In specimen *R1* at a load of 1.25 kips/ft there was noticeable vertical dis-

placement between the interior boards at the joint and one interior board was cracked at the upper end near the loaded edge. In specimens *R2* and *R3* at a load of 1.375 kips/ft there was noticeable vertical displacement at the joint between the interior boards, some nails in the top plate pulling through the edge of the interior boards. At the maximum loads each of the specimens failed by the top plate pulling the nails from the studs and through the edges of the sheathing and interior board.

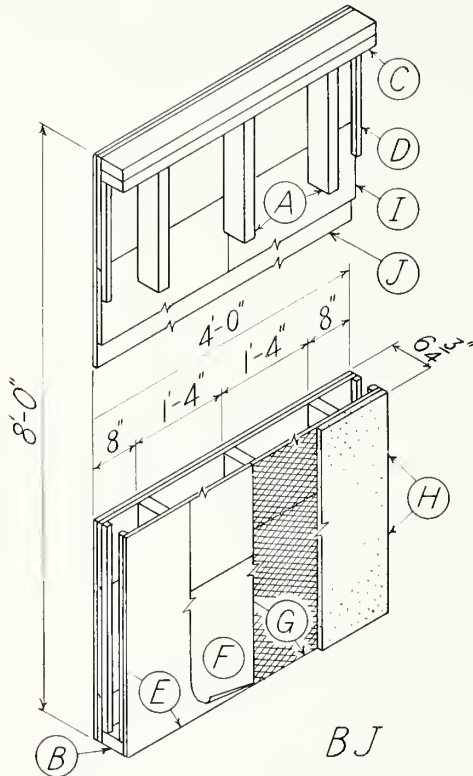
FIGURE 38.—Four-foot wall specimen *BJ*.

*A*, stud; *B*, floor plate; *C*, top plate; *D*, nailing strip; *E*, sheathing; *F*, sheathing paper; *G*, metal lath; *H*, stucco; *I*, lath; *J*, plaster.

The 4-ft wall specimens were 8 ft 0 in. high, 4 ft 0 in. wide, and 6¼ in. thick. Each specimen consisted of a wood frame to which the faces were fastened. The frame consisted of three studs, *A*, shown in figure 38, fastened to a floor plate, *B*, and a top plate, *C*, by nails. The outside face consisted of wood nailing strips, *D*, insulating-board sheathing, *E*, sheathing paper, *F*, metal lath, *G*, and stucco, *H*. The inside face consisted of wood nailing strips, *D*, insulating-board lath, *I*, and plaster, *J*. The specimens were not painted.

*Top plate.*—The top plate, *C*, consisted of two pieces of red pine,  $1\frac{1}{8}$  by  $3\frac{5}{8}$  in. (nominal 2 by 4 in.), 4 ft 0 in. long, fastened by ten 10d common nails driven from the top of the plate.

*Nailing strips.*—The nailing strips, *D*, were red pine,  $\frac{3}{4}$  by  $\frac{3}{4}$  in., 7 ft 7 in. long. In the

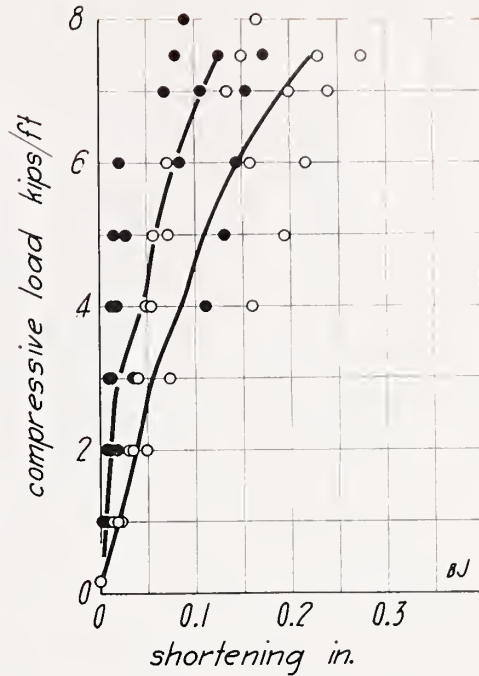
FIGURE 40.—Compressive load on wall *BJ*.

Load-shortening (open circles) and load-set (solid circles) results for specimens *BJ-C1*, *C2*, and *C3*. Load applied one-third the thickness (1.21 in.) from the inside surface of the studs. The loads are in kips per foot of actual width of specimen.

specimens *BJ-C1*, *C2*, and *C3* are shown in table 13 and in figures 40 and 41.

At loads of 6.5, 3.5, and 6 kips/ft on specimens *C1*, *C2*, and *C3*, respectively, the plaster spalled at one end of the specimen. At a load of 7.5 kips/ft on specimen *C3* the stucco cracked transversely across the specimen about 6 in. from the upper end. At the maximum loads specimens *C1* and *C3* failed by crushing of the lower member of the top plate locally at the inside edge of the studs. Specimen *C2* failed by the top plate crushing locally at the inside edge of the studs and separating at the outside edge. In specimen *C2* this rotation pulled the nails from the studs, ruptured the sheathing transversely across the specimen, and allowed the specimen to push out under load without breaking the studs.

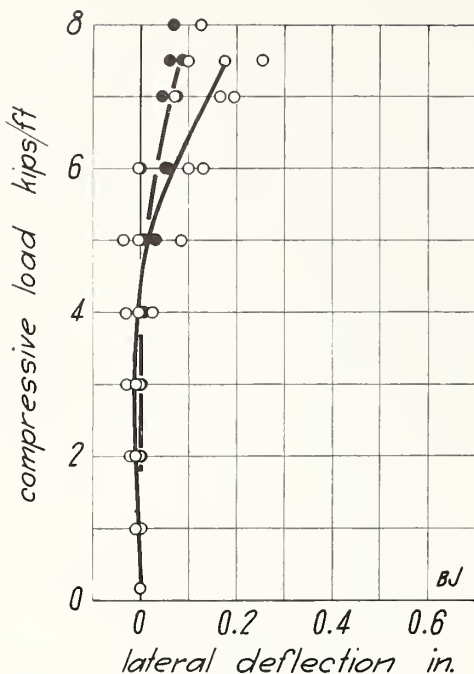
FIGURE 41.—Compressive load on wall BJ.

Load-lateral deflection (open circles) and load-lateral set (solid circles) results for specimens *BJ-C1*, *C2*, and *C3*. Load applied one-third the thickness (1.21 in.) from the inside surface of the studs. The loads are in kips per foot of actual width of specimen.

The lateral deflections shown in figure 41 are plotted to the right of the vertical axis for deflections of the specimens toward the outside face and to the left for deflections toward the inside face. No explanation was found for the deflections of the specimens toward the inside face under loads less than 6 kips/ft.

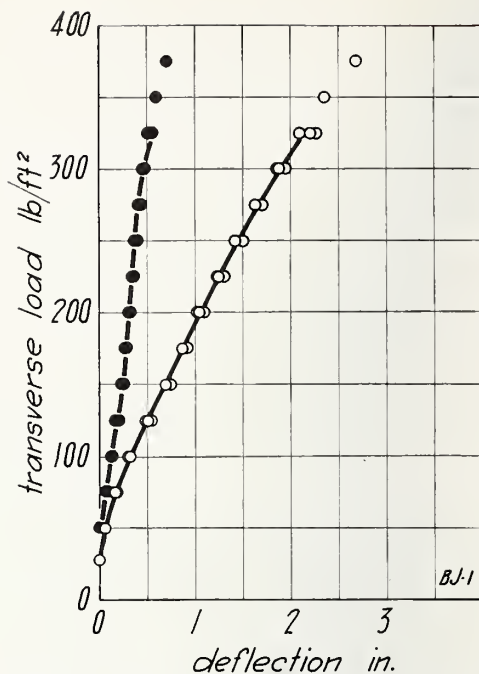
FIGURE 42.—Transverse load on wall BJ, load applied to inside face.

Load-deflection (open circles) and load-set (solid circles) results for specimens *BJ-T1*, *T2*, and *T3* on the span 7 ft 6 in.

The results are shown in table 13 and in figure 42 for wall specimens *BJ-T1*, *T2*, and *T3*, loaded on the inside (plastered) face, and in figure 43 for wall specimens *BJ-T4*, *T5*, and *T6*, loaded on the outside (stuccoed) face.

In each of the specimens *T1*, *T2*, and *T3* the stucco cracked transversely across the specimen in several places either near or between the loading rollers. The first cracks occurred at loads of 97 lb/ft<sup>2</sup> on each specimen and deflections of 0.30, 0.28, and 0.30 in. in specimens *T1*, *T2*, and *T3*, respectively. In each of the specimens the plaster cracked longitudinally along the studs at the loading rollers and transversely across the specimen in several places. The first longitudinal cracks occurred at loads of 250, 275, and 150 lb/ft<sup>2</sup> and deflections of 1.50, 1.63, and 0.69 in. in specimens *T1*, *T2*, and *T3*, respectively. The first transverse cracks occurred at loads of 300, 275, and 300 lb/ft<sup>2</sup> and deflections of 1.95, 1.63,

and 1.87 in. in specimens *T1*, *T2*, and *T3*, respectively. About one-half of the transverse cracks in the plaster occurred at lath joints. At the maximum loads specimens *T1* and *T3* failed by rupture of the center stud, one outer stud, and the sheathing at a loading roller. Specimen *T2* failed by rupture of all three studs and the sheathing at a loading roller.

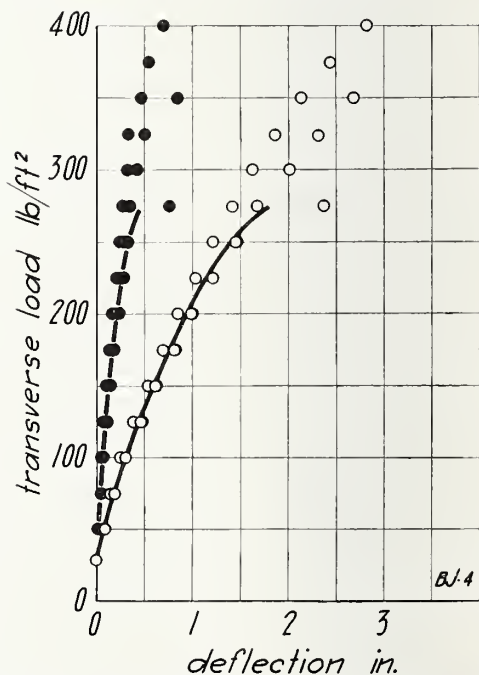
FIGURE 43.—Transverse load on wall BJ, load applied to outside face.

Load-deflection (open circles) and load-set (solid circles) results for specimens *BJ-T4*, *T5*, and *T6* on the span 7 ft 6 in.

In each of the specimens *T4*, *T5*, and *T6* (loaded on the stuccoed face) the plaster cracked transversely across the specimen at each of the lath joints and also between some of the lath joints. The first cracks occurred at loads of 100, 70, and 100 lb/ft<sup>2</sup>, and deflections of 0.24, 0.15, and 0.31 in. in specimens *T4*, *T5*, and *T6*, respectively. For each of the specimens the stucco cracked transversely across the specimen at one or both loading rollers. The first cracks occurred at loads of 375, 250, and 200 lb/ft<sup>2</sup> and deflections of 2.43, 1.45, and 1.00 in. in specimens *T4*, *T5*, and *T6*, respectively. At the maximum load, specimen *T4* failed by rupture of all three studs at a loading roller. Specimen *T5* failed by rupture of the center stud and one outer stud between the loading rollers. Specimen *T6* failed by rupture of both outer studs between the loading rollers.

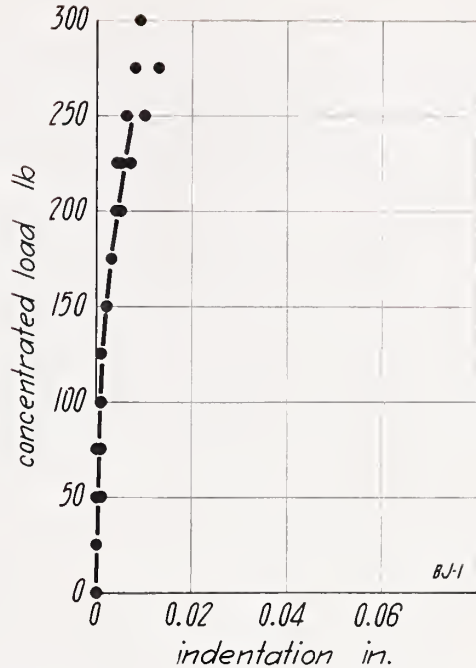
FIGURE 44.—Concentrated load on wall BJ, load applied to inside face.

Load-indentation results for specimens *BJ-P1*, *P2*, and *P3*.

The results are shown in table 13 and in figure 44 for specimens *BJ-P1*, *P2*, and *P3*, loaded on the inside (plastered) face, and in figure 45 for specimens *BJ-P4*, *P5*, and *P6*, loaded on the outside (stuccoed) face.

The concentrated loads were applied to the inside face of specimens *P1*, *P2*, and *P3* on the plaster midway between two studs and about 4 ft from one end. Each of the specimens failed by punching of the disk through the plaster and into the lath.
