**BUILDING  
MATERIALS  
AND  
STRUCTURES**

REPORT BMS31

Structural Properties of  
"Insulite" Wall and "Insulite"  
Partition Constructions  
Sponsored by The Insulite Co.

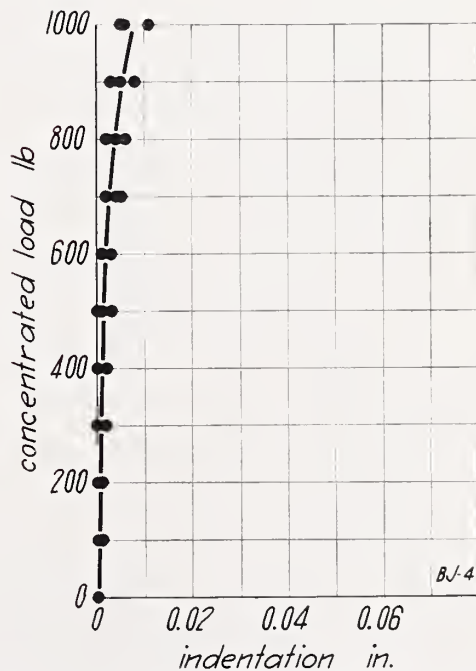
FIGURE 45.—Concentrated load on wall BJ, load applied to outside face.

Load-indentation results for specimens *BJ-P4*, *P5*, and *P6*.

The concentrated loads were applied to the outside face of specimens *P4*, *P5*, and *P6* on the stucco midway between two studs and about 4 ft from the lower end. The indentations after a load of 1,000 lb had been applied were 0.005, 0.006, and 0.011 in. in specimens *P4*, *P5*, and *P6*, respectively, and no other effect was observed.

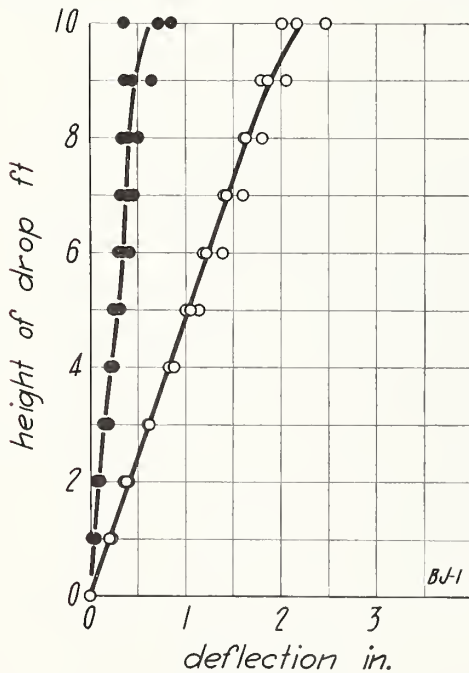
FIGURE 46.—Impact load on wall *BJ*, load applied to inside face.

Height of drop-deflection (open circles) and height of drop-set (solid circles) results for specimens *BJ-I1*, *I2*, and *I3* on the span 7 ft 6 in.

The results are shown in table 13 and in figure 46 for wall specimens *BJ-I1*, *I2*, and *I3*, loaded on the inside face, and in figure 47 for wall specimens *BJ-I4*, *I5*, and *I6*, loaded on the outside face.

The impact loads were applied to the center of the inside face of specimens *I1*, *I2*, and *I3*, the sandbag striking the plaster directly over the center stud. In each of the specimens *I1*, *I2*, and *I3* at drops of 2.5, 2, and 2.5 ft and deflections of 0.49, 0.40, and 0.47 in., respectively, the stucco cracked either along or diagonally across the center stud. At drops of 3, 4.5, and 4 ft, respectively, the inside face of each specimen failed by rupture of the plaster where the sandbag struck. At drops of 4, 8, and 6 ft and deflections of 0.88, 1.61, and 1.22 in., respectively, the stucco cracked transversely across each specimen near midspan. In specimens *I1* and *I3* at a drop of 8 ft the outside face of each specimen failed by opening of the cracks in the stucco. In specimen *I1* the center stud broke at midspan at a drop of 9.5 ft. The sets after

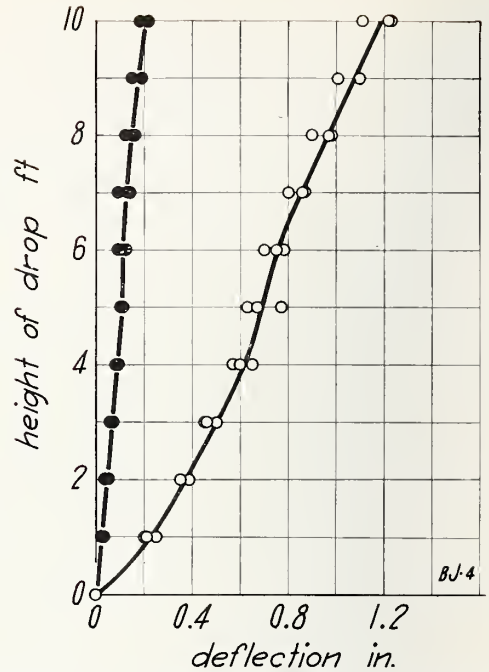
FIGURE 47.—Impact load on wall *BJ*, load applied to outside face.

Height of drop-deflection (open circles) and height of drop-set (solid circles) results for specimens *BJ-I4*, *I5*, and *I6* on the span 7 ft 6 in.

The impact loads were applied to the center of the outside face of specimens *I4*, *I5*, and *I6*, the sand bag striking the stucco directly over the center stud. In each of the specimens *I4*, *I5*, and *I6* at drops of 3.5, 1, and 3.5 ft and deflections of 0.58, 0.20, and 0.54 in., respectively, the plaster cracked transversely across each specimen at a lath joint near midspan. At drops of 6.5, 5.5, and 5 ft for specimens *I4*, *I5*, and *I6*, respectively, the inside face of each specimen failed by opening of the cracks in the plaster. In each of the specimens the stucco cracked longitudinally at drops of 6.0, 6.5, and 6.5 ft and deflections of 0.78, 0.75, and 0.79 in., respectively, and transversely at drops of 7.5, 8.5, and 10 ft and deflections of 0.90, 0.95, and 1.23 in., respectively. In specimen *I4* the outside face failed by opening of a longitudinal crack over the center stud. The sets after a drop of 10 ft were 0.18, 0.22, and 0.22 in. in specimens *I4*, *I5*, and *I6*, respectively, and the studs and sheathing and lath were undamaged.

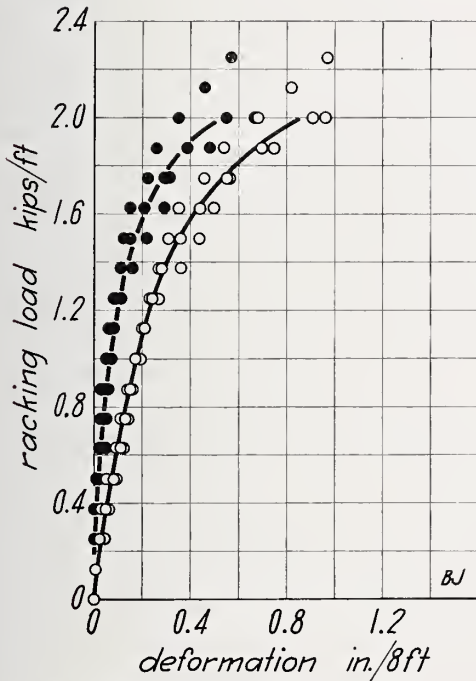
FIGURE 48.—Racking load on wall *BJ*.

Load-deformation (open circles) and load-set (solid circles) results for specimens *BJ-R1*, *R2*, and *R3*. The loads are in kips per foot of the face width of specimen (8 ft 0 in.).

The results for wall specimens *BJ-R1*, *R2*, and *R3* are shown in table 13 and in figure 48.

The racking loads were applied to the top plate only, and the stop was in contact with the floor plate only. In each of the specimens the plaster cracked in several places approximately parallel to a diagonal from the point of application of load to the stop. The first cracks occurred at loads of 1.625, 1.750, and 1.750 kips/ft and deformations of 0.50, 0.46, and 0.56 in./8 ft in specimens *R1*, *R2*, and *R3*, respectively. At the maximum load each of the specimens failed by shearing of the plaster from the lath, pulling of some of the nails through the edges of the sheathing, and pulling the top plate from the studs. The stucco was undamaged.

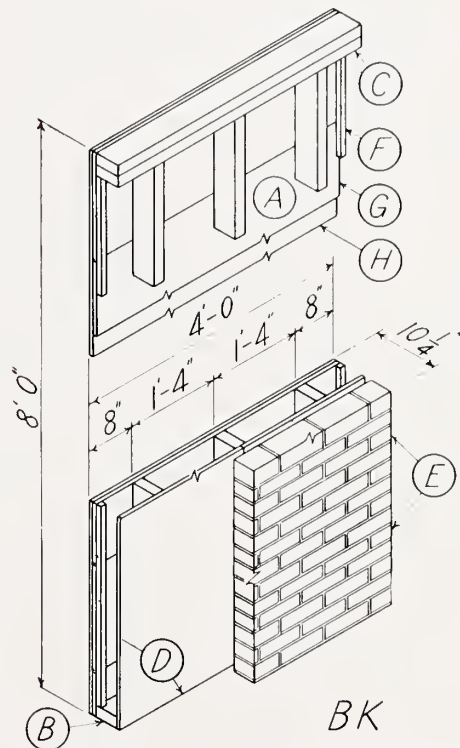
FIGURE 49.—Four-foot wall specimen *BK*.

*A*, stud; *B*, floor plate; *C*, top plate; *D*, sheathing; *E*, brick veneer; *F*, nailing strips; *G*, lath; *H*, plaster.

The 4-ft wall specimens were 8 ft 0 in. high, 4 ft 0 in. wide, and 10¼ in. thick. Each speci-

men consisted of a wood frame to which the faces were fastened. The frame consisted of three studs, *A*, shown in figure 49, fastened to a floor plate, *B*, and a top plate, *C*, by nails. The outside face consisted of insulating-board sheathing, *D*, and brick veneer, *E*, fastened to the studs by wall ties. The inside face consisted

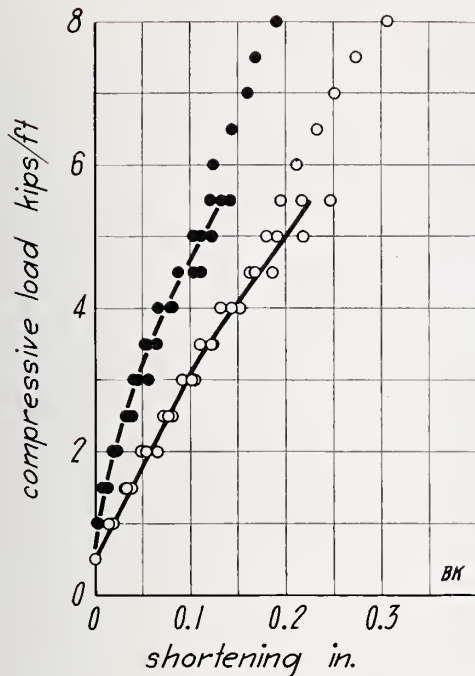
FIGURE 50.—Compressive load on wall BK.

Load-shortening (open circles) and load-set (solid circles) results for specimens BK-C1, C2, and C3. Load applied to the wood frame only, one-third the thickness (1.21 in.) from the inside surface of the studs. The loads are in kips per foot of actual width of specimen.

The results for wall specimens *BK-C1*, *C2*, and *C3* are shown in table 13 and in figures 50 and 51.

Each of the specimens failed by the top plate crushing locally at the inside edge of the studs and separating at the outside edge. This rotation of the top plate pulled the nails from the studs, ruptured the sheathing transversely across most of the width of the specimen, and either ruptured the lath or separated it from the upper ends of the studs. No failure of the brick veneer was observed.

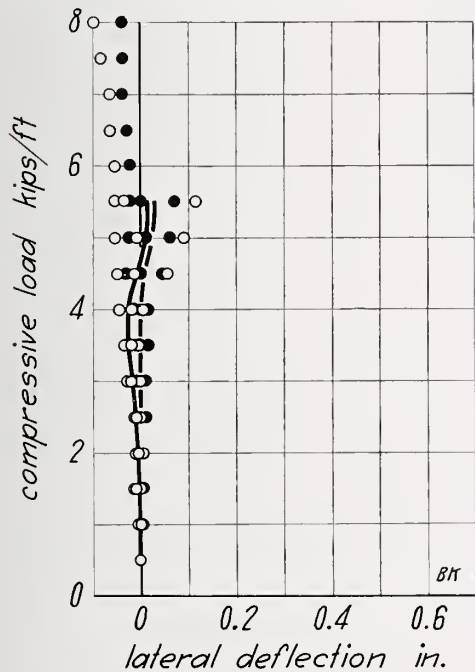
FIGURE 51.—Compressive load on wall BK.

Load-lateral deflection (open circles) and load-lateral set (solid circles) results for specimens BK-C1, C2, and C3. Load applied to the wood frame only, one-third the thickness (1.21 in.) from the inside surface of the studs. The loads are in kips per foot of actual width of specimen.

The upper loading plate was not in contact with the brick veneer. The lateral deflections shown in figure 51 are plotted to the right of the vertical axis for deflections of the specimens toward the outside face and to the left for deflections toward the inside face. Specimens *C1* and *C3* deflected toward the inside face for all loads up to and including the maximum load. Specimen *C2* deflected toward the outside face for almost all loads. The lateral deflections of specimens *C1* and *C3* toward the inside face were probably due either to the stiffness of the inside face counteracting the effect of the eccentric loads or to the little resistance afforded by the brick veneer to deflection in this direction.

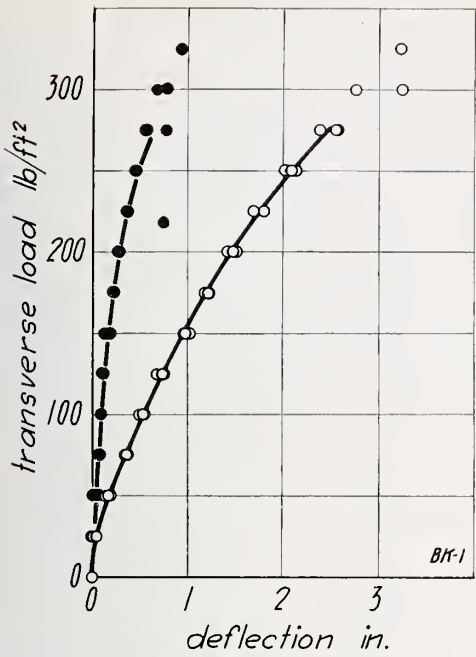
FIGURE 53.—Transverse load on wall BK, load applied to inside face.

Load-deflection (open circles) and load-set (solid circles) results for specimens BK-T1, T2, and T3 on the span 7 ft 6 in.

Wall specimen BK-T3 under transverse load is shown in figure 52. The results are shown in table 13 and in figure 53 for wall specimens BK-T1, T2, and T3, loaded on the inside (plastered) face, and in figure 54 for wall specimens BK-T4, T5, and T6, loaded on the outside (brick-veneer) face.

The deflections of the studs and of the brick veneer were each measured. The lateral deflections shown in figures 53 and 54 are the average of these values.

In each of the specimens T1, T2, and T3 the brick veneer cracked at three or four bed joints owing to rupture of the bond between the brick and the mortar. The first cracks occurred at or between the loading rollers at loads of 75, 50, and 50 lb/ft<sup>2</sup> and deflections of 0.38, 0.19, and 0.17 in. in specimens T1, T2, and T3, respectively. In each of the specimens the plaster cracked longitudinally along either one or both outer studs and transversely across the specimen at each lath joint. The first longitudinal cracks occurred at loads of 200, 150, and 150 lb/ft<sup>2</sup> and deflections of 1.41, 0.97, and 1.01 in. in specimens T1, T2, and T3, respectively. The first transverse cracks occurred at or between loading rollers at loads of 150, 175, and 225 lb/ft<sup>2</sup> and deflections of 0.96, 1.23, and 1.80 in. in specimens T1, T2, and T3, respectively. At the maximum loads each of the specimens T1, T2, and T3 failed by rupture of one outer stud at the upper loading roller and lateral displacement of the lower portion of the brick veneer with respect to the upper portion at a ruptured bed joint.

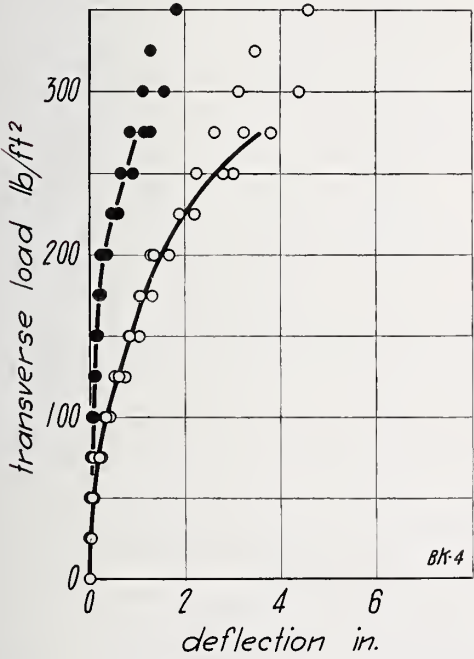
FIGURE 54.—Transverse load on wall BK, load applied to outside face.

Load-deflection (open circles) and load-set (solid circles) results for specimens BK-T4, T5, and T6 on the span 7 ft 6 in.

In each of the specimens T4, T5, and T6 (loaded on the brick veneer) the brick veneer cracked at four or five bed joints owing to rupture of the bond between the brick and the mortar. The first cracks occurred at or near

the upper loading roller at loads of 64, 85, and 75 lb/ft<sup>2</sup> and deflections of 0.16, 0.17, and 0.21 in. in specimens *T4*, *T5*, and *T6*, respectively. In each of the specimens the plaster cracked transversely across the specimen in several places. About one-half of the cracks were at lath joints. The first cracks occurred near the upper loading roller at loads of 124, 100, and 132 lb/ft<sup>2</sup> and deflections of 0.76, 0.32, and 0.66 in. in specimens *T4*, *T5*, and *T6*, respectively. At the maximum load specimens *T4* and *T6* failed by rupture of one outer stud at a loading roller and lateral displacement of the brick veneer at a ruptured bed joint. Specimen *T5* failed by rupture of the center stud and one outer stud at midspan.

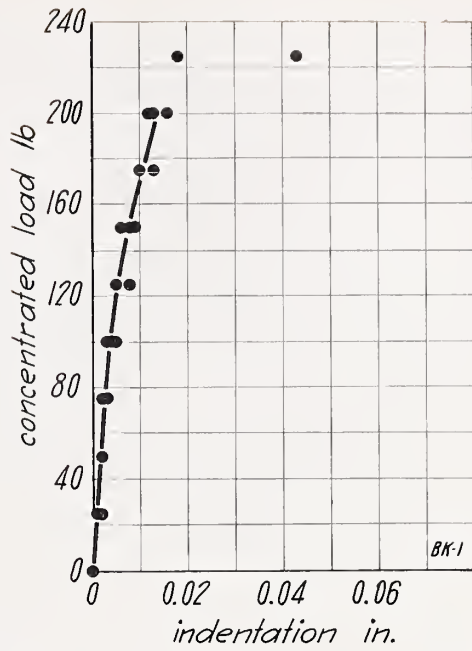
FIGURE 55.—Concentrated load on wall BK, load applied to inside face.

Load-indentation results for specimens BK-P1, P2, and P3.

The results are shown in table 13 and in figure 55 for wall specimens *BK-P1*, *P2*, and *P3*, loaded on the inside face, and in figure 56 for wall specimens *BK-P4*, *P5*, and *P6*, loaded on the outside face.

The concentrated loads were applied to the inside face of specimens *P1*, *P2*, and *P3* on the plaster midway between two studs and about 3 ft from the lower end. Each of the specimens failed by punching of the disk through the plaster and into the lath.

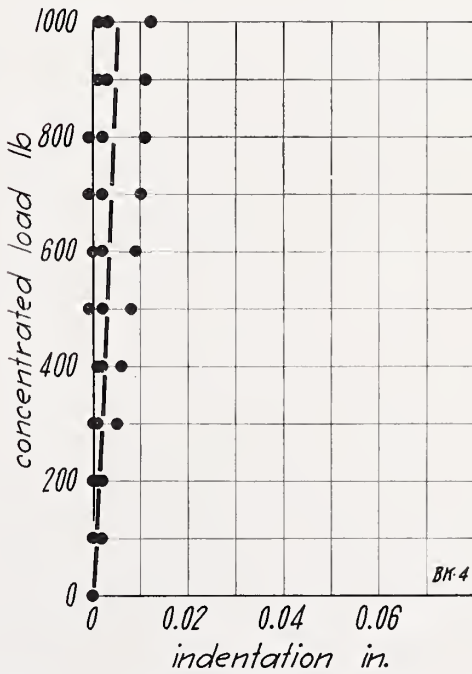
FIGURE 56.—Concentrated load on wall BK, load applied to outside face.

Load-indentation results for specimens BK-P4, P5, and P6.

The concentrated loads were applied to the outside face of specimens *P4*, *P5*, and *P6* on a brick at midwidth in a course midway between

wall ties, about 3½ ft from the lower end. The indentations after a load of 1,000 lb had been applied were 0.001, 0.012, and 0.003 in. in specimens *P*<sub>4</sub>, *P*<sub>5</sub>, and *P*<sub>6</sub>, respectively, and no further effect was observed.

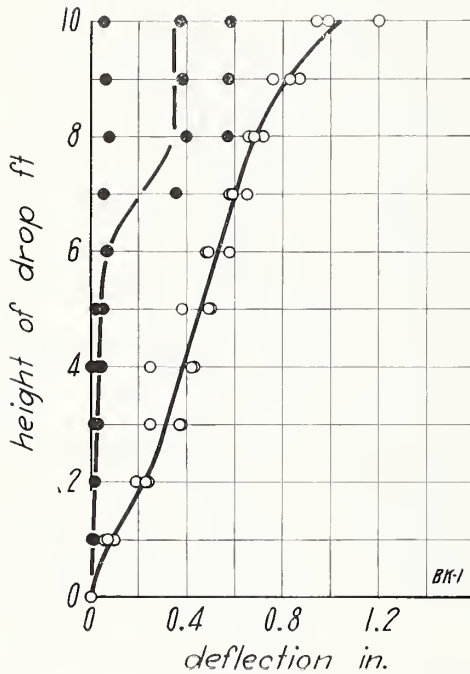
FIGURE 57.—Impact load on wall BK, load applied to inside face.

Height of drop-deflection (open circles) and height of drop-set (solid circles) results for specimens *BK-I*<sub>1</sub>, *I*<sub>2</sub>, and *I*<sub>3</sub> on the span 7 ft 6 in.

The results are shown in table 13 and in figure 57 for wall specimens *BK-I*<sub>1</sub>, *I*<sub>2</sub>, and *I*<sub>3</sub>, loaded on the inside face, and in figure 58 for wall specimens *BK-I*<sub>4</sub>, *I*<sub>5</sub>, and *I*<sub>6</sub>, loaded on the outside face.

The specimens were vertical when tested. The impact loads were applied to the center of the inside face of specimens *I*<sub>1</sub>, *I*<sub>2</sub>, and *I*<sub>3</sub>, the sandbag striking the plaster directly over the center stud. At drops of 3.5, 3.5, and 2.5 ft on specimens *I*<sub>1</sub>, *I*<sub>2</sub>, and *I*<sub>3</sub>, respectively, the inside face failed by rupture of the lath and plaster where the bag struck. At drops of 3, 2.5, and 3.5 ft, and deflections of 0.38, 0.32, and 0.25 in., respectively, the brick veneer of each specimen cracked by rupture of the bond

between the brick and mortar at a bed joint near midspan. At drops of 6, 6, and 7.5 ft on specimens *I*<sub>1</sub>, *I*<sub>2</sub>, and *I*<sub>3</sub>, respectively, the outside face of each specimen failed by lateral displacement of the brick veneer at a ruptured bed joint. The sets after a drop of 10 ft were 0.58, 0.37, and 0.05 in., respectively, and the studs were undamaged.

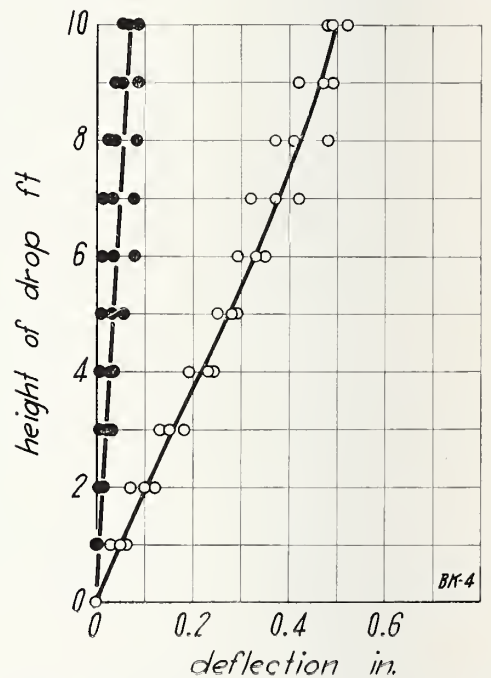
FIGURE 58.—Impact load on wall BK, load applied to outside face.

Height of drop-deflection (open circles) and height of drop-set (solid circles) results for specimens *BK-I*<sub>4</sub>, *I*<sub>5</sub>, and *I*<sub>6</sub> on the span 7 ft 6 in.

The impact loads were applied to the center of the outside face of specimens *I*<sub>4</sub>, *I*<sub>5</sub>, and *I*<sub>6</sub>, the sandbag striking the brick veneer directly over the center stud. In specimens *I*<sub>4</sub> and *I*<sub>5</sub> at drops of 7 and 9 ft and deflections of 0.42 and 0.42 in., respectively, the brick veneer of

each specimen cracked owing to rupture of the bond between the brick and the mortar at a bed joint near midspan. In specimen *I*<sub>4</sub> at a drop of 10 ft and a deflection of 0.52 in., the plaster cracked transversely across the specimen near midspan. The sets after a drop of 10 ft were 0.08, 0.07, and 0.05 in. in specimens *I*<sub>4</sub>, *I*<sub>5</sub>, and *I*<sub>6</sub>, respectively, and neither the faces nor the studs failed.

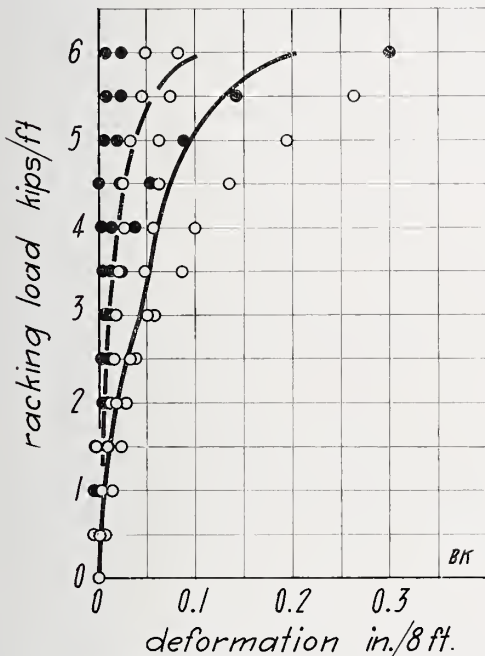
FIGURE 59.—Racking load on wall *BK*.

Load-deformation (open circles) and load-set (solid circles) results for specimens *BK-R1*, *R2*, and *R3*. The loads are in kips per foot of the face width of specimen (8 ft 0 in).

The results for wall specimens *BK-R1*, *R2*, and *R3* are shown in table 13 and in figure 59.

Specimen *R2* failed by rupture of the brick veneer in a stepwise crack approximately along a diagonal from the point of application of load to the stop. The crack usually followed the bed and head joints but went through the brick in a few places. No other failure of the specimen was observed. In specimen *R3* the set after a load of 6.25 kips/ft had been applied was 0.026 in./8 ft, and no further effect was observed.

tions and sets shown in figure 59 for a height of 8 ft were computed from the values obtained from the measuring-device readings. The gage length of the vertical measuring device was 6 ft 9 in. The gage length of the horizontal measuring device was 5 ft. The deformations and sets are the averages of the deformations and sets for the wood frame and for the brick veneer measured independently by two sets of deformation-measuring devices.

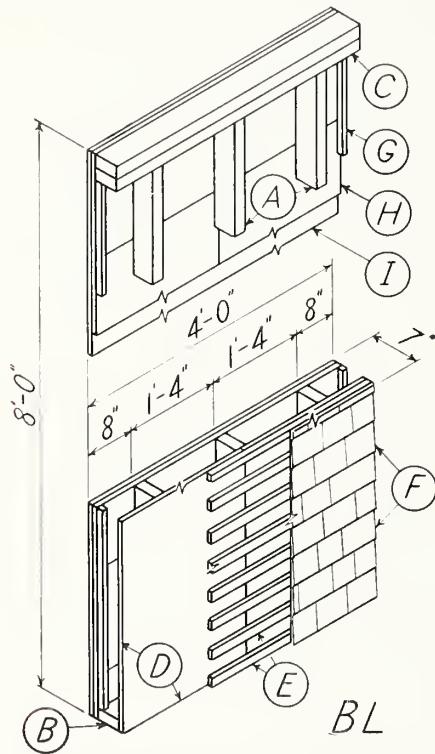
FIGURE 60.—Four-foot wall specimen BL.

*A*, stud; *B*, floor plate; *C*, top plate; *D*, sheathing; *E*, furring strip; *F*, shingles; *G*, nailing strip; *H*, lath; *I*, plaster.

The 4-ft wall specimens were 8 ft 0 in. high, 4 ft 0 in. wide, and 7 in. thick. Each specimen consisted of a wood frame to which the faces were fastened. The frame consisted of three studs, *A*, shown in figure 60, fastened to a floor plate, *B*, and a top plate, *C*, by nails. The outside face consisted of insulating-board sheathing, *D*, wood furring strips, *E*, and wood shingles, *F*. The inside face consisted of wood nailing strips, *G*, insulating-board lath, *H*, and plaster, *I*. The specimens were not painted.

*Studs.*—The studs, *A*, were red pine, 1½ by 3½ in. (nominal 2 by 4 in), 7 ft 7½ in. long,

*Floor plate.*—The floor plate, *B*, was red pine, 1½ by 3¾ in. (nominal 2 by 4 in.), 4 ft 0 in. long.

*Top plate.*—The top plate, *C*, consisted of two pieces of red pine, 1½ by 3¾ in. (nominal

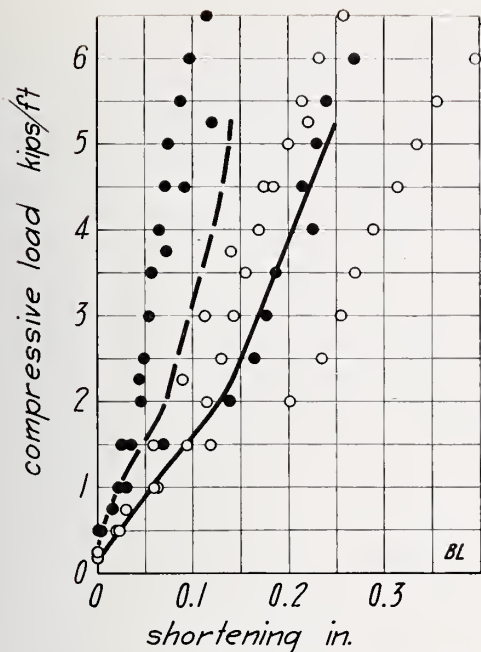
FIGURE 61.—Compressive load on wall BL.

Load-shortening (open circles) and load-set (solid circles) results for specimens *BL-C1*, *C2*, and *C3*. Load applied one-third the thickness (1.21 in.) from the inside surface of the studs. The loads are in kips per foot of actual width of specimen.

The results for wall specimens *BL-C1*, *C2*, and *C3* are shown in table 13 and in figures 61 and 62.

Each of the specimens failed by crushing of the lower member of the top plate, locally, at the inside edge of the studs, causing the plate to rotate and allowing the specimens to push out under load without breaking the studs.

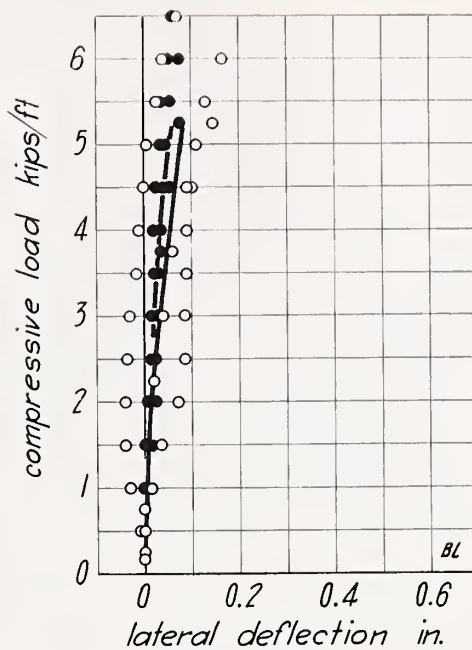
FIGURE 62.—Compressive load on wall BL.

Load-lateral deflection (open circles) and load-lateral set (solid circles) results for specimens *BL-C1*, *C2*, and *C3*. Load applied one-third the thickness (1.21 in.) from the inside surface of the studs. The loads are in kips per foot of actual width of specimen.

The lateral deflections shown in figure 62 were plotted to the right of the vertical axis for deflections of the specimens toward the outside face and to the left for deflections toward the inside face. Specimen *C3* deflected toward the inside face for loads up to 4.5 kips/ft, probably owing to the stiffness of the inside face counteracting the effect of the eccentric load.

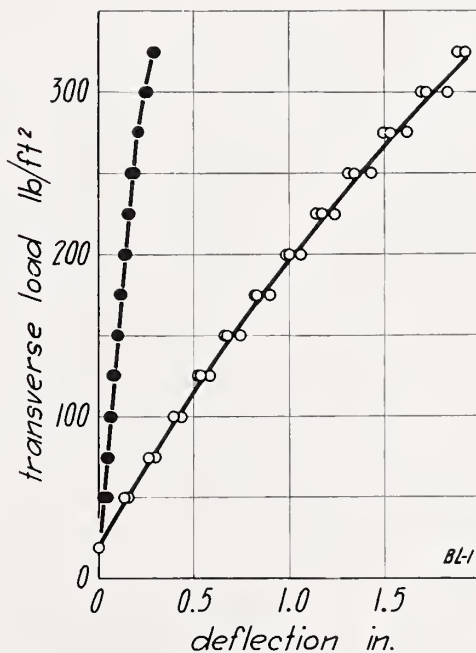
FIGURE 63.—Transverse load on wall BL, load applied to inside face.

Load-deflection (open circles) and load-set (solid circles) results for specimens *BL-T1*, *T2*, and *T3* on the span 7 ft 6 in.

The results are shown in table 13 and in figure 63 for wall specimens *BL-T1*, *T2*, and *T3*, loaded on the inside (plastered) face, and in figure 64 for wall specimens *T4*, *T5*, and *T6*, loaded on the outside (shingled) face.

In each of the specimens *T1*, *T2*, and *T3*, the plaster cracked longitudinally along one or both outer studs and transversely across the specimen in several places. The first longitudinal cracks occurred at loads of 225, 75, and 75 lb/ft<sup>2</sup> and deflections of 1.14, 0.26, and 0.29 in. in specimens *T1*, *T2*, and *T3*, respectively. Some of the transverse cracks occurred at lath joints. The first transverse cracks occurred at or between the loading rollers at loads of 225, 200, and 175 lb/ft<sup>2</sup> and deflections of 1.14, 1.00, and 0.90 in. in specimens *T1*, *T2*, and *T3*, respectively. At the maximum loads each of the specimens failed by rupture of the center stud, one outer stud, and the sheathing at or between the loading rollers. In addition, in specimen *T1*, some of the shingles separated from the furring strips where the studs ruptured.

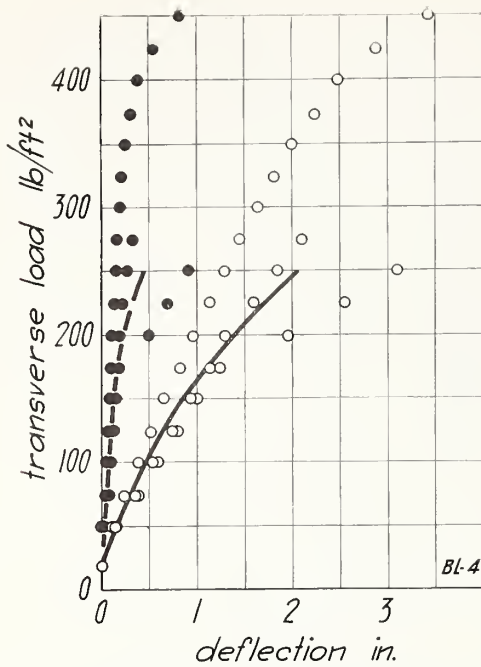
FIGURE 64.—Transverse load on wall BL, load applied to outside face.

Load-deflection (open circles) and load-set (solid circles) results for specimens BL-T4, T5, and T6 on the span 7 ft 6 in.

In each of the specimens *T4*, *T5*, and *T6* (loaded on the shingles) the plaster cracked transversely across the specimen in several places. Some of the cracks occurred at lath

joints. The first cracks occurred at loads of 75, 60, and 75 lb/ft<sup>2</sup> and deflections of 0.34, 0.24, and 0.23 in. in specimens *T4*, *T5*, and *T6*, respectively. At the maximum load specimen *T4* failed by rupture of one outer stud at mid-span. Specimens *T5* and *T6* failed by rupture of all three studs at or between the loading rollers.

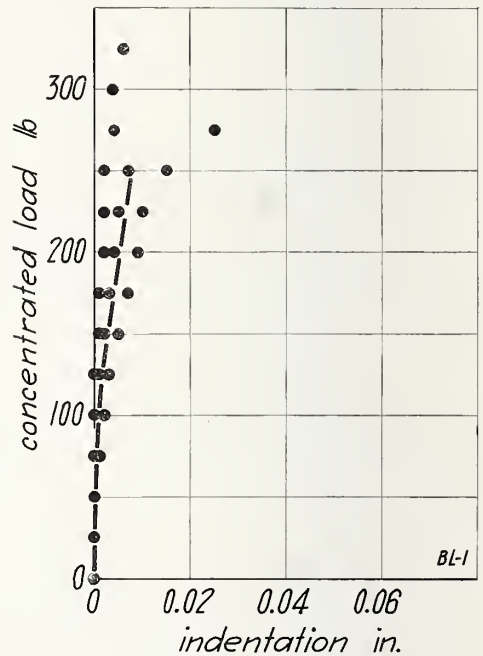
FIGURE 65.—Concentrated load on wall BL, load applied to inside face.

Load-indentation results for specimens BL-P1, P2, and P3.

The results are shown in table 13 and in figure 65 for wall specimens BL-P1, P2, and P3, loaded on the inside (plastered) faces, and in figure 66 for wall specimens BL-P4, P5,

The concentrated loads were applied to the inside face of specimens P1, P2, and P3 on the plaster midway between two studs and 1½ to 2 ft from one end. On specimens P2 and P3 the load was applied over a lath joint. Each of the specimens failed by punching of the disk through the plaster and into the lath.

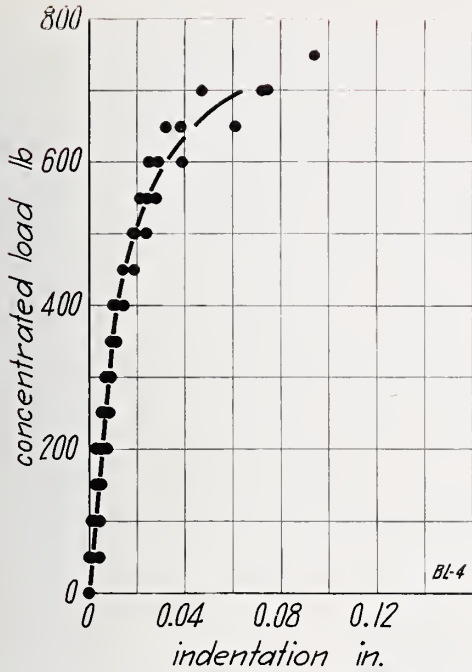
FIGURE 66.—Concentrated load on wall BL, load applied to outside face.

Load-indentation results for specimens BL-*P*<sub>4</sub>, *P*<sub>5</sub>, and *P*<sub>6</sub>.

The concentrated loads were applied to the outside face of specimens P4, P5, and P6 on a

shingle  $2\frac{3}{4}$  in. from the lower edge and about  $2\frac{1}{2}$  ft from one end of the specimen, midway between two furring strips and two studs. In specimen *P*<sub>4</sub> at a load of 650 lb and in specimen *P*<sub>6</sub> at a load of 700 lb the shingle split along the grain at one edge of the disk. At the maximum loads each of the specimens failed by punching of the disk through the shingles.

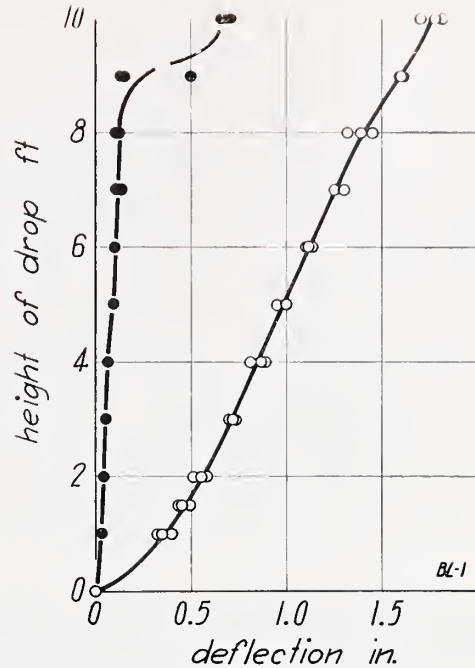
FIGURE 67.—Impact load on wall BL, load applied to inside face.

Height of drop-deflection (open circles) and height of drop-set (solid circles) results for specimens BL-*I*<sub>1</sub>, *I*<sub>2</sub>, and *I*<sub>3</sub> on the span 7 ft 6 in.

The results are shown in table 13 and in figure 67 for wall specimens BL-*I*<sub>1</sub>, *I*<sub>2</sub>, and *I*<sub>3</sub>, loaded on the inside face, and in figure 68 for wall specimens BL-*I*<sub>4</sub>, *I*<sub>5</sub>, and *I*<sub>6</sub>, loaded on the outside face.

The impact loads were applied to the center of the inside face of specimens *I*<sub>1</sub>, *I*<sub>2</sub>, and *I*<sub>3</sub>, the sandbag striking the plaster directly over the center stud. In each of the specimens *I*<sub>1</sub>, *I*<sub>2</sub>, and *I*<sub>3</sub> the plaster cracked longitudinally over either one or both outer studs at a drop of 1 ft, and at drops of 2.5, 3, and 2.5, respectively, the inside face of each specimen failed by sagging of the overhanging plaster edges. At drops of 3.5, 2, and 3 ft and deflections of

0.79, 0.69, and 0.72 in. in specimens *I1*, *I2*, and *I3*, respectively, the plaster cracked transversely across each specimen at a lath joint near midspan. The sets after a drop of 10 ft were 0.66, 0.71, and 0.68 in. in specimens *I1*, *I2*, and *I3*, respectively. Some of the furring strips were separated from the sheathing near midspan, but the outside face and the studs did not fail.

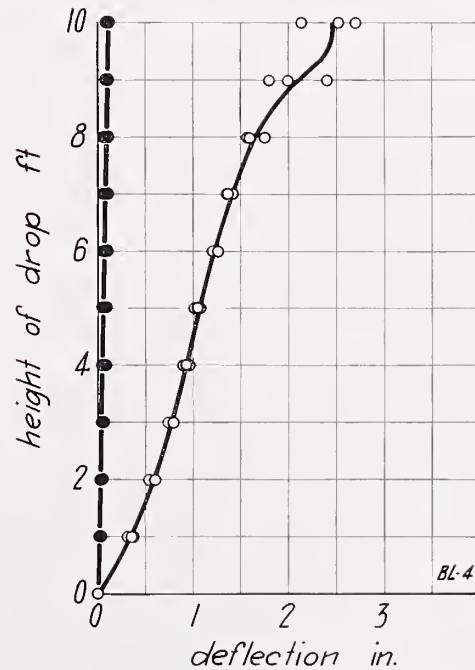
FIGURE 68. Impact load on wall BL, load applied to outside face.

Height of drop-deflection (open circles) and height of drop-set (solid circles) results for specimens BL-*I*<sub>4</sub>, *I*<sub>5</sub>, and *I*<sub>6</sub> on the span 7 ft 6 in.

The impact loads were applied to the center of the outside face of specimens *I4*, *I5*, and *I6*, the sandbag striking the shingles directly over the center stud. In each of the specimens the plaster cracked transversely across each specimen at several places. The first cracks occurred at lath joints near midspan at drops of 3, 2.5, and 2.5 ft and deflections of 0.79, 0.69, and 0.65 in. in specimens *I4*, *I5*, and *I6*, re-

spectively. At drops of 4, 4.5, and 4 ft, respectively, the inside (plastered) face of each specimen failed by opening of the cracks in the plaster. The sets after a drop of 10 ft were 0.12, 0.08, and 0.08 in. in specimens *I4*, *I5*, and *I6*, respectively. Most of the plaster had fallen, but the outside face and studs were undamaged.

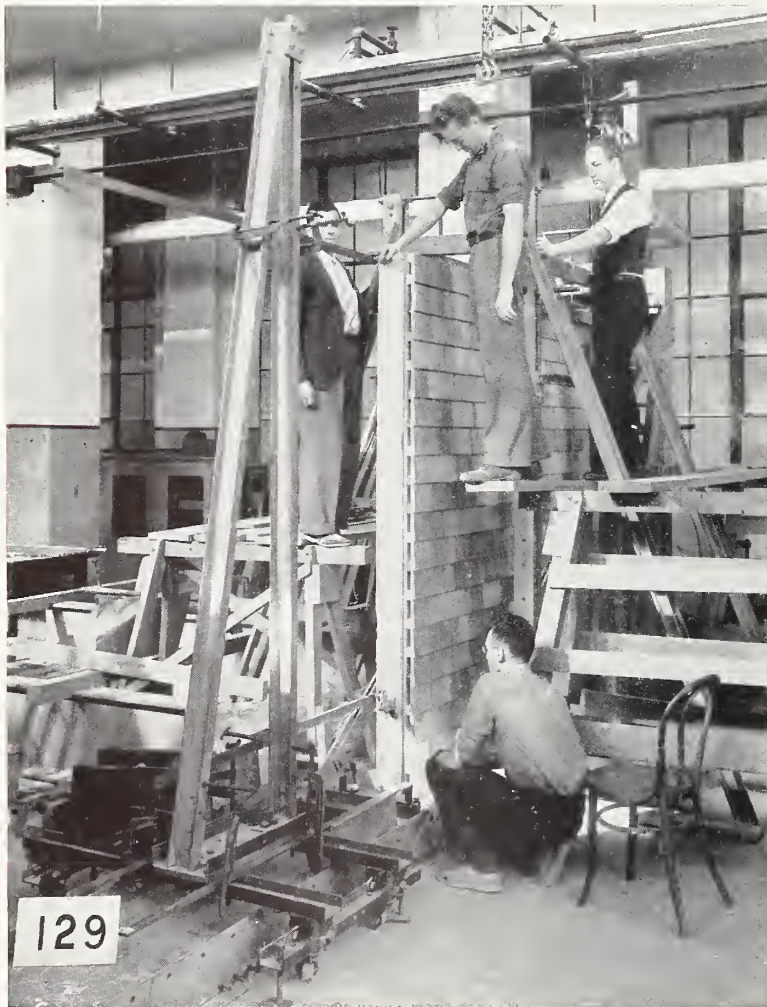
FIGURE 69.—Wall specimen *BL-R1* under racking load.

Wall specimen *BL-R1* under racking load is shown in figure 69. The results for wall specimens *BL-R1*, *R2*, and *R3* are shown in table 13 and in figure 70.

The racking loads were applied to the top plate only and the stop was in contact with the floor plate only. In each of the specimens the plaster cracked in several places. Most of the

cracks were parallel to a diagonal from the point of application of load to the stop. The first cracks occurred at loads of 1.125, 1.125, and 1.375 kips/ft and deformations of 0.49, 0.47, and 0.67 in./8 ft in specimens *R1*, *R2*, and *R3*, respectively. At a load of 1.50 kips/ft on specimens *R1* and *R2* some of the nails fastening the sheathing to the top plate pulled through the edges of the sheathing. At loads of 1.625, 1.375, and 1.592 (maximum) kips/ft

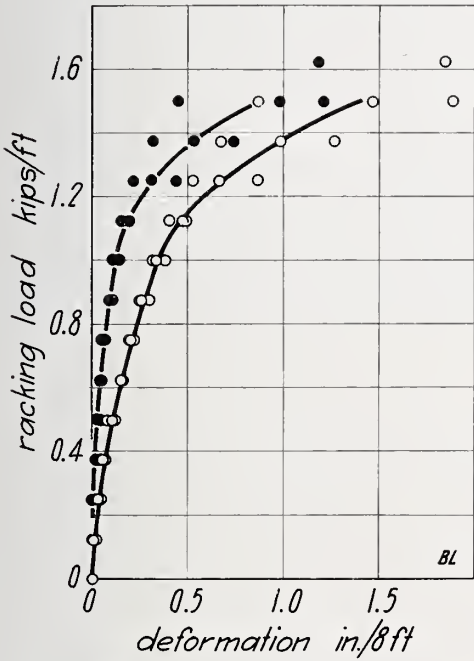
FIGURE 70.—Racking load on wall *BL*.

Load-deformation (open circles) and load-set (solid circles) results for specimens *BL-R1*, *R2*, and *R3*. The loads are in kips per foot of the face width of specimen (8 ft 0 in.).

on specimens *R1*, *R2*, and *R3*, respectively, there was noticeable vertical displacement between the two sheathing boards at the joint. At the maximum loads each of the specimens failed by the top plate pulling the nails from the studs and through the sheathing and lath.

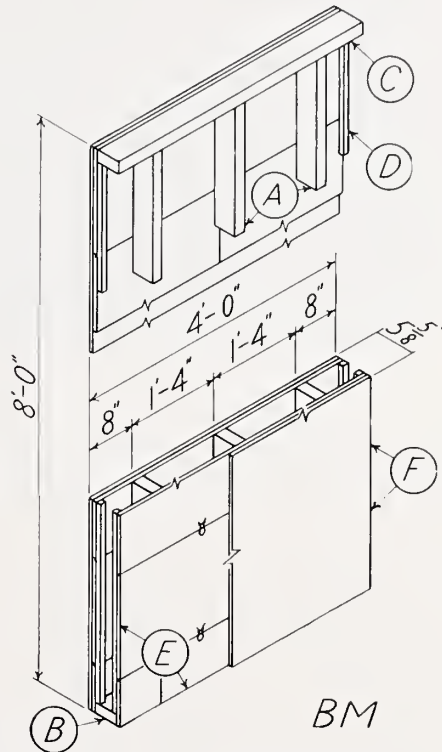
FIGURE 71.—Partition specimen *BM*.

*A*, stud; *B*, floor plate; *C*, top plate; *D*, nailing strip; *E*, lath; *F*, plaster.

The partition specimens were 8 ft 0 in. high, 4 ft 0 in. wide, and 5½ in. thick. Each specimen consisted of a wood frame to which two like faces were fastened. The frame consisted of three studs, *A*, in figure 71, fastened to a floor

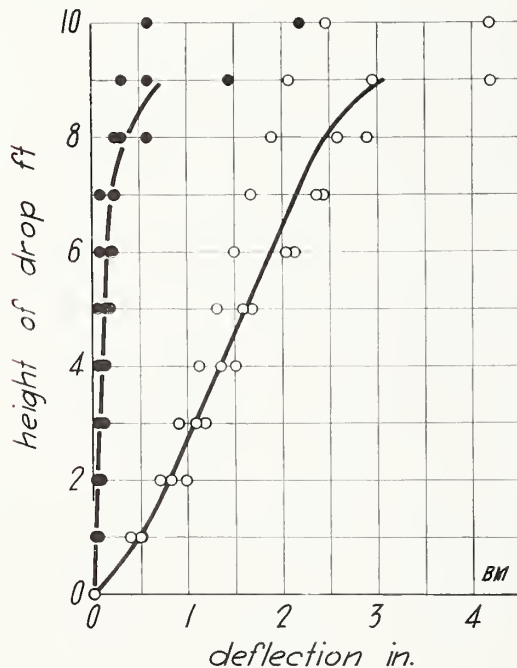
FIGURE 72.—Impact load on partition *BM*.

Height of drop-deflection (open circles) and height of drop-set (solid circles) results for specimens *BM-11*, *I2*, and *I3* on the span 7 ft 6 in.

The results for partition specimens *BM-11*, *I2*, and *I3* are shown in table 14 and in figure 72.

The impact loads were applied to the center of one face of each specimen, the sandbag striking the plaster directly over the center stud. In each of the specimens the plaster on both faces cracked longitudinally along the studs and transversely across each specimen in several places. The first transverse cracks in the face opposite the face struck occurred at lath joints near midspan at drops of 2, 1, and 1.5 ft and deflections of 0.70, 0.50, and 0.70 in. in specimens *I1*, *I2*, and *I3*, respectively. The first transverse cracks in the face struck occurred at lath joints near midspan at a drop of 3 ft and deflections of 0.90, 1.08, and 1.18 in. in specimens *I1*, *I2*, and *I3*, respectively. At drops of 4, 5, and 4.5 ft, on specimens *I1*, *I2*, and *I3*, respectively, the face struck by the sandbag failed owing to rupture of the plaster at midspan, especially at the point of impact. At drops of 5.5, 6.5, and 6 ft on specimens *I1*, *I2*, and *I3*, respectively, the face opposite that struck by the sandbag failed by falling of some of the plaster. In each of the specimens the center stud broke at midspan at drops of 10, 9, and 10 ft, respectively. Specimen *I2* failed structurally at a drop of 10 ft by the sandbag passing through the specimen.

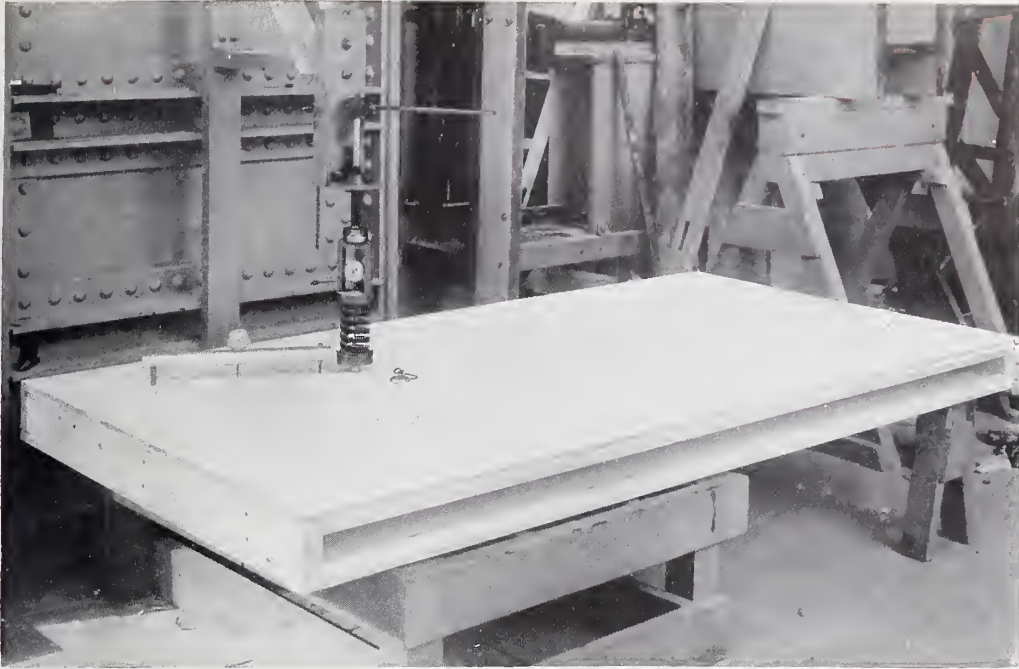
FIGURE 73.—Partition specimen *BM-P2* under concentrated load.

Partition specimen *BM-P2* under concentrated load is shown in figure 73. The results for partition specimens *BM-P1*, *P2*, and *P3* are shown in table 14 and in figure 74.

The concentrated loads were applied to one face of each specimen on the plaster midway between two studs over a lath joint  $1\frac{1}{2}$  to 2 ft from one end of the specimen. Each of the

specimens failed by punching of the disk through the plaster and by the spreading of the lath at the joint.

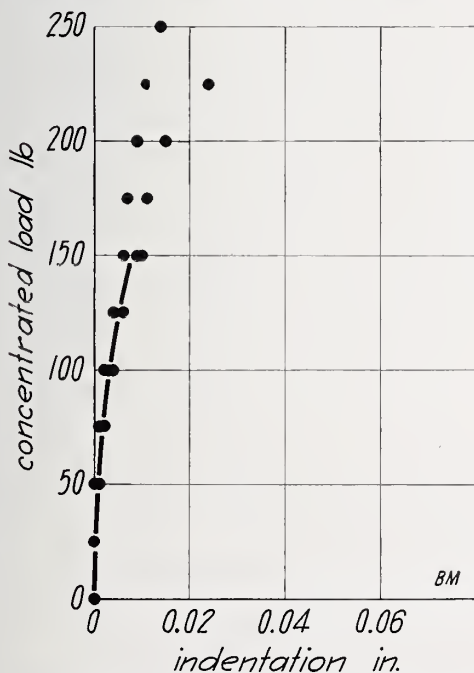
FIGURE 74.—Concentrated load on partition *BM*.  
Load-indentation results for specimens *BM-P1*, *P2*, and *P3*.

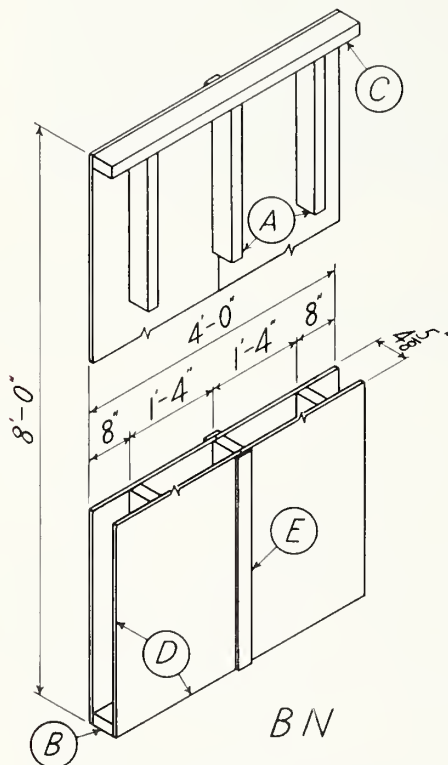
FIGURE 75.—Partition specimen *BN*.

*A*, stud; *B*, floor plate; *C*, top plate; *D*, interior board; *E*, batten strip.

The frame consisted of three studs, *A*, shown in figure 75, fastened to a floor plate, *B*, and a top plate, *C*, by nails. Both faces consisted of

interior board, *D*, with a vertical joint at midwidth covered by a batten strip, *E*. The specimens were not painted.

in., 8 ft 0 in. long, with the linen-textured surface exposed. There was a vertical joint on the center stud with ½-in. clearance between the edges of the boards on each face. The interior board was fastened to the center stud, floor plate, and top plate by 4d galvanized roofing nails spaced 3 in., about ½ in. from the edges of the board, and to the outer studs by

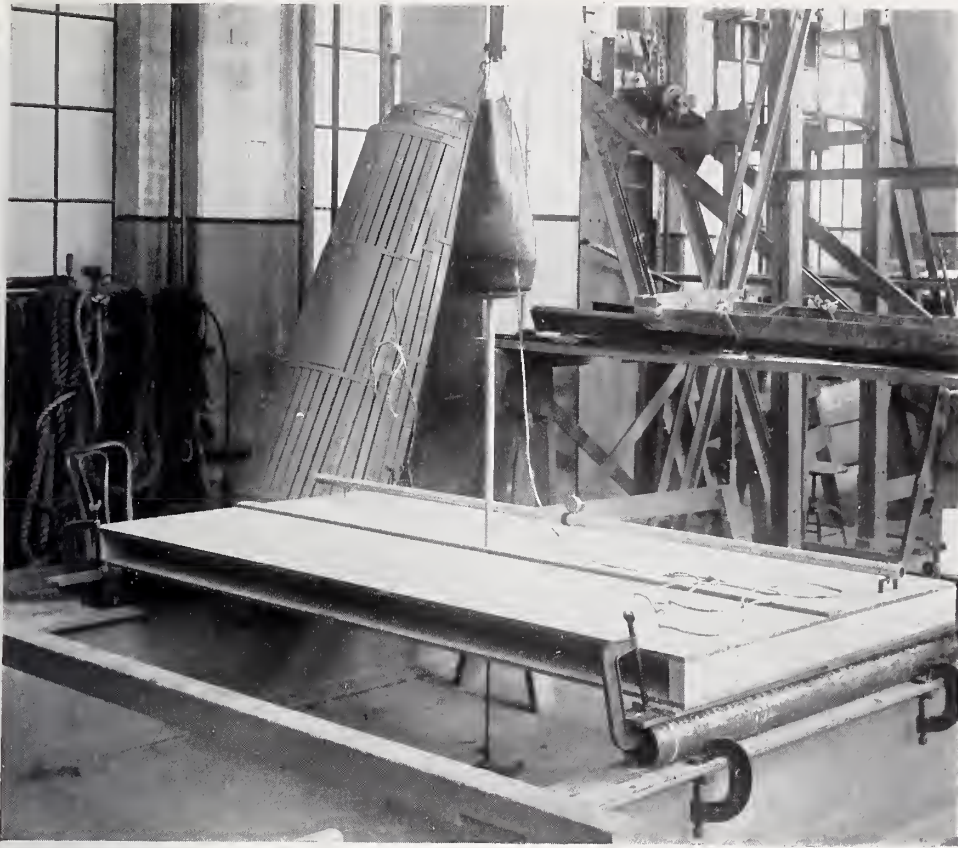
FIGURE 76.—Partition specimen BN-12 during the impact test.

Partition specimen *BN-I2*, during the impact test, is shown in figure 76. The results for partition specimens *BN-I1*, *I2*, and *I3* are shown in table 14 and in figure 77.

The impact loads were applied to the center of one face of each specimen, the sandbag striking the batten strip and the interior board directly over the center stud. In each of the specimens the interior board on the face opposite the face struck separated from the studs at drops of 4, 7, and 6 ft on specimens *I1*, *I2*, and *I3*, respectively, and these faces failed by rupture of the interior board at midspan transversely across each specimen at drops of 4.5, 8, and 6 ft, respectively. At drops of 5, 8, and 3.5 ft, respectively, the face struck failed by rupture of the interior board where the sandbag struck. At drops of 4.5, 7.5, and 6 ft, respectively, the center stud of each specimen ruptured at midspan. At the maximum height of drop, each specimen failed by the sandbag passing through the specimen.

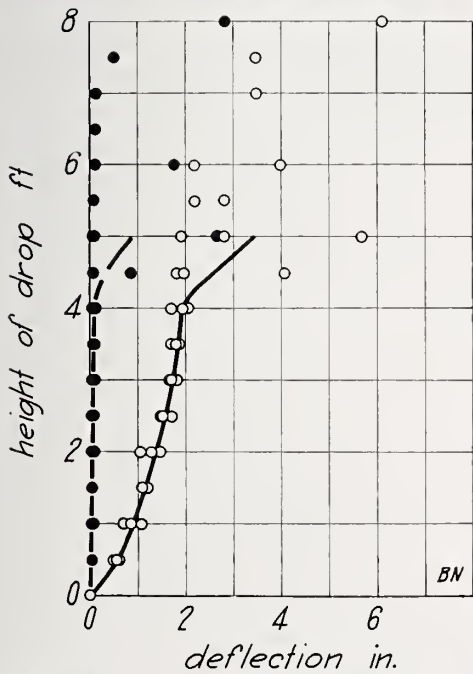
FIGURE 77.—Impact load on partition BN.

Height of drop-deflection (open circles) and height of drop-set (solid circles) results for specimens BN-11, 12, and 13 on the span 7 ft 6 in.

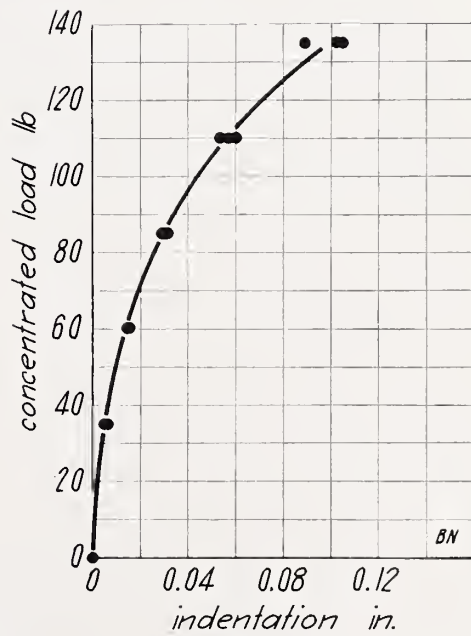
FIGURE 78.—Concentrated load on partition BN.

Load-indentation results for specimens BN-P1, P2, and P3.

The results for partition specimens *BN-P1*, *P2*, and *P3* are shown in table 14 and in figure 78.

The concentrated loads were applied to one face of each specimen on the interior board midway between two studs and about 1½ ft from one end of the specimen. Each of the specimens failed by punching of the disk through the interior board.
