# A Side-by-Side Comparison of New and Old Construction

BY SCOTT JOERGER

**Fire Engineering**  
TRAINING THE FIRE SERVICE FOR 124 YEARS

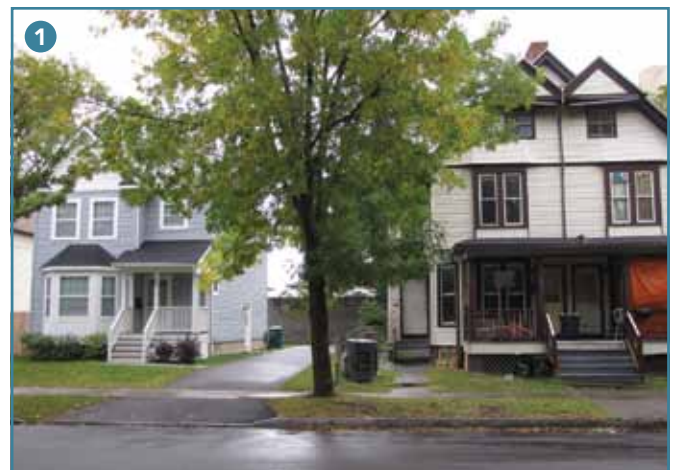
(1) The two structures: 12 Washington Avenue is on the left; 10 Washington Avenue is on right. (Photos by author unless otherwise noted.)

article addresses key construction differences, how they relate to firefighting, and suggested tactics for firefighting in buildings using lightweight wood construction (photo 1).

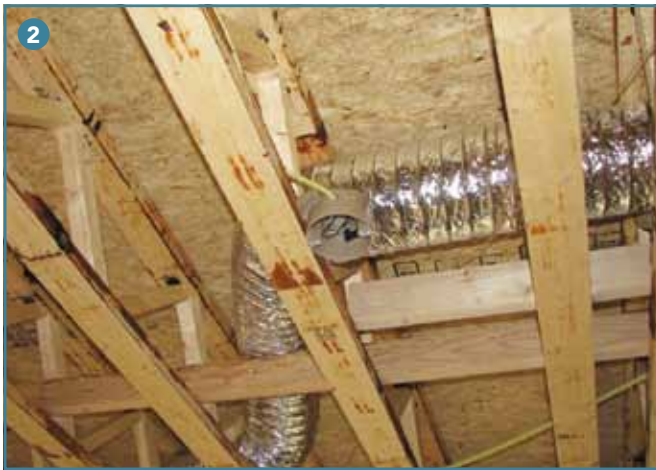
(2) Wood floor trusses like those in the 12 Washington Avenue structure.

The house at 12 Washington Avenue uses 2- × 4-inch and 2- × 3-inch wood trusses as support for the first floor. The trusses can span the entire width of the basement without any supporting beams or columns. The web members of the truss are smaller, nondimensional 1¾-inch pieces of wood that are fastened by finger joint and glued in place (photo 2). Floor decking is ¾-inch oriented strand board (OSB) finished off with carpet or linoleum. In other homes, the floor decking can be only ½-inch thick and finished off with additional surfaces such as hardwood flooring and tiles. The trusses consist of a top and bottom chord made of long 2- × 4-inch or 2- × 3-inch dimensional lumber (photo 2).

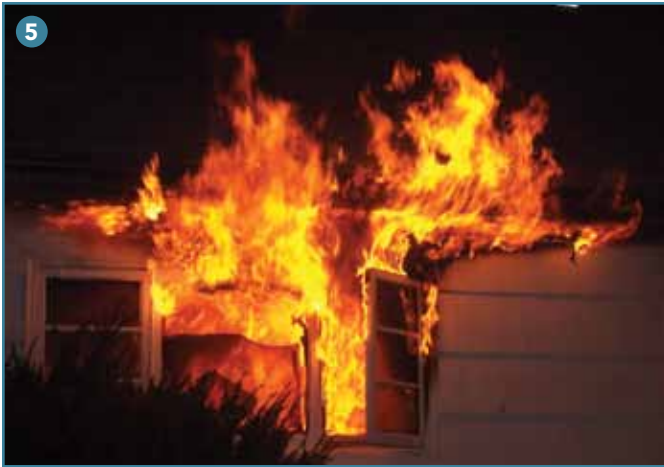
(5) Flames from the window vent out and spread along the vertical obstruction of the soffit. The soffit is made of wood and is not vented, so flames outside of the window will spread to the attic, but not immediately. (Photo by Mike Edelstein, Pittsford Fire Department.)

The exterior of 10 Washington Avenue is covered with 1-× 6-inch wood clapboard siding covered with years of paint coatings and attached to the 2- × 4-inch framing. The paint on the wood siding does not always burn quickly; in most cases, it provides a slight barrier to the combustibility of wood siding, slowing vertical fire extension. This does not last long but is helpful compared to the windows. The windows are old and break easily. They quickly break in a room-and-contents fire, which will provide oxygen in and fire out. Once the flames begin to vent out a window, if there is a window directly above, which is common with balloon construction, the window on the floor above may break and allow fire to enter. Flames venting out of second-floor windows can spread up to the soffit or roof overhang and then spread along this vertical obstruction (photo 5). Eventually, this causes fire to spread into the attic.

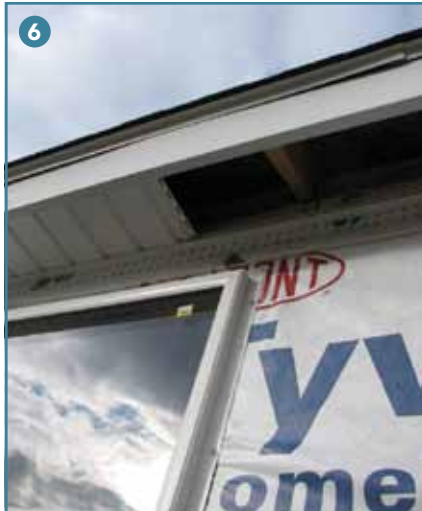
(6) You cannot stop the flames venting out of this window from immediately entering the attic above.

8-foot sheets of ½-inch OSB sheathing and attached over the 2- × 4-inch framing. The windows are double-hung thermal pane glass, which do not easily break. A room-and-contents fire usually needs intensity or time to break out these windows. Once the window breaks, the fire will extend. The vinyl siding melts and burns, as do the foam underlayment and moisture barrier. The exposed OSB now quickly ignites, and fire travels up the outside wall of the home. It may move so fast that it initially passes over a thermal pane window above as it spreads up. On the B and D sides of the house, the load-bearing sides, a fire will quickly extend up the exterior and enter the attic through the soffit vents on the B and D sides of the house (photo 6).

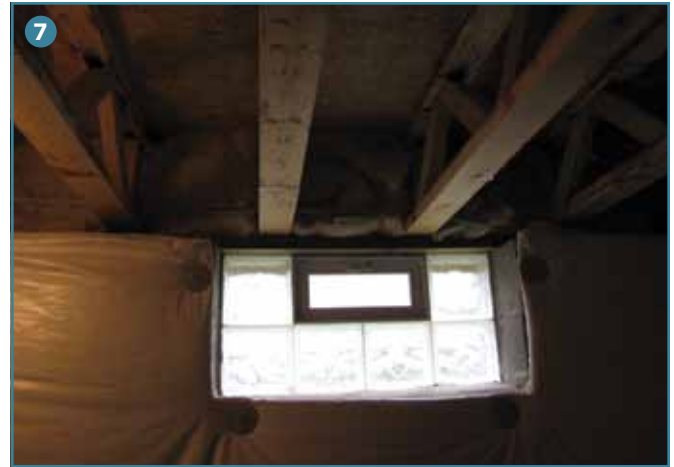
(7) The basement window can be effective for applying water from a hose stream from the exterior into the basement and trusses or I-beams. (8) The tip of the gooseneck applicator is removed, and the water stream has reach and penetration.

The windows should be below the trusses or wooden I-beams, so a water stream directed up, if possible, should be effective (photo 7). If basement windows are not an option, cut a triangular hole from the exterior of the house into the rim board. Start this procedure by first removing the exterior siding, the foam underlayment, and any moisture barrier to expose the rim board; this should be just above the masonry foundation wall where the siding starts.

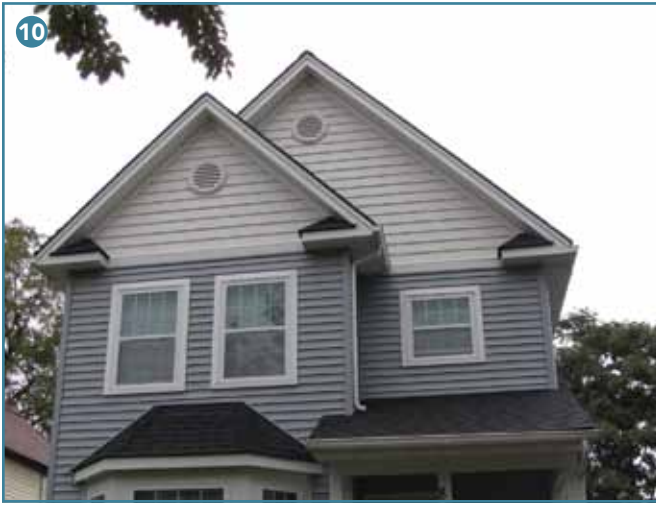
(10) The gable could be an effective way to apply water into an attic fire from the exterior. From a ground or an aerial ladder, use a hand tool to cut a hole from the exterior below the gable and just above the top floor to direct a stream into the attic.
