# Characterization of indoor hygrothermal conditions in houses in different northern climates

### NRCC-50080

Rousseau, M.; Manning, M.; Said, M.N.; Cornick, S.M.; Swinton, M.C.

A version of this document is published in / Une version de ce document se trouve dans: Thermal Performance of Exterior Envelopes of Whole Buildings X International Conference, Clearwater, Florida, Dec. 2-7, 2007, pp. 1-14

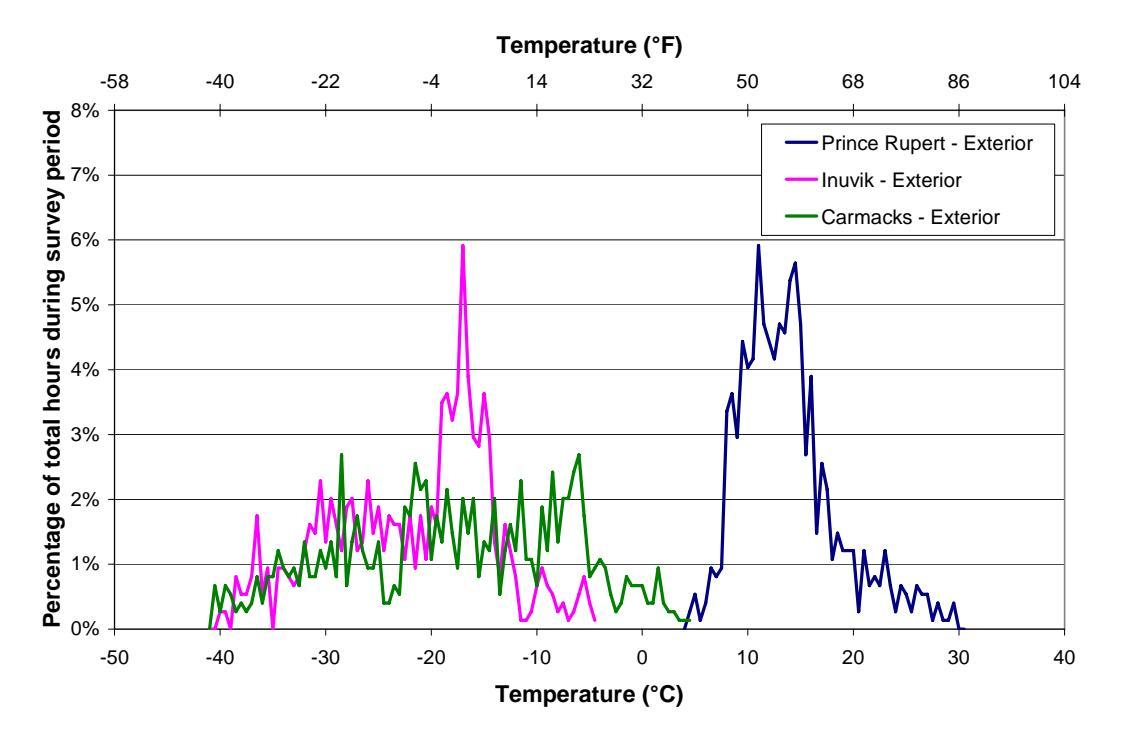
Figure 2. Distribution of outdoor temperature measured during the one-month survey period in each location

Northern coastal climates (i.e. cool and very humid) and northern climates (i.e. very cold and dry) were included in the surveys. Table 1 provides some outdoor climate data from the survey sites. Figure 2 shows the outdoor temperature prevailing during the survey periods using probability distribution curves.

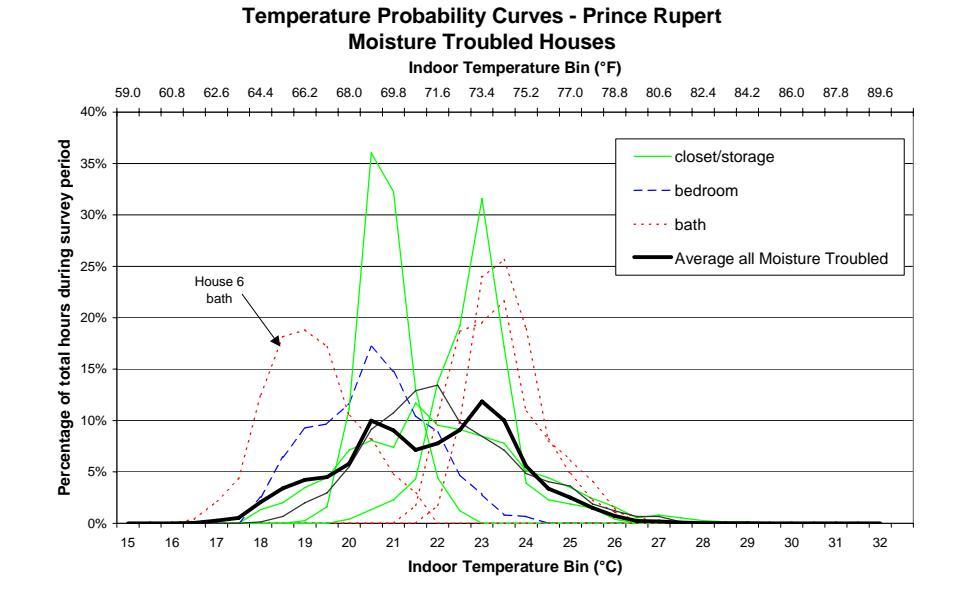
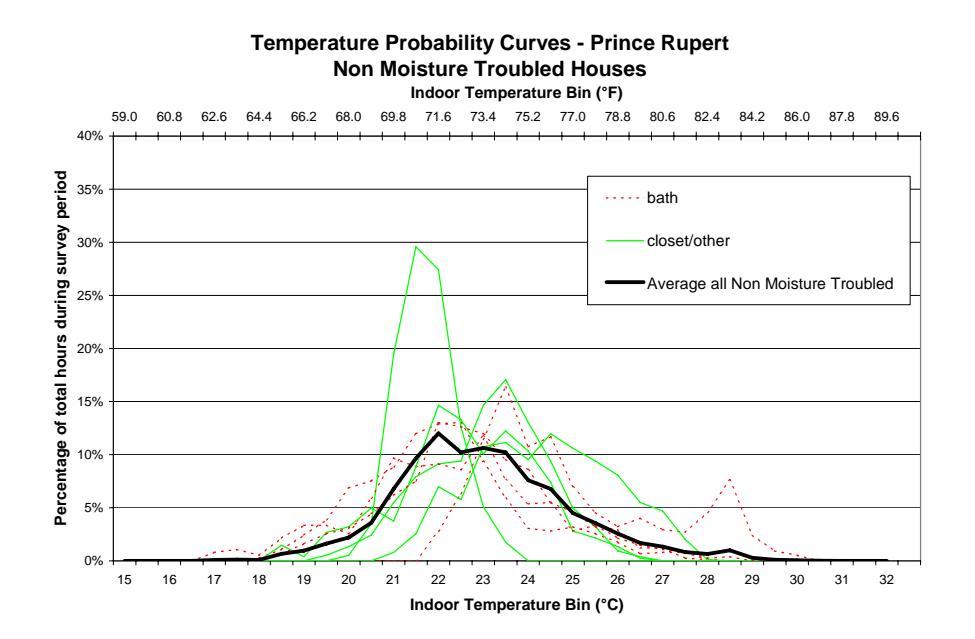
#### Figure 3. Distribution of indoor temperature measurements for the one-month survey in Prince Rupert BC. The legend on the right hand side corner of the graph provides the room where the sensor was located.

**Indoor Temperature.** In the mild and wet climate of Prince Rupert (in springtime), average daily indoor temperatures were widely spread between 15°C and 32°C (59 and 90°F) (Figure 3). Bathrooms in houses with moisture problems operated at much lower or higher indoor temperature for longer periods than the houses without reported moisture problems. Other surveyed spaces included closets and storage rooms (moisture problems were reported at these locations), and in some cases these spaces operated at cooler temperatures than living spaces. For instance, the house no. 6 (3 occupants) bathroom operated between 16 and 22°C (61 and 72°F), did not have a bathroom exhaust fan and experienced recurrent moisture problems such as mould growth on the bathroom ceiling.

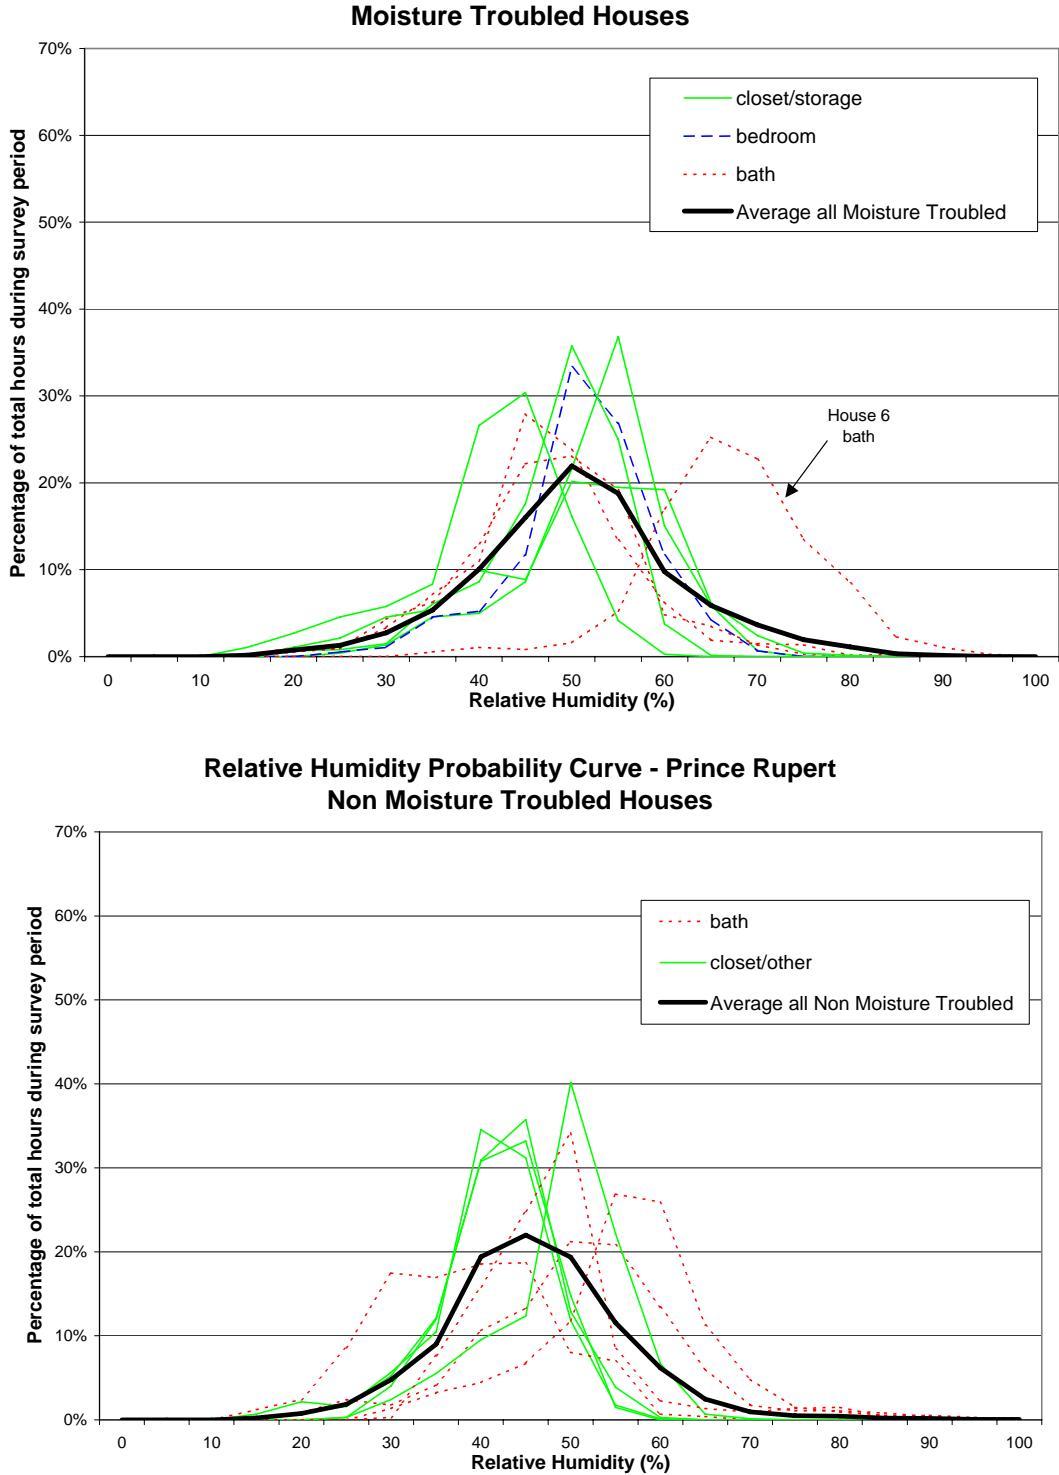
#### Relative Humidity Probability Curve - Prince Rupert Moisture Troubled Houses

Figure 4. Distribution of indoor relative humidity measurements during the one-month survey in Prince Rupert BC. The legend on the right hand side corner of the graph provides the room where the sensor was located.

**Indoor Relative Humidity.** For the month of the survey, the average relative humidity measured in the surveyed houses ranged between 36% and 65% RH. Probabilities of occurrences for hourly measurements in each surveyed house are presented in Figure 4. Daily change in the humidity ratio in any of the houses surveyed ranged from 7 to 22 g/kg of dry air (0.0007 to 0.0022  $lb_w/lb_{da}$ ). Since bathrooms were surveyed in each house of this survey, data clearly showed that bathrooms were subjected to the largest daily increase in moisture loads, with an average of 19g/kg (0.0019  $lb_w/lb_{da}$ ). In such a northern coastal climate, the outdoor air tends to be cool and humid and the difference in humidity ratio between exterior and interior was not large, thus providing a low drying potential for ventilation air; on average the difference in humidity ratio (interior-exterior) during the survey period ranged between 0.7 and 3.3 g/kg (0.0007 to 0.0033  $lb_w/lb_{da}$ ).

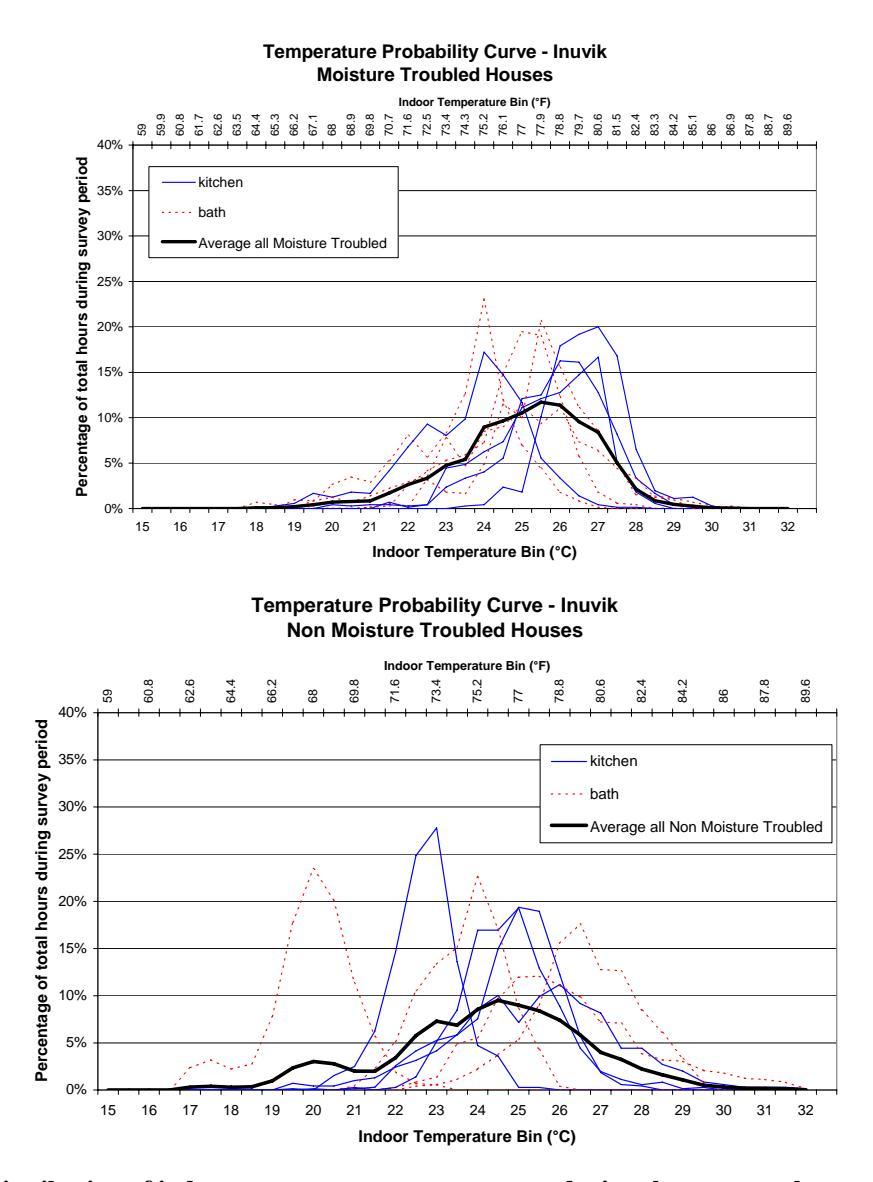
Figure 5. Distribution of indoor temperature measurements during the one-month survey in Inuvik NT. The legend in the box in the upper part of the graph provides the room where the sensor was located.

**Indoor Temperature.** In general the houses surveyed operated at higher temperature (the average was 25.5°C [77.9°F]) than the other two surveys (Figure 5).

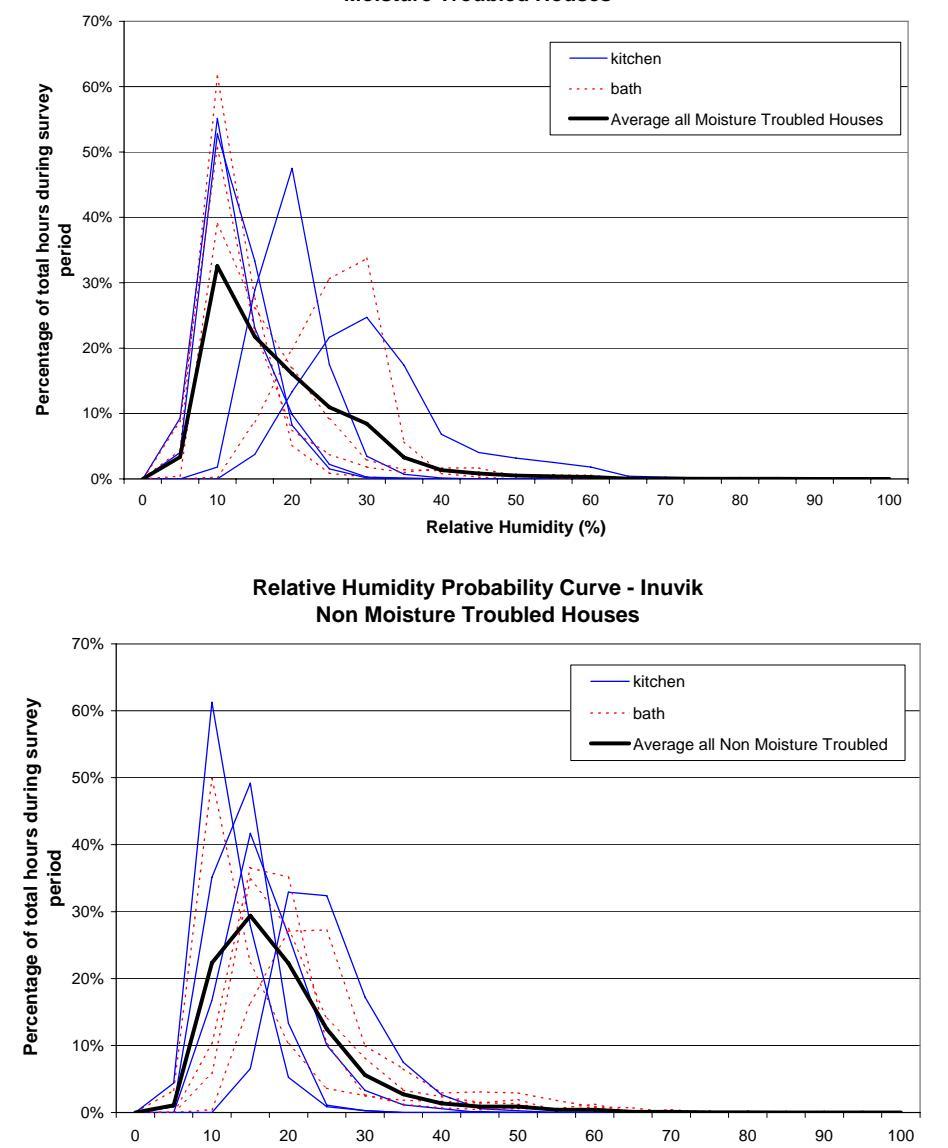
#### Relative Humidity Probability Curve - Inuvik Moisture Troubled Houses

Figure 6. Distribution of indoor relative humidity measurements from the one-month survey in Inuvik NT. The legend in the right-hand side corner of the graph provides the room where the sensor was located.

**Indoor Relative Humidity**. For the month of the survey, the average relative humidity measured in the surveyed houses was between 9 and 29% RH. Probabilities of occurrences for the hourly measurements in each surveyed house are presented in Figure 6. The daily change in absolute air moisture content ranged from 6 to 28 g/kg (0.0006 to 0.0028 lb<sub>w</sub>/lb<sub>da</sub>). This can be related to the cold outdoor conditions during the survey period (average:  $-22^{\circ}$ C [ $-7.6^{\circ}$ F], min  $-41^{\circ}$ C [ $-42^{\circ}$ F] and max: $-4^{\circ}$ C [ $25^{\circ}$ F]), the leakiness of the houses (between 3 and 12 ACH @50 Pa[1.0 lb/ft<sup>2</sup>]) and the absence of sources of humidification. Bathrooms and kitchen experienced short-term peaks of increased RH, near saturation for bathrooms and up to 85% in kitchens. Moisture problems included dew and frost on double glazed windows and doors as well as on the interface between exterior walls and penetrations such as vent ducts, water damage to interior finish (when frost melted) and mould growth around window frames and in bathrooms.

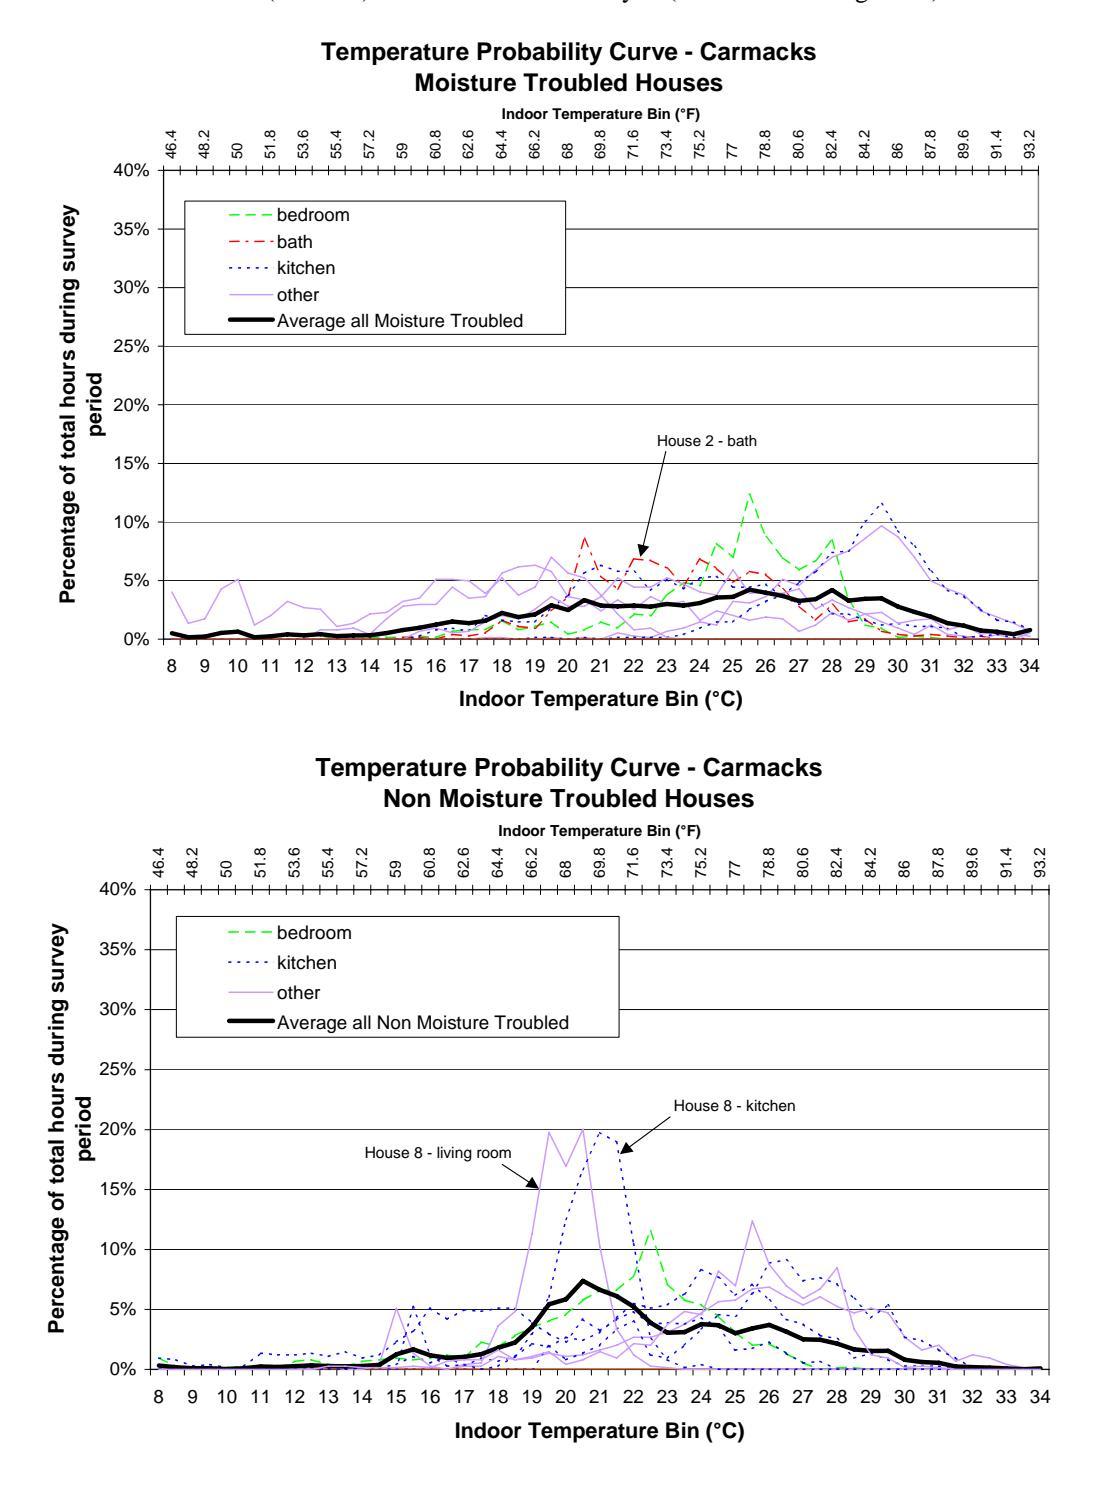
#### Figure 7. Distribution of indoor temperature measurements for the month of the survey in Carmacks Yukon. The legend on the left hand side corner of the graph provides the room where the sensor was located

**Indoor Temperature.** The surveyed houses in Carmacks differ significantly from the other two surveys, in that most of the houses were heated with a central wood-stove, without a heat distribution system - reportedly a decision of the occupants in this First Nations community. This resulted in very large temperature fluctuations in the houses and between rooms - depending on their location in relation to the proximity of the heat source (Figure 7). The spread of daily average temperature for all houses was from 8 to 34°C (46 to 93°F). Kitchens were maintained at a higher temperature than the other rooms (i.e. living

rooms and bedrooms). In some cases, 3-minute temperature measurements clearly showed a pattern where the occupant would stoke up the wood stove in the morning and re-stoke it in late afternoon (Figure 8). The only house with a heat distribution system and a furnace (house no. 8) experienced tighter temperature control between  $17-23^{\circ}C$  (63-73°F) in the two rooms surveyed (kitchen and living room).

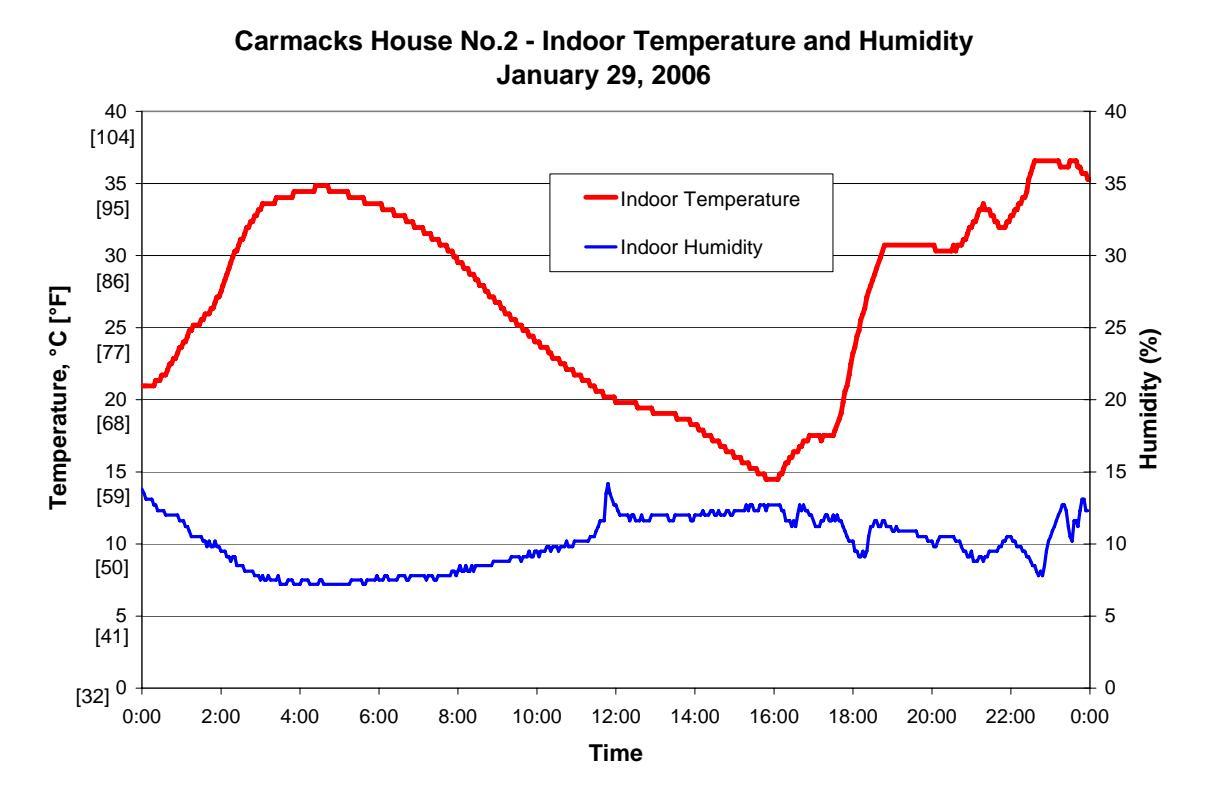
Figure 8. Indoor temperature fluctuations over a 24-hour period in January 2006 in living room of house No. 2 (with moisture problems) occupied by one person.

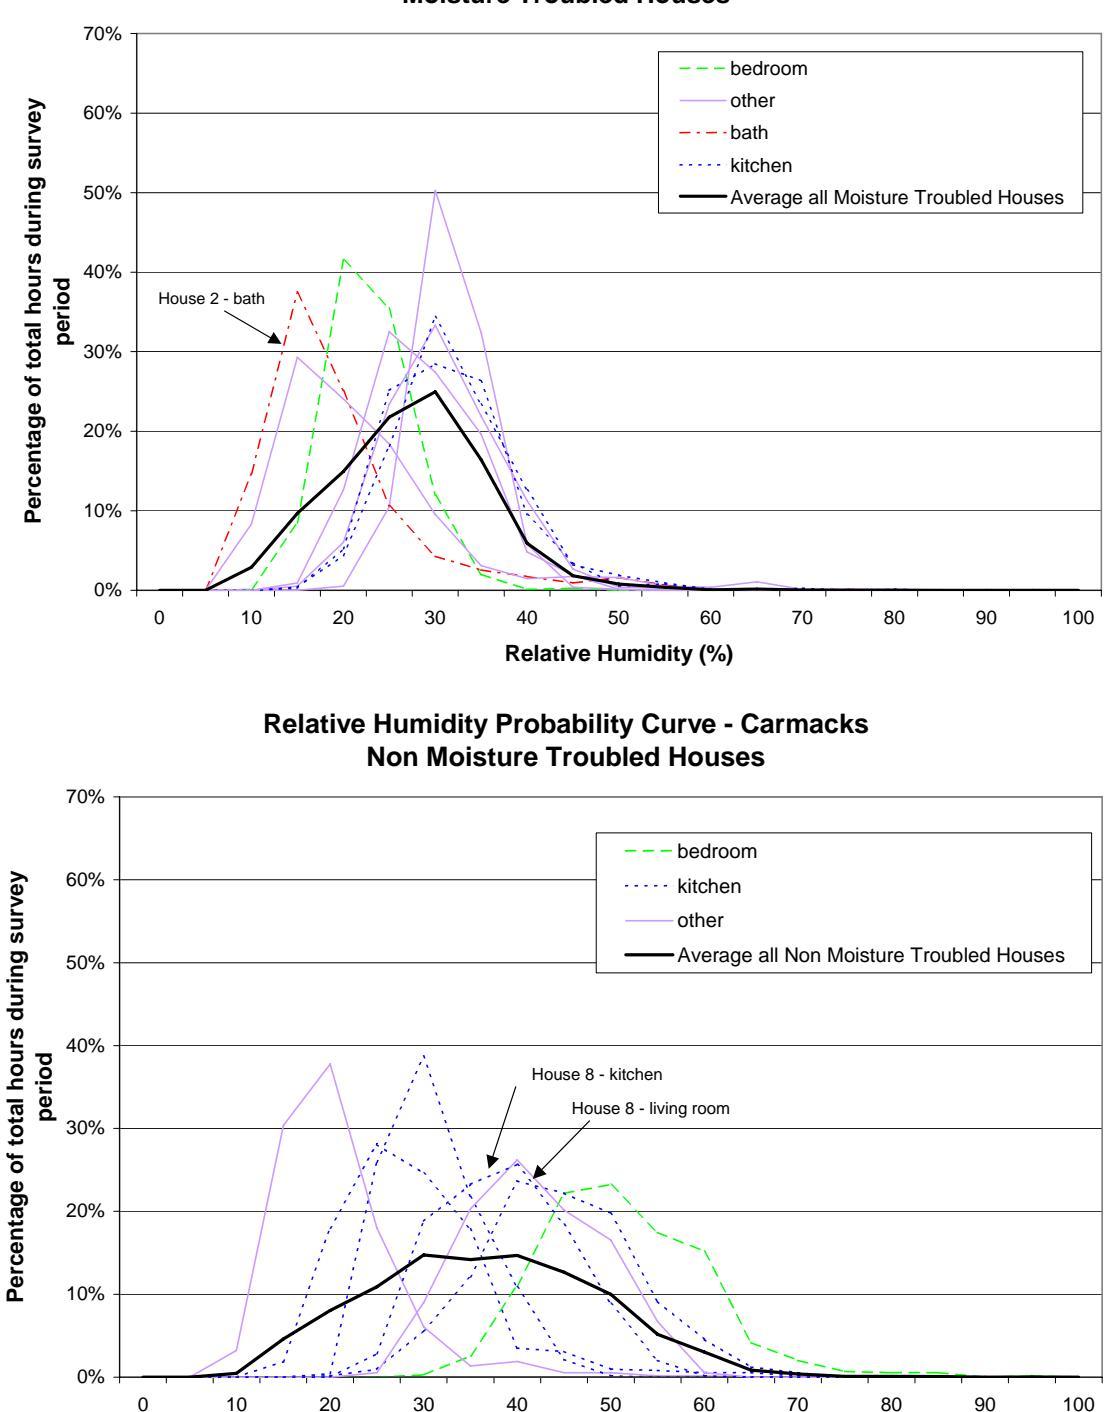
Relative Humidity Probability Curve - Carmacks Moisture Troubled Houses

Figure 9. Distribution of indoor relative humidity measurements from the Carmacks Yukon survey. The legend on the right hand side corner of the graph provides the room where the sensor was located

**Indoor Relative Humidity**. For the month of the survey the average relative humidity measured in the surveyed Carmacks YT houses was between 17% and 49% RH. Daily RH averages are plotted in Figure 9. Because indoor temperature fluctuated greatly as well, absolute moisture content in air (g/kg [lb<sub>w</sub>/lb<sub>da</sub>]) provided data on the daily changes in indoor moisture. The probability distribution curves are presented in Figure 9. The maximum fluctuation occurred in the only bathroom surveyed, in house No. 2 (Figure 10). Even though the houses were originally classified as with and without moisture problems, it became clear during the survey that most households experienced some forms of moisture problems. In many cases, the occupants regularly cleaned mould growth on the wall interior surfaces and consequently the houses were not reported as having moisture problems. Poor heat distribution and associated large temperature fluctuations combined with moisture generating activities, such as drying clothes indoors and boiling water for prolonged periods, and with poor envelope performance could have resulted in moisture problems. All houses were equipped with manually-operated exhaust fans in bathrooms and most had one such fan in the kitchen as well.

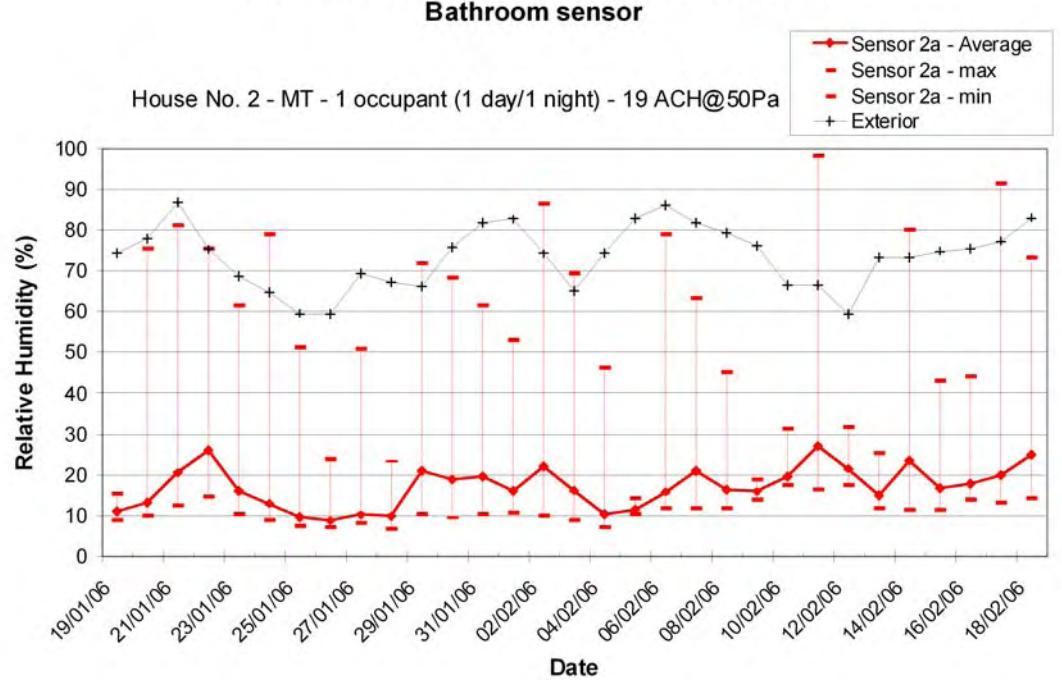
Carmacks House No. 2 - Daily Relative Humidity Bathroom sensor

Figure 10. Daily average, minimum and maximum indoor RH measurements in Bathroom of House no. 2 in the Carmacks Yukon survey

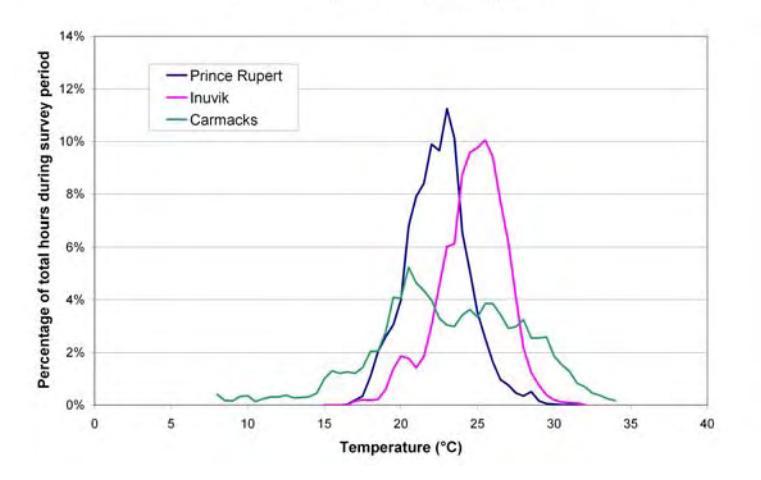
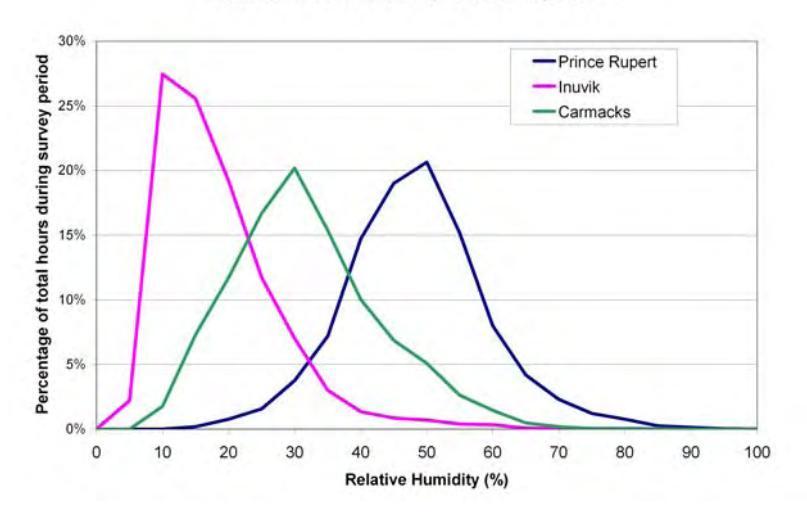
Interior Temperature - Probability Curve

Interior Relative Humidity - Probability Curve

Figure 11. Distribution curves for the hourly average indoor temperature and relative humidity measured in 2 rooms of 8 homes in three regions during the one-month survey.

Figure 11 provides a comparison of the probability of measured indoor temperature and relative humidity for the three surveys.

• The Carmacks YT surveyed houses experienced atypically poor temperature control indoors (Figure 11) due to the absence of a heat distribution system compounded by high air leakage rates through the building envelope. Average RH values in these houses were not considered excessively high (mostly below 40%) and occupancy loads were not extreme; however problems of mould growth and condensation were common. It is not surprising that these houses experienced moisture problems
