Full Length Research Paper

# Wood identification in Yıldız Palace Harem structures (19<sup>th</sup> century) in Istanbul

# Nazire Papatya Seckin

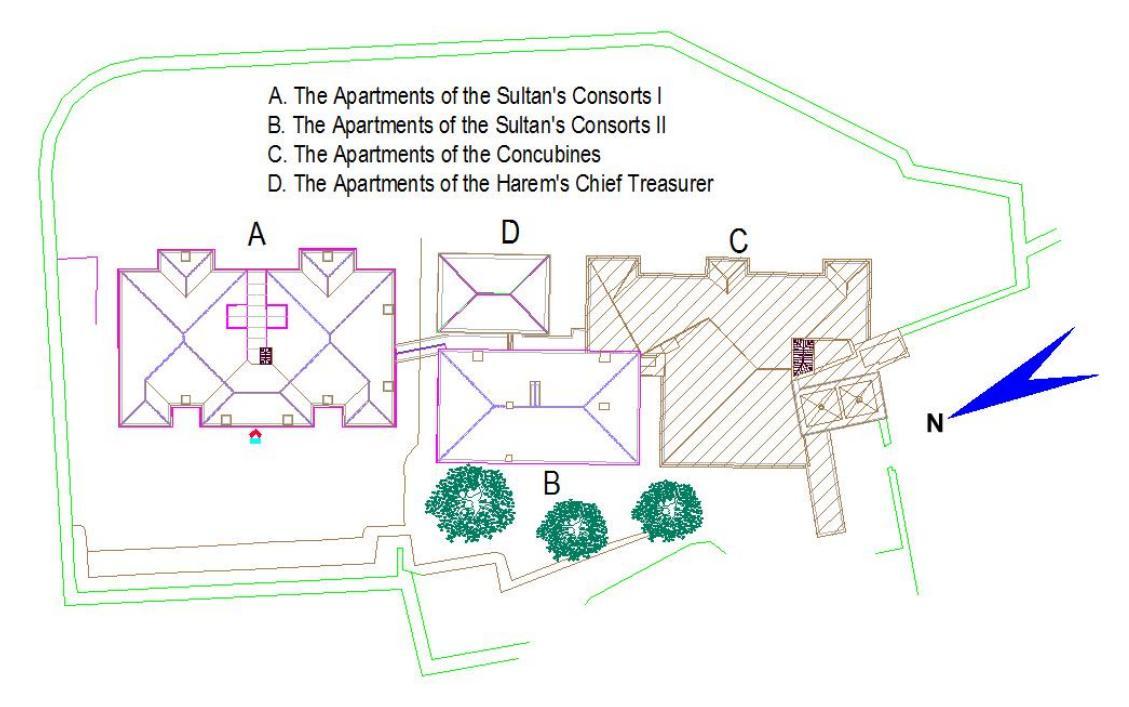
Figure 1. Site plan of the Harem Structures (İnkaya, 2009).

Yıldız Palace Harem Structures, which is the case study of this paper, are one of the important of parts of this complex. Harem Structures' construction had started in 1876 and continued with additional structures until 1906. Harem Structures are composed of five parts: the apartments of the Sultan's consort I and II, the apartments of the concubines, the apartments of the Harem's chief treasurer and the passages between apartments (Figure 1).

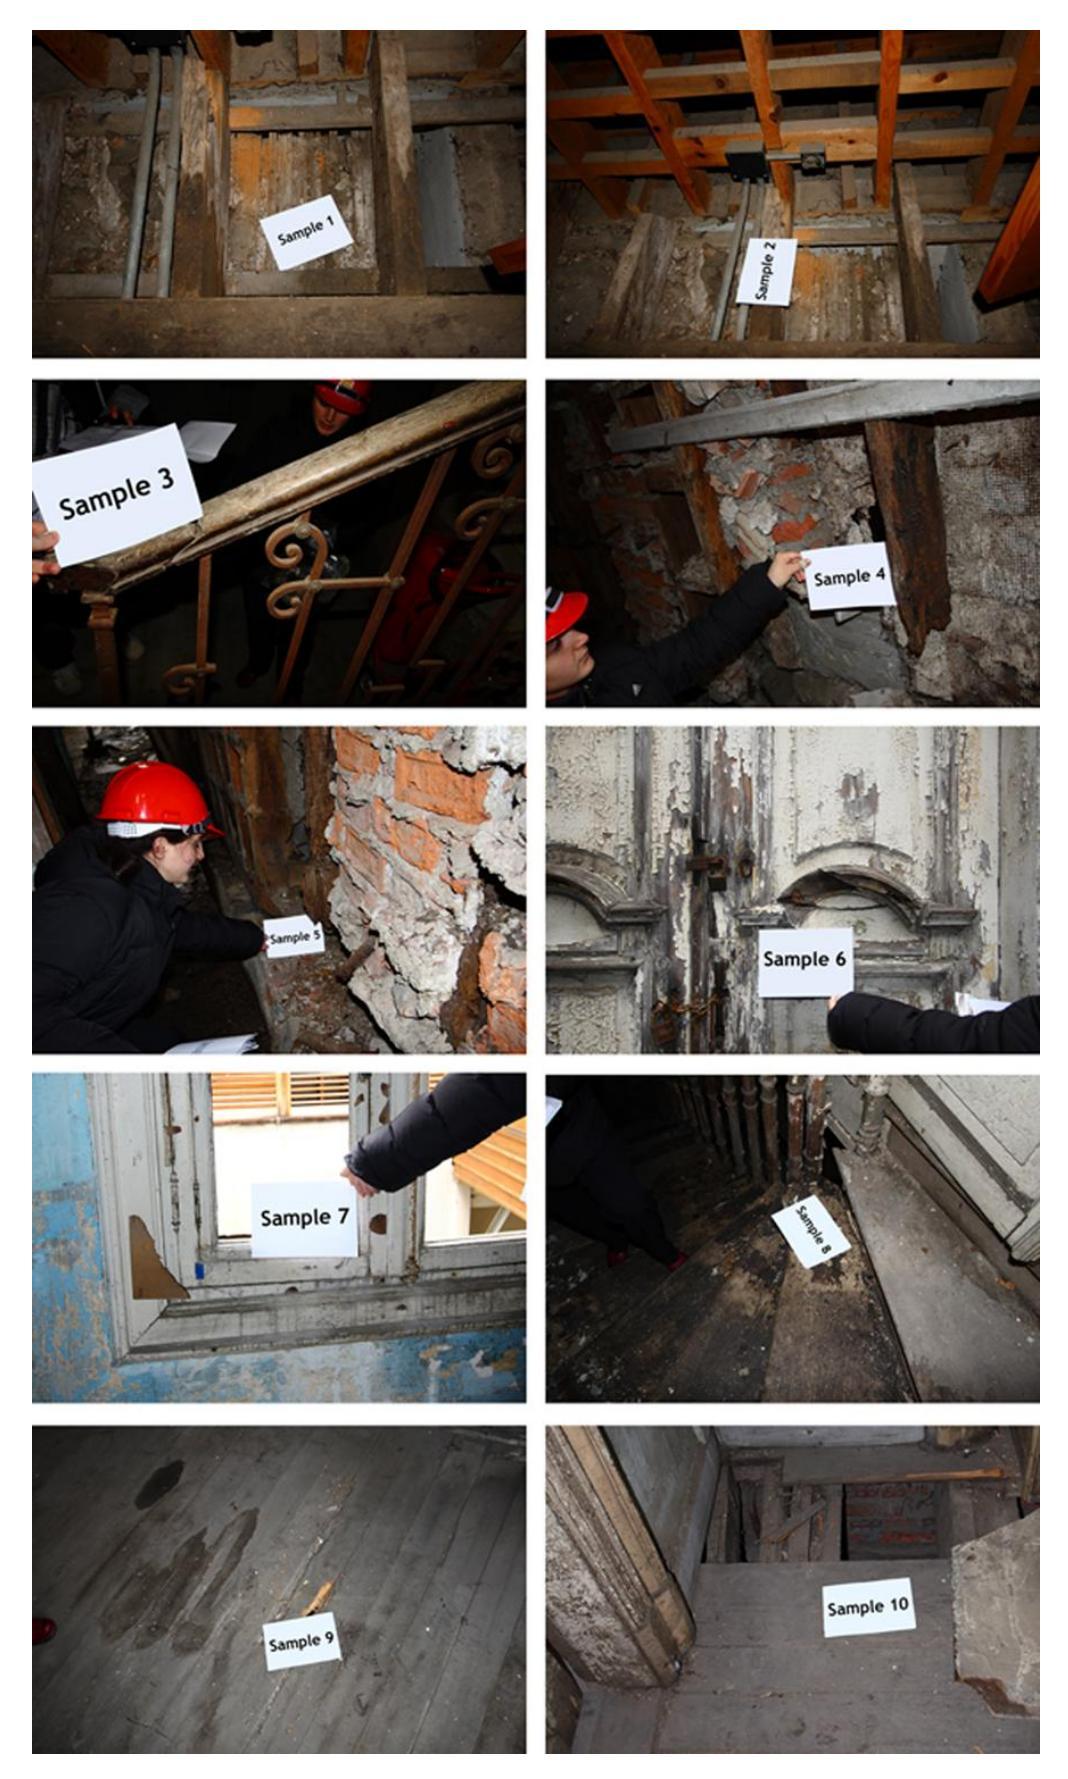
Figure 2. The locations of the samples (2011).

During this study, a total of ten wood fragments were taken from the different buildings of Harem Structures: six from the apartments of the Harem's chief treasurer, three from the apartments of the concubines and one from the apartments of the Sultan's consorts (Kudeb, 2011). Table 1 shows the elements of these buildings that samples were taken, and the locations are also indicated in Figure 2. The sizes of the fragments ranged from 1 to about 13 mm

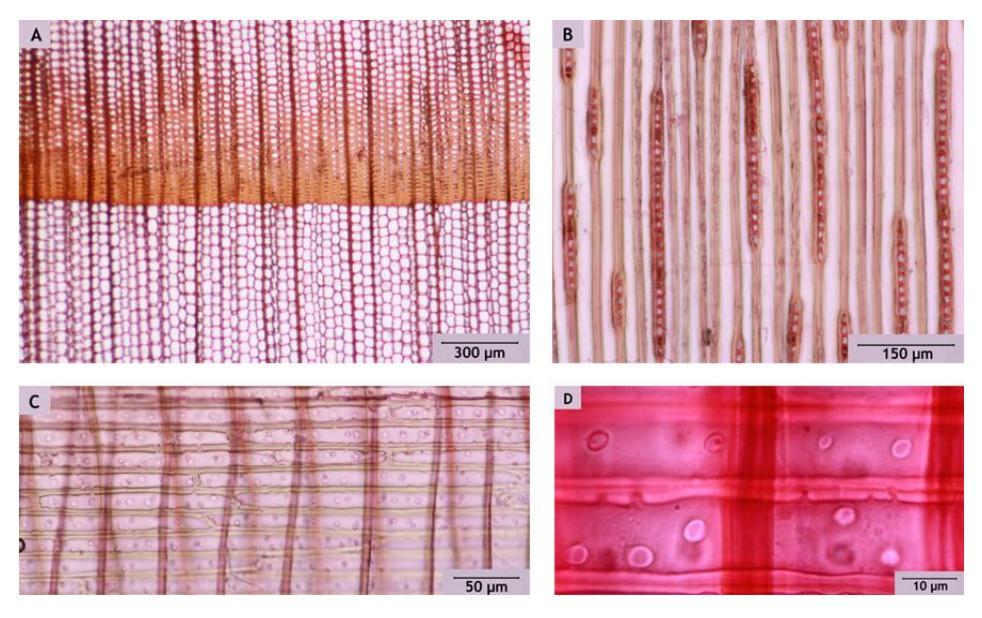
**Figure 3.** Microstructure of *Abies* sp. A, No resin canals; B, average ray height 15 to 25 (sometimes up to 60) cells; C, rays homocellular; D, taxodioid pits in earlywood rays.

Abies sp. was found in one sample (Figure 3). It was identified due to its characteristics shown in the Table 2. In addition to characteristics above, a further study was developed during which some specific researches on *Abies* sp. (Esteban et al., 2009; Özdemir, 2004) were studied and sample 2 is identified as *Abies* bornmuelleriana.

1. The joist in the first floor of the apartments of the concubines is Bornmueller's Fir (*Abies bornmuelleriana*). Fir has low resistance to shock loads and has no insect or decay resistance qualities after logging. Because of these features, the wood of most firs is considered unsuitable for general timber use, and it is onlyrecommended for indoor use. In accordance with this recommendation, the builders of the Harem structures used it interior construction of the apartments of the

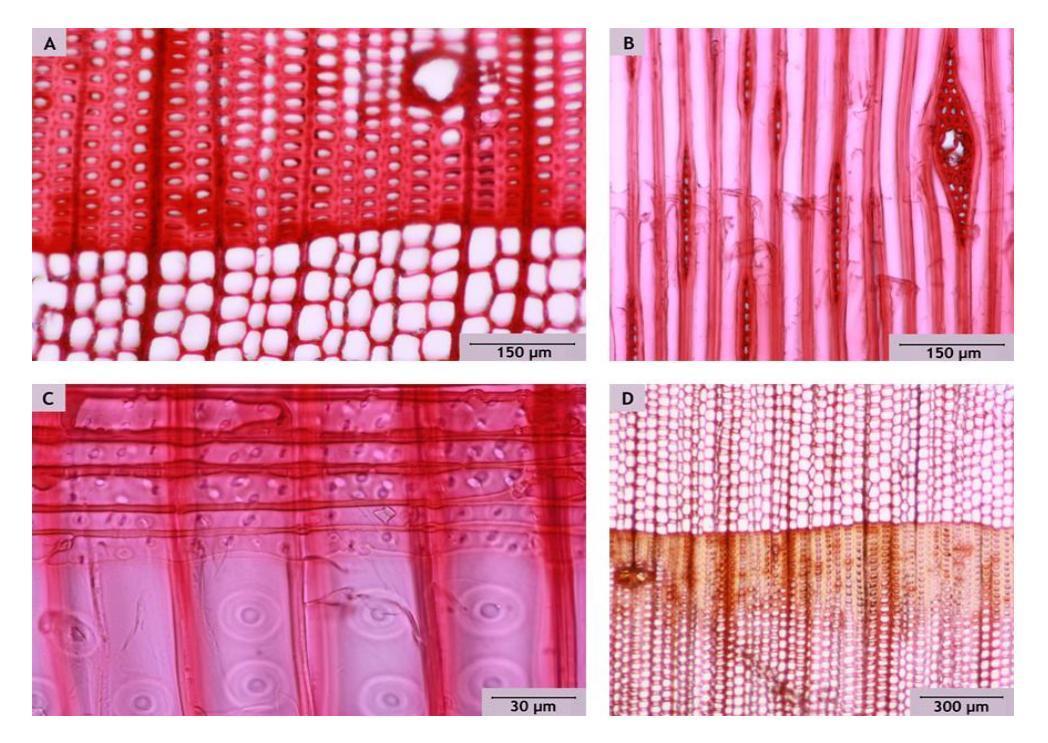
**Figure 4.** Microstructure of *Picea* sp. A, Resin canals surrounded (bordered) by 8 to 12 rather thick-walled epithelial cells; B, resin canals with thick-walled epithelial cells; C, rays hetero-cellular and ray tracheids present, with smooth walls; D, early-latewood transition is gradual.

The features at Table 3 were observed in sample 10, and with these characteristics, it is identified as *Picea* sp. (Figure 4). The *Picea* sp. cannot be distinguished from each other on the basis of their wood anatomy.

2. The floor covering in the first floor of the apartments of the Sultan's consorts is spruce (*Picea* sp.). Spruce has

low stiffness, medium crushing and bending strength. It works easily with hand tools, and it is very suitable material for floor covering, woodworking and interior

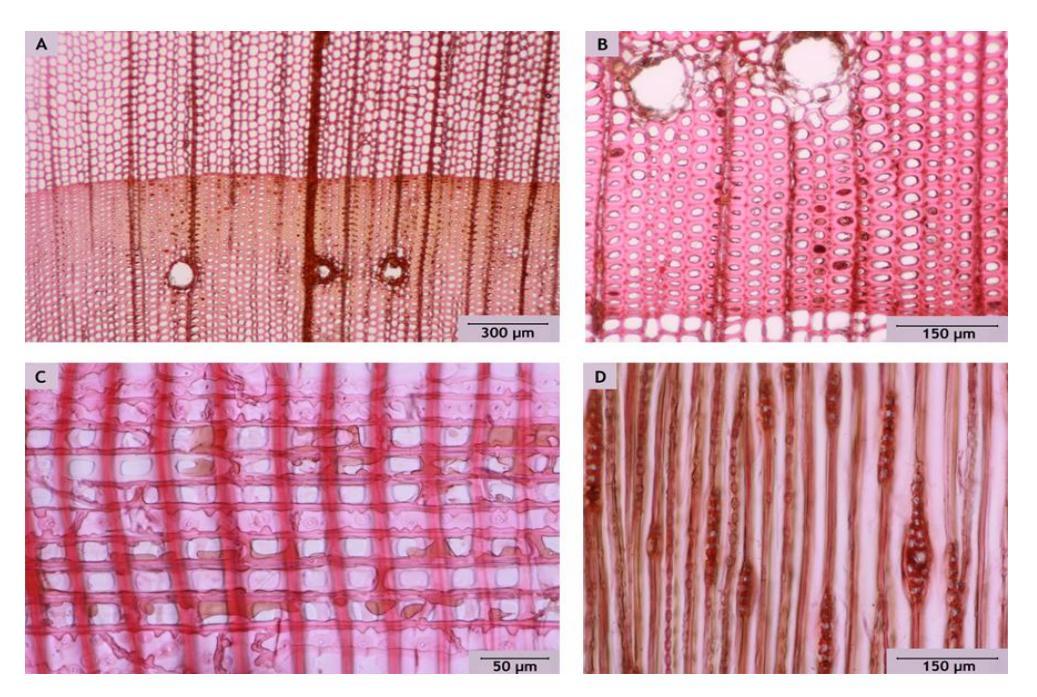
**Figure 5.** Microstructure of *Pinus* sp. A, Resin canals mostly located in latewood; B, resin canals are large with thin-walled epithelial cells; C, raytracheids with dentated walls and large fenestriform (window-like) pits; D, rays with resin canals.

*Pinus sylvestris* were found in four samples (Figure 5). Each was identified by its characteristics illustrated in the Table 4.

3. The floor covering and the sash in the first floor of the apartments of the Harem's chief treasurer, the entrance door of same building and the lath taken from the first floor of the apartments of the concubines are yellow pine (*Pinus slyvestris*). Pine has low resistance to shock loads, low stiffness and low to medium bending and

crushing strength. Due to its low stiffness, it works well with hand tools. With this feature, it is a very suitable material for jointing and carpentry, as it was used in Harem Structures.

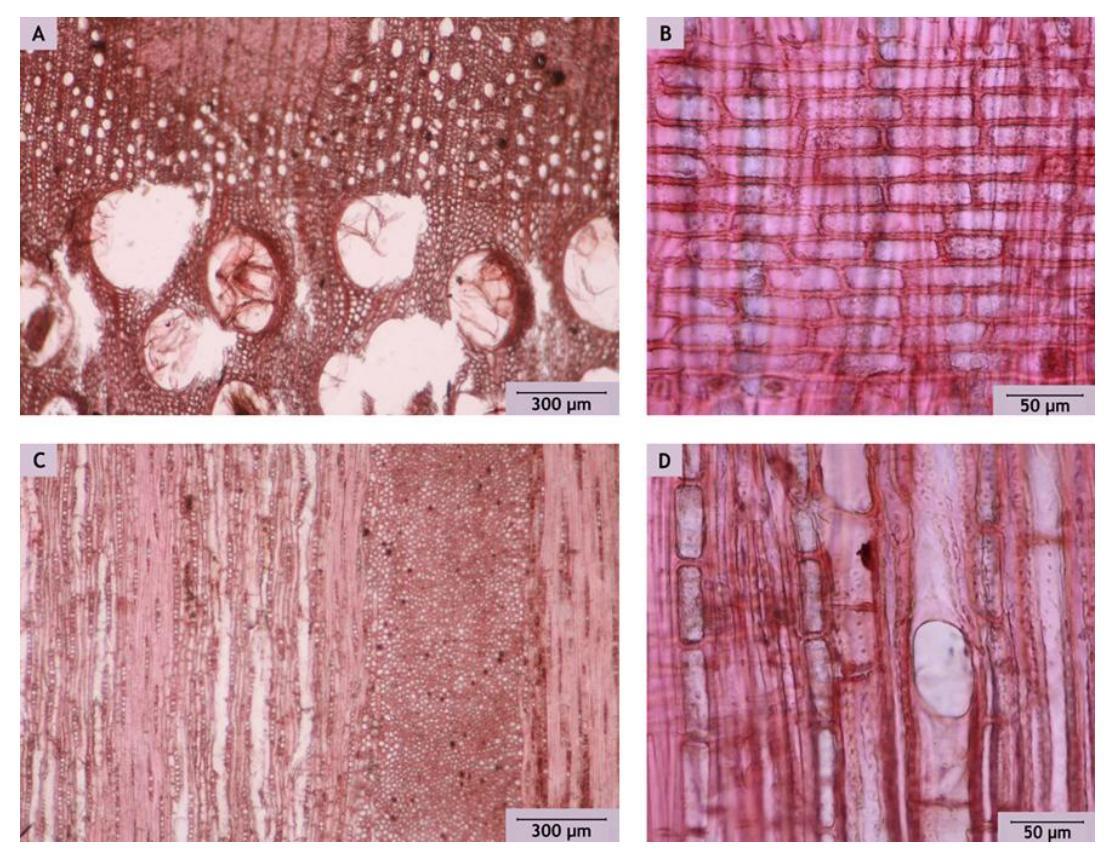
**Figure 6.** Microstructure of *Quercus* sp. A, Tyloses in earlywood vessels is common; B, procumbent ray cells; C, rays of two distinct sizes; D, simple perforation plates.

Three samples were identified as *Quercus* sp. (Figure 6) based on its key characteristics illustrated in the Table 5. Samples 3, 4 and 5 were identified as white oak group.

4. The stud and the belt at the façade of the apartments of the Harem's chief treasurer, and the stair handrail in the ground floor of the apartments of the concubines are oak (*Quercus* sp.). They all belong to white oak group. Oak isa fairly hard, heavy and dense material, with high crushing and bending strength, low stiffness and resistance to shock loads. With these properties, it is suitable to use in wood construction and carpentry.

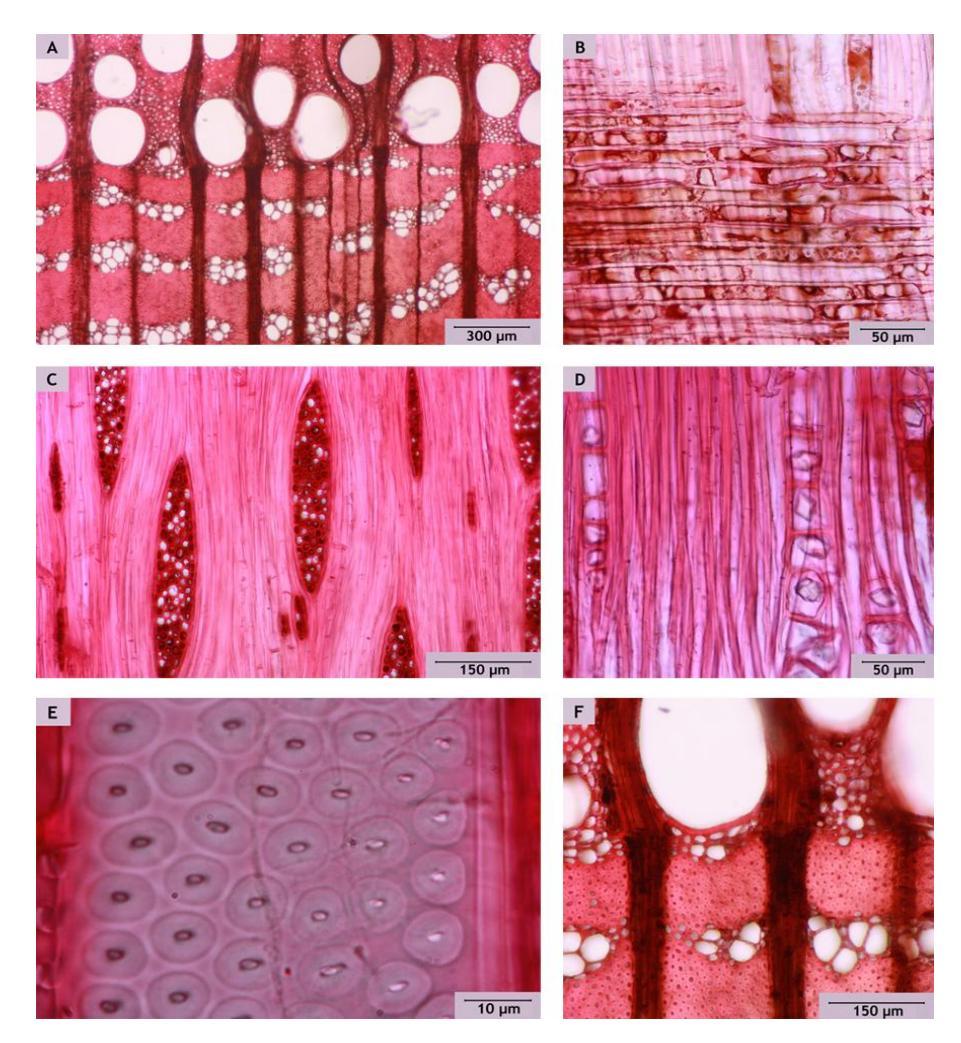
**Figure 7.** Microstructure of *Ulmus* sp. A, Vessels in tangential bands; B, procumbent ray cells; C, rays of two distinct sizes; D, prismatic crystals present; E, alternate intervessel pits; F, thick-walled ground tissue.

Ulmus sp. was found in one sample (Figure 7). It was

identified based on its features shown in the Table 6. In addition to characteristics above, a further study was developed. During this study, some specific researches on *Ulmus* sp. (Wiegrefe et al., 1994; Merev, 2003; Wheeler and Manchester, 2007) were studied and sample 8 is identified as Ulmus glabra.

5. The stair flooring in the first floor of the apartments of the Harem's chief treasurer is wychelm (*Ulmus glabra*). Elm is quiet heavy and dense wood, with a fairly high bending and crushing strength and medium hardness. It generally works well with hand tools and it is typically preferred in making furniture, veneering and flooring as it is in Harem Structures.
