COMMUNITY HEALTH EFFECTS RELATED TO EXPOSURES FROM CREOSOTE AND/OR CCA WOOD TREATMENT PLANTS

Dr. A. P. Ryan

Department of Occupational and Environmental Health

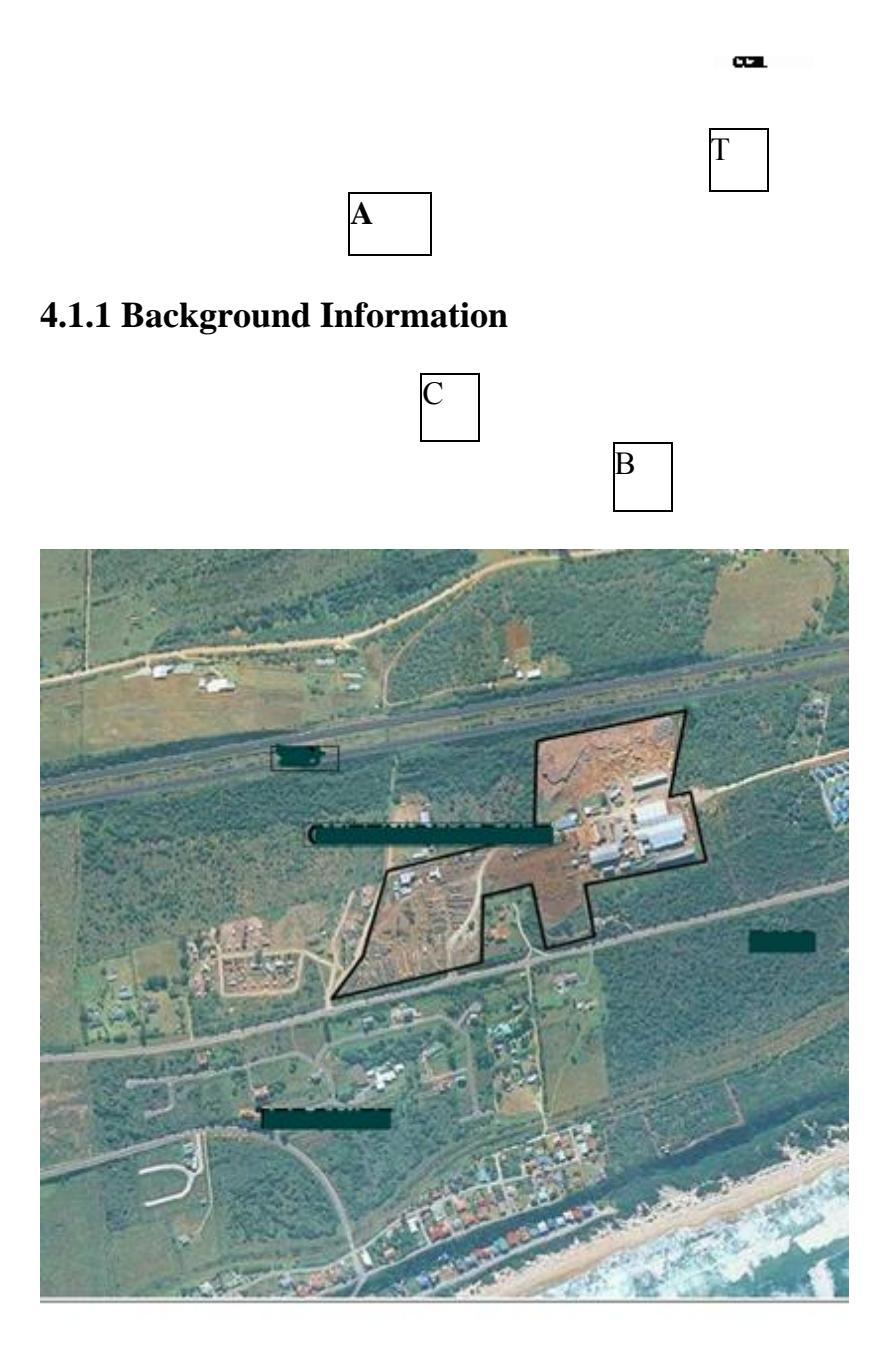
Fig 1 : Layout of the treatment plant

The treatment plant (T) is shown in figure 1 above. It is situated in a coastal area, between a large national highway to the north (A), an up-market seaside holiday and residential area to the south (B), separated from the plant by a secondary road, and a lower-income community to the west (C). The CCA and creosote treatment areas are located towards the eastern and western ends of the site respectively, as shown, with intervening land used for stockyards of treated wood, bark stripping and sawing areas and, in the southeastern corner, currently unused buildings.

The treatment areas are several hundred metres apart, as shown in Fig 1. The creosote treatment area consists of cylinders and storage tanks housed under corrugated iron roofing. Immediately adjacent, to the south, is a building housing the site managers' offices and eating and washing areas for staff, and to the west, the boiler. The CCA treatment plant is smaller, with a single cylinder and storage tank, and is less conspicuous from the road. There was extensive coating and pooling of creosote in and around the creosote plant area, and some pooling of CCA near the CCA treatment cylinder.
