#### FAILURES IN TRADITIONALLY CONSTRUCTED DOMESTIC CHIMNEYS

FRANK G. McCLOSKEY, MSc RIBA Research & Development Northern Ireland Housing Executive Carlton House, Shaftesbury Square, Belfast, BT2 7LH

The following paper sets out the conclusions reached by the Northern Ireland Housing Executive for the large scale failure of traditionally constructed domestic chimneys in their housing stock, with an account of the unsuccessful and successful remedial action which has been taken.

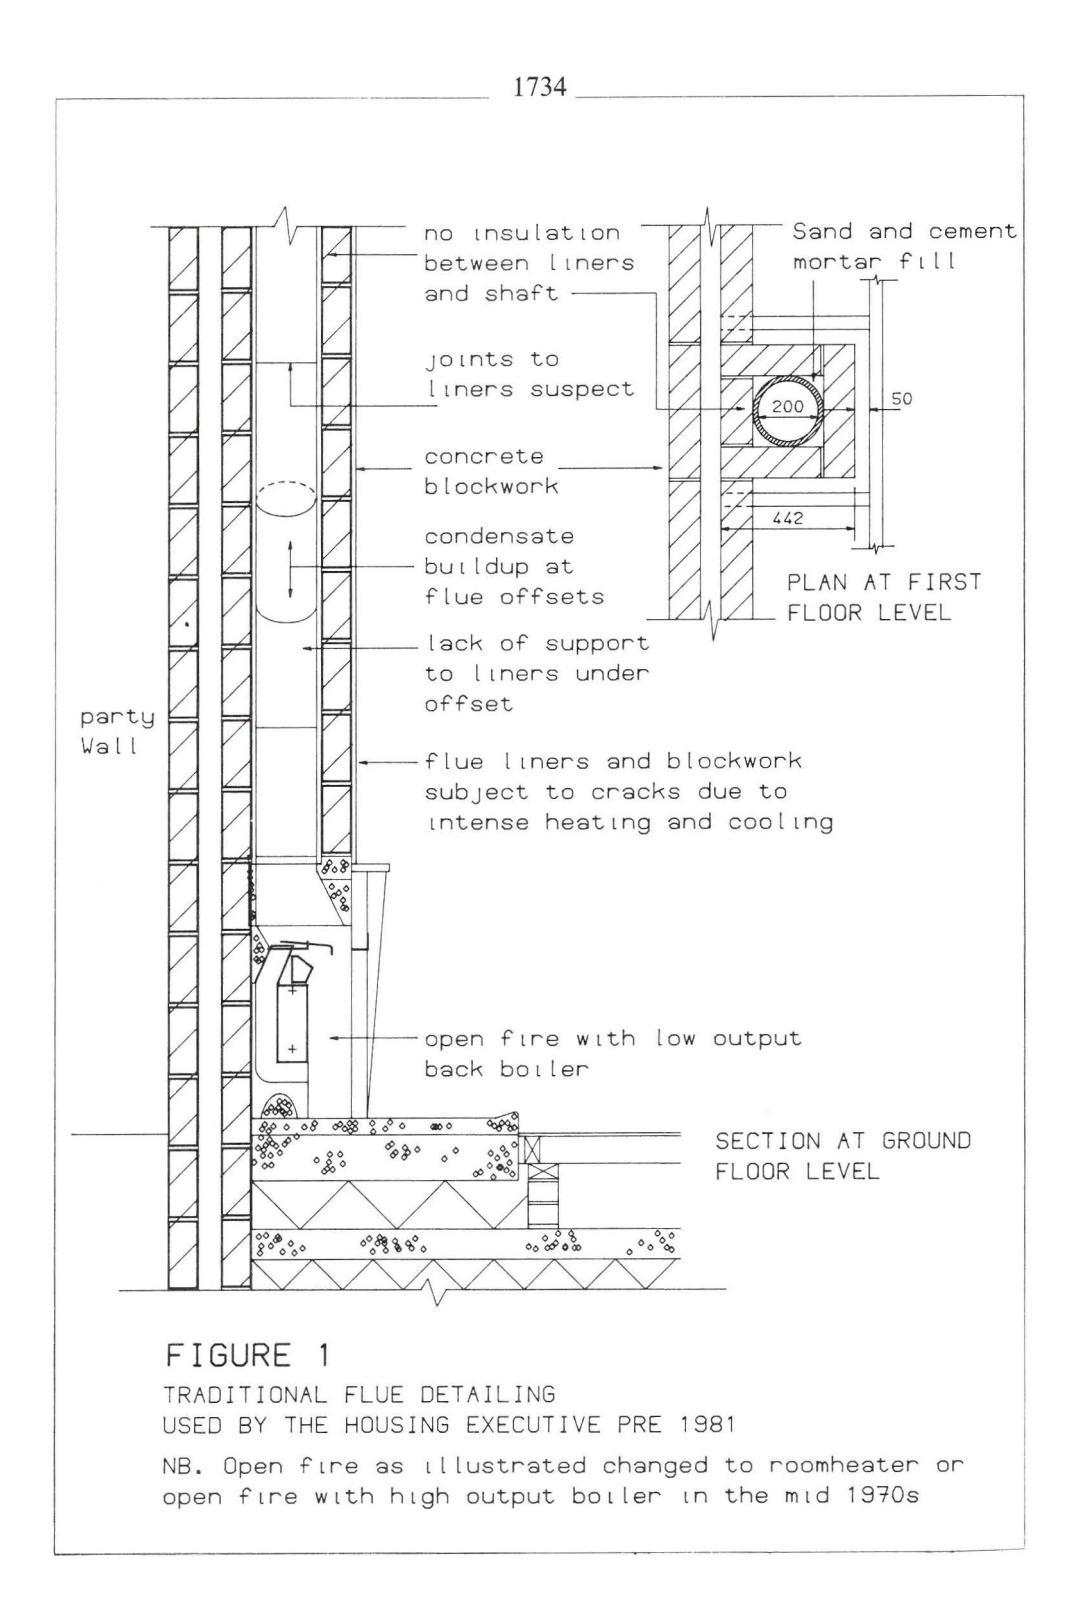
Although all of the older types of chimneys were subject to the failures, it is considered sufficient to discuss the failures in the context of the chimney detailing which was common practice from the early 1960s as illustrated in Figure 1. A 200mm internal diameter fireclay flue liner which had a 240mm external diameter was built into a block shaft with 240 x 240mm internal dimensions; it was a tight fit.

The temperatures created by the roomheaters were far in excess of those which the flues could withstand. The flues were not insulated and there was no room for expansion. When the appliance was not in use the shaft cooled down very quickly. The intense heating and cooling caused the fireclay liners to crack. Cold air leaking into the flue in various places caused the smokeless fuel gases to condense. The condensates forming on the surface of the flue decreased its effective diameter and the acids in the condensates attacked the walls of the flue. As tenants rarely if ever seemed to clean their chimneys, the result of all this was blocked flues and its blocked flues which cause fatalities.

The fact that workmanship on the building sites seemed to be deteriorating all the time did not help matters. The joints of the fireclay liners were not lined up properly. The liners were often cut so advantage was not taken of the rebated or socketed joints. There were voids everywhere but particularly around offsets and anything that happened to be lying around the building site seemed to be used as fill between the liners and the blockwork shaft. Chimney construction is extremely difficult to supervise properly and even when it seemed correct, very often the perpendicular joints in the brickwork were not filled with mortar so air leaks were built in from the beginning.

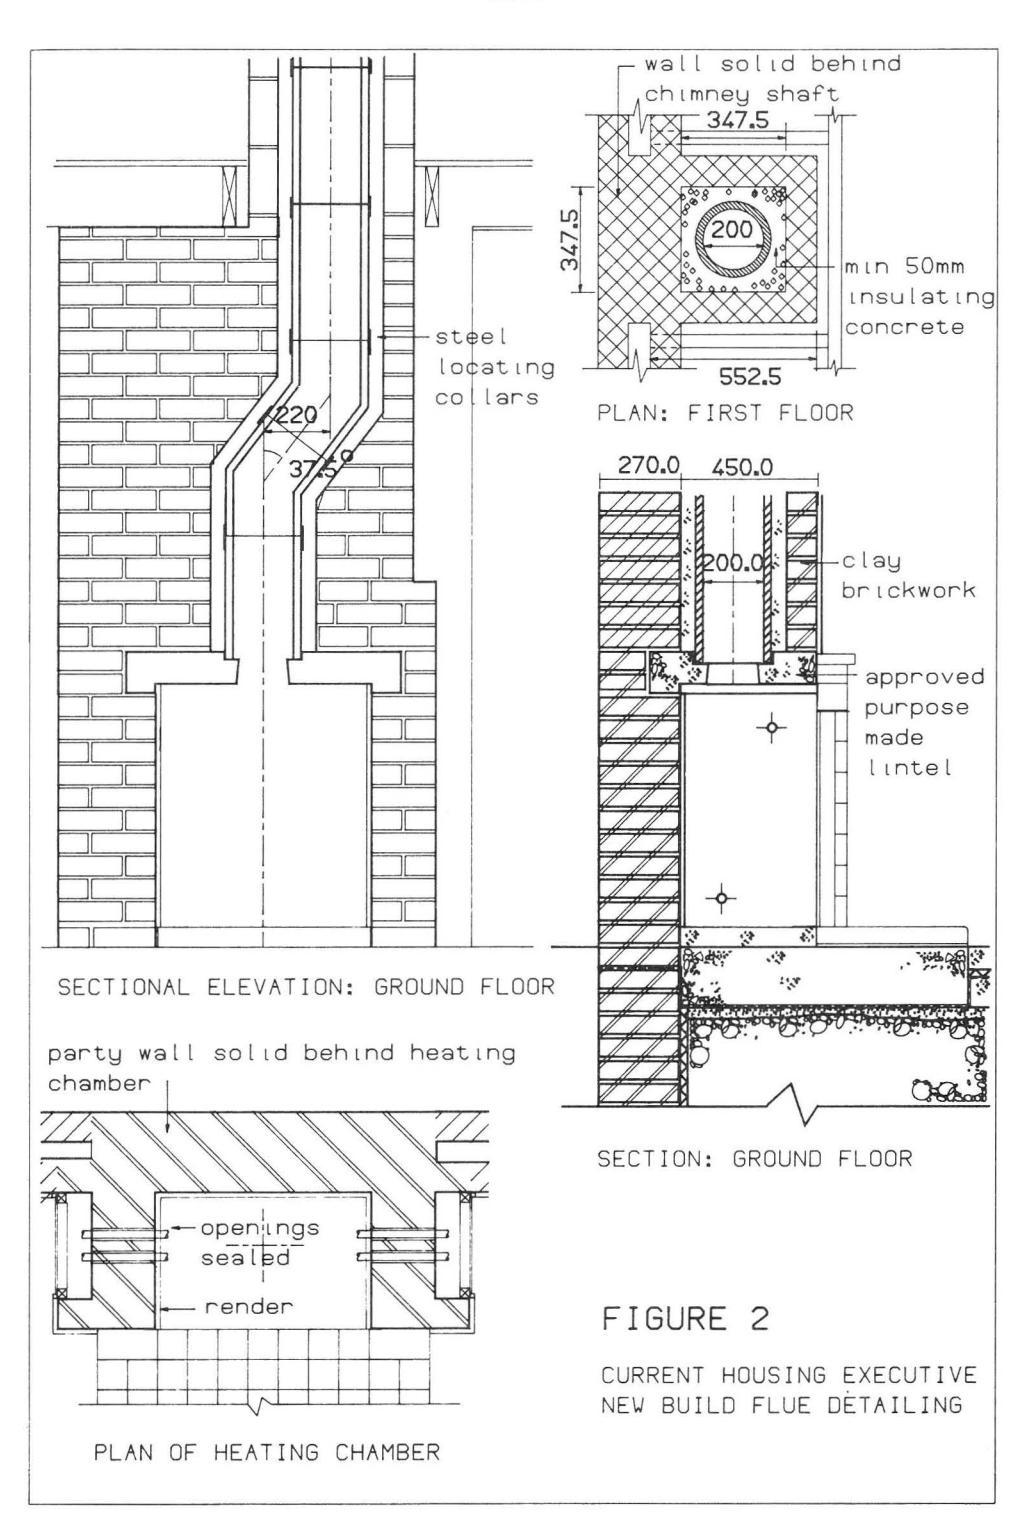
The Housing Executive changed their traditional chimney detailing in the early 1980s to make it satisfactory for both roomheaters and open fires with high output back boilers. Since that time several revisions have been made as a result of site experience and performance in use. The current detailing is illustrated in Figure 2. It may be useful to draw particular attention to the following points:

- The recess of the heating appliance is rendered as it is often built shoddily and can leak. The openings for circulatory pipes are well sealed.
- Although it is Executive practice to have cavities in party walls, the wall is now always solid behind the heating chamber and the chimney shaft except in gable wall situations.

- 3. The chimney breast up to ground floor ceiling level is built in clay brickwork which withstands more heat than concrete blockwork and is less likely to crack.

- 4. In line with the recommendations in BS 6461 : Part 1 : 1984 [2] straight flues are used whenever possible. When the plan arrangement inside a house so dictates, an offset is introduced; an angle of  $37\frac{1}{2}^{\circ}$  from the vertical has been found to be the optimum in respect of brickwork detailing, level of frictional resistance to flow of fuel gases and ease of cleaning. It should be noted that in a very high percentage of the flue failures, the initial breakdown has been at the offset.

- 5. The minimum internal dimensions of any flue shaft is now 1<sup>1</sup>/<sub>2</sub> bricks x 1<sup>1</sup>/<sub>2</sub> bricks. As 200mm internal diameter flue liners are used, this gives a minimum thickness of 50mm of insulation between the external surface of the liner and flue shaft.

- All rebated or butt jointed liners, regardless of material type, require a galvanised steel locating collar at each joint.

- 7. Brickwork corbelling detailing in the roofspace must comform to good building practice and the external surface of the chimney shaft in the roofspace must be rendered. The second largest percentage of failures have occured because of breakdown of flues in this area.

- 8. It is essential that damp proof courses and lead flashings to the chimney stack are effective. If the insulating material around the flue liners becomes damp, the chilling effect causes large quantities of condensates to form inside the flue in a very short time.

- Before fitting the coping and chimney pot, 75mm of waterproof mortar must be used to seal the top of the insulating void fill.
- 10. The Housing Executive only use approved concrete components, purpose made to their requirements, e.g. lintels over roomheaters, throating blocks for open fires and chimney copings. In respect of the earlier points about preventing rainwater from penetrating the insulation material, it is important that concrete copings have rebated circular openings to receive chimney pots which are then pointed and flaunched in waterproof mortar with a bonding agent.
