Norwegian Wood: A Case Study of Stave Churches

Submitted in Partial Fulfillment of the Requirements for the Degree of Master of Architecture at the Massachusetts Institute of Technology February 1982

This thesis addresses the question: How did the medieval Norwegians meet the challenges entailed in designing a small wooden building (e.g., resisting snow and wind loads, detailing wood connections), <u>and</u> create an architectural masterpiece?

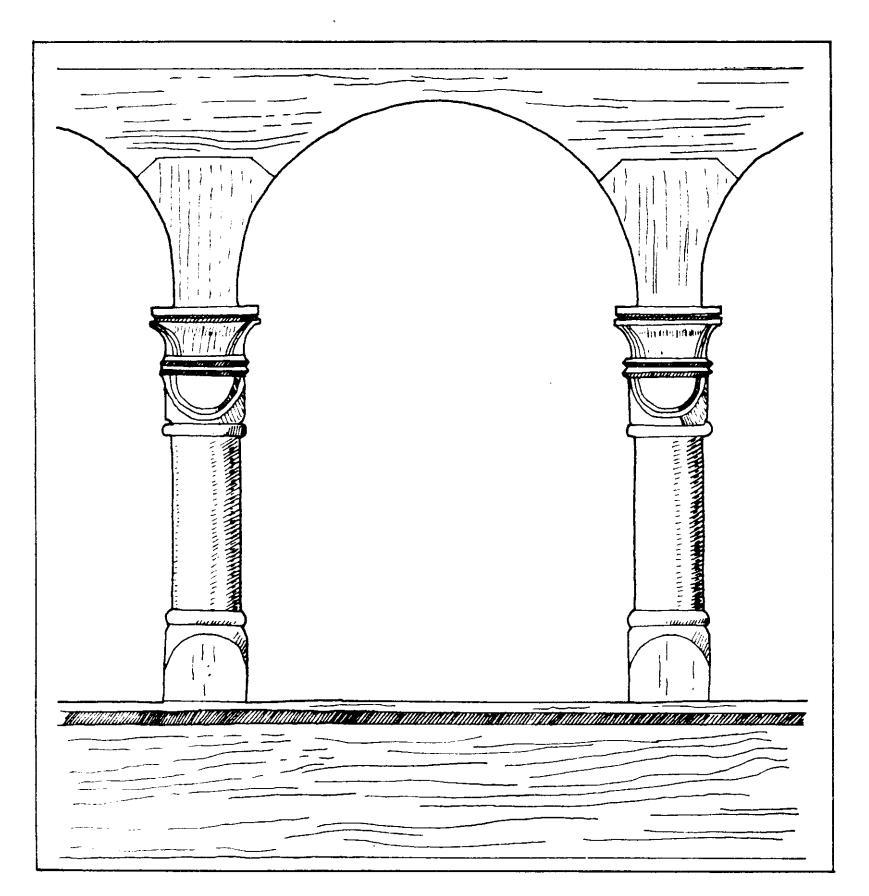
This drawing is of the arcade that surrounds the Gol Stave Church near Oslo. The scale is one-eighth actual size. The cube capitals and bases of the wooden columns bear a strong resemblance to Norman stone architecture built in England and France during the Middle Ages.

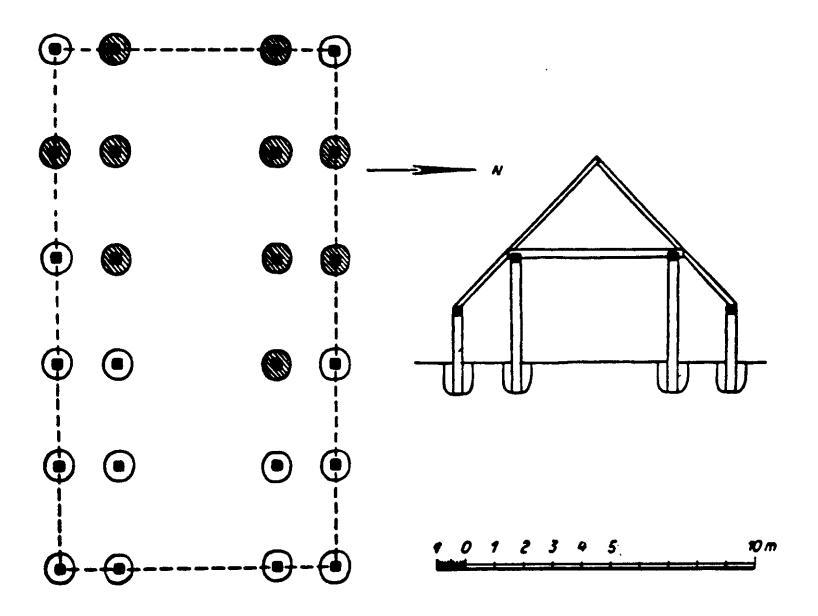
A Carolingian timber church unearthed at Breberen (near Aachen) Germany can be attributed to the eighth or ninth century by pottery shards and other accessories.

architecture. What was unearthed at the excavation in Breberen, Germany, was a Carolingian timber church. Judging from the post holes that remain, it is clear that the church had a central nave and side aisles. Pottery shards and other accessories discovered at the site led archeologists to believe that the church was from the eighth or ninth century. With this new evidence Hauglid's argument began to weaken, since the bay and aisle plan common to both the stave and Romanesque churches was observed in a timber church that predates both traditions.

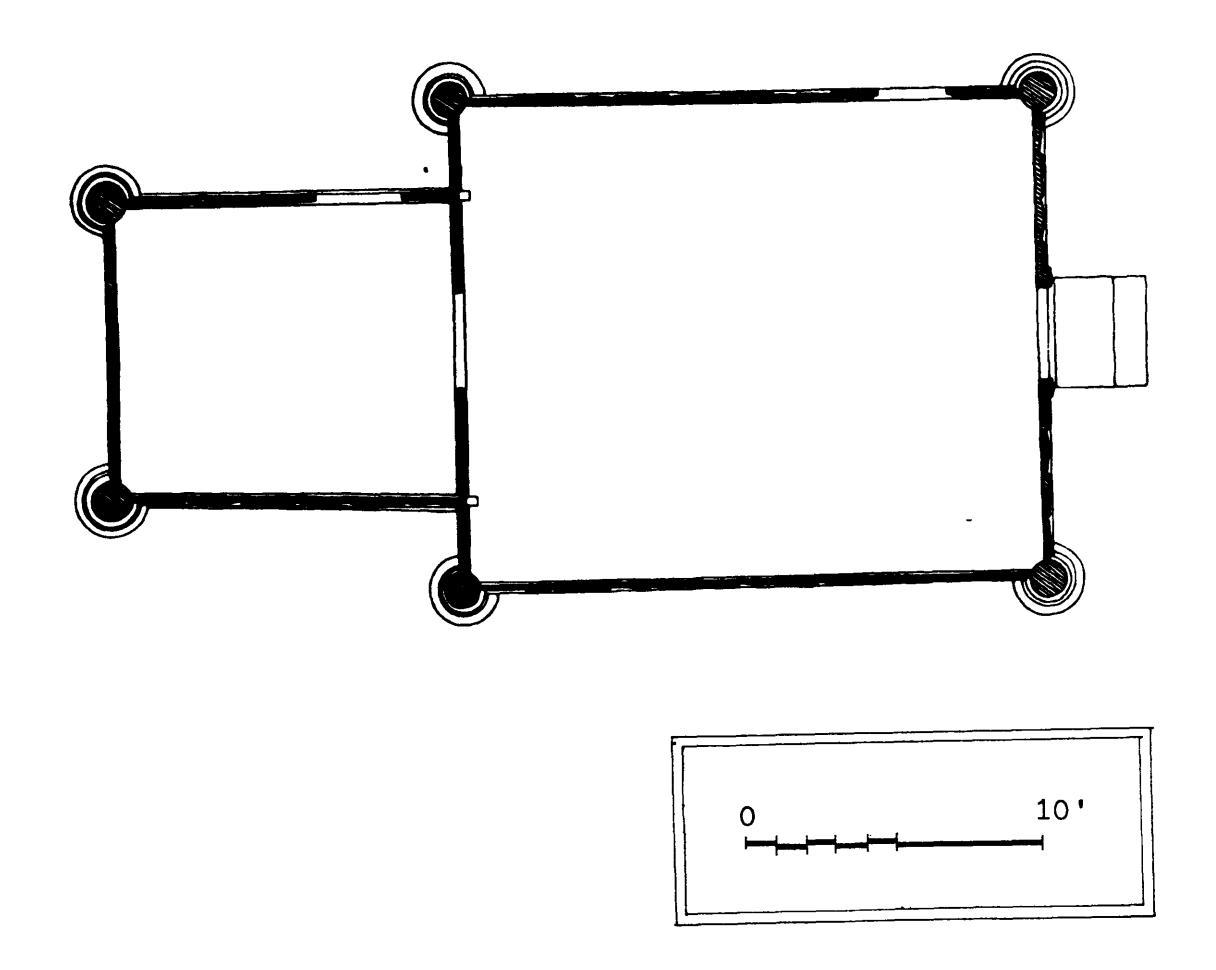
The Holtdalen Stave Church

The stave church at Holtdalen is one of the oldest and simplest of all the stave churches. No one knows its exact age, but many experts believe it was built in about the year 1100. The larger room, the nave, measures fifteen feet by nineteen feet. The smaller room, the chancel, is nine feet by eleven feet. The main entrance is on the west wall (on the right hand side of the page). There are two other entrances, both on the south side of the building (on the top of the page). A distinguishing feature of this building is the round wooden globe at the base of each of the corner columns.

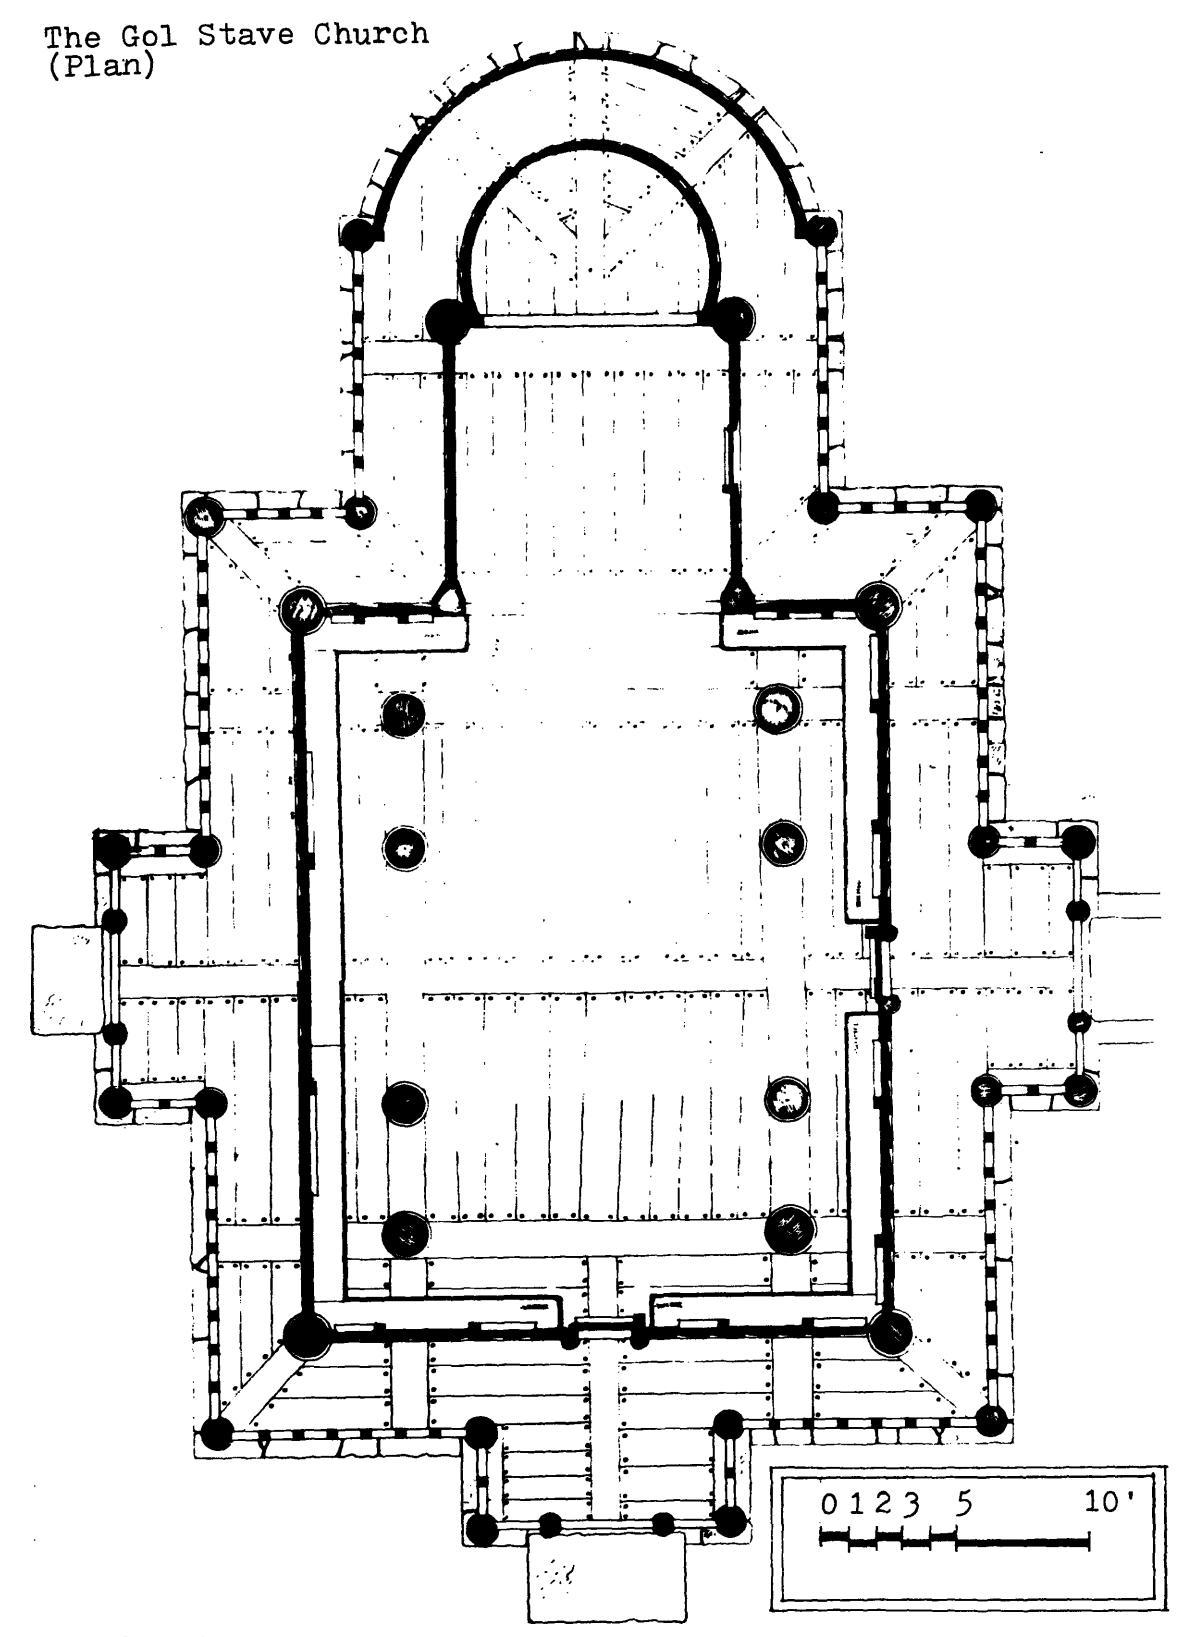
With its free-standing columns, a complete ambulatory and a semi-circular apse, the Gol Church represents one of the final stages of stave development.

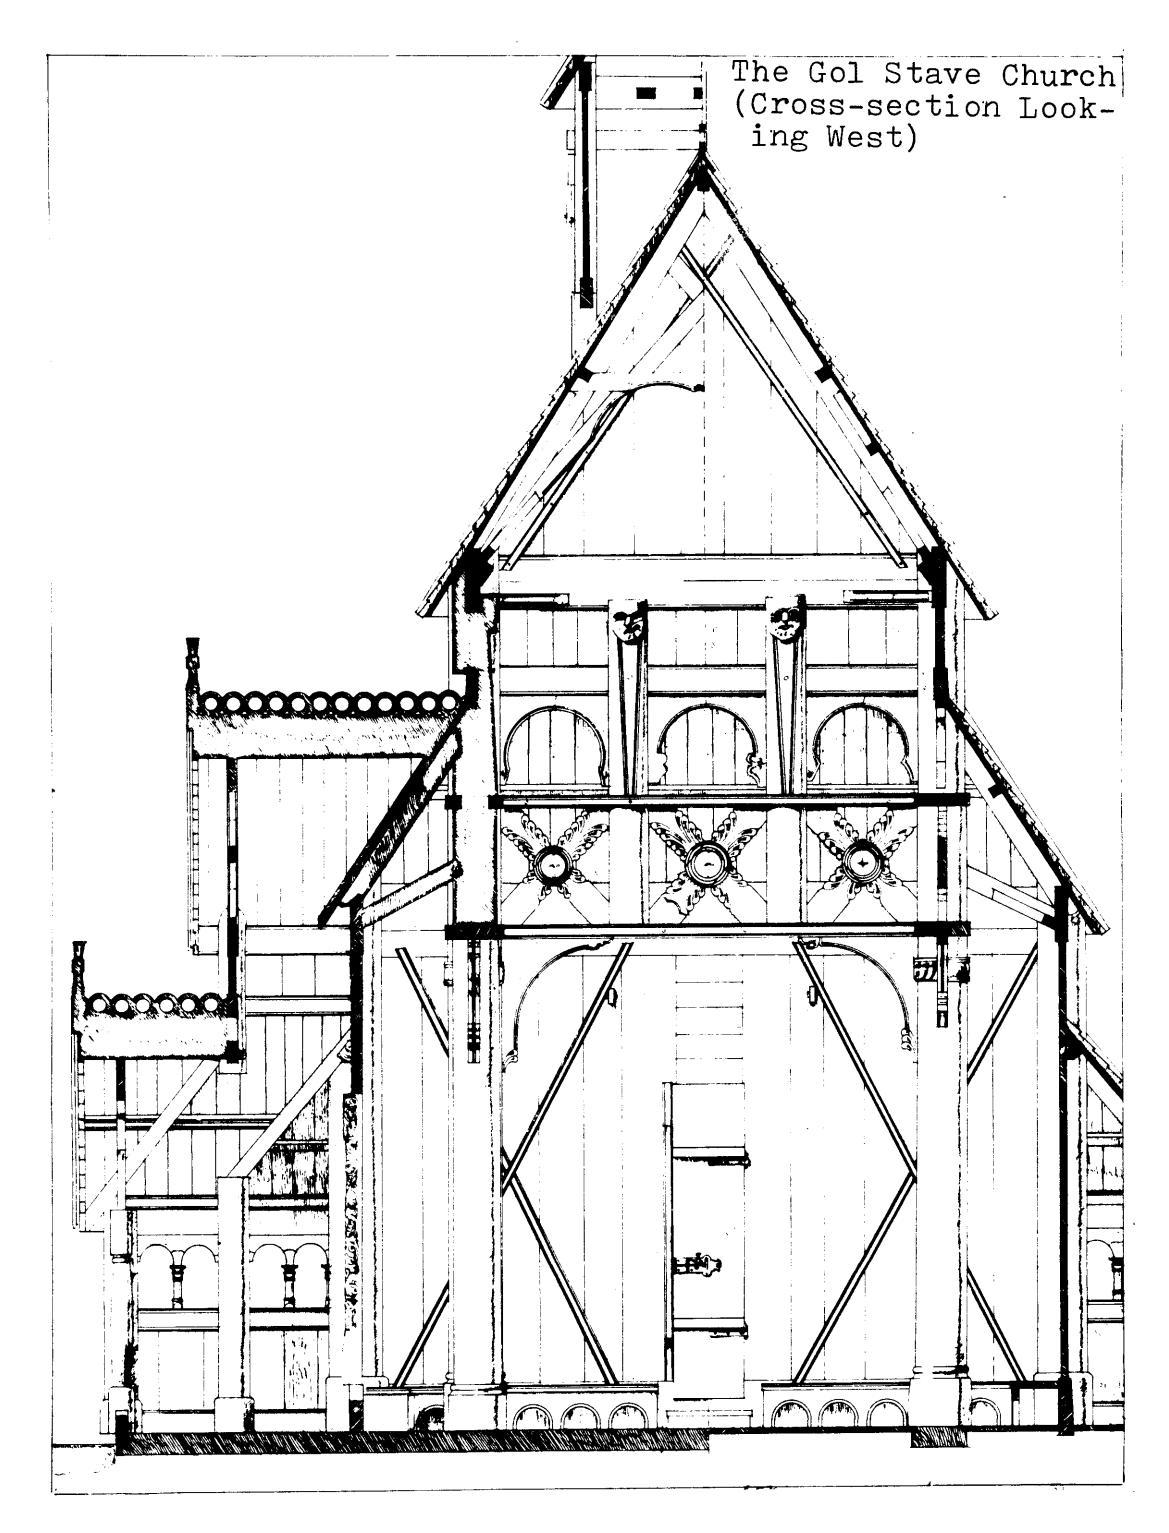
The stave designers had come a long way from Holtdalen by the time they designed the Gol Stave Church, and they exhibited a marked talent for engineering in wood. By developing a very elaborate bracing system that transferred loads to the corner columns, the designers were able to terminate the middle columns before they reached the floor, thereby freeing-up extra space for the nave.

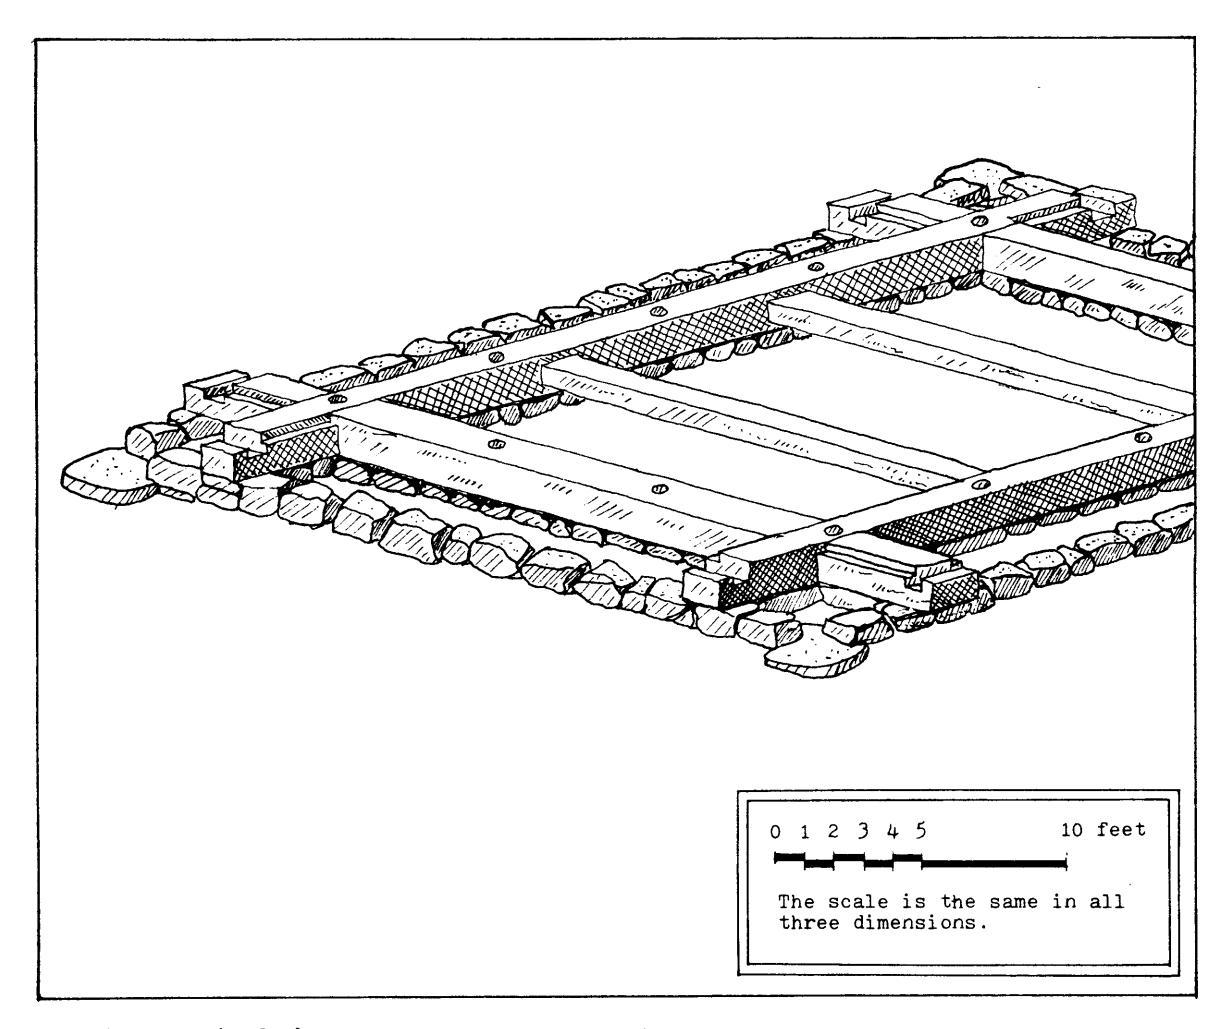
THE STONE FOUNDATION AND THE PRIMARY SILL

Connected in the form of a tic-tac-toe grid, the four primary sills are raised above the ground and protected against the detrimental effects of the soil's humidity.

The construction of the Torpo stave church began with the foundation, the only major portion of the building that is not made from wood. The short foundation walls are made from roughly cut or uncut stones gathered from nearby fields. No mortar was used to hold the stones together, and no metal ties have been found anchoring the sills to the foundation.

Aligned along an east/west axis, the foundation resembles a tic-tac-toe grid inside a larger rectangle. This shape corresponds directly to the wooden structure it supports. The foundation not only provides a continuous support for the sills (which eases the transfer of the building's weight into the earth), but it also raises the wooden members above the ground, thereby avoiding the harmful effects of the soil's humidity.

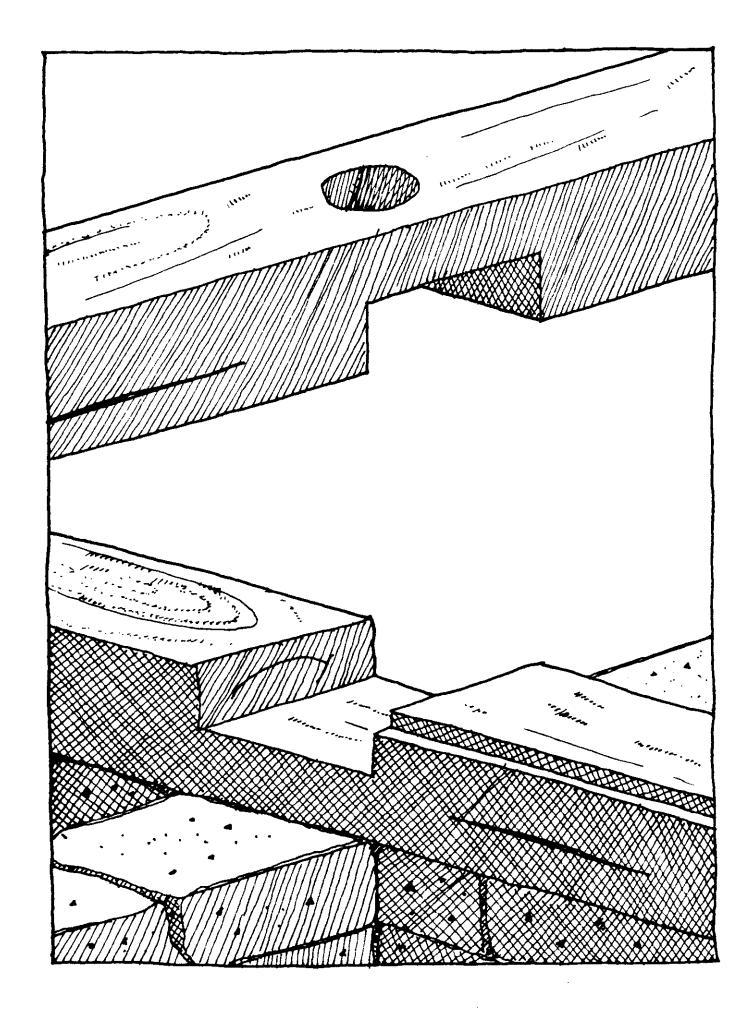
The primary sills are attached together with a half-lap joint that prevents either member from slipping out of position. The round hole cut into the top of the sill is designed to hold one of the free standing columns, which is inserted later.

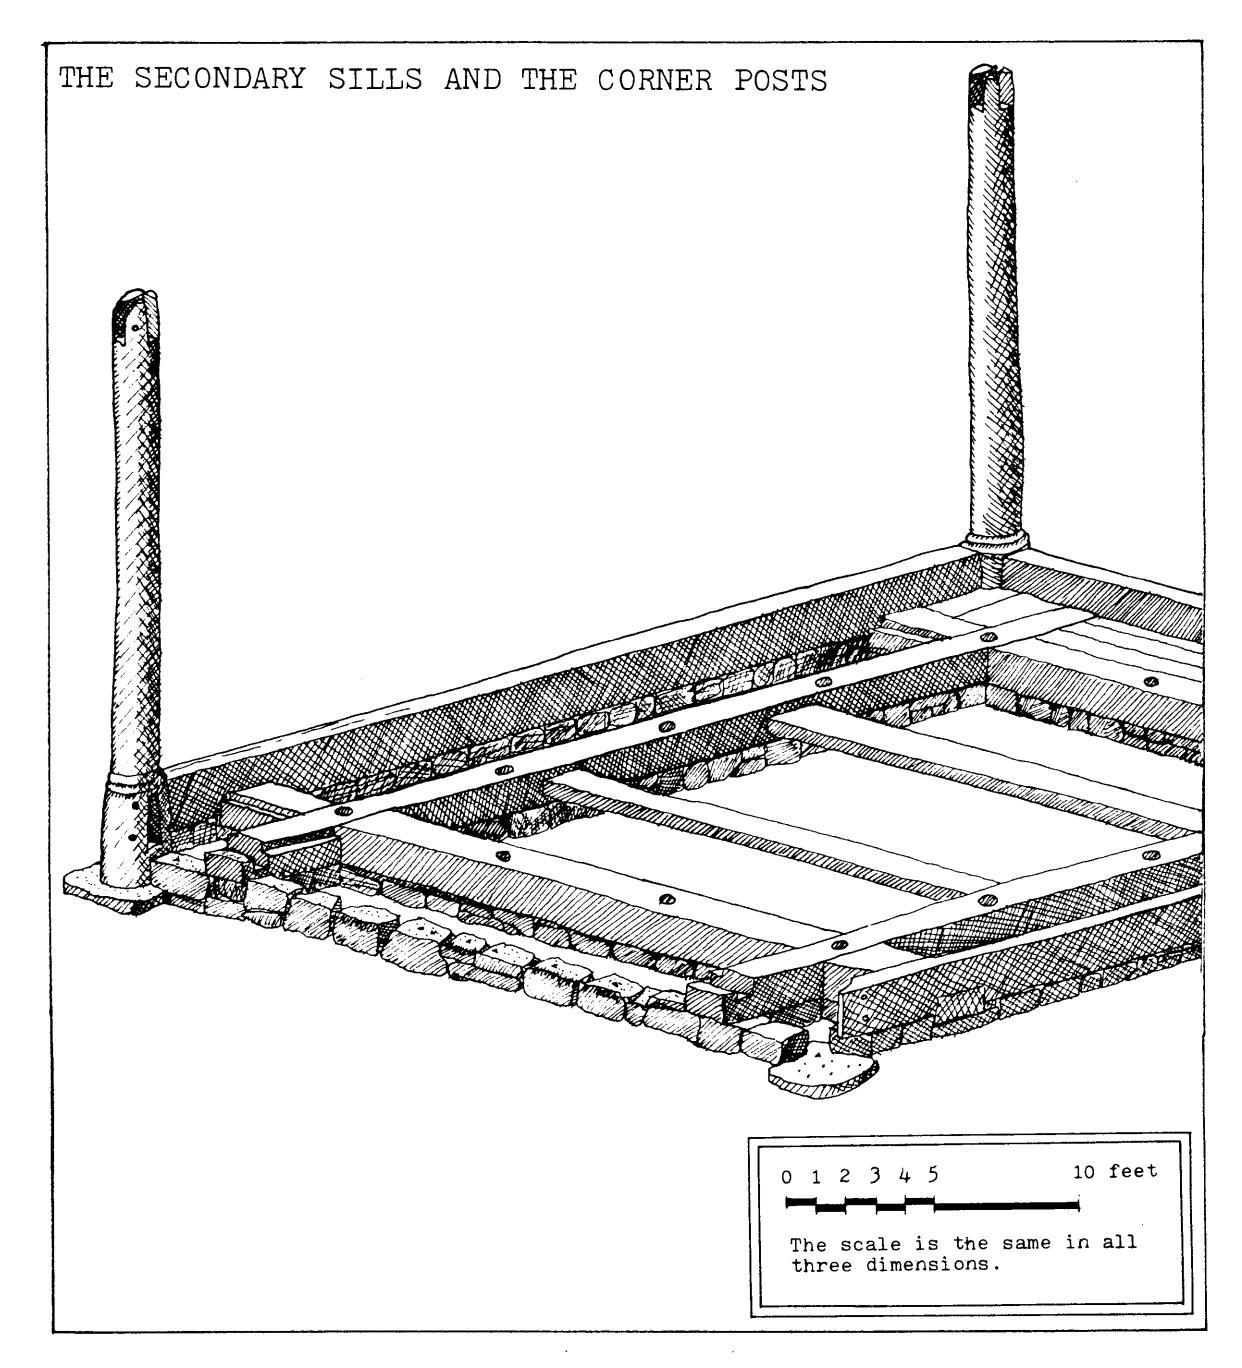
The large (one foot by two feet) horizontal members, which line the lower edge of the building, are the secondary sills. Their main function is to support the stave walls that will come later. The secondary sill rests on its own stone foundation and is connected to both the primary sill and the corner posts. The interlocking connection of the primary and secondary sill prevents either member from slipping out of position.

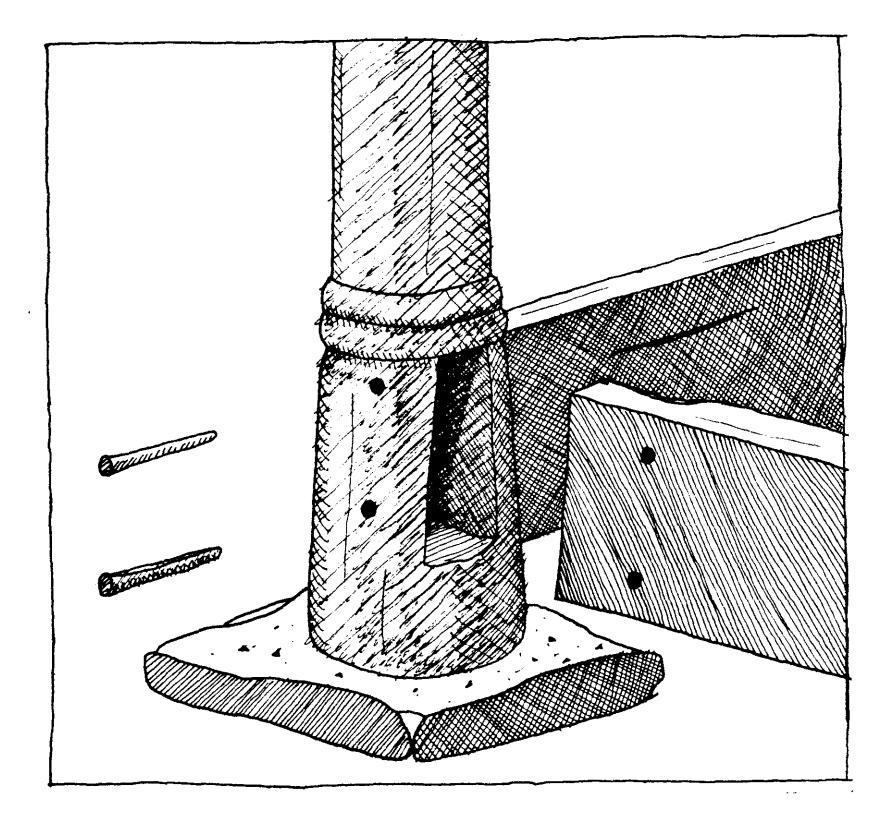
The ends of the secondary sill are attached to the base of the wooden columns. Two wooden pegs lock the members together.

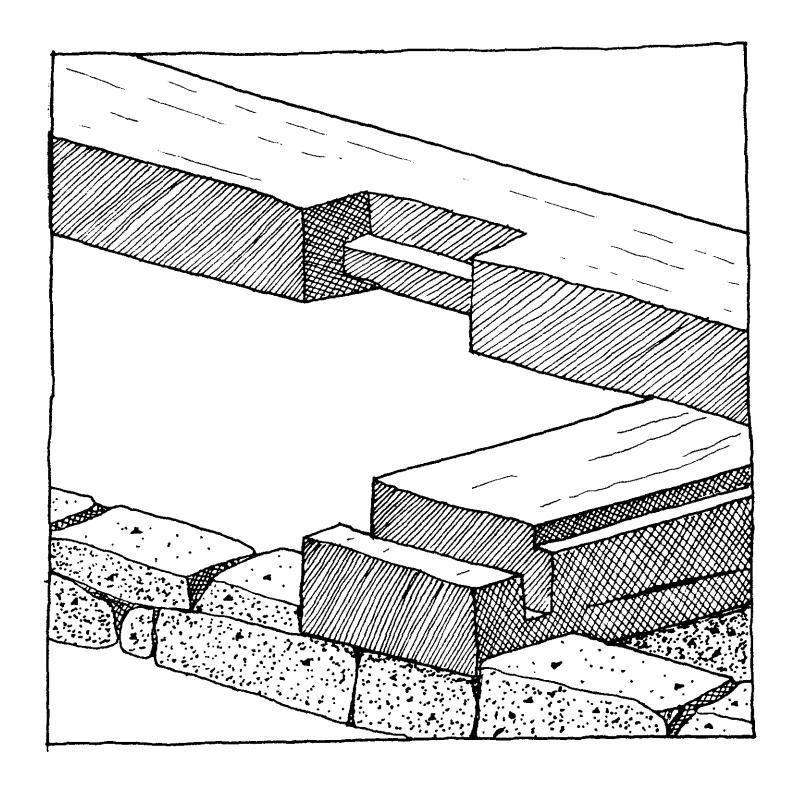
The secondary sill connects to the primary sill. The secondary sill has been raised and rotated to reveal the detail of the wood joint.

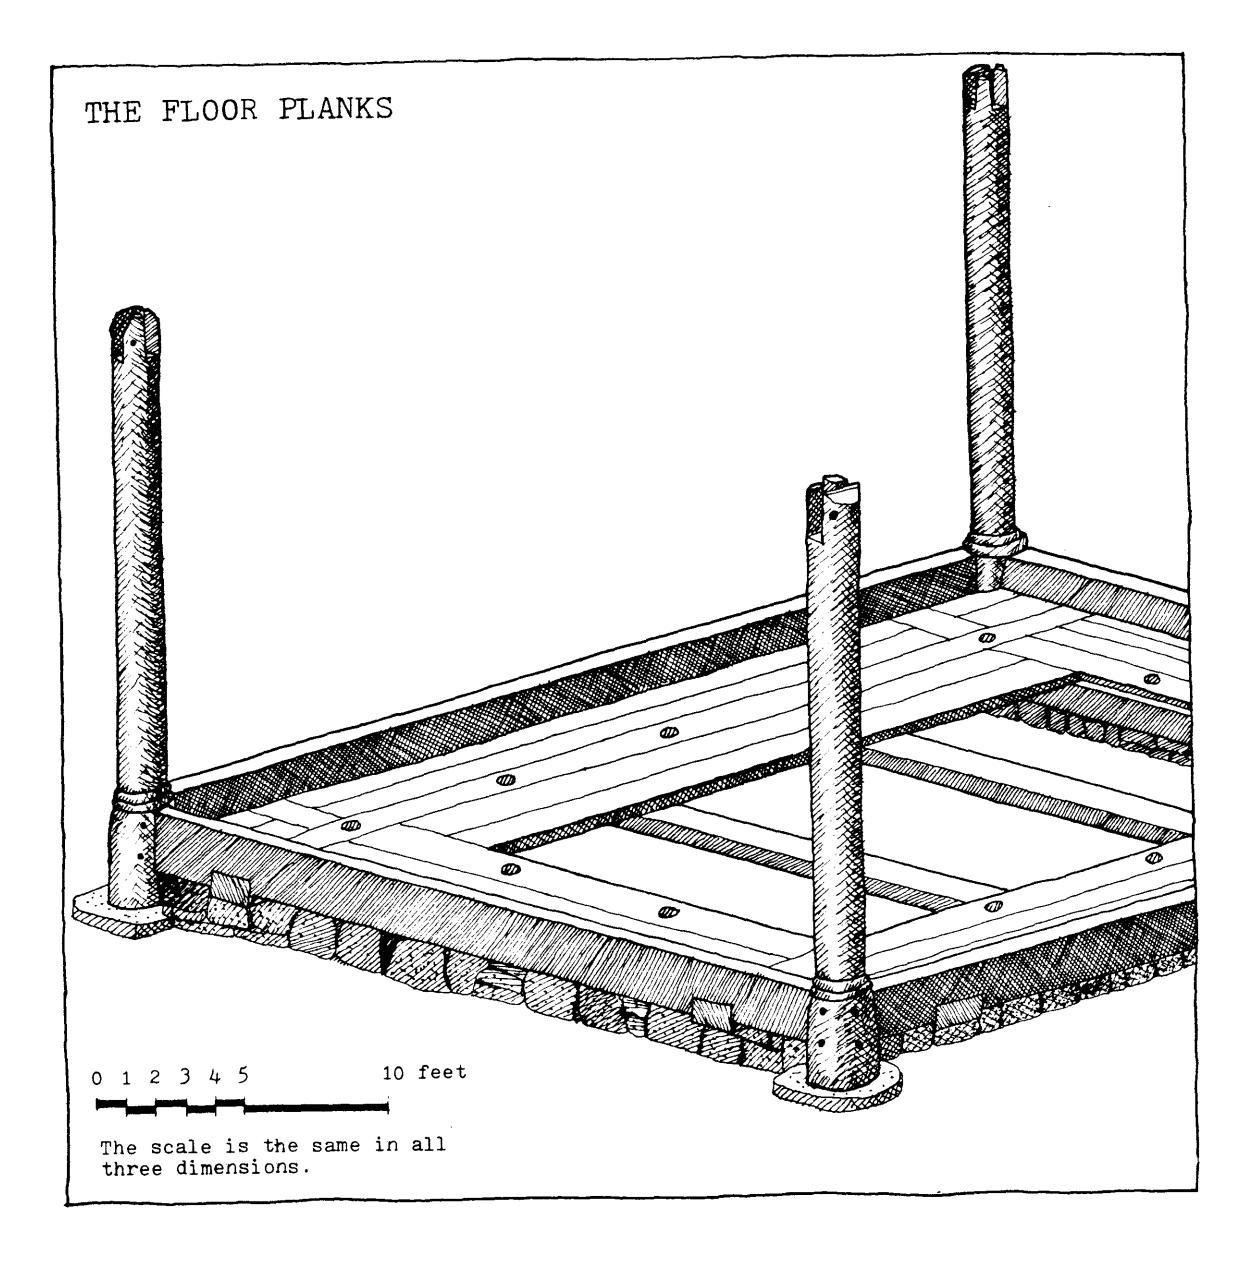
Once the sills and the four corner posts were in place, the carpenters began building the floor. Planks twenty-four inches wide were cut to the exact length needed to span between primary sills, and they were then placed in position on top of the floor joists. Ledges in the primary sill received the ends of the planks, and this joint created a flush fit across the top of the plank and the primary sill. This joint both enabled the sills to serve as part of the finished floor, and allowed the planks to transfer part of their load directly into the sills.

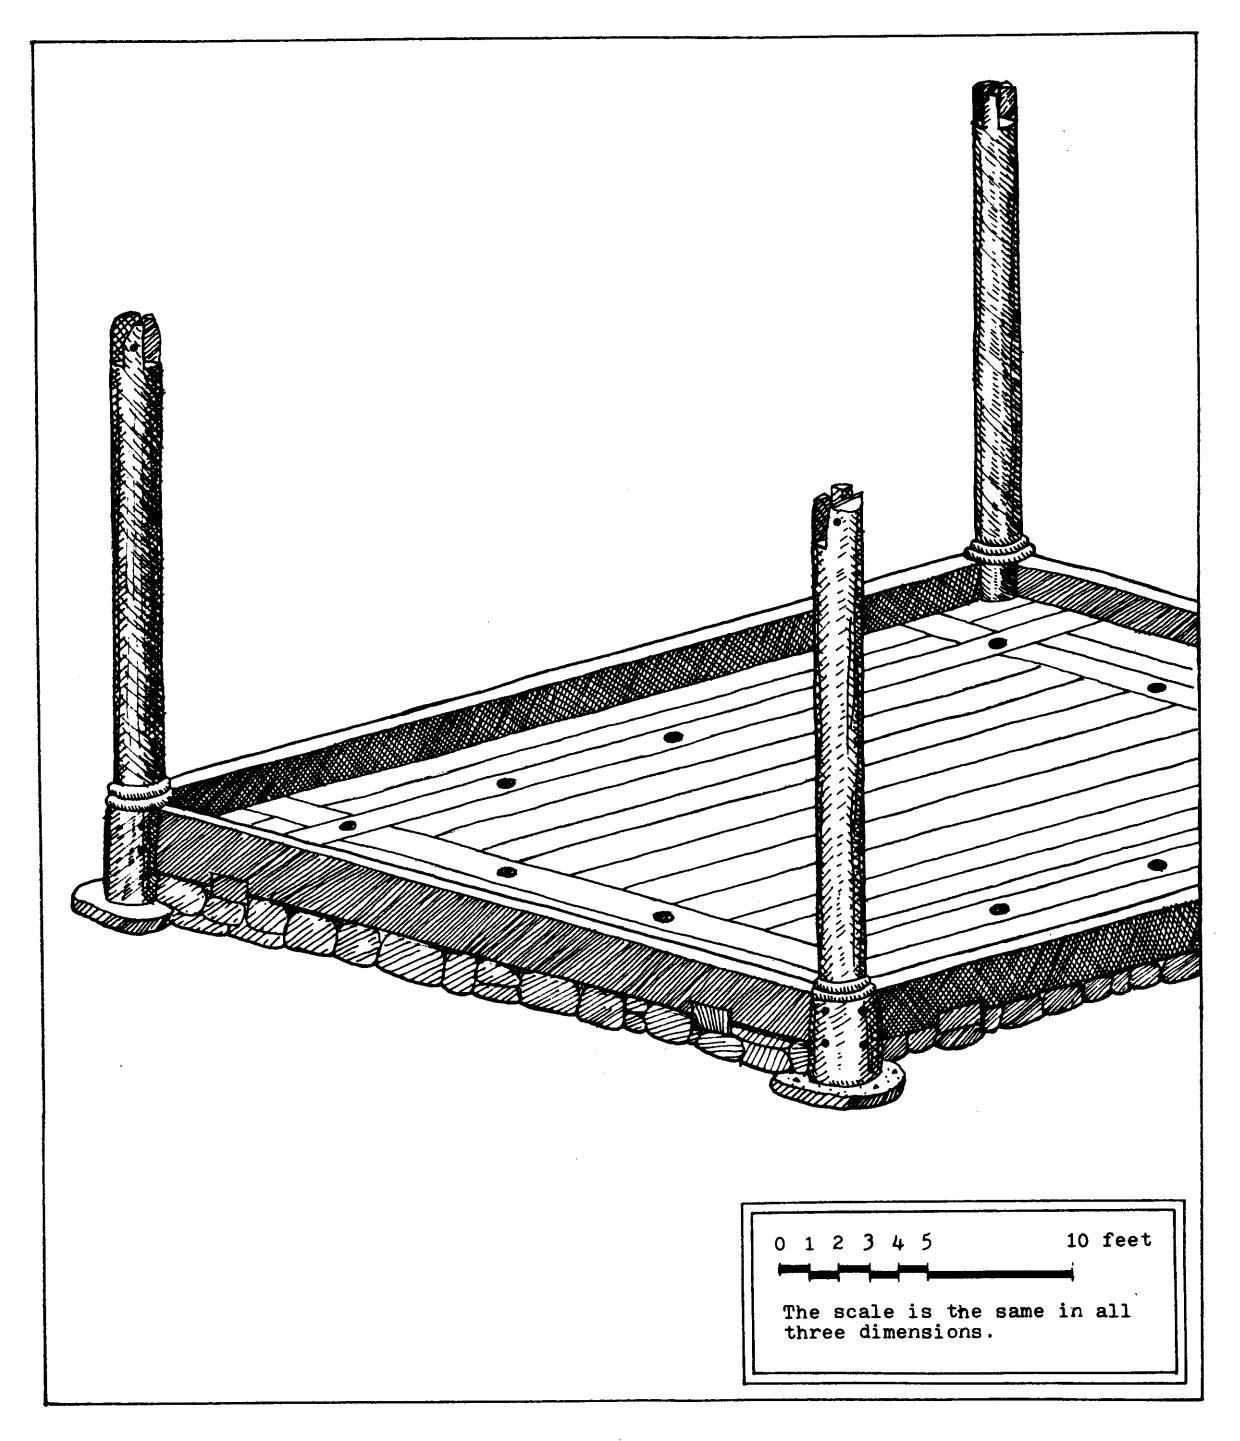
The floor of the Torpo Stave Church measures twenty-five feet by thirty feet, and stands two feet above the level of the ground. The round holes in the floor mark the spots where free-standing columns will be inserted.

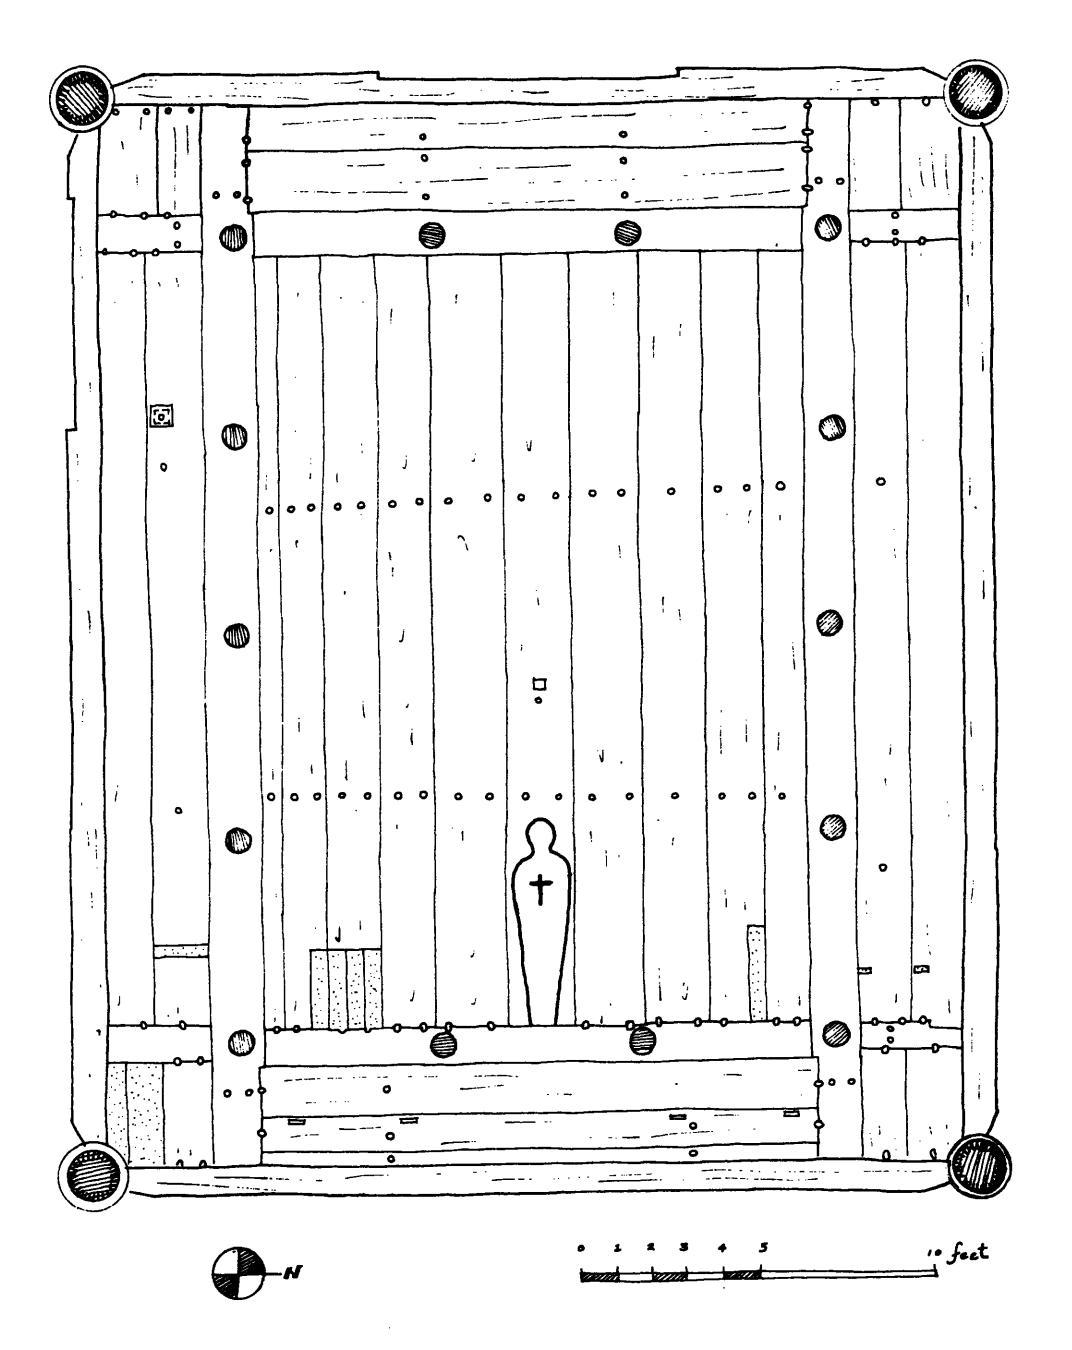
One advantage of pegging the floor planks was that it allowed for the possibility of removing them at a later date. Sometimes the ground below the floor was used for burying the dead. The figure outlined in the central floor plank of the nave marks the burial site of an important religious dignitary. The dotted portions of the floor indicate members that have been used to repair or replace the original flooring.

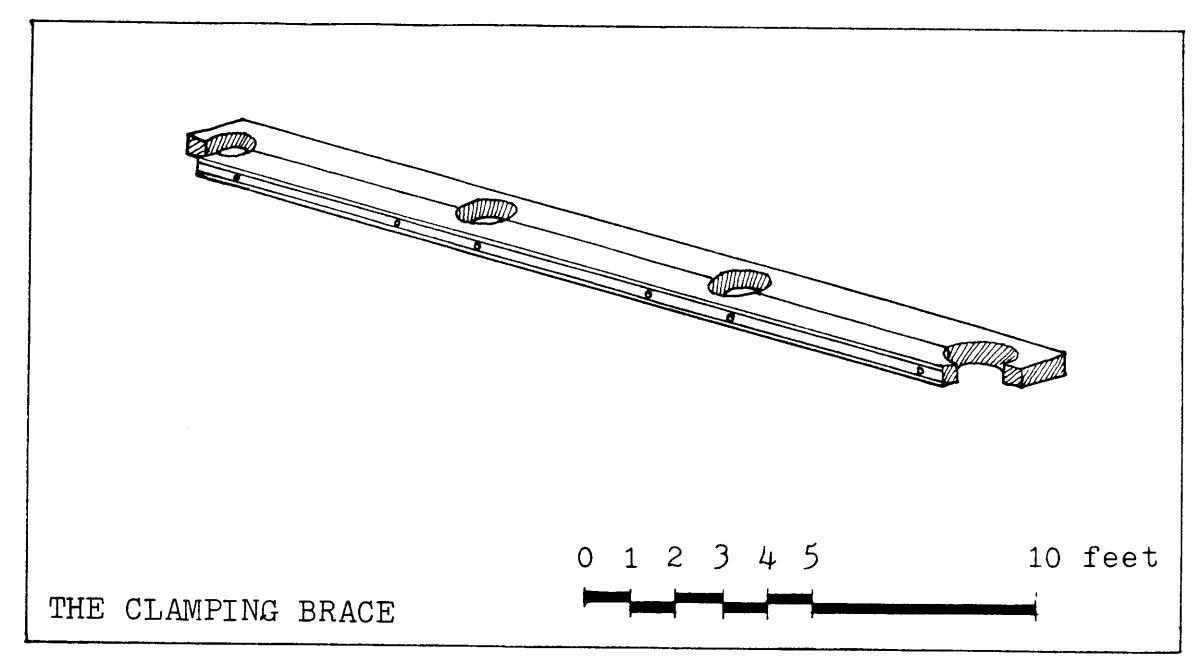
At the critical moment during construction when the row of columns is being raised like a wall into its final standing position, the clamping beam is called into action. The clamping beam helps hold the columns together, allowing them to be raised in a single motion. (This is desirable because it enables the wall to be assembled on the ground rather than in the air.) The role of the clamping beam does not end once the column wall is in position. Not only does the clamping beam continue to keep the columns in line, and prevent the braces from slipping out of position, but it also works in conjunction with the other bracing to resist wind loads.

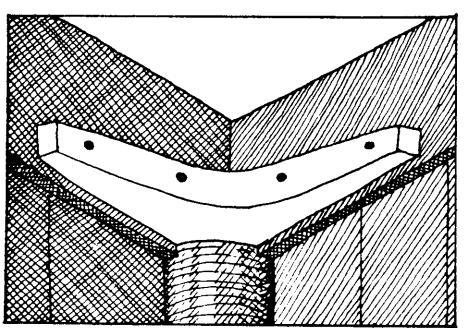
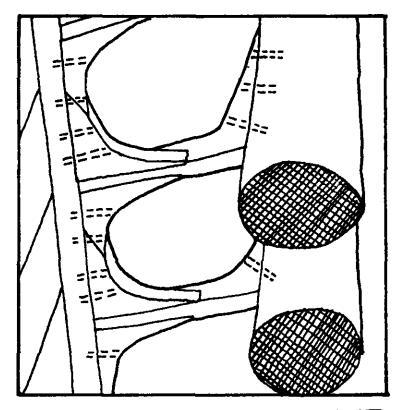
THE KNEE BRACE

The knee brace not only makes the corner stronger but it creates a pleasing visual transition as well. The knee brace, whose back sides measure from two to three feet, is attached to the corner with dowels. The knee brace is the most frequently employed brace in stave construction. In Torpo alone the knee brace is used eighty-four times. Eric Lundberg, the noted Swedish architectural historian, postulates that in "primitive" stave churches, the knee braces were attached to each other to form a three dimensional brace. Located above the aisle, a series of these three dimensional braces connected the top of the aisle wall to the free-standing column. The dashes indicate the location of the dowels; the cross-hatching indicates where the columns are severed (for the illustration).

Even though the St. Andrew cross is an efficient structural form for handling lateral loads, the knee brace is in fact more effective. This is because for a given lateral load, the knee brace causes a smaller bending moment in the column than the St. Andrew cross. The reason for this is simply that the knee brace is closer to the base of the column than the St. Andrew cross. Though these two braces perform the major roles in resisting lateral forces, the upper arch, the clamping brace, and the clerestory wall assist them to a lesser extent.

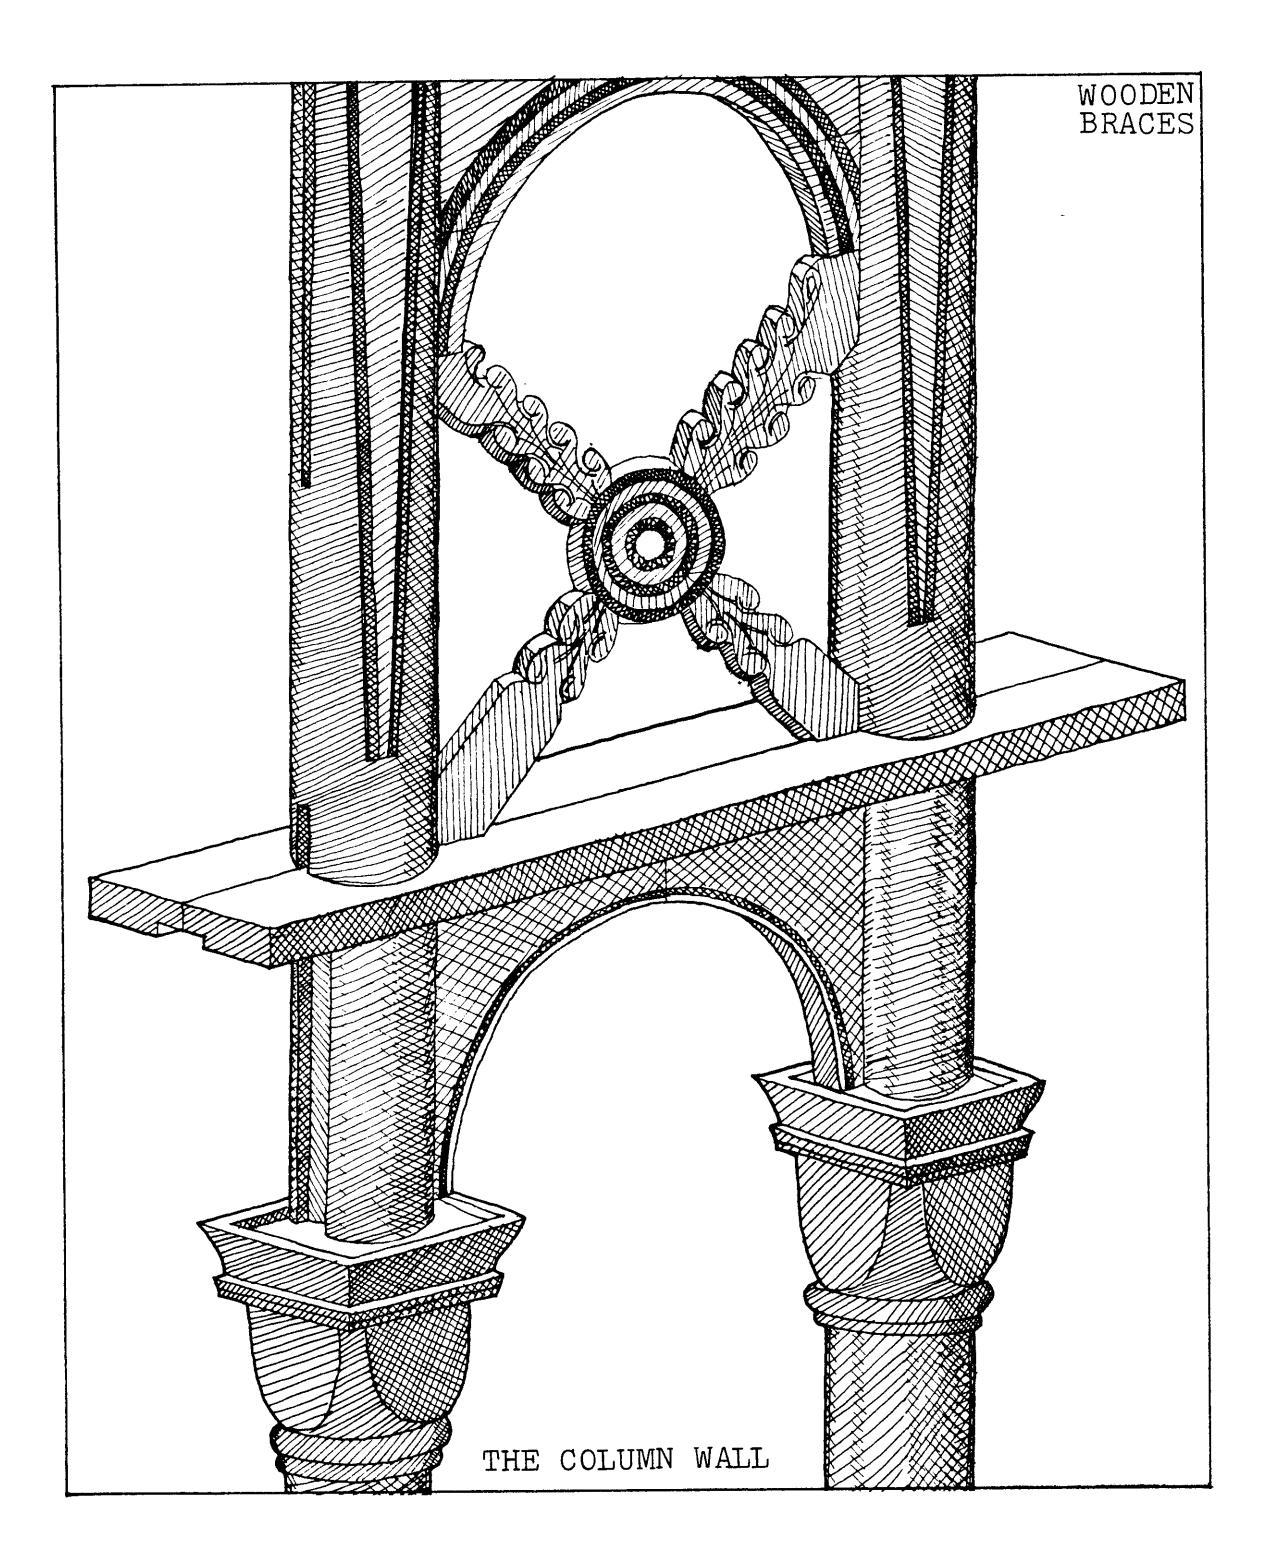
The braces are engineered to hold each other in place and to assist each other in the bearing of loads. Both of these functions are made possible by the tight joinery and the direct bearing of the braces against each other. But perhaps the most significant achievement of the column wall was its sculptural approach to structural engineering.
