Norwegian Wood: A Case Study of Stave Churches

Submitted in Partial Fulfillment of the Requirements for the Degree of Master of Architecture at the Massachusetts Institute of Technology February 1982

This thesis addresses the question: How did the medieval Norwegians meet the challenges entailed in designing a small wooden building (e.g., resisting snow and wind loads, detailing wood connections), <u>and</u> create an architectural masterpiece?

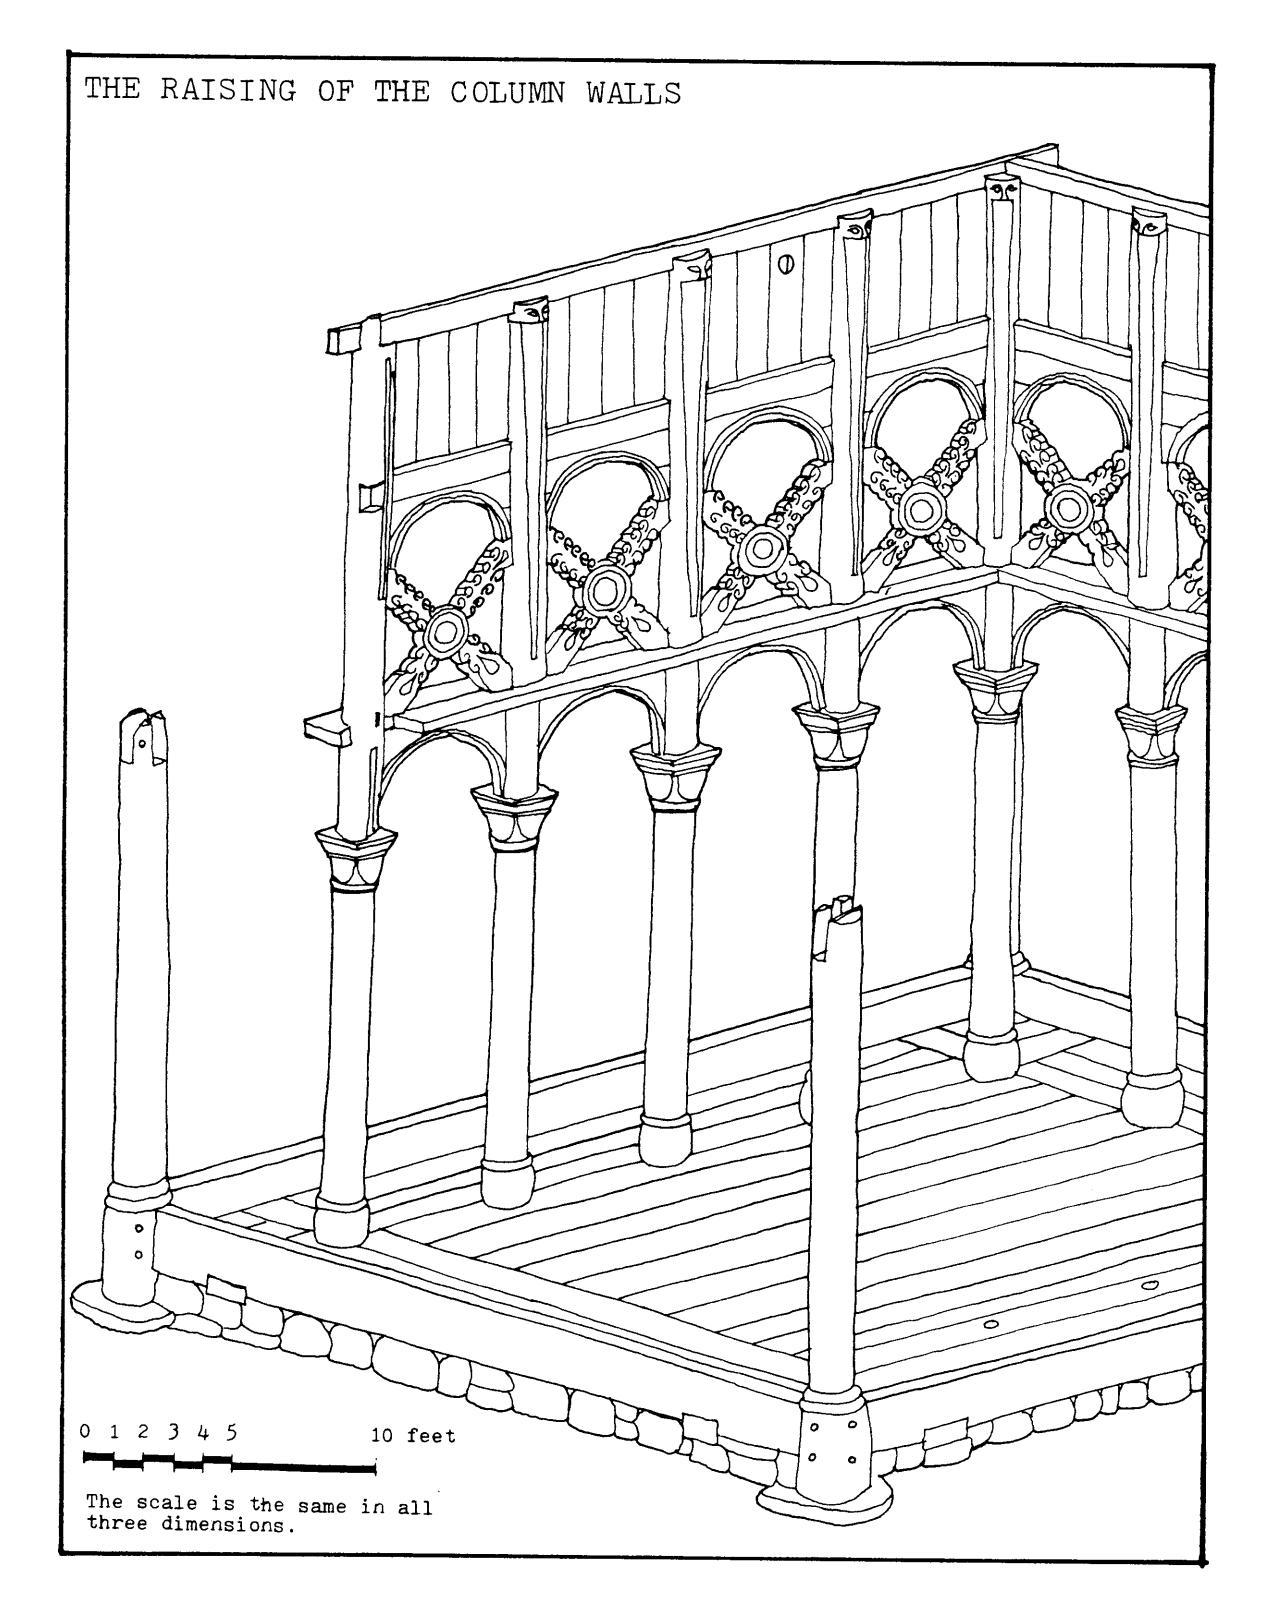
A second column wall is assembled on the ground, raised into position, and attached to the first column wall. The attaching of the column walls is performed in the air and entails connecting the wooden braces of the second column wall into the corner post of the first column wall.

The procedure of assembling the column walls on the ground and lifting them up and into position is continued until all four walls are fastened together. These four walls are the building's main structural support and form a kind of three-dimensional chassis. Other structural elements such as the aisle roof and the trusses are attached to the chassis. Structurally the chassis is analogous to a card table in that both are braced at the top and not the bottom. Such a bracing system works satisfactorily in resisting lateral forces as long as three conditions are met: (a) the columns must be large enough in diameter to resist the wind loads in bending, (b) the base of the columns must be prevented from sliding by at least a pin connection, (c) the building must be heavy enough to prevent it from overturning in a wind. The fact that the building is still standing after so many centuries is proof that the designers met the specific conditions imposed by elevated bracing.

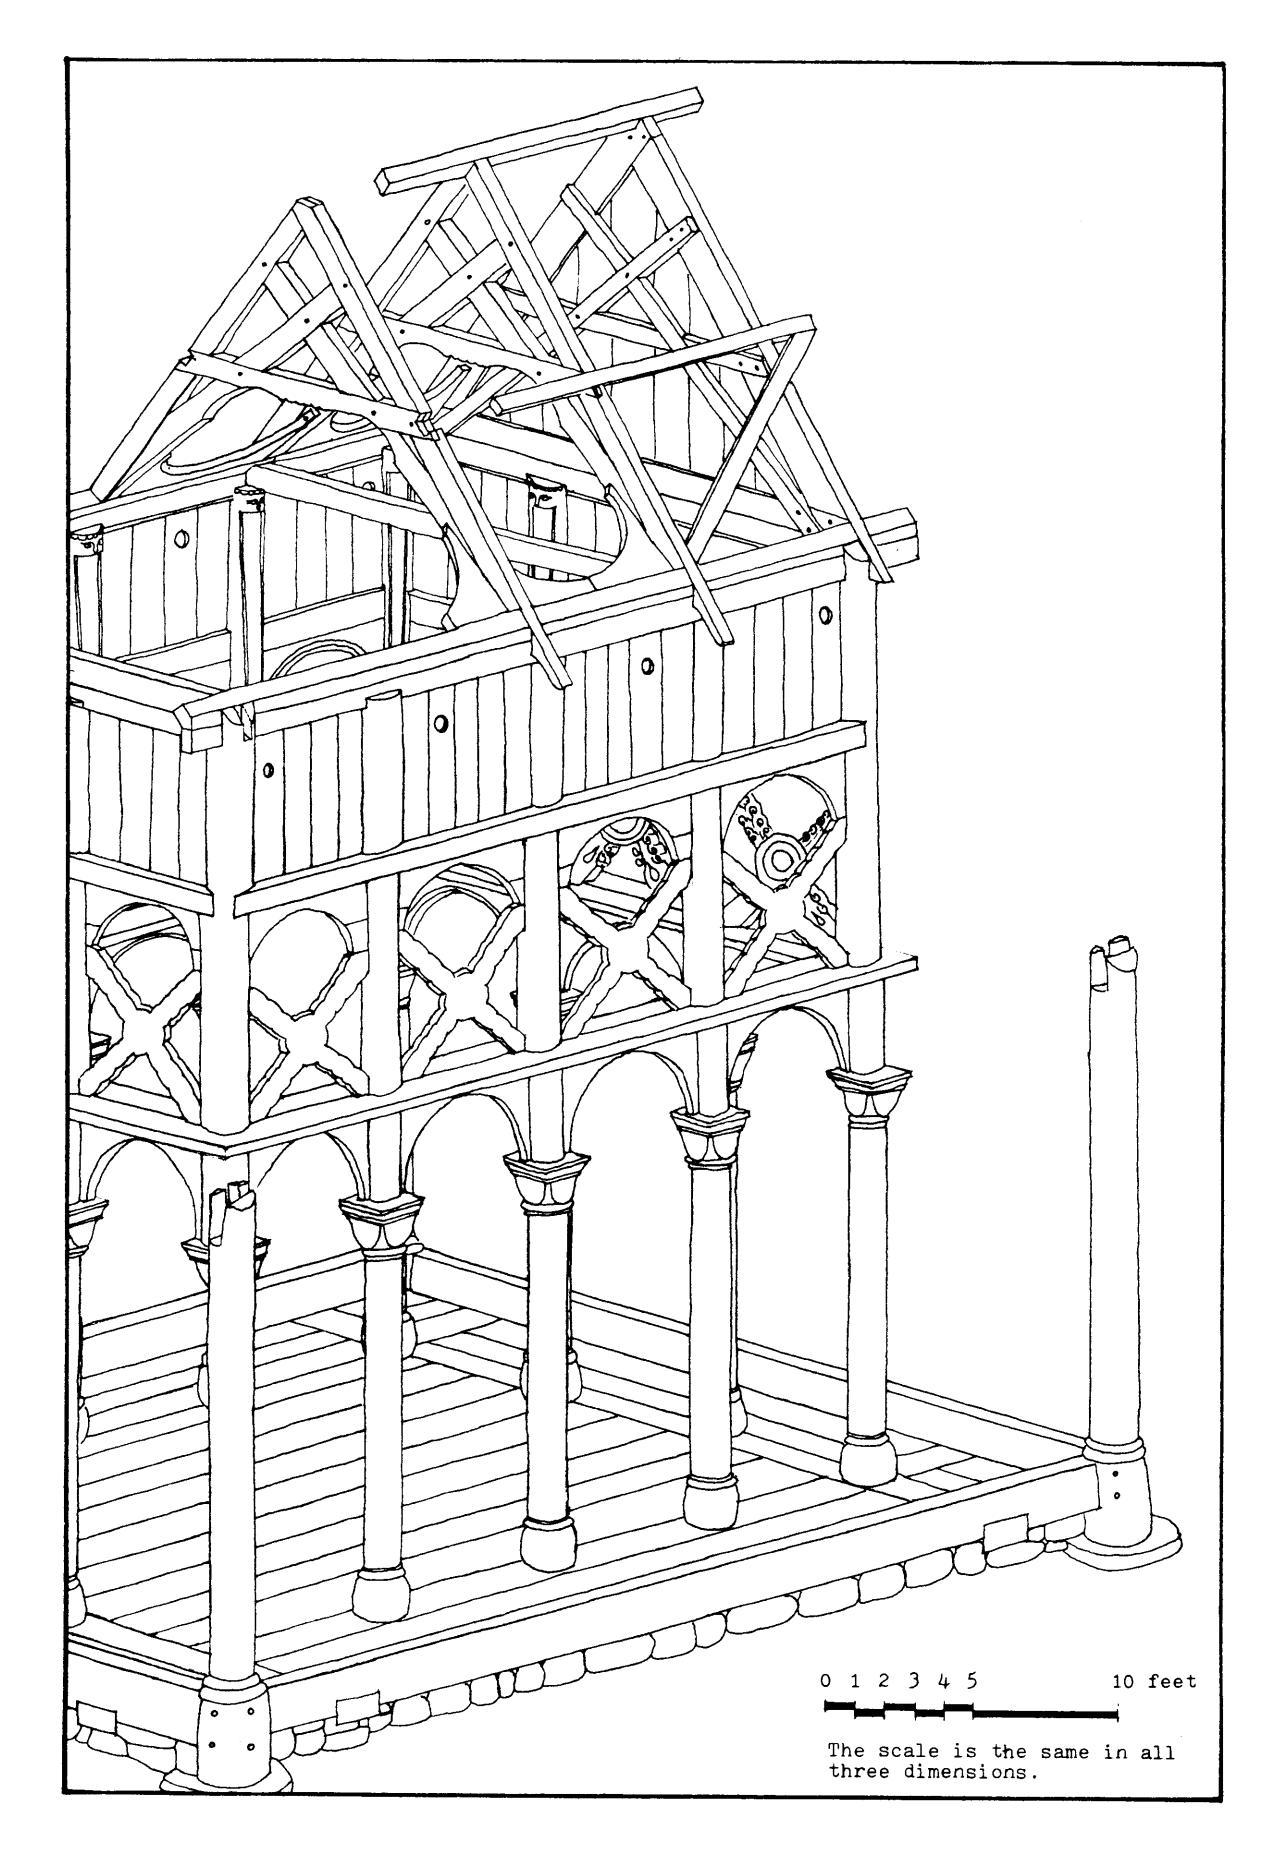
The trussed rafters of the Norwegian stave church are a forerunner of the modern scissor truss. The lateral beam of the truss contributes greatly to the strength and stiffness of the truss.

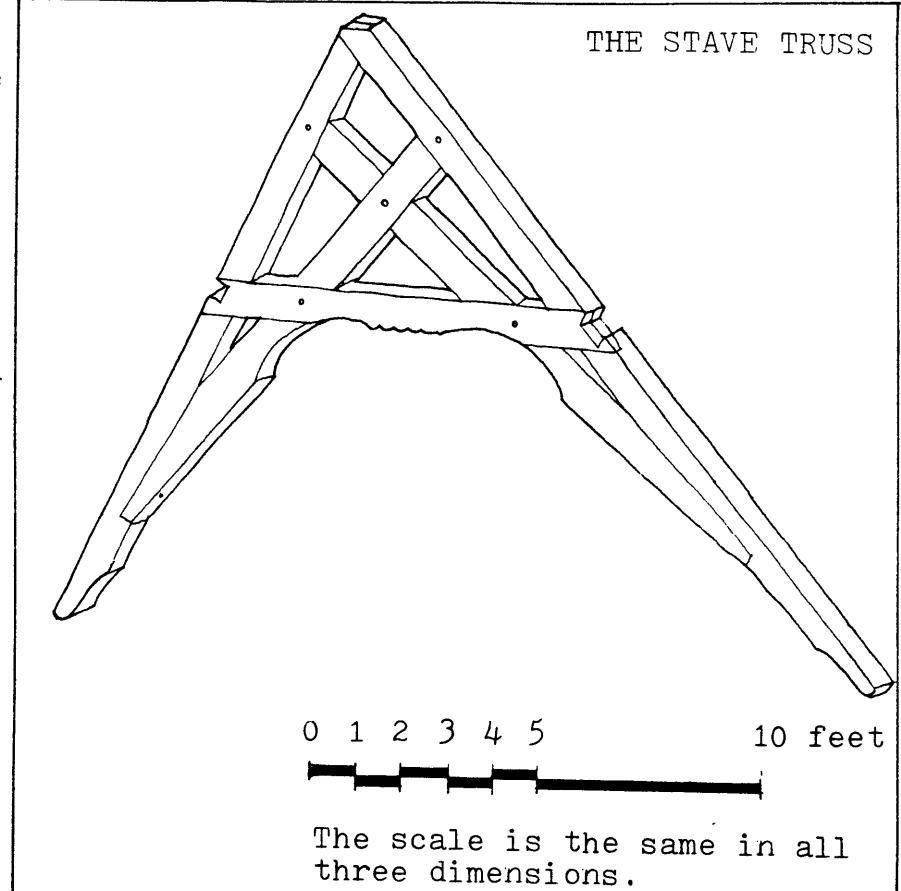
Perhaps partly because it allowed an open view of the ceiling, and partly because it gave an impression of a vault, the scissor truss gained wide acceptance in stave architecture. Employed in almost all of the remaining stave churches, the trussed rafter undergoes only slight variations from church to church, and even these changes are mostly stylistic. From a practical standpoint the steep pitch of the truss has been helpful in preventing large build-ups of snow which the comparatively weak scissor truss may not be capable withstanding. Roar Hauglid, the noted Norwegian historian of stave churches, believes that the truss was imported from abroad, probably France or England.

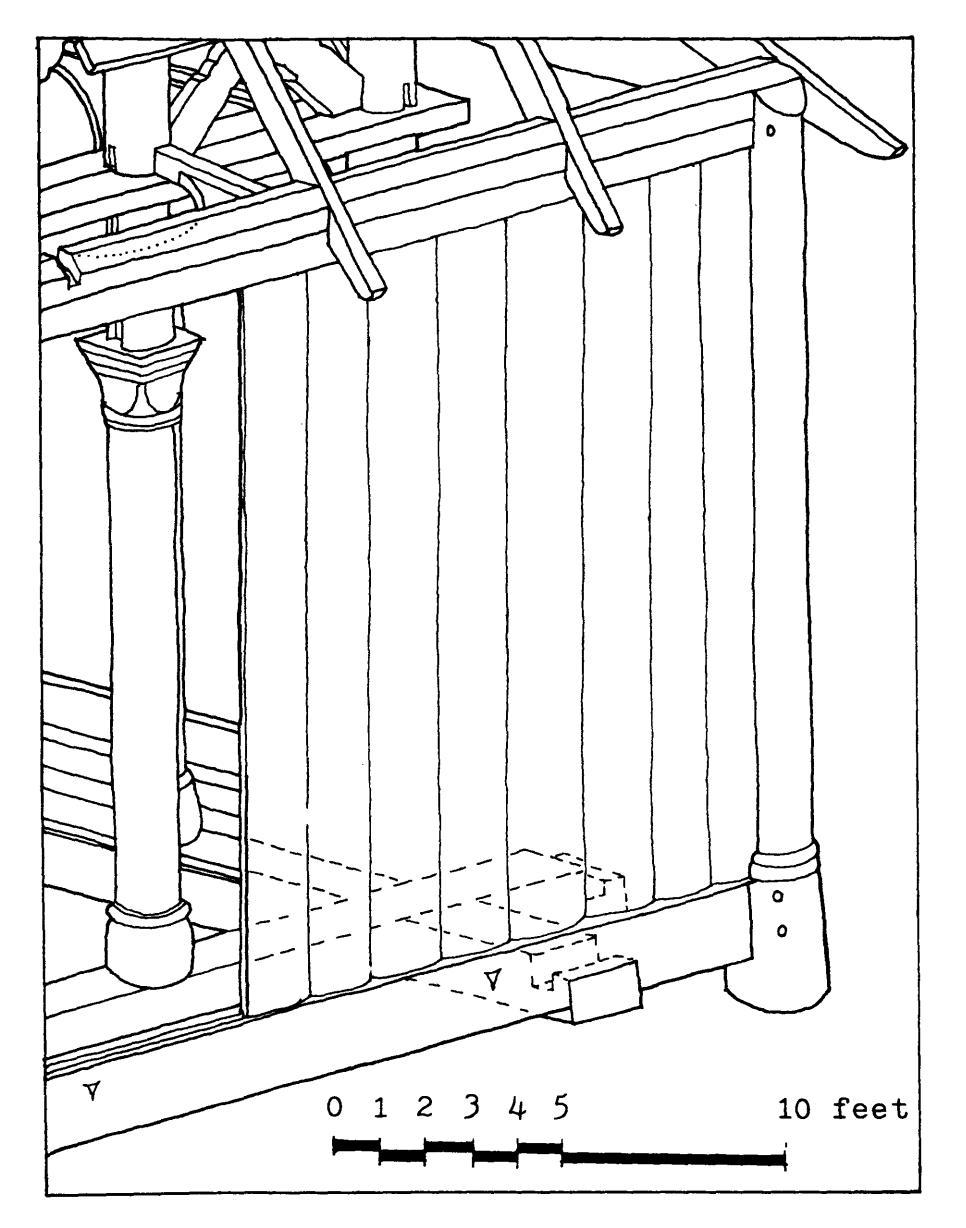
The technique employed in the building of the exterior wall accounts for the name "stave" construction. The stave wall can be understood as a wooden framework filled in by vertical planks, called staves. In this illustration of the Torpo Stave Church, the framework is composed of a sill, two corner posts (only one is shown) and a top plate. The staves have tenons carved on both ends and these fit into grooves cut into the top of the sill and the bottom of the wall plate. The staves connect to each other and to the corner posts with a tongue and groove joint. The expertise with which the joinery is executed enables the wall to act structurally, carrying a limited amount of the wind load into the foundation. The tight joinery also keeps out the cold winter weather.

A small but significant example of how the Norwegian designers sought to perfect and preserve their work can be seen in their solution to a problem that arose at the base of the outside walls. The groove in the top of the sill caused a problem in wet weather because it collected the rain water that ran down the walls. With the groove acting like a water trough, both the sills and the bottom ends of the wall planks remained wet for long periods of time, leaving them susceptible to rot. If left unattended the rotting would collapse the walls, and this in turn would leave the interior unprotected.

Rather than abandon the vertical method of construction that seemed to be causing the problem, they opted to modify the existing design. They carved a series of small holes in the sill from the outside slightly below the bottom of the groove. The "V" shaped holes penetrated into the groove and served as minature drains which prevented the rain water from collecting in the sill. The holes also allow air to circulate in the joint thereby evaporating any excess moisture that might have built up during a rain. As witnessed by the absence of rot in these joints today, a potentially serious problem was resolved in a simple yet effective way.

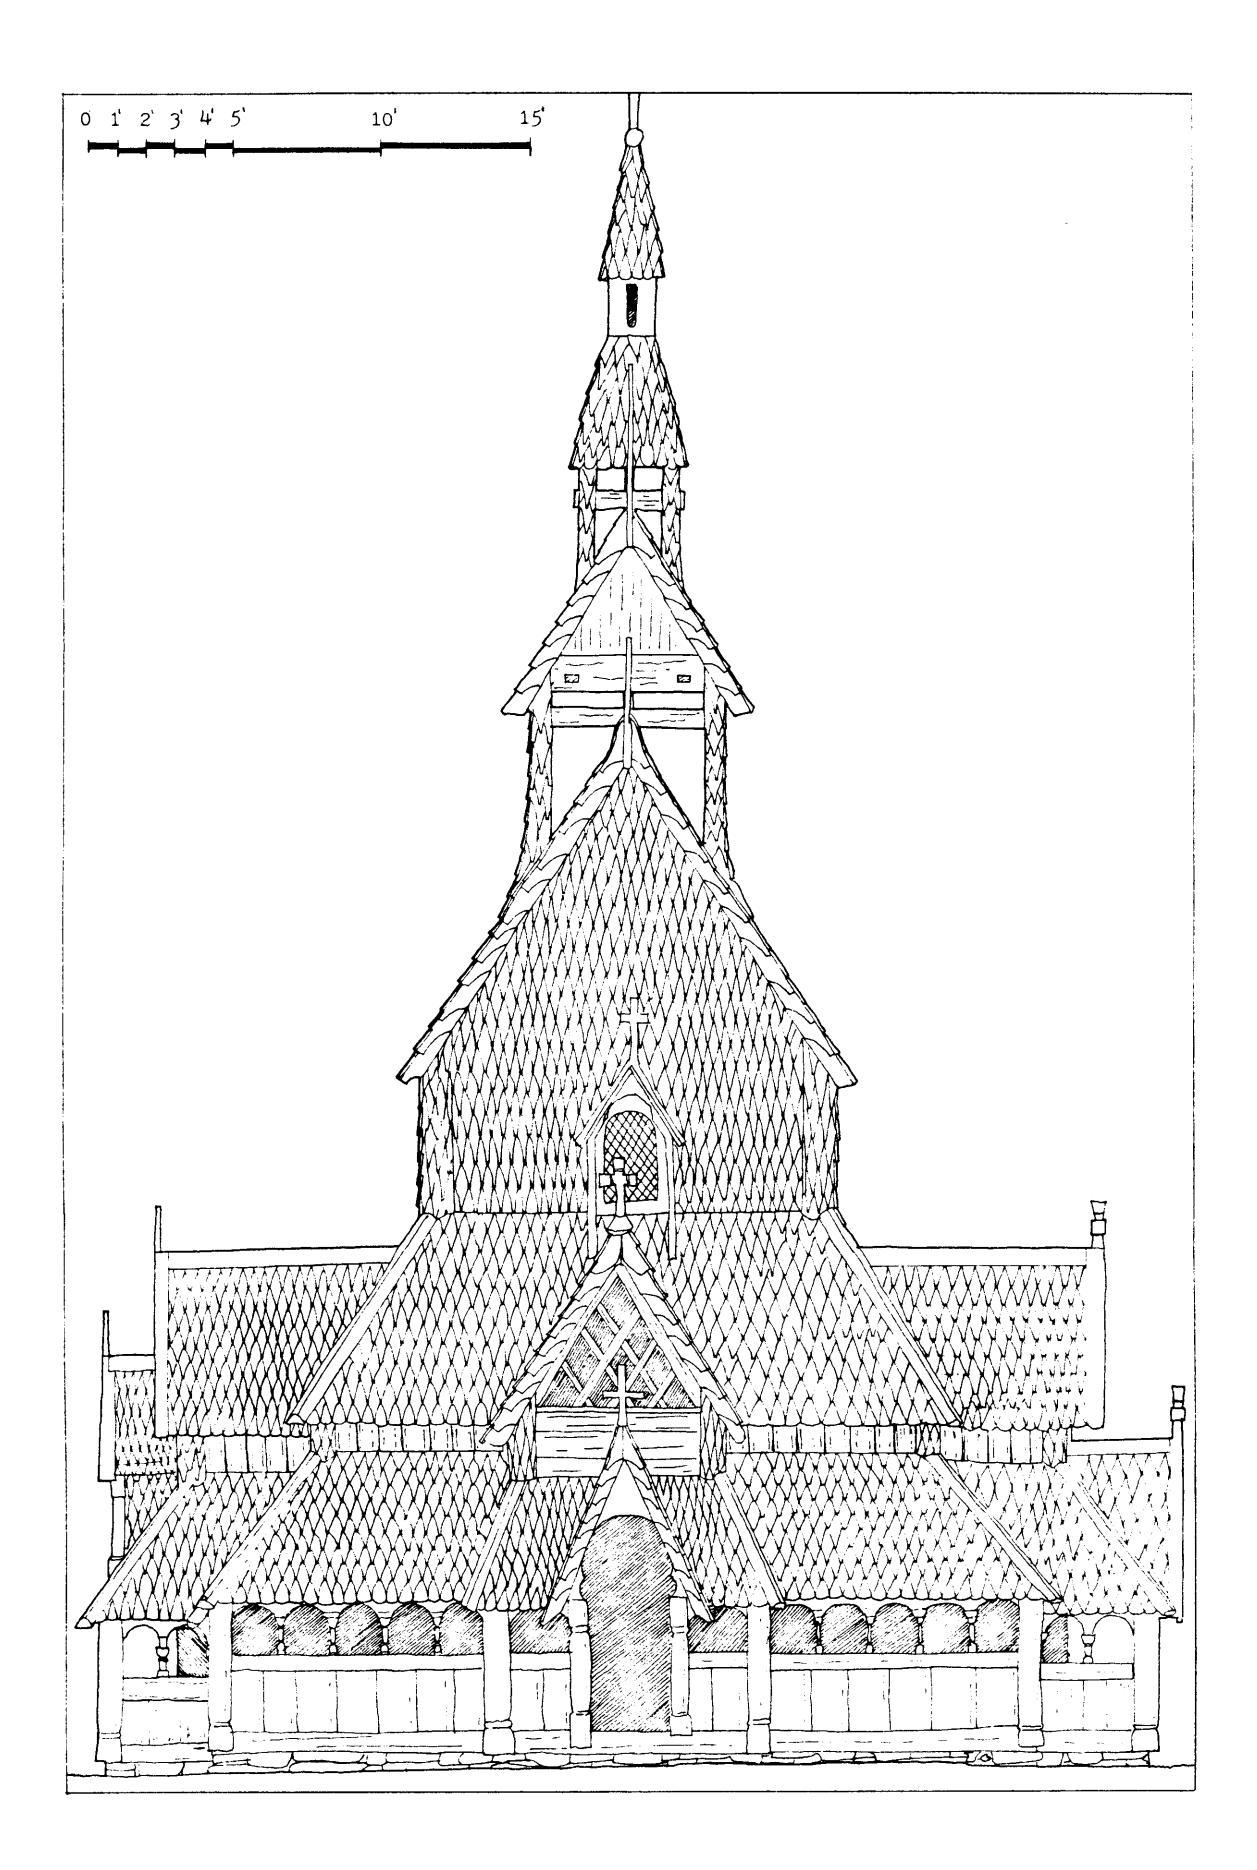
THE EXTERIOR

During the warm summer months when the sun beats down on the coated shingles, the black tar heats up and softens. Over a period of years some of the tar coating enters the pores of the wood making the surface of the wood virtually waterproof. As the tar wears off, it leaves the wood with a range of pleasing brown and red hues. This color change is most apparent on the south side of the building where the sunlight is the strongest. Conversely, the north side of the building tends to remain the cold black color of the tar compound. The striking difference in color from side to side is a reliable clue for fixing the orientation of the building.

In order to maintain the moisture barrier a new coating of tar is applied to the exterior about every four years. This process, which is still carried out to this day, has been kept up since the Middle Ages. Incidently, the Vikings used a similar tar compound to waterproof their wooden ships. One important difference was that the Vikings added horse hair to their tar mixture.

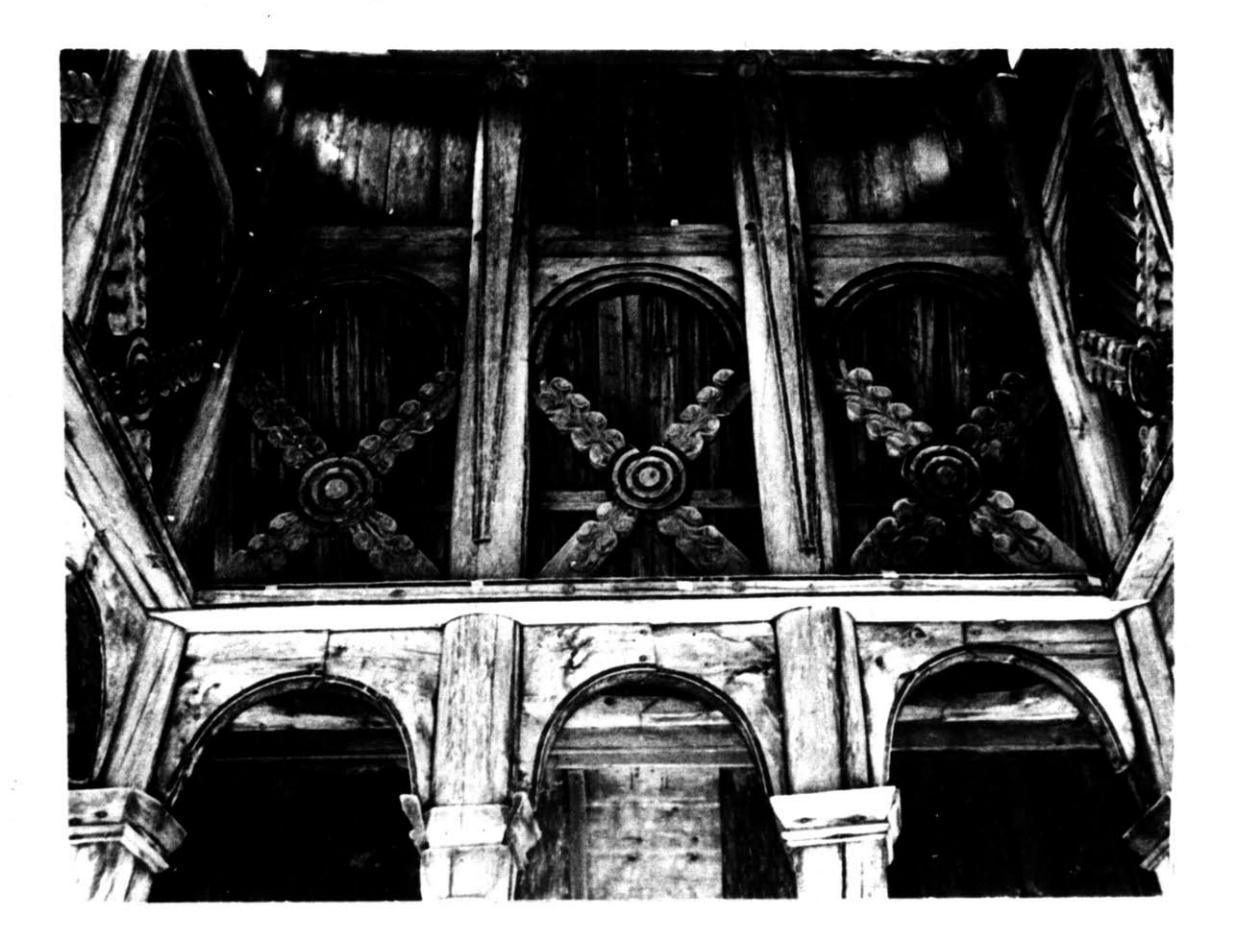
Columns and braces of the Torpo Church

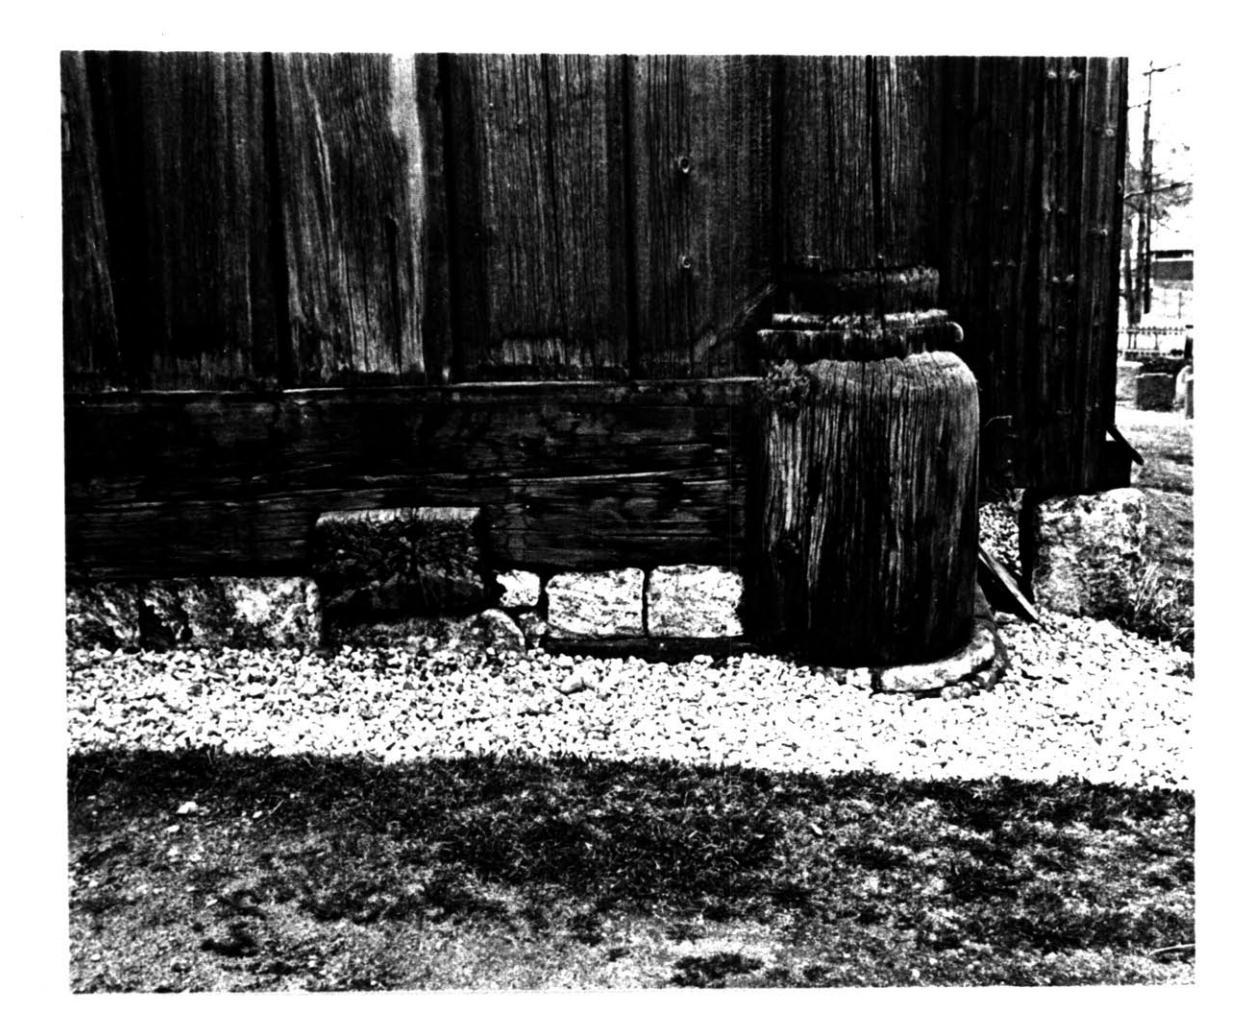
Stone foundation, sills, corner post, and staves of the Torpo Stave Church

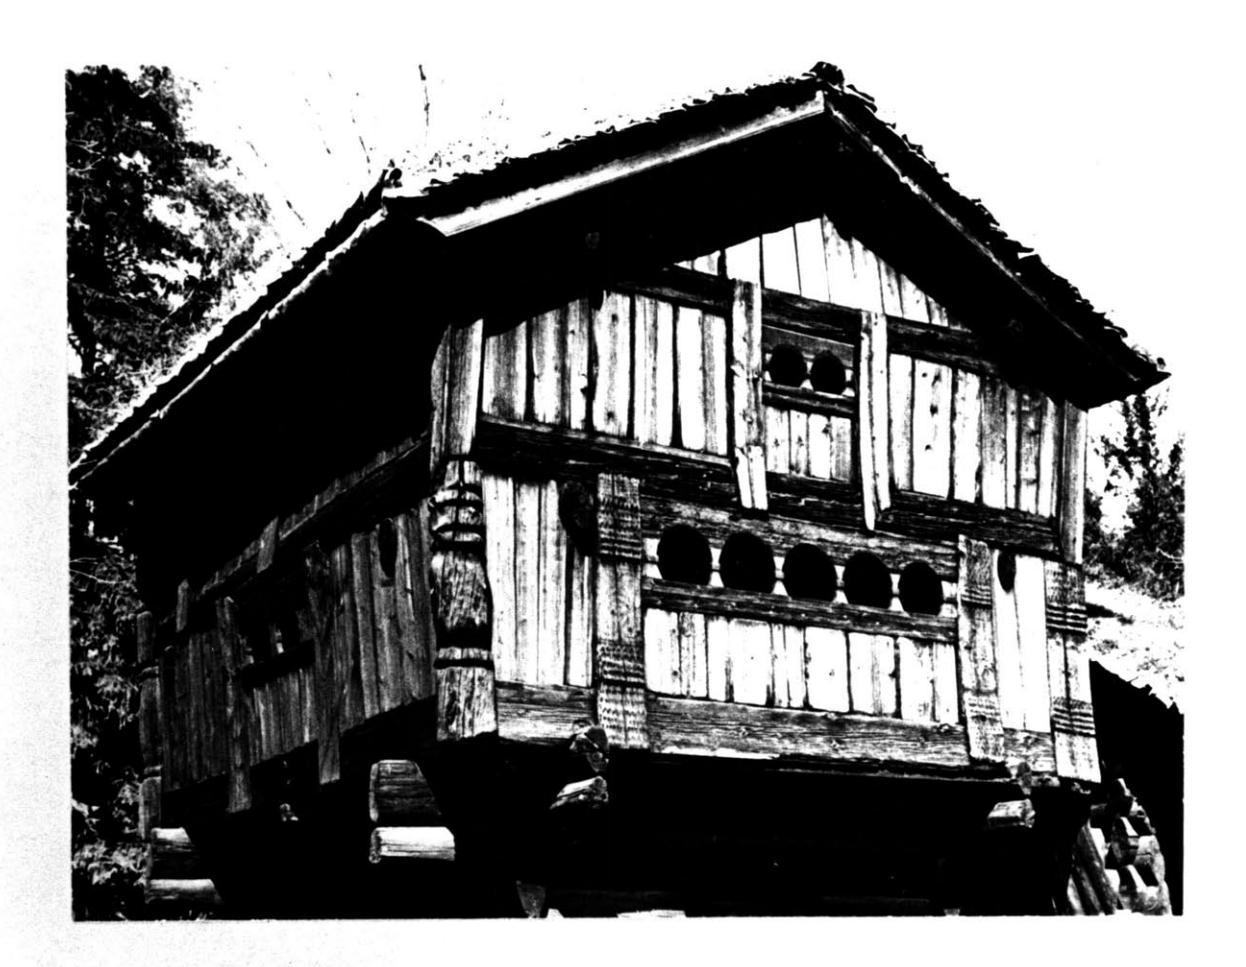
Medieval Norwegian granary built in the stave style
