# Historical nail-making techniques revealed in metal structure

Krysta Ryzewski and Robert Gordon

*ABSTRACT: Characteristics diagnostic of manufacturing technique are retained in the microstructure of iron nails even though the original surfaces are lost in corrosion. Distinctive metal structures differentiate hand-forged and machine-made nails. The one-operation machines that automatically cut and headed nails left unique shear bands in the nail-head metal. Presence of these shear bands indicates that nails cut and headed by machine were in use in Rhode Island before 1781. Before about 1815 nail machines in New England operated on pre-heated iron plate, as shown by the recrystallization of the shear band. Nails made thereafter until about 1850 were formed from cold iron and have un-recrystallized shear bands. Cut nails made after about 1850 are in the longitudinal rather than transverse orientation, and have a folded head structure resulting from improved design of the nail machine header grips.*

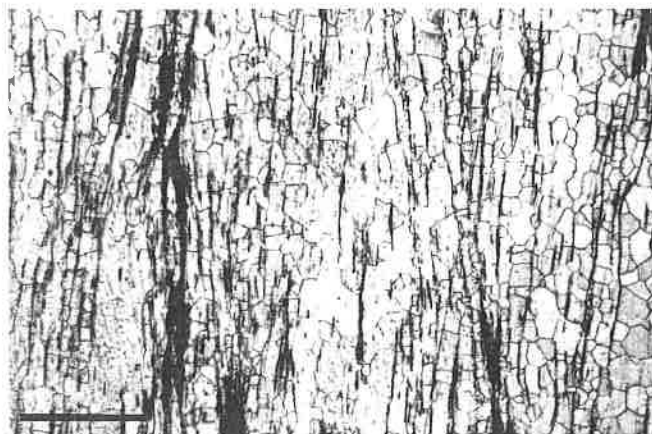
Figure 3: The slag fibres in the shank of nail 8 are oriented parallel with the length of the shank (vertical in the image), thereby showing the longitudinal orientation of a nail. Nital etch; length of scale bar 0.2mm.

The orientation of the included slag shows the direction in which a nail was cut from its parent iron. The density, size, shape, and orientation of the slag fibres is determined by the forging and/or rolling that formed the metal stock used in nail making. Typically these forming processes produce slag fibres parallel with the long axis of the rod or plate that was used by a nail maker. Hence nails made from rod are in the longitudinal orientation. In nails cut from a rolled plate with their long axes transverse to the rolling direction, the included slag fibres are perpendicular to their length (Nelson 1968). The nail orientation relative to its parent stock may be revealed by preferential corrosion on the surface of the iron or, more reliably, by examination of a metallographic specimen. While some of the nails examined had an easily discerned orientation relative to the iron fibre (Fig 3), in others the slag had not been well distributed
