Early 20th-Century Building Materials: Resilient Flooring

Richa Wilson, Intermountain Regional Architectural Historian
Kathleen Snodgrass, Project Leader

This tech tip is the third in a series about innovative building materials developed in the first half of the 20th century and commonly used in Forest Service buildings. The series will help you identify materials by describing their histories, manufacture, and physical characteristics. It will also address common problems and provide guidance on maintenance, repair, and replacement.

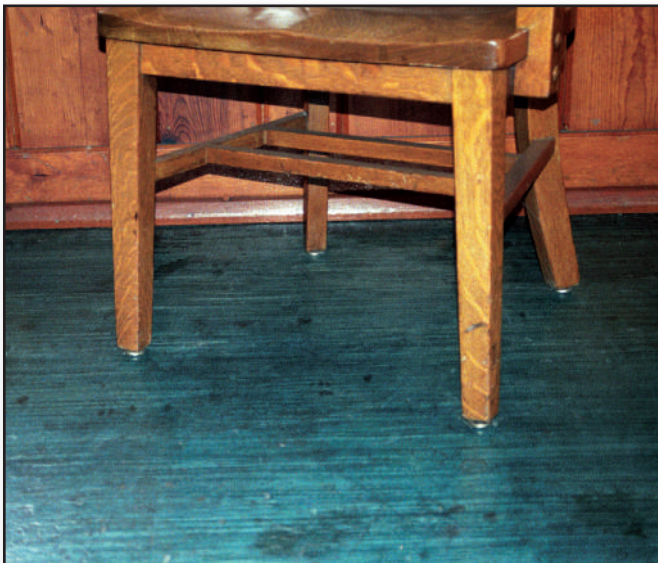
Figure 1—This jaspé pattern flooring has many dents and stains from years of use in the cookhouse at the Fenn Ranger Station (Nez Perce National Forest, Northern Region), but it is still serviceable.

Jaspé and marbled patterns were more decorative than plain linoleum. They were characterized by streaks of color running in one direction (jaspé, figure 1) or with no distinguishable direction (marbled, figure 2).

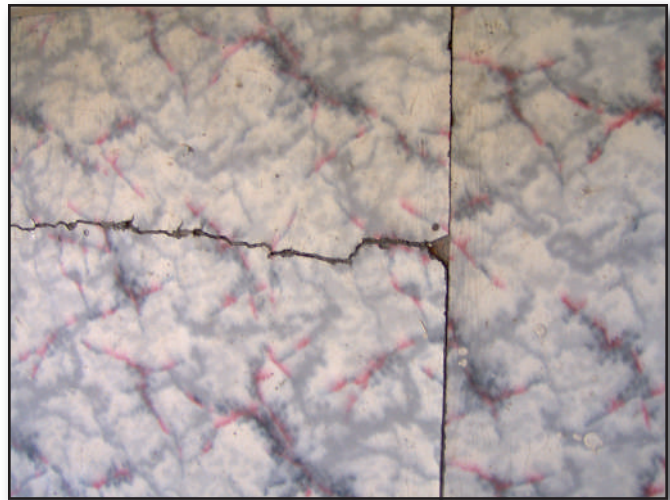
Figure 2—This marbled pattern linoleum flooring has developed cracks. Small nails secure the flooring to the subfloor.

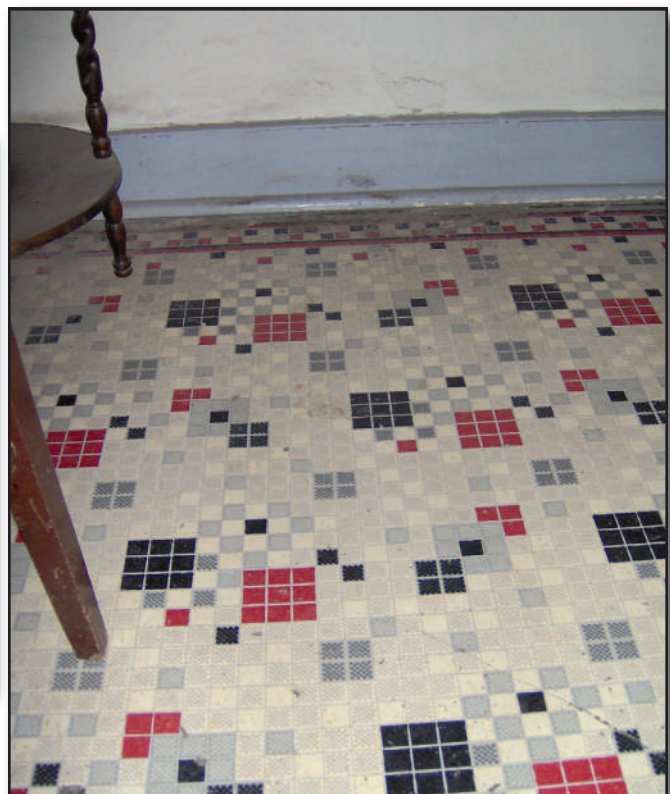
Figure 3—This linoleum flooring is holding up fairly well, but the printed pattern is scratched and worn.

Linoleum was often printed or inlaid with floral designs and geometric shapes, including patterns that imitated brick or stone. Printed linoleum, with its block-stamped patterns, could be quite intricate. However, the printed colors were susceptible to wear if they were not sealed regularly with wax (figure 3).

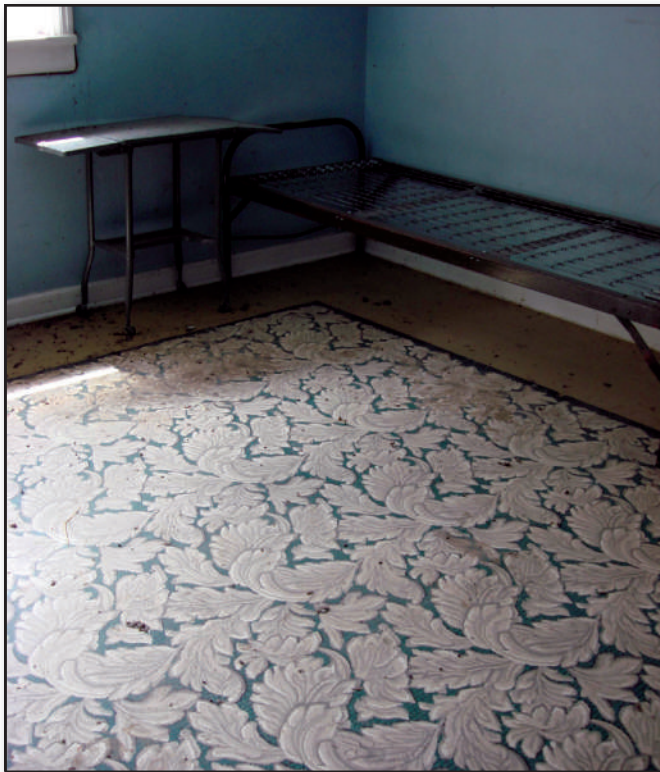
Figure 4—This intricately patterned, felt-base Congoleum “rug” protects the middle of the painted softwood floor of a bedroom at the Warm River Hatchery (Ashton-Island Park Ranger District, Caribou-Targhee National Forest, Intermountain Region). The Congoleum is in very good shape. The floor is spotted with flies that accumulated over the winter and have not yet been swept from the seasonal-use building.

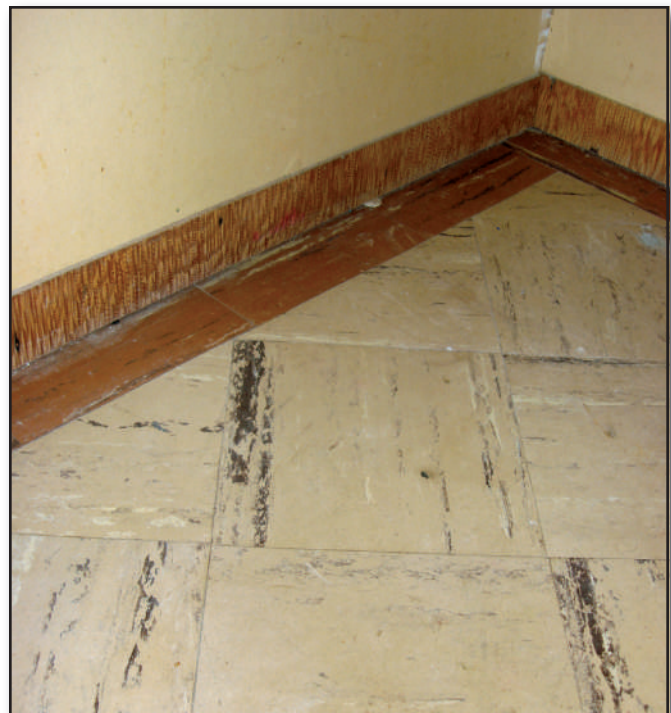
Figure 5—This asphalt tile flooring from 1951 has a darker band of tiles around the edge of the room for contrast and a plywood baseboard that was painted to look like the flooring.

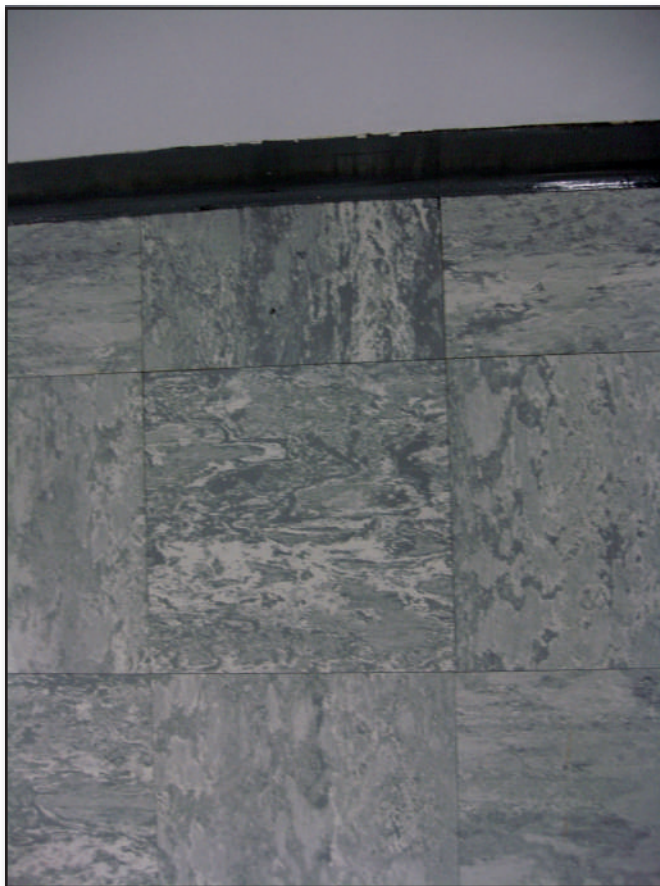
Figure 6—Although vinyl flooring can be manufactured in almost any pattern and color, this vinyl tile in the Intermountain Regional Office (Ogden, UT) is patterned to resemble gray-and-white marble.

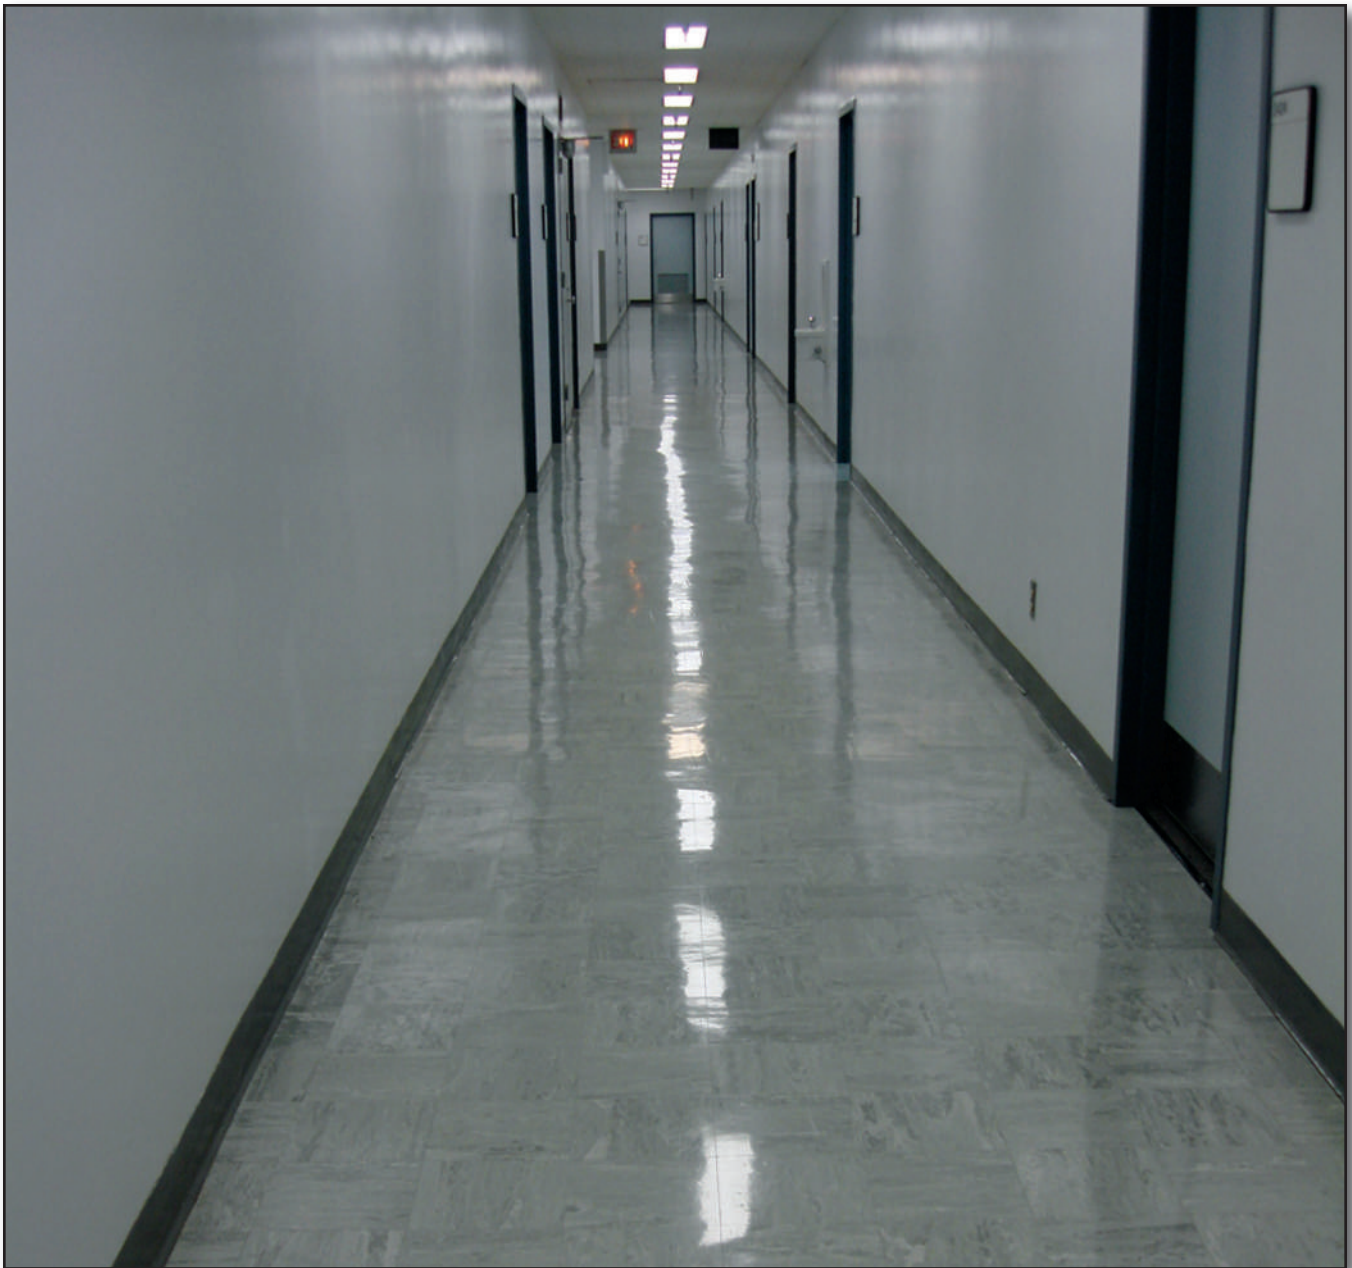
Figure 7—This vinyl flooring in the Intermountain Regional Office (Ogden, UT) has been freshly waxed and polished.

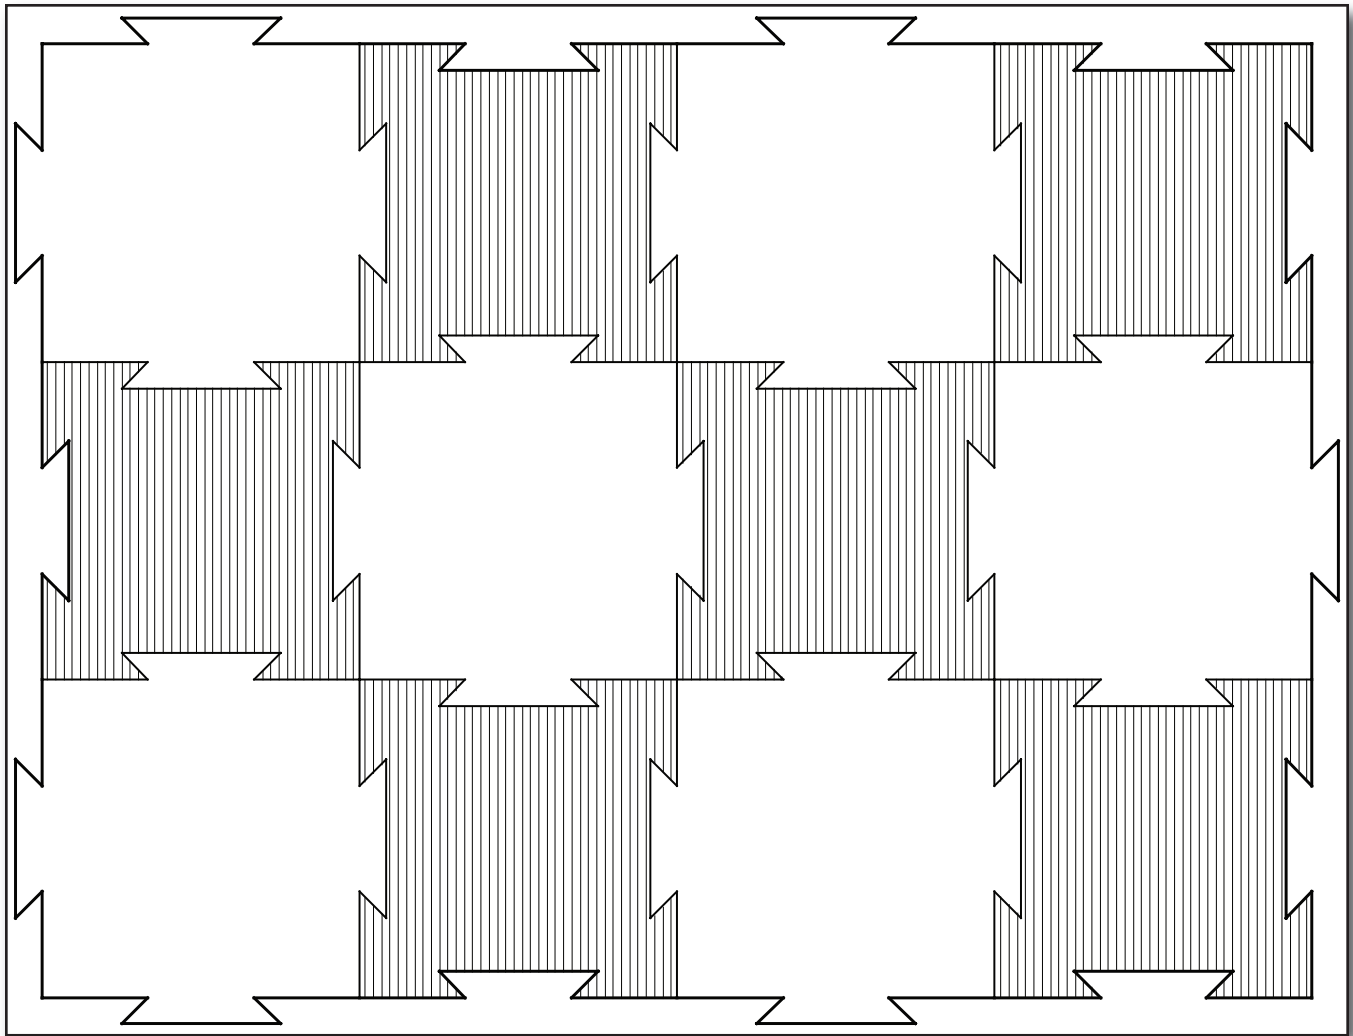
Figure 8—Rubber flooring used in the early 1900s consisted of small, interlocking tiles. The tile pattern shown in this drawing was patented in 1894 by Philadelphia architect Frank Furness.

Rubber flooring was manufactured in the mid-19th century, but its use became more common after 1894 when Philadelphia architect Frank Furness patented a system of small, interlocking rubber tiles (figure 8). By the early 20th century, several companies were producing similar tiles in square, rectangular, and triangular shapes. Tiles typically measured 2 inches square, and they could be assembled in creative, colorful mosaics. Larger tiles became available in many sizes and often were laid in checkerboard,
