# 48 PRESERVATION BRIEFS

## Preserving Grave Markers in Historic Cemeteries

National Park Service  
U.S. Department of the Interior

Technical Preservation Services

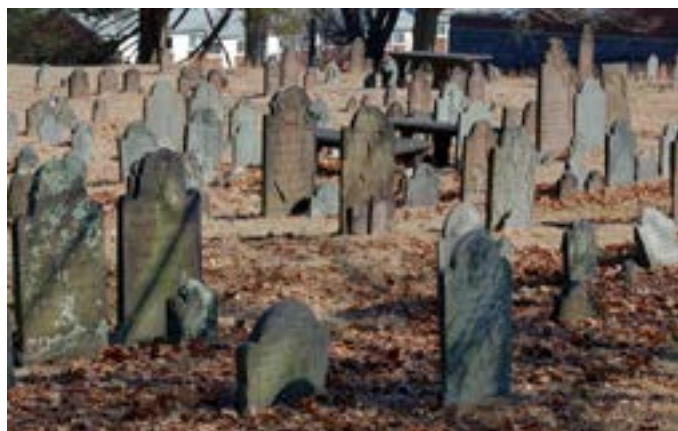
*Figure 1. Sandstone and slate grave markers in the Ancient Burying Ground in New London, CT, display a variety of weathering conditions. Markers in the cemetery date from the mid-17th to the early 19th centuries. Photo: Jason Church.*

While cemeteries are often considered to be perpetual, their most prominent feature—the grave markers—are not. They weather, naturally decay, often are poorly maintained and repaired and, on occasion, are vandalized (Fig. 1). Grave markers are usually noteworthy not only for their inscriptions but also for their craftsmanship. Exceptional markers are considered works of art.

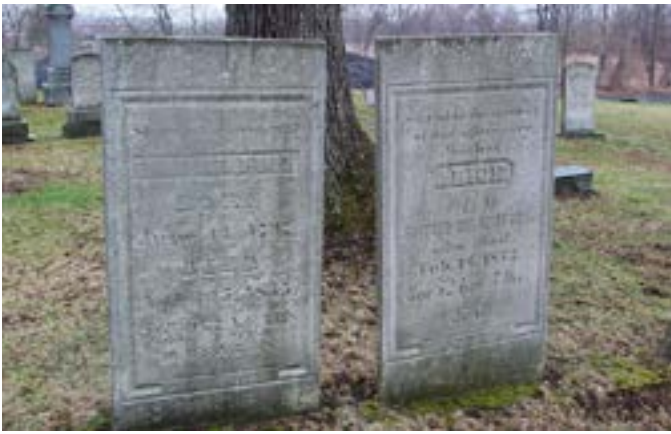
Figure 2. These mid-19th century, single-element stone grave markers in the Grove Cemetery in Bath, NY, are set in a vertical position. Photo: Jason Church.

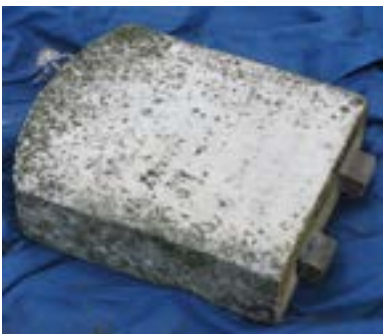
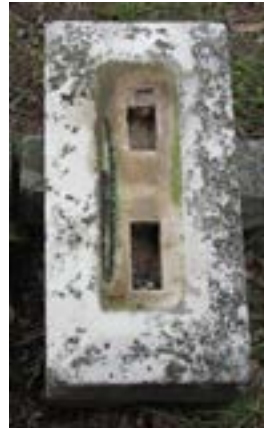
Figure 3. A multi-element grave marker from the early 19th century in the St. Michael’s Cemetery, Pensacola, FL, consists of a vertical element with tabs (left image) into a slotted base (right image). Photo: Fran Gale.

slot” grave marker, the tabbed upper stone was set in a slotted base (Fig. 3). More common today, the upper headstone is secured with a technique that uses small spacers set on the base and a setting compound. This technique or one that uses an epoxy adhesive may be found on older markers where the stones have been reset.

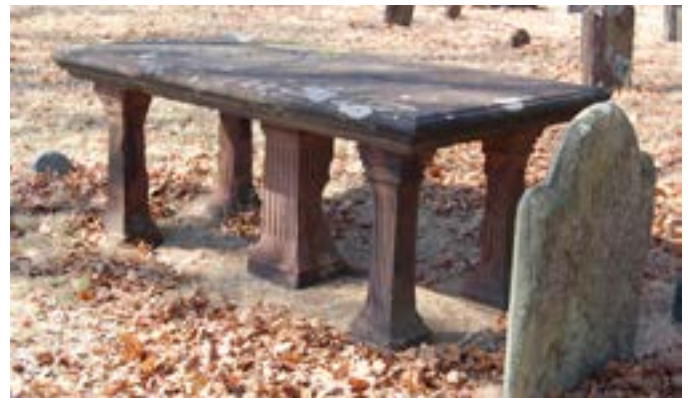
Figure 4. This sandstone table tomb, located in Cedar Grove Cemetery, New London, CT, is an engineered grave marker structure consisting of a horizontal stone tablet supported by four vertical table “legs” with and a central column,. Photo: Jason Church.

Grave markers can also be engineered structures. Examples of grave marker structures include masonry arches, box tombs, table tombs, grave shelters, and mausoleums (Fig. 4). The box tomb is a rectangular structure built over the gravesite. The human remains are not located in the box itself as some believe, but

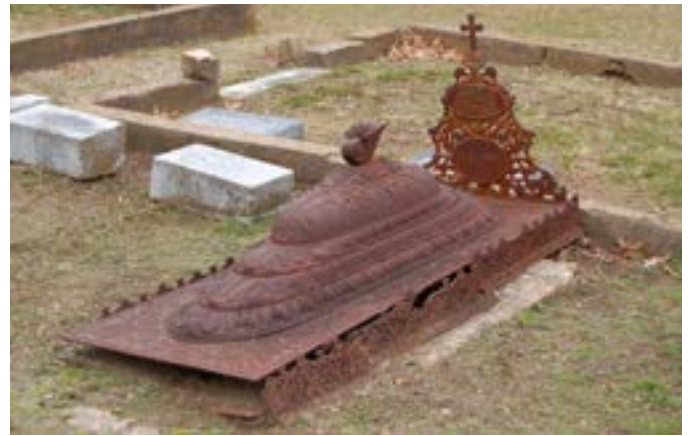
Figure 6. Decorative cast-iron grave markers like this late-19th century one in Oakland Cemetery in Shreveport, LA, are produced by heating the iron alloy and casting the liquid metal into a mold. Photo: Jason Church.

Metals are solid materials that are typically hard, malleable, fusible, ductile, and often shiny when new (Fig. 6). A metal alloy is a mixture or solid solution of two or more metals. Metals are easily worked and can be melted or fused, hammered into thin sheets, or

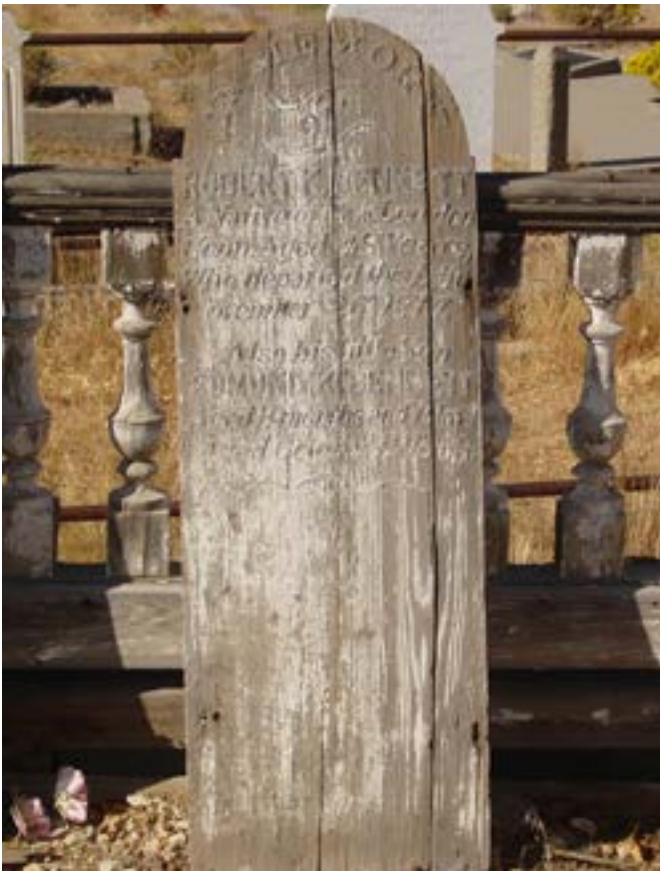
Figure 7. As shown by this 1877 marker in Silver Terrace Cemetery, Virginia City, NV, exposure to sunlight can damage wood grave markers, making the wood more susceptible to water damage and cracking. Photo: Jason Church.

and characteristics of these cells determine the wood's appearance and influence wood properties. Wood-cell walls and cavities contain moisture. Oven drying reduces the moisture content of wood. After the drying process, the wood continues to expand and contract with changes in moisture content. The loss of water from cell walls causes wood to shrink, sometimes distorting its original shape (Fig. 7).

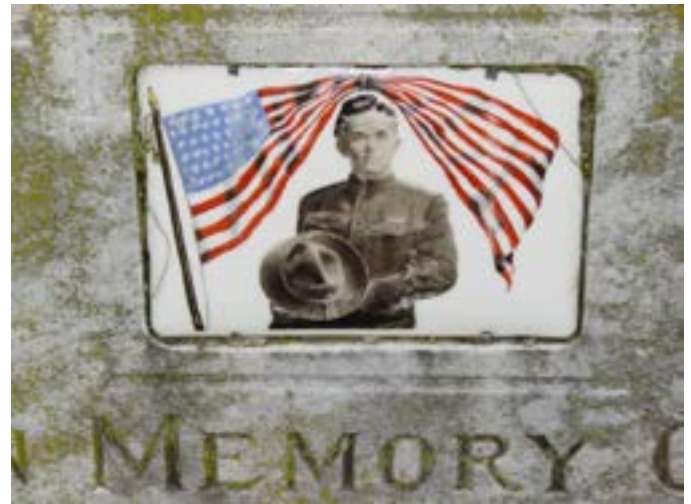
Figure 8. A fired ceramic, this cameo is set in a marble grave marker, located in Elmwood Cemetery, Memphis, TN. Different materials may require different conservation approaches. Photo: Mary Striegel.

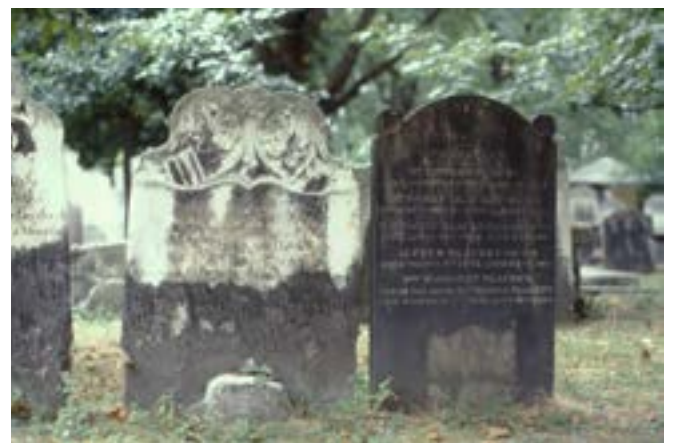
Figure 9. The limestone and sandstone grave markers in this historic cemetery have different weathering processes. On the left, the limestone shows surface loss in areas exposed to rainwater and gypsum crust formation below. The sandstone marker on the right displays uniform soiling, but surface hardening may be occurring. Photo: Fran Gale.

All grave marker materials deteriorate when they are exposed to weathering such as sunlight, wind, rain, high and low temperatures, and atmospheric pollutants (Fig. 9). If a marker is composed of several materials, each may have a different weathering rate. Some weathering processes occur very quickly, and others gradually affect the condition of materials. Weathering results in deterioration in a variety of ways. For example, when exposed to rainwater some stones lose surface material while others form harder outer crusts that may detach from the surface.

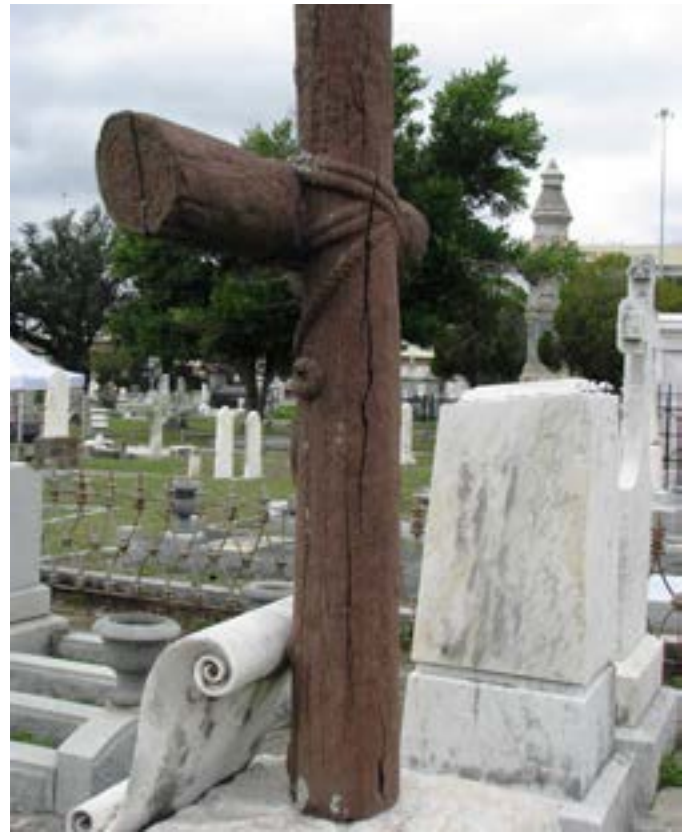
Figure 10. The sandstone cross (carved to look like wood) in this grave marker in St. Michael's Cemetery in Pensacola, FL, provides an example of inherent vice – the severe delamination affecting the sandstone has occurred along its natural bedding planes. Photo: Fran Gale.

The term “inherent vice” is used to describe a material with a naturally occurring problem that leads to premature deterioration (Fig. 10). An example of this problem is marble that has cracked due to natural locked-in stresses. Inherent vice also describes grave markers that are composed of incompatible materials, where decay is accelerated in one or both materials because of chemical interactions caused by their close proximity. An example is the galvanic corrosion that occurs when dissimilar metals, such as copper and iron, are in contact and exposed to moisture.

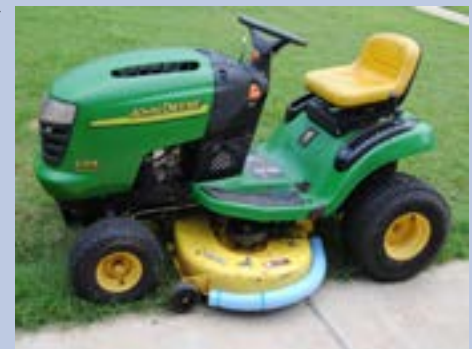
*Figure B. A pool ‘noodle’ can be fitted to the deck of a lawnmower to prevent damage to grave markers. Photo: Debbie Dietrich Smith.*

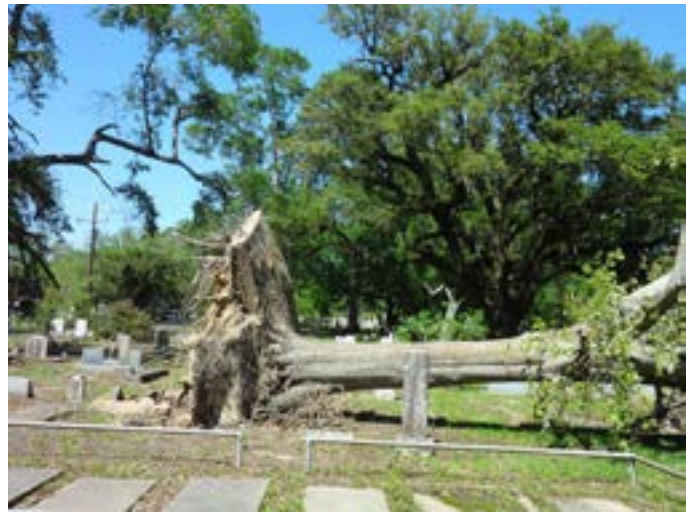
*Figure 11. Woody vegetation can damage grave markers and pose a risk to visitors unless well managed and maintained. Photo: Jason Church.*

Woody vegetation can damage grave markers in a variety of ways (Fig. 11). Trees, bushes, and vines can shade grave markers, extending the time that the markers are exposed to moisture. Tendrils and roots may burrow into mortar joints and openings, causing mechanical damage and large plants may lift up or shift markers. Even leaves and twigs, when allowed to collect on the ground near grave markers, can affect water drainage and evaporation (Fig. 12).

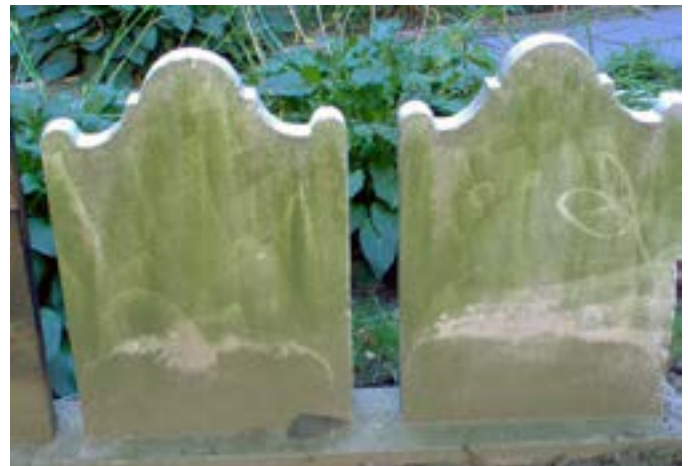
Figure 14. High-pressure water washing can damage grave markers. The photograph shows "wand marks" on the headstones produced by inappropriate pressure washing. Photo: Jason Church.

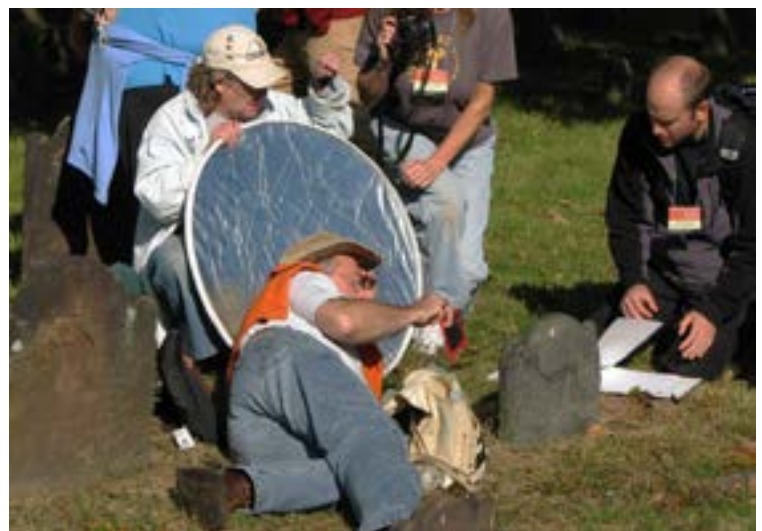
Figure 15b. Photographs are used to document the condition of the grave marker as part of a condition assessment. Photo: Fran Gale.

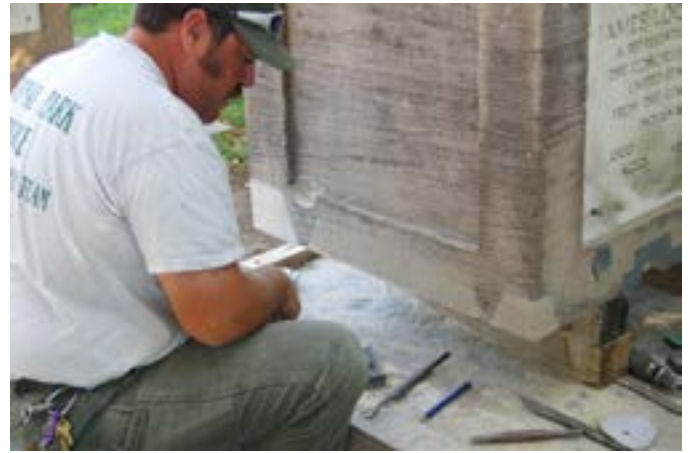
*Figure 16. A professional mason works to insert a new piece of stone. Often referred to as a “dutchman”, this repair technique requires replacing the deteriorated stone section with a new finished piece of the same size and material. Photo: Jason Church.*

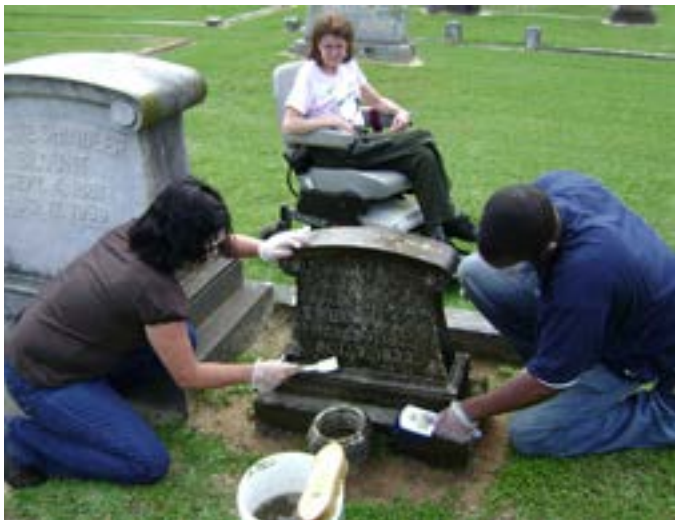
Figure 17. Volunteers can undertake cleaning of grave markers once they have received initial training. Cleaning methods may include wetting the stone, using a mild chemical cleaner, gently agitating the surface with a soft bristle brush, and thoroughly rinsing the marker with clean water. Photo: Jason Church.

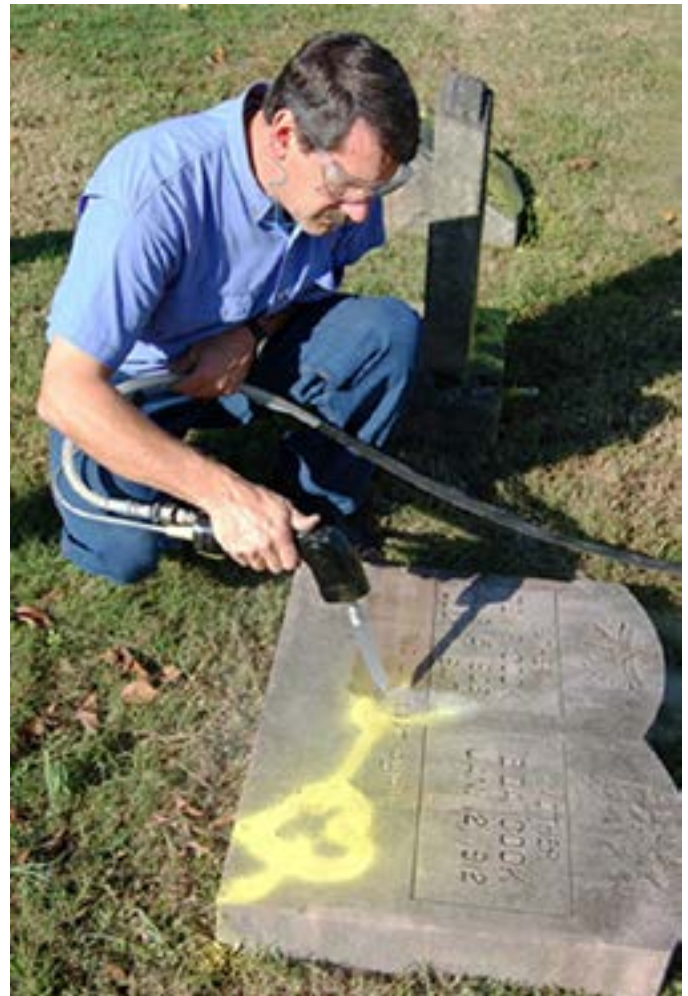
Figure 18. Graffiti is carefully removed using a low-pressure dry-ice misting instrument. Photo: Jason Church.

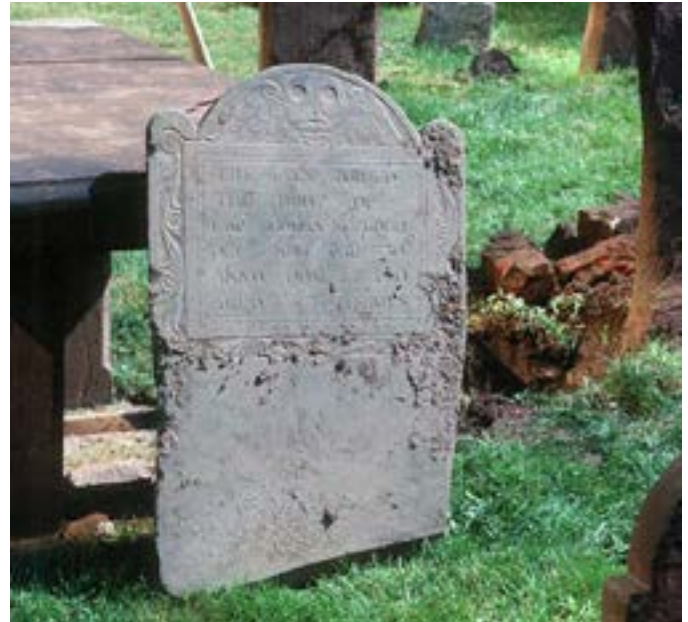
Figure 20a. This slate grave marker in the Ancient Burying Ground in Hartford, CT, is a ground-support stone. Resetting requires digging a hole that will hold the base of the stone and then compacting the soil at the bottom of the hole by hand. Photo: Fran Gale.
