# REVIEW OF STRUCTURAL MATERIALS AND METHODS FOR HOME BUILDING IN THE UNITED STATES: 1900 to 2000

REVIEW OF STRUCTURAL MATERIALS AND METHODS FOR  
HOME BUILDING IN THE UNITED STATES: 1900 to 2000

NAHB Research Center, Inc.  
Upper Marlboro, MD

January 25, 2001

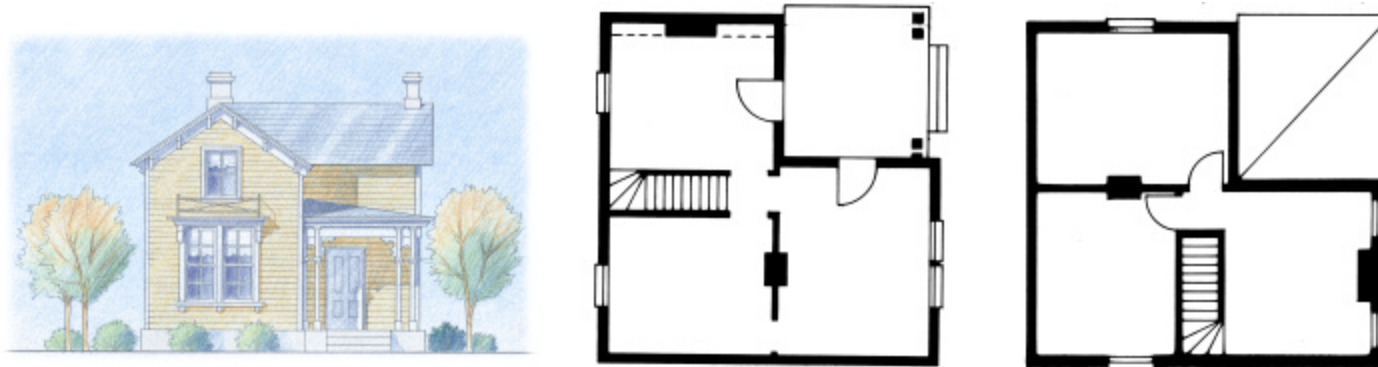
Figure 1. Profile home in 1900 (2 story).<sup>2</sup>

The front elevation and floor plan of a typical home produced in 1900 is shown in Figure 1. Good examples of traditional housing styles and architectural plans in the early 1900s are found in catalogues produced by Sears, Roebuck and Co., a major producer of traditional American kit homes from about 1910 into the early 1930s (see Bibliography). Likewise, it should be recognized that a large portion of the public lived in rural areas that were not subject to municipal building codes, and housing needs were likely fulfilled in a variety of ways that may not be well documented in the popular literature on housing construction. For example, in *Cotton Field's No More* it is stated that "more than half of the farmers lived in one- and two-room shacks that had not been whitewashed or painted for many years, if ever. Many of these houses had holes in the roof, wall, and floor." Further, U.S. Census data for 1900 reports that the value of land and buildings per farm in eleven Southern states ranged from \$600 to \$2,000. By contrast, the values for Indiana and Kansas were \$6,550 and \$3,718, respectively. Thus, living conditions and housing varied widely in the early 1900s.

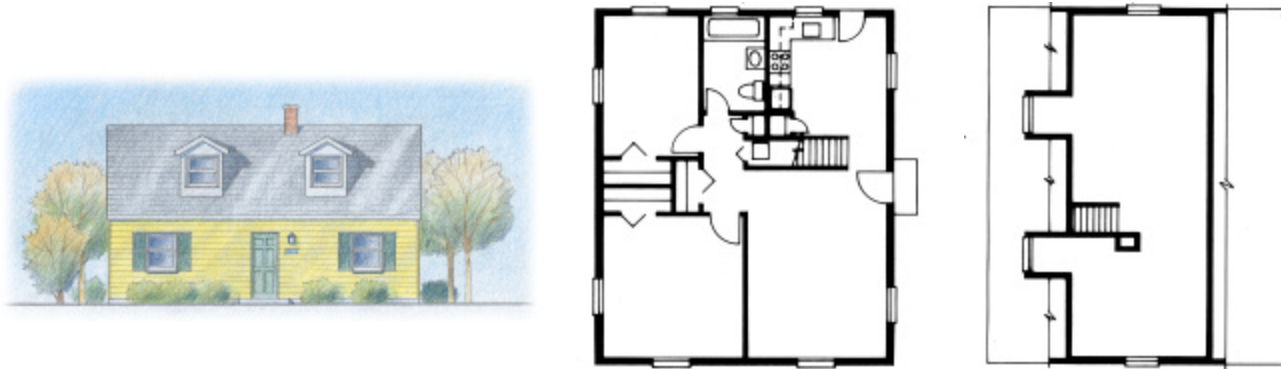
**Figure 2. Profile home in 1950 (upper 1/2 story optional).**

By the mid-1900s, the use of standardized products, materials, and methods of constructing homes had become fairly mature. In particular, lumber grading and sizes had become essentially uniform across the country. Much of the standardization in home building may be attributed to the Federal Housing Administration (current day Department of Housing and Urban Development) with its Minimum Property Requirements (MPRs) which were applied across the country following WWII, and which were eventually superseded by a first edition of the *Minimum Property Standards* (MPS) in 1958. At this point, the older “rules-of-thumb” were giving way to prescriptive construction requirements (e.g., span tables, construction specifications, etc.) that were based on practical as well as basic technical (engineering) criteria. Newer materials such as plywood sheathing were addressed as well as standard construction details. This document was, in the opinion of the author, one of the best organized, instructive, and comprehensive building standards developed in the United States.

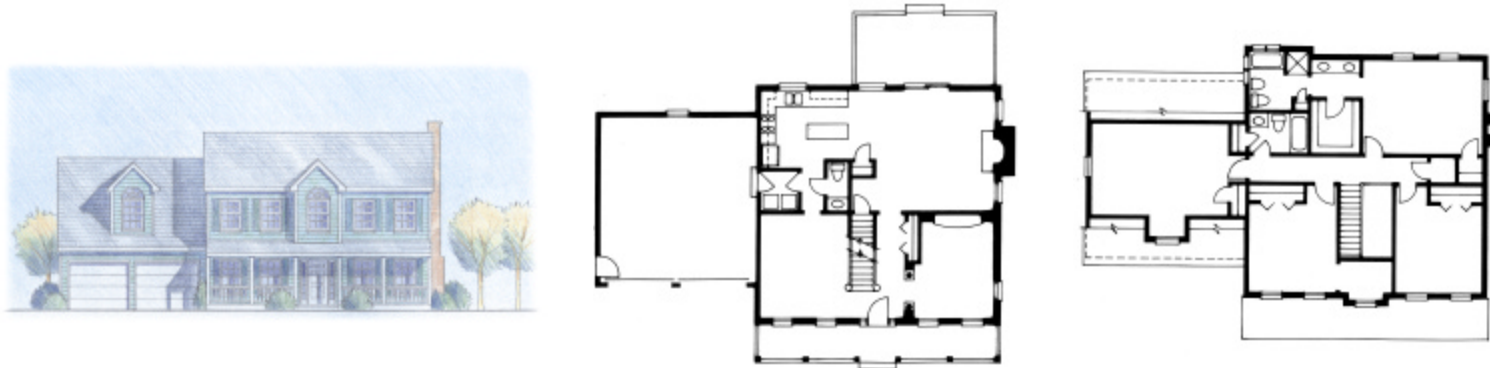
Figure 3. Profile home in 2000 (2 story).

The front elevation and floor plan of a typical home produced in 2000 is shown in Figure 3.

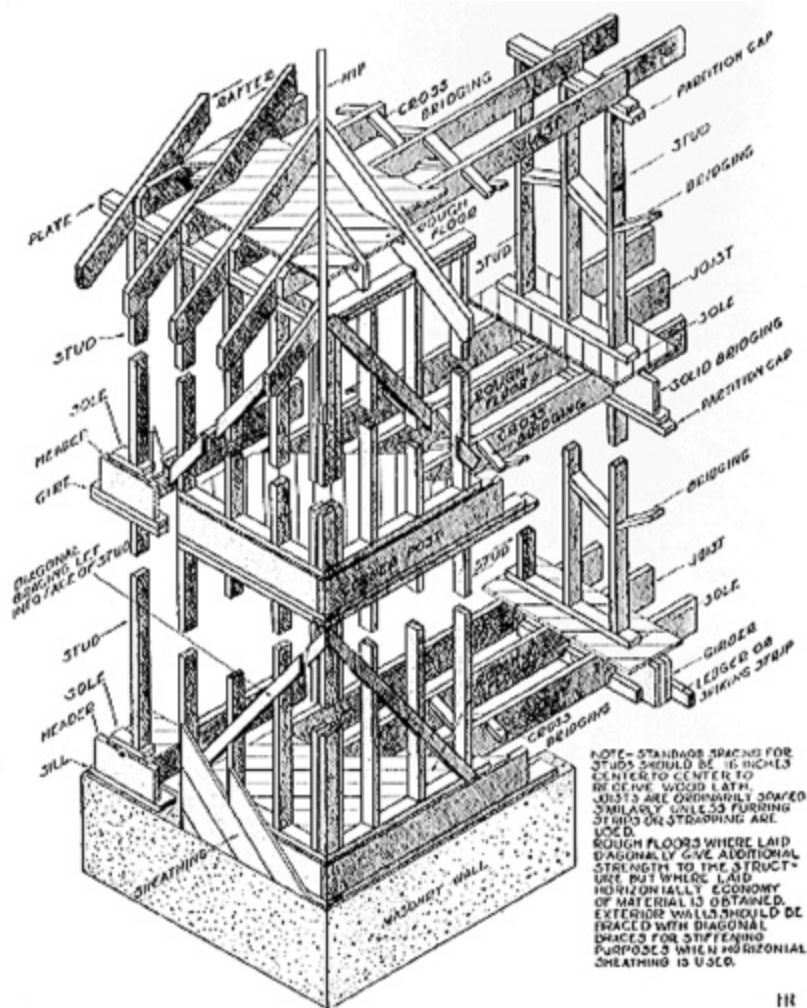
**Figure 6. Platform Framing.**

By the mid-1900s and during the housing “boom” following WWII, the preferred framing practice had evolved to platform framing, a further refinement of balloon framing. Platform framing is shown in Figure 6. This change was driven by economy and practicality. For example, balloon framing required the use of long wall framing members (studs) which were more expensive and less available. Also, balloon framing required fire blocking between wall framing at story levels to comply with modern building codes (initiated in the 1920s). In contrast, platform framing is inherently fire blocked by the use of horizontal wall plates at the top and bottom of each story. In addition, the balloon frame approach was essentially limited to “regular” two-story construction and did not readily allow for newer housing styles that featured story offsets (i.e., floor overhangs) and other “irregularities” in design. Finally, the platform framing technique provides a solid and safe work platform from which to stage construction for upper stories. Platform framing has dominated the housing market since the mid-1900s with a few refinements as follows:

Note: Platform framing in Figure 6 is representative of early platform framing. Platform framing in the mid- to late-1900s used panel products in lieu of board sheathing and bridging in floors and walls was eliminated.
