# Water Well Maintenance and Rehabilitation

**Water wells require regular maintenance to ensure adequate water flow and optimum water quality.**

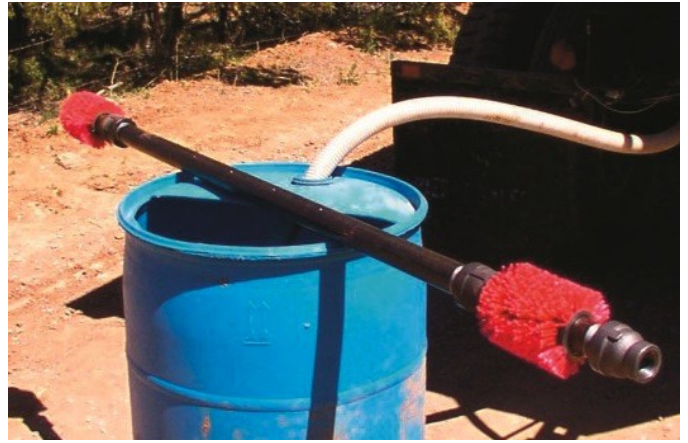
Brush to be attached to drilling rig as one method of physical rehabilitation.

Physical methods include using a brush attached to a drilling rig, high pressure jetting, hydrofracturing, and well surging.

The latter three techniques all include injecting water (and sometimes chemicals) into the well under extreme pressure. Sometimes contractors will use a combination of these methods depending upon the reason(s) for the decrease in well performance.

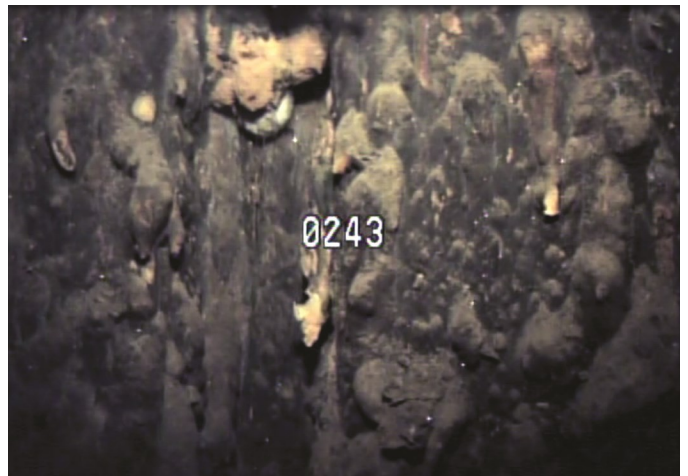
Well video image showing heavy biological and scale fouling, completely covering the screened section of the well.

Chemical and biological incrustation are common causes of well failure. Incrustations are physical obstructions which develop on well screens and rock fractures or openings delivering water to the well screen or borehole.

In severe cases, the obstruction to flowing water can render the well useless. Major forms of incrustations can occur from build up of calcium and magnesium salts, iron and manganese compounds, or plugging caused by slime producing iron bacteria or other similar organisms (bio-fouling).

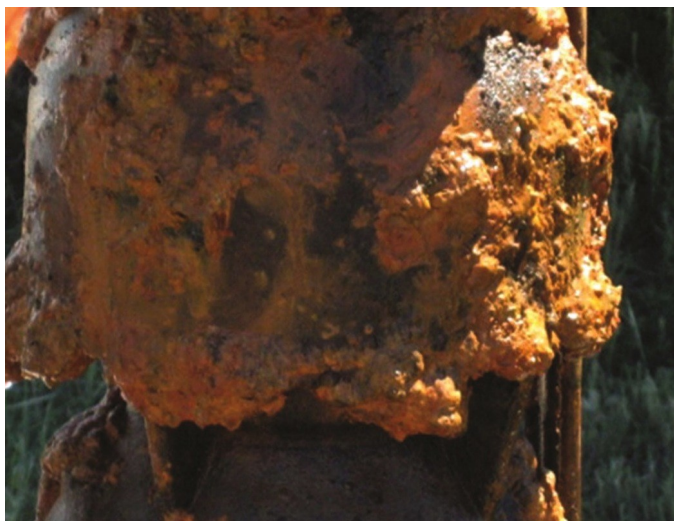
A submersible pump being pulled from a well exhibiting iron oxide, iron bacteria and biofilm.

The primary cause of bio-fouling, or biological clogging, of well screens and rock fractures is attributed to iron bacteria. These and other similar bacteria create a slimy, voluminous "biomat".

Rapid growth of these bacteria can quickly clog well screen pores and render a well virtually useless in a matter of months. Once iron bacteria become established in a well, they are

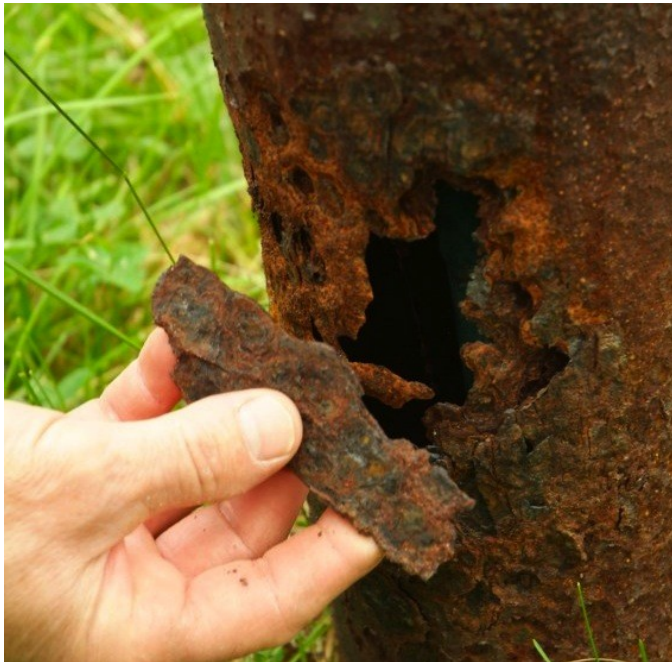
Hole in casing caused by corrosion.

Corroded and enlarged well screen holes may lead to sand pumping, which in turn results in abrasive deterioration of pump parts and enlarged screen openings leading to excessive sediment velocities.

In this case, abrasive materials carried in high velocity flows can lead to erosion of the screen openings. A screen or well casing that has undergone significant corrosive deterioration may collapse altogether. A final negative impact of well

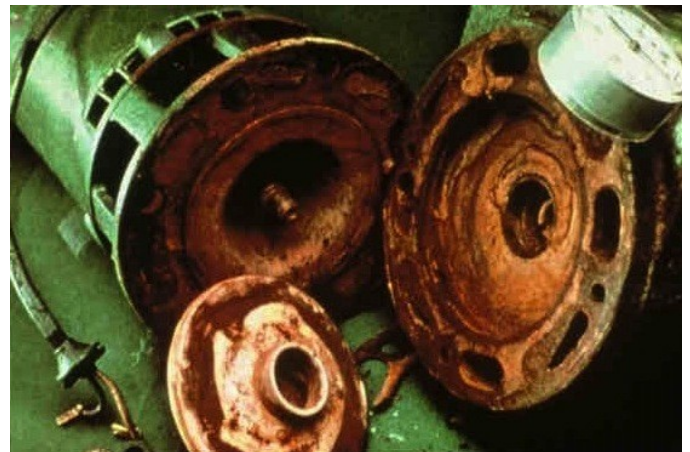
Abrasion caused by pumping sand.

Abrasive deterioration resulting from sand pumping is the leading cause of pump failure.

Excessive sediment concentrations in well water can be brought about by inadequate initial well development, absence of a well screen in a loose rock formation, oversized screen openings, excessive well screen entrance water velocities resulting from undersized openings, or well screen corrosion.
