The Use of Awnings on Historic Buildings: Repair, Replacement and New Design

NPS Preservation Brief 44

By Chad Randl

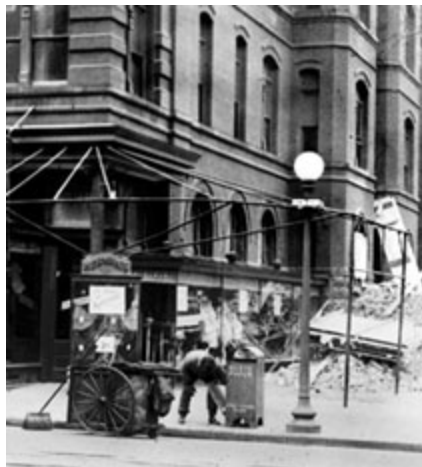
During the second half of the 19th century, iron plumbing pipe became a popular material for fixed awning

frames. Here, a pipe frame without its canvas cover extends around the corner of a building in Washington, D.C. Photo: Library of Congress, Prints and Photographic Division, LC-USZ62-121160.

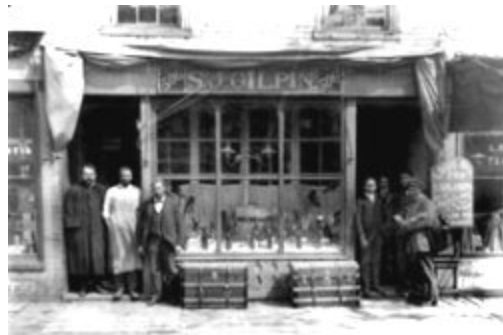
A 19th century shoe store in Richmond,

Virginia had an operable awning retracted against the building facade. Hinged extension arms were raised and lowered allowing for an awning configuration easily changed in response to weather conditions. This photo shows how the fabric gathered and was exposed to the elements when retracted - part of the reason roller awnings later became prevalent. Photo: Library of Congress, Prints and Photographic Division, LC-USZ62-99053.

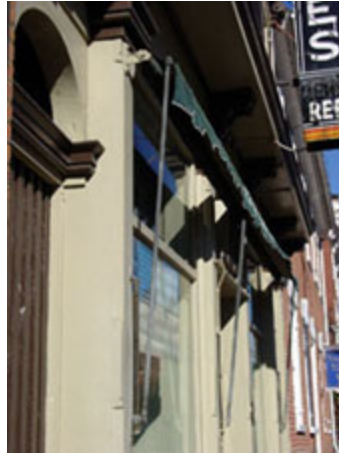
The roller bar at the top of a fixed-arm awning is cranked to release the fabric. As the canvas unfurls the vertical arms swing downward from their lower point. Because the pictured

awning had a large projection, extending far from the building wall, the lower hinges were mounted on vertical slide rods affixed to the facade. When the awning is lowered, the bottom hinges of the arms travel up the slide rod to increase headroom beneath the fully extended awning. Photo: NPS files.

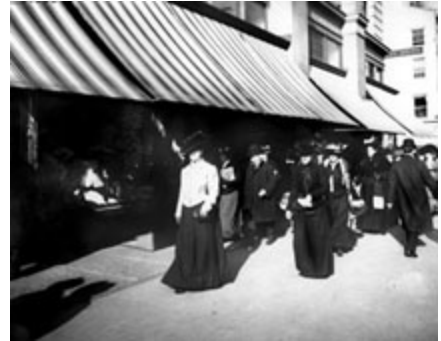
A wide selection of striped patterns took the awning beyond its original, utilitarian function

to serve as a decorative and appealing building feature. Photo: Library of Congress, Prints and Photographic Division, LC-D4-62072.

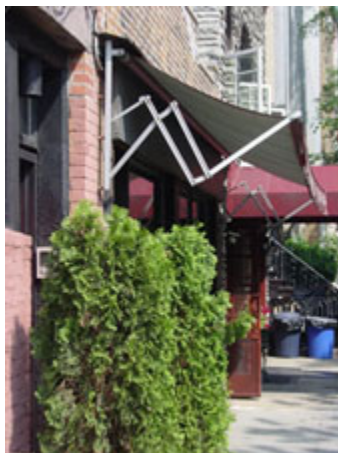
Scissor arm awnings have a pair of vertical, hinged arms on either side of the assembly supporting

ing the front bar. To unfurl the awning, the roller is cranked and the arms extend outward pulling the cover away from the roller.

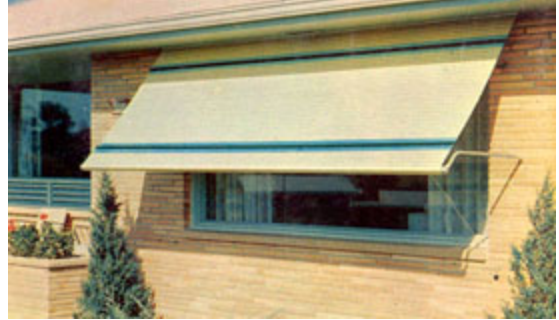
The years after World War II saw the widespread adoption of aluminum awnings on both storefronts and residences. Operable aluminum awnings incorporated a spring-loaded roller into the frontbar. Photo: NPS files.

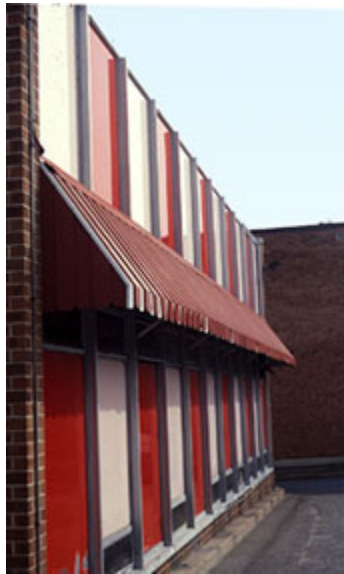
This 1950s-era dry cleaner has an aluminum awning that, with its vertical pattern and alternating stripes, complements the facade's porcelain enamel panels and aluminum mullions. The awning forms an essential element of the building's historic character. Photo: NPS files.

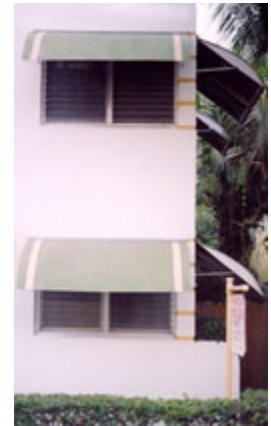
These fiberglass "clamshell" awnings, although not as old as the 1930s building to which they were affixed, are important features that have acquired significance. They were retained when the building was recently rehabilitated. Photo: NPS files.

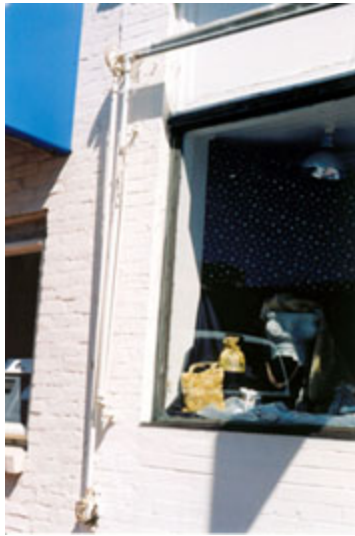
A gearbox, slide rod, roller, front bar, and extension arm reveal that this 19th century facade once featured a retractable awning. It is likely that with minor repairs the surviving hardware could again be made operable, recovered with a canvas or acrylic fabric, and reused to service the storefront. Photo: NPS files.

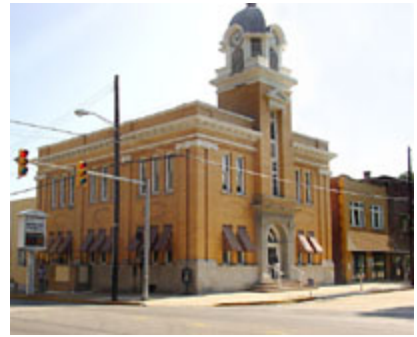
Using the historic photo as a guide (see photo, above,

left), new awnings with a similar shape and stripe pattern were installed increasing the comfort of employees and protecting county records from direct sunlight. Photo: NPS files.

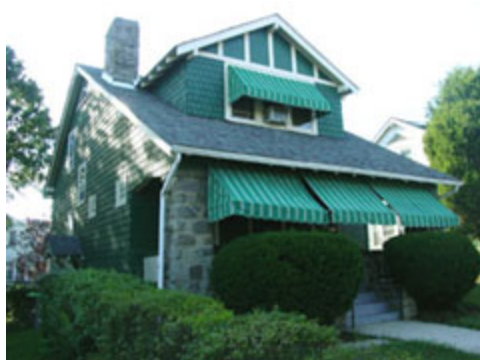
Simple shed-type awnings with acrylic or canvas coverings and free-hanging valances are appropriate for most historic residences featuring rectilinear openings. Photo: NPS files.

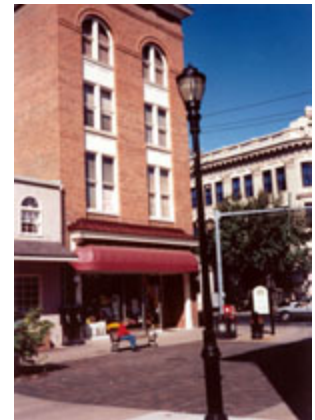
A dome awning was an inappropriate addition to this circa 1890s building. In order to qualify for historic tax credits the new vinyl awning was replaced with a shed awning with a canvas-like woven acrylic covering. Photo: NPS files.

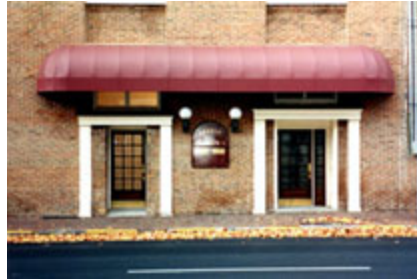
Single awnings should not be set over more than one door or window bay. A separate shed awning with a canvas or acrylic covering would be more appropriate over each of these openings. Photo: NPS files.

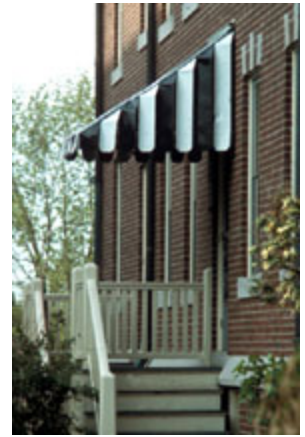
This postwar aluminum awning does not contribute to the character of this 19th century residence and could be replaced during a rehabilitation project with a fabric shed awning more in keeping with the building's age and appearance. Photo: NPS files.

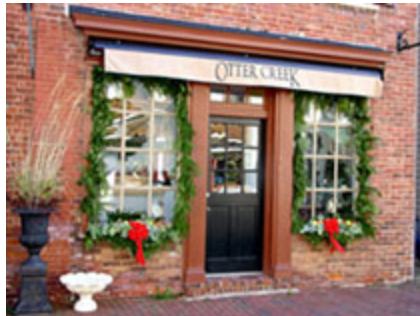
Appropriate lettering, as on this roller awning valance, can function as distinctive signage without detracting from the historic character of the building. Photo: NPS files.

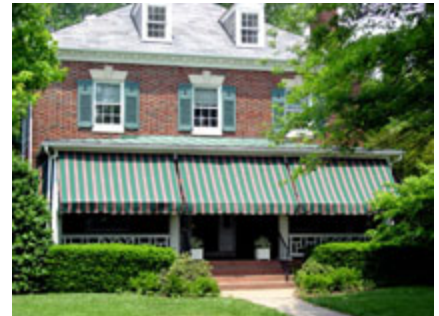
The green and burgundy stripes that decorate these porch awnings complement the matching shutters and brick facade. Photo: NPS files.
