Repairing Historic Flat Plaster Walls and Ceilings

[nps.gov/tps/how-to-preserve/briefs/21-flat-plaster.htm](https://www.nps.gov/tps/how-to-preserve/briefs/21-flat-plaster.htm)

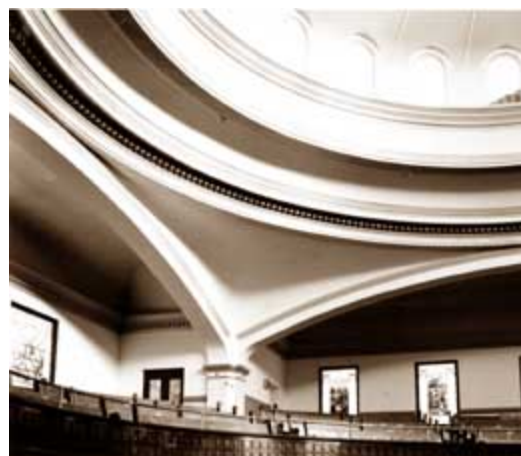
Plaster was used as the interior surface coating of this elegant 1911 church located in Eugene, Oregon. Photo: NPS files.

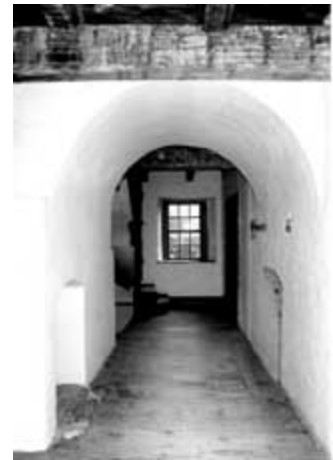
Schifferstadt, a simple house of German origin that dates to 1756, utilized plaster for both flat and curved walls. The building is located in Frederick, Maryland
Photo: NPS files.

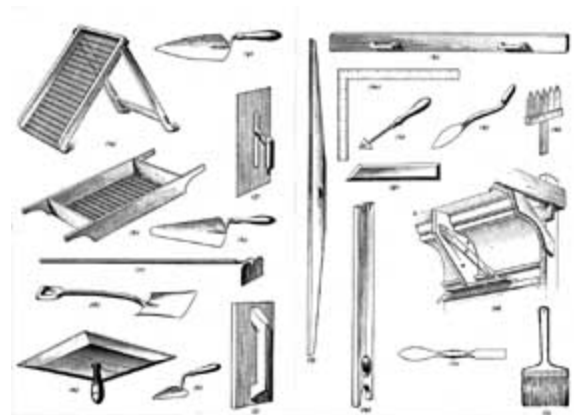
Many of these traditional plastering tools are still used today. Drawing: NPS files.

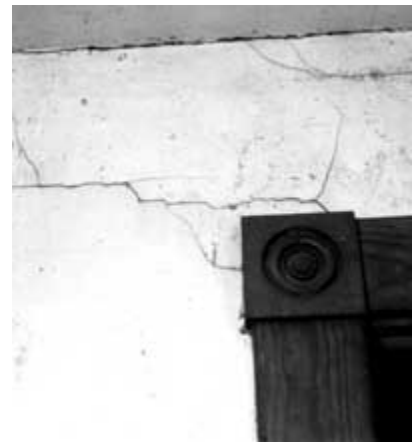
Stress cracks in plaster over a kitchen door frame can be repaired using fiberglass mesh tape and joint compound.

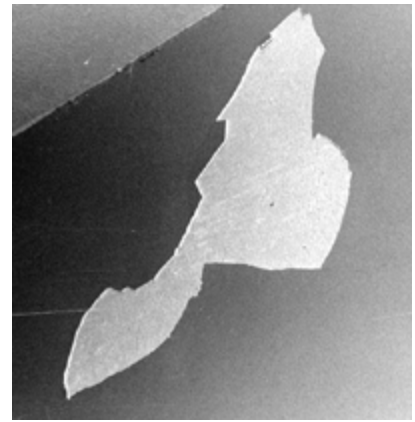
The smooth-trowled lime finish has delaminated from the brown coat underneath. Photo: Marylee MacDonald.

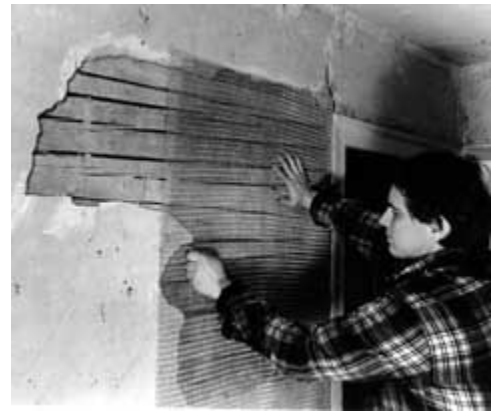
In this New Hampshire residence dating from the 1790s, the original plaster was a single coat of lime, sand, and horsehair applied over split lath. A one-coat repair, in this case, is appropriate. Photo: John Leeke.

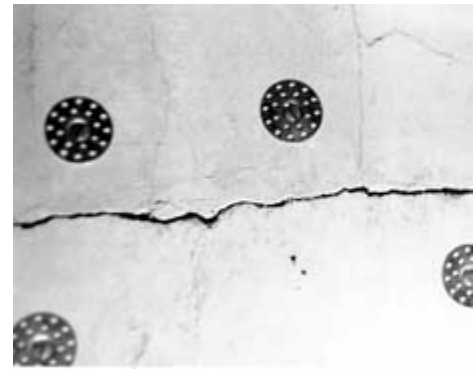
Flat-head wood screws and plaster washers were used to reattach loose ceiling plaster to the wood lath. After the crack is covered with fiberglass mesh tape, all will be skim-coated with a patching compound. Photo: John Obed Curtis.

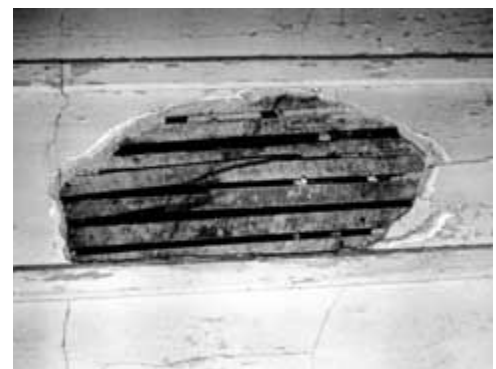
This beaded ceiling in one of the bedrooms of the 1847 Lockwood House, Harpers Ferry, West Virginia, is missing portions of plaster due to broken keys. Photo: NPS files.

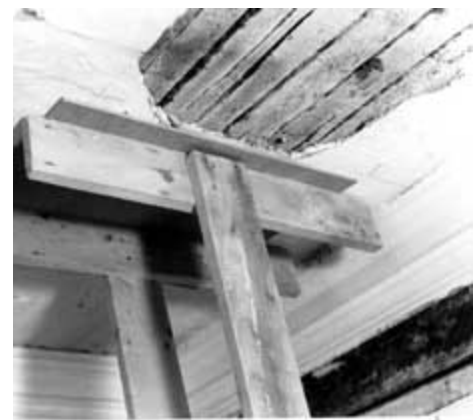
When ceiling repairs are made with wet plaster or with an injected adhesive mixture, the old loose plaster must be supported with a plywood brace until re-keying is complete. Photo: John Leeke.
