Tobacco-Juicing

How Biological Runoff Can Affect the Look of Shingles

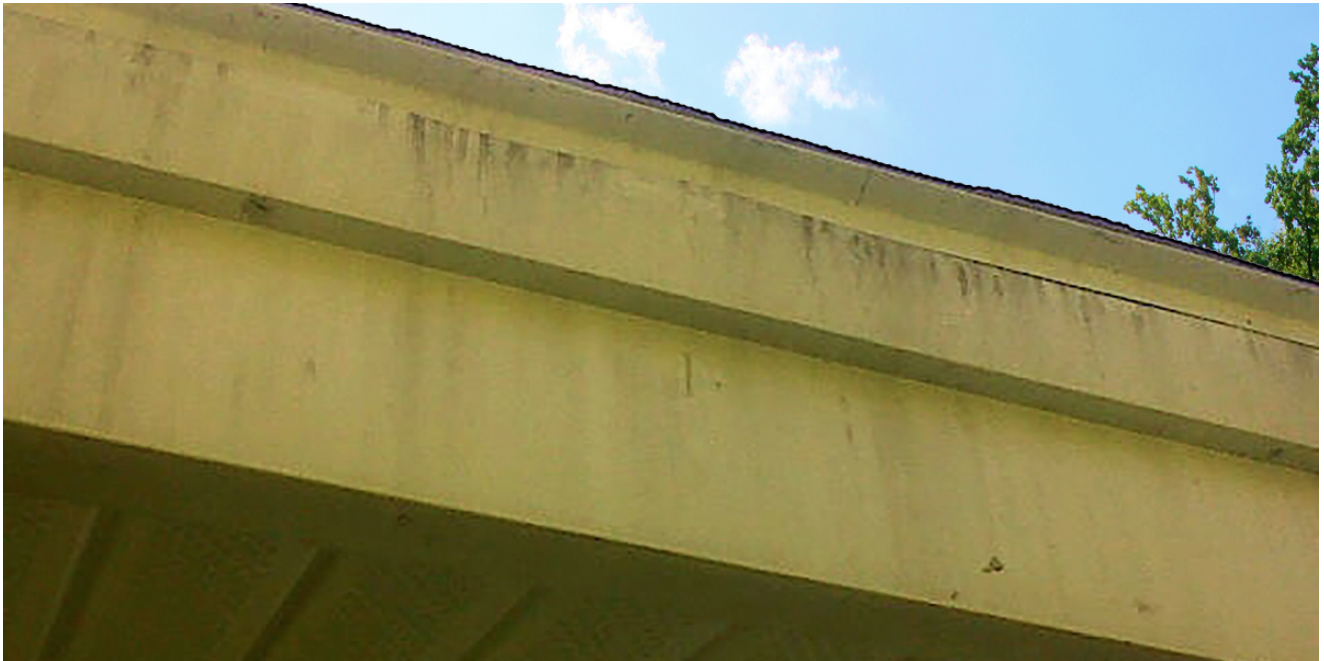
Roofers are all too familiar with the unsightly stains caused by algae, but there's also a lesser known, naturally occurring phenomenon that can affect the look of shingles, known as "tobacco juicing."

So named for its brown color, "tobacco juice" residue is attributed to the weathering of asphalt roofing. The phenomenon has been attributed to environmental contamination, including biological runoff and/or pollutant deposits, such as excessive air pollution accompanied by nighttime dew conditions and a prolonged lack of rain.

Air pollutants can collect on roof surfaces as dew is forming, then run down onto lower areas, including the fascia and siding. While the residue typically does not affect the performance of the roof, it can continue to accumulate until the surfaces are washed off or a significant rainfall occurs.

- Add or retrofit the drip edge at the eaves and rakes where not previously installed. (Note: The drip edge should have a well-defined kick edge, ensuring that runoff will be diverted away from the residence.)
- Install gutters to capture and divert the runoff.
- Extend the overhang of shingles at the eaves and rakes to the maximum length identified by manufacturer instructions (typically up to ¾") to allow runoff to fall away from the structure.
- Require edge metal with a drip lip on parapet walls where the metal slopes outward, is rounded and has no existing lip on the outside edge to assure the residue-laden runoff will fall away from the building.

During long, dry periods — especially the first summer after installation — Atlas also recommends regularly hosing down the roof, but resist the urge to power wash the shingles. (Note: This is not recommended without proper fall protection in place or where steps have not been taken to protect exterior surfaces that may come into contact with the wash-off, such as siding on a house without gutters.)

In addition, if the fascia is already stained, Atlas recommends painting it with an exterior silicon-based paint with mold and/or algae inhibitors.
