Septic Systems and Nutrients

STATE OF MICHIGAN, DEPARTMENT OF ENVIRONMENTAL QUALITY

Nutrient Framework to Reduce Phosphorus and Nitrogen Pollution

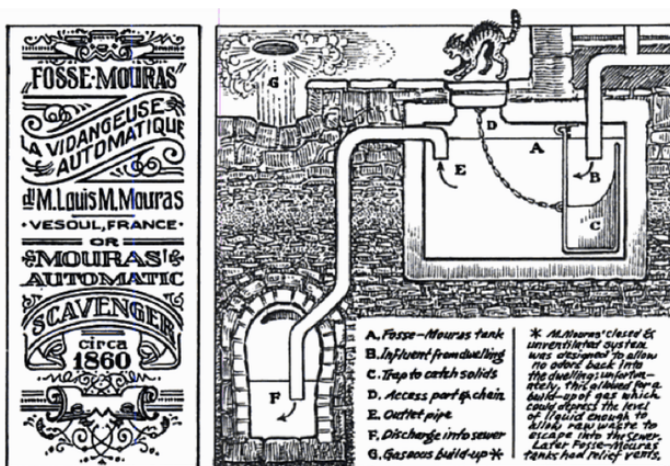
Fig 1. Schematic of an early-design septic tank from 1860.
(from <http://djwl.co.uk/blog/brief-history-septic-tanks/>)

The invention of the first septic tank is often credited to a Frenchman by the name of Jean-Louis Mouras in 1860 (Fig. 1). Mouras invented a tank for waste disposal with the idea that storing the solid wastes would be a better disposal method than discharging them straight into the nearest waterway. Which, up until then, had been the preferred method of waste disposal. The first septic tank was later installed in the U.S. in 1883. Some 50-60 years later, drainfields or "soakaways" were recognized as being necessary for the liquid effluent that left the tank. Today, the basic design and concept of the septic tank system has changed little from its earlier prototypes.

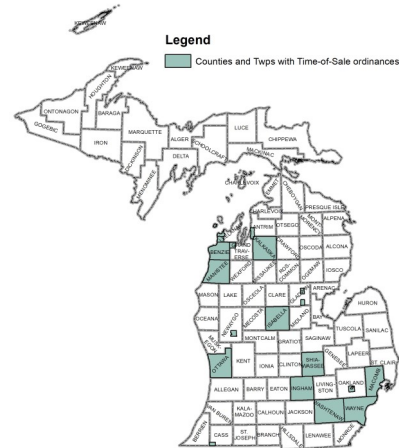
Figure 4. Counties and municipalities that currently have time-of-sale/time-of-transfer ordinances requiring septic system inspections.

Michigan is the only state that does not have a state-wide regulation for small (<10,000 gallon/day) septic systems. Rather, local county health departments are responsible for ensuring that septic systems are designed and functioning properly. A goal of the Michigan Department of Environmental Quality's (MDEQ) Office of the Great Lakes 25-year water strategy is to enact a state-wide septic code. Currently, 10 counties, 8 townships, and 1 village in Michigan have adopted time-of-sale/transfer ordinances (Fig. 4).
