# THE EFFECTS OF ULTRAVIOLET RADIATION ON PVC PIPE

**UNI-TR-5-03**

**Uni-Bell PVC Pipe Association**

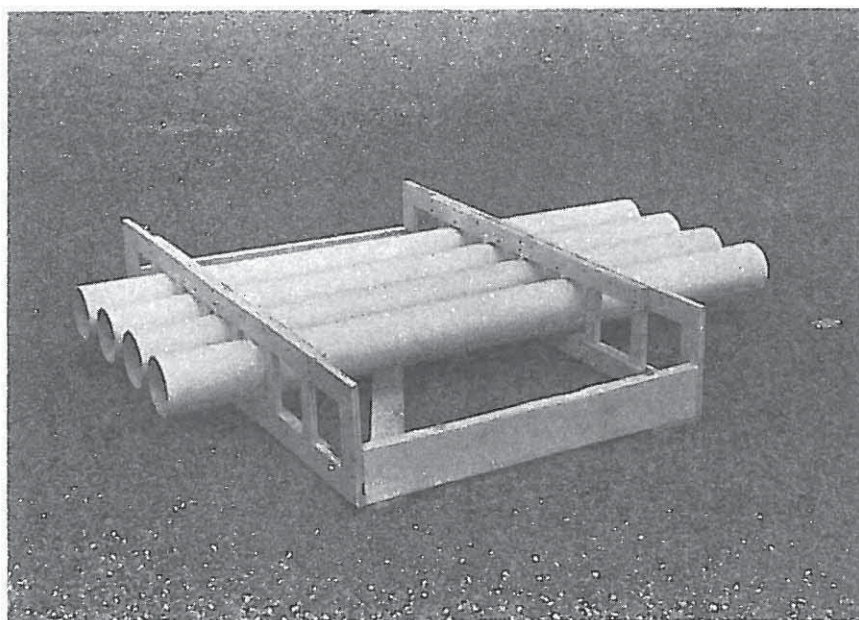
**FIGURE 1**  
**UNSHADED ROOF-TOP EXPOSURE AREA**

The remaining 10 pipe samples from each test lot were mounted horizontally on specially designed elevated exposure racks and placed in unshaded outdoor areas. In most cases, flat roof tops afforded maximum exposure and assured non-disturbance throughout the testing period. Each exposure rack was designed to provide for parallel spacing of the pipes to minimize shading of adjacent pipes. Figures 1 and 2 show some typical exposure racks of pipe. All northern exposure sites utilized elevated racks to either prevent or minimize snow cover during the winter months.

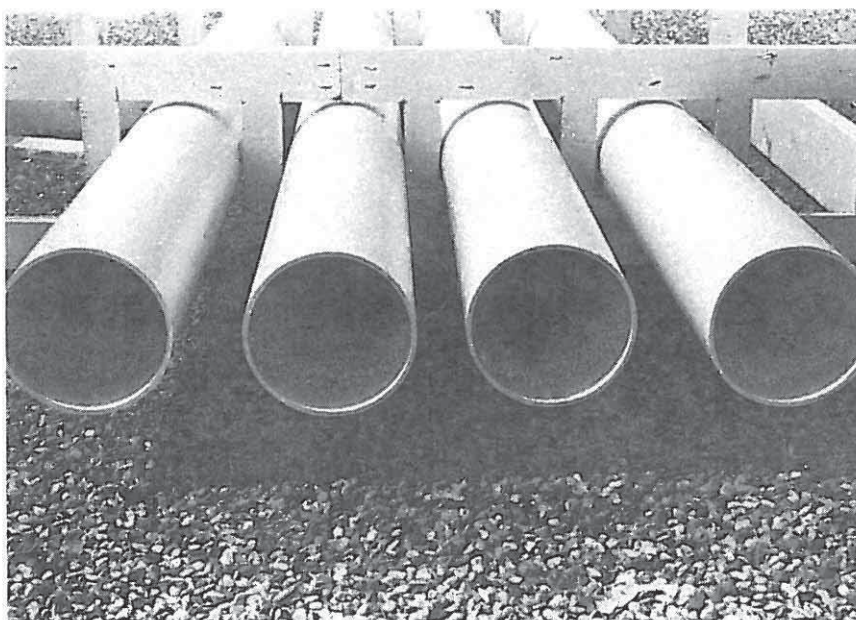
**FIGURE 2**  
**PIPES SPACED IN STORAGE RACK TO MAXIMIZE**  
**EXPOSURE TO SUNLIGHT**

Figure 3 shows the locations of 12 sites where the UV exposure of 130 lengths of PVC pipe took place. Ten pipe lengths were stored at each location except for Denver, Colorado, where 20 pipes were aged. The test locations provided exposure to a broad range of climatic conditions that ranged from hot and dry to cold and humid. All pipe samples were positioned in the exposure racks with the print side down, i.e., the identifying pipe marking which is stamped on the pipe. Thus, the side of the pipe opposite to the printed side could be easily identified as the side of maximum UV exposure after removal from the rack.

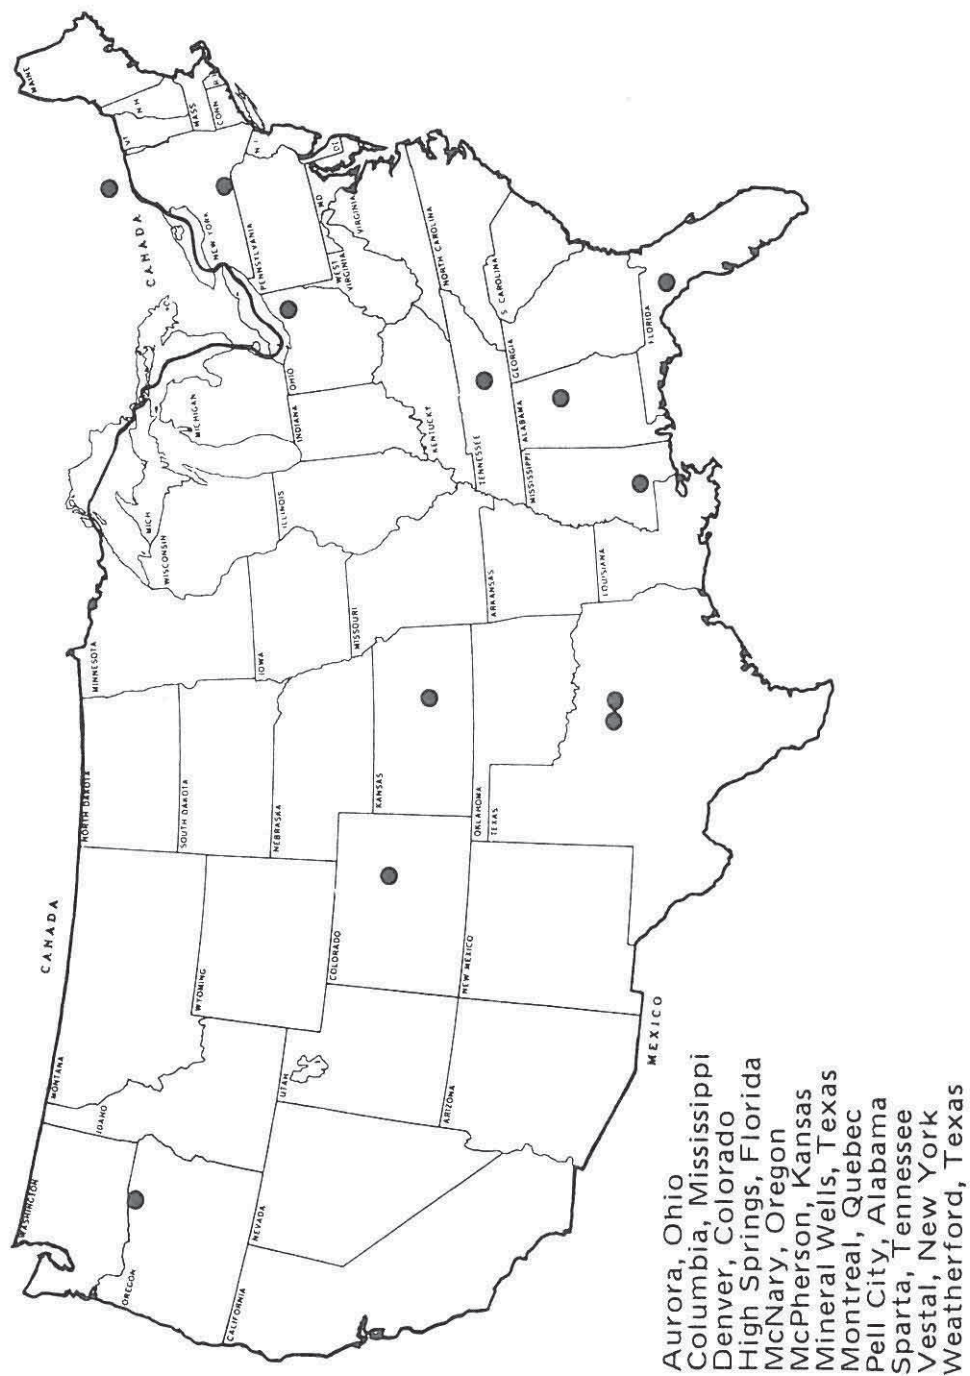
**FIGURE 3**  
**LOCATIONS OF THE 12 UV AGING SITES**

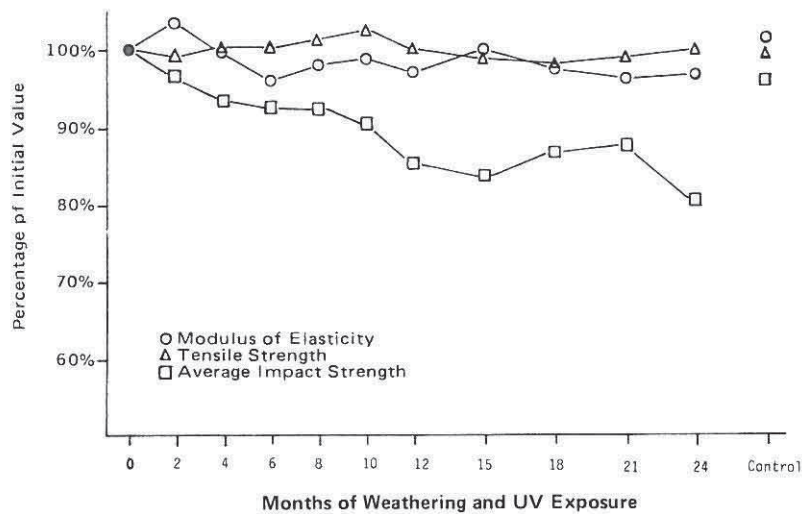
**FIGURE 4**  
**GRAPHICAL REPRESENTATION OF MECHANICAL PROPERTY**  
**CHANGES OVER THE 24-MONTH EVALUATION PERIOD**

Figure 4 is a graphical representation of the information given in Table 1.

<b>Aging Period (Months)</b>	<b>Average Impact Strength, (%)</b>	<b>Modulus of Tensile Elasticity, (%)</b>	<b>Tensile Strength, (%)</b>
2	-3.7	+3.2	-1.3
4	-7.0	-0.8	0.0
6	-7.6	-4.3	0.0
8	-7.9	-2.2	+1.0
10	-9.7	-1.4	+2.0
12	-14.7	-3.1	-0.3
15	-16.7	-0.3	-1.5
18	-13.5	-2.7	-2.3
21	-12.8	-4.2	-1.5
24	-20.3	-3.9	-0.8
Control	-4.4	+1.0	-1.3

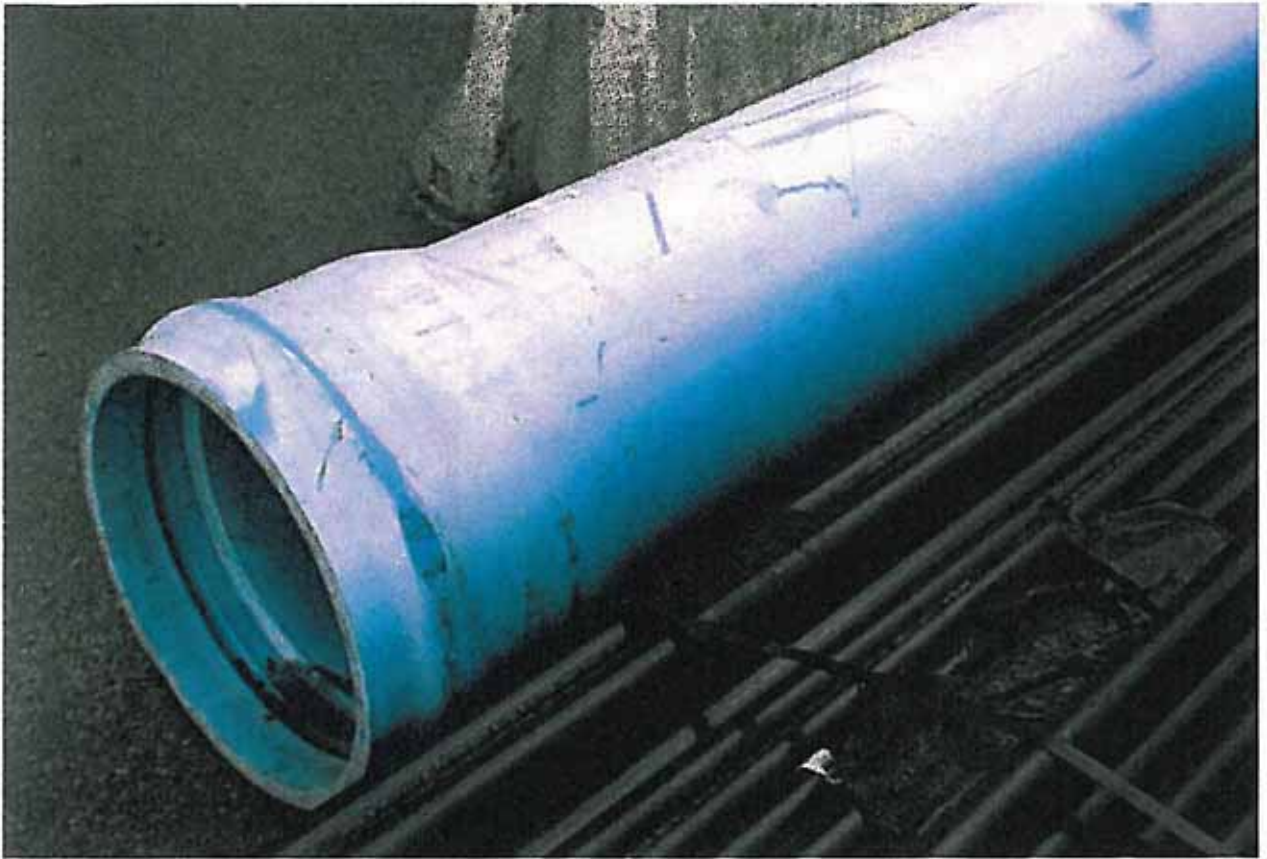
**FIGURE A1**

**THIS LARGE DIAMETER PRESSURE PIPE WAS STORED OUTDOORS, UNPROTECTED FOR 15 YEARS**

The following is a summary of testing conducted on 15-year old PVC pressure pipe that had been continuously exposed to sunlight. The pipe was returned to its plant of origin for testing and evaluation.

<b>PVC Pressure Pipe Specifics</b>	350 mm (14-inch), DR18, PR 235 psi
	Certified to CSA B137.3
	Manufactured on May 23, 1986
	Pipe was severely faded to a maximum depth of 0.002 inches over approximately 180 degrees of its exterior surface.
<b>Storage Location</b>	Outdoors City of Saskatoon Public Works Yard 330 Ontario Avenue Saskatoon, Saskatchewan
<b>Climate</b>	Saskatoon averages 2380 hours of sunshine per year

Even though the PVC pipe endured severe conditions of ultraviolet exposure from 15 years of daytime sunlight, the pipe exhibited no loss of physical strength and should be considered very suitable for ordinary usage.
