# Understanding the Significance of

# Breaches to and Sediment Buildup in Finished Drinking Water Storage Tanks

Bob Clement, Environmental Engineer M.S., Microbiologist EPA Region 8, April, 2016

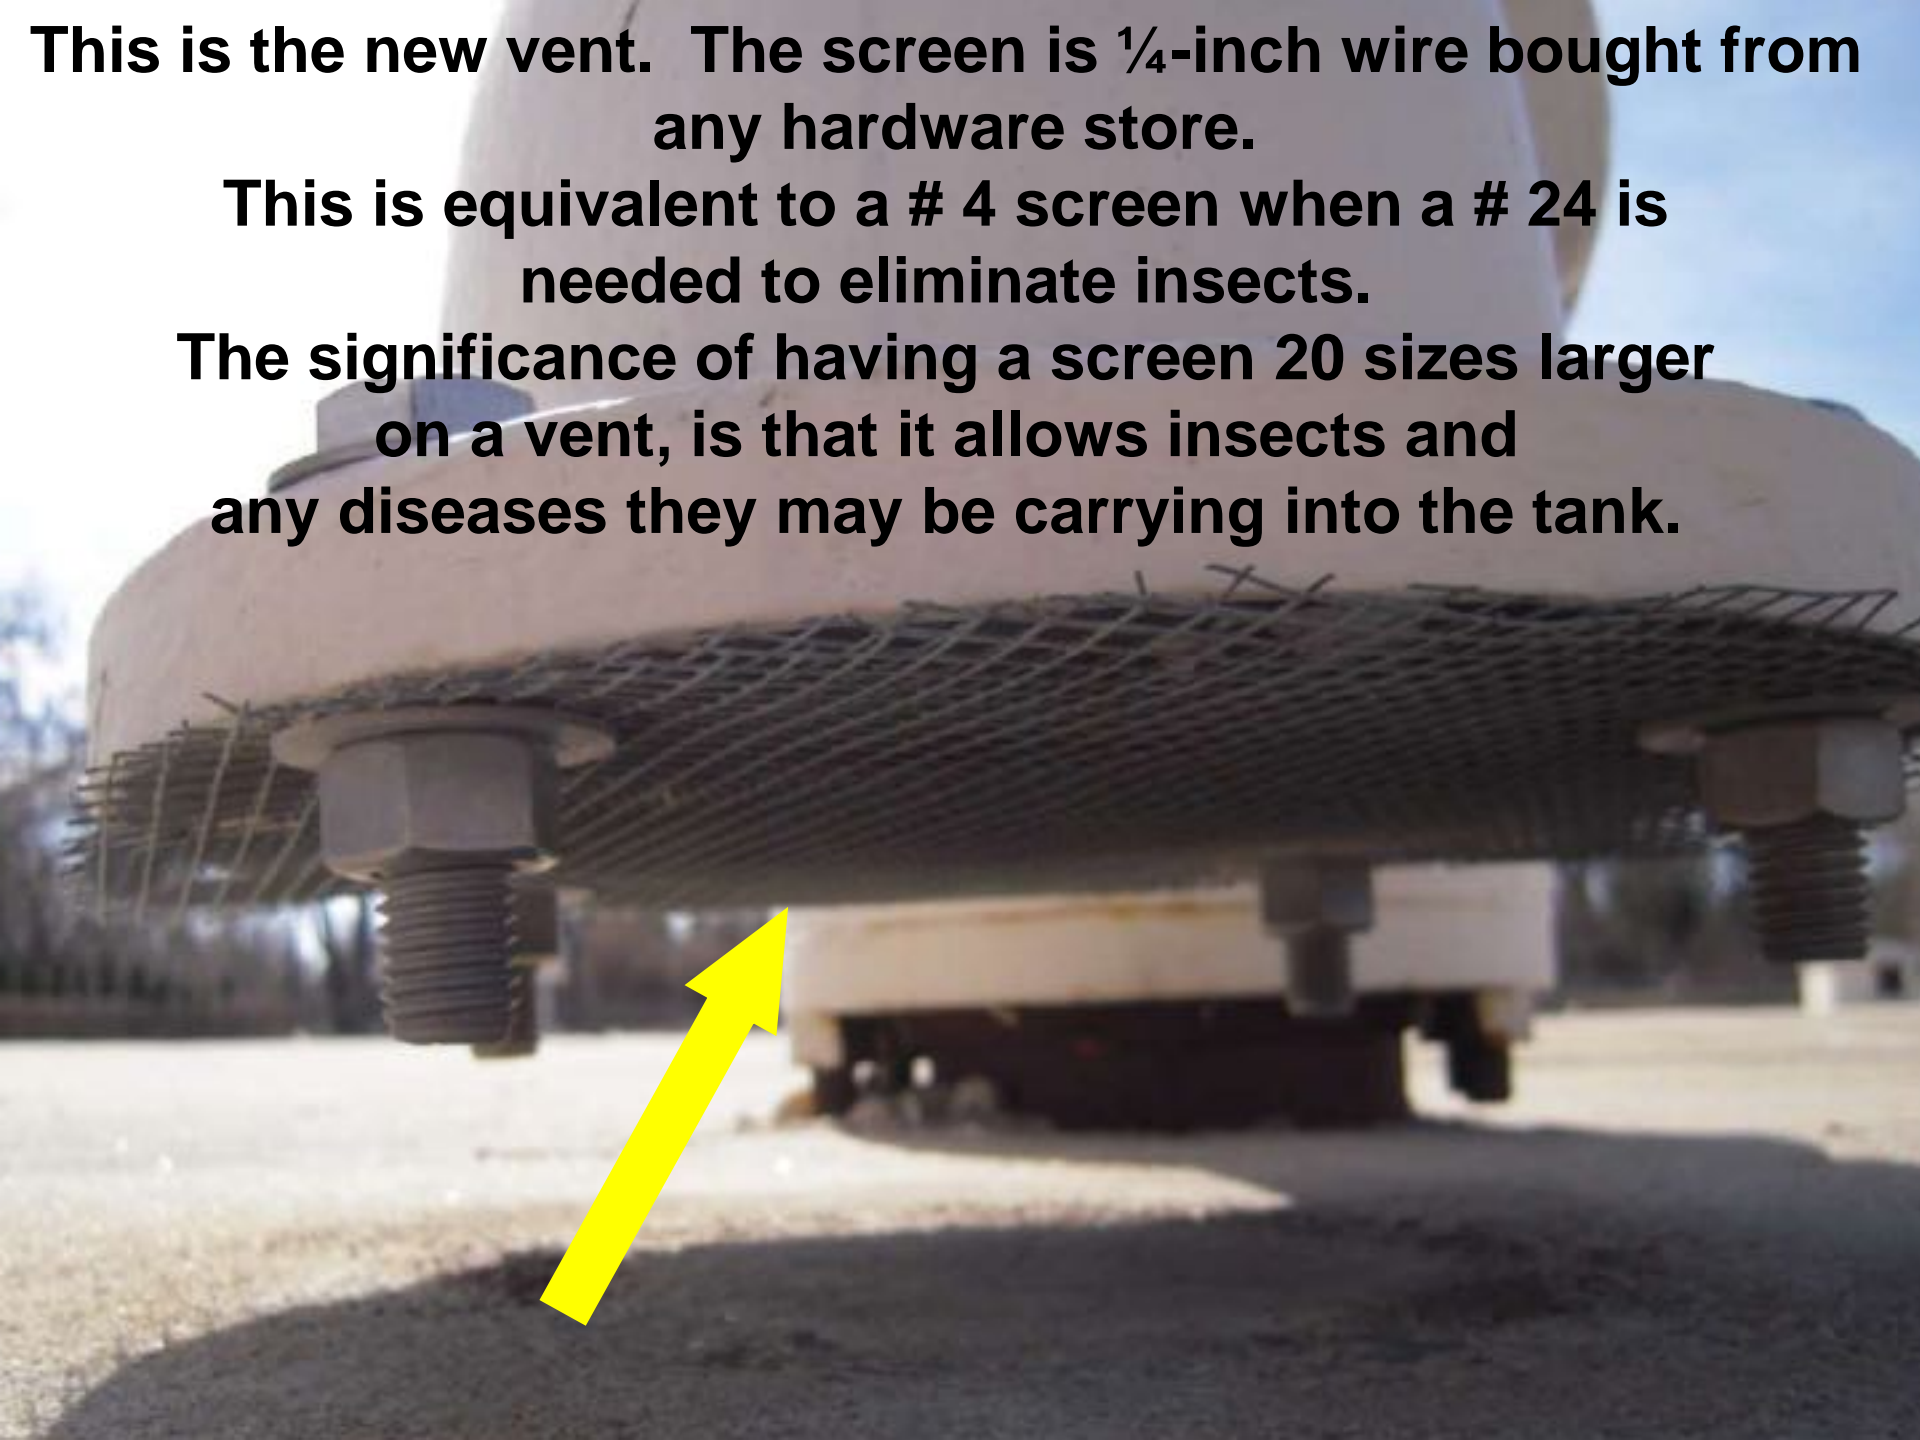
**These 1-inch by ½-inch screens typically found on elevated tanks will allow all types of insects into the tank.**

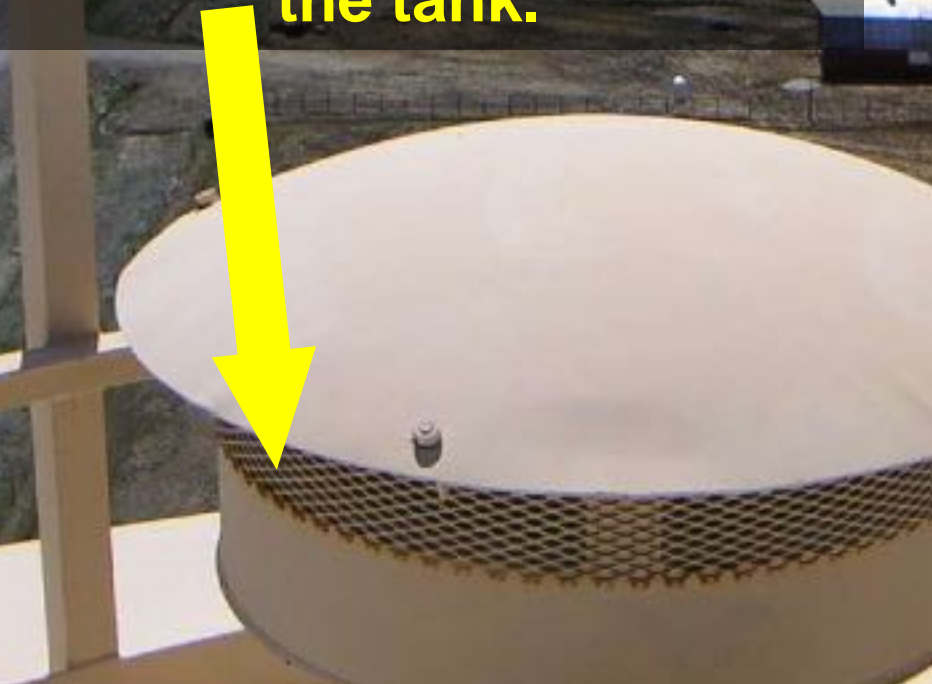
**The myth is that insects can not fly to the height of an elevated tank. That myth is easily disproved in talking with entomologists**

**Elevated tanks may have blinking lights on top so planes don't fly into them. The lights can attract a high concentration of flying insects around a vent that is inadequate to prevent them from entering.**

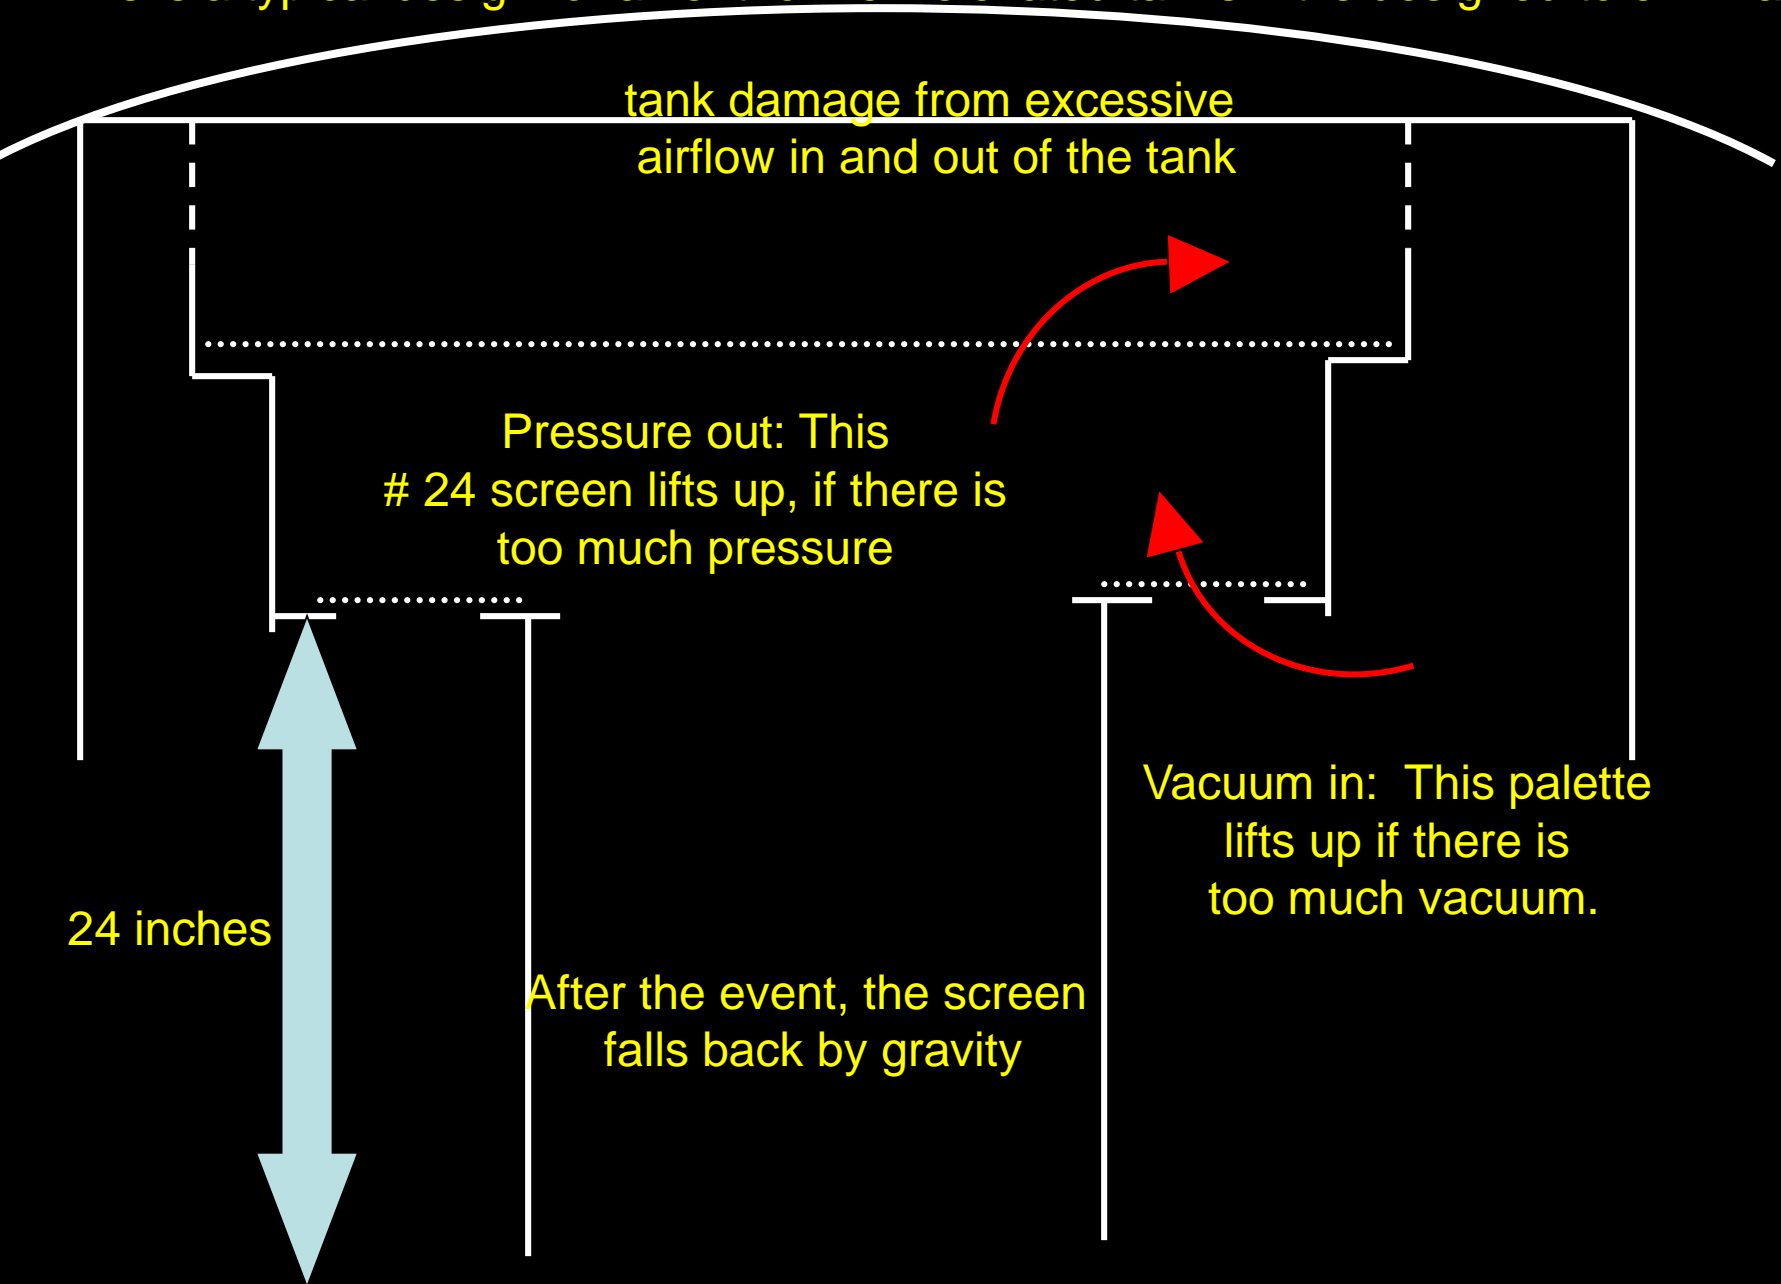
In a vacuum event, the air pressure outside the tank becomes greater than the air pressure inside the tank. This pressure difference lifts the solid vacuum pallet that is this ring up allowing air to flow into the tank preventing tank damage. Once the vacuum is equalized, the pallet falls back by gravity.

In a pressure event the air pressure inside the tank becomes greater than the air pressure outside the tank. This pressure difference lifts the #24 mesh screen pressure pallet up allowing air to flow out of the tank through the coarse exterior bird screen preventing tank damage. Once the pressure is equalized, the pallet falls back by gravity.

Under normal operating conditions these pallets will not move. A #16 mesh is what comes standard, but simply ask for #24 mesh. The air flow difference between a #16 and #24 is small, but check that the square inches of area for a vent is at least  $\frac{1}{2}$  the square inches of area of the largest pipe. Or you can check calculations with the vent manufacturer or engineer.

Like any moving part, maintenance includes checking to see if the pallets lie flat and is not warped. Warped pallets need to be replaced.

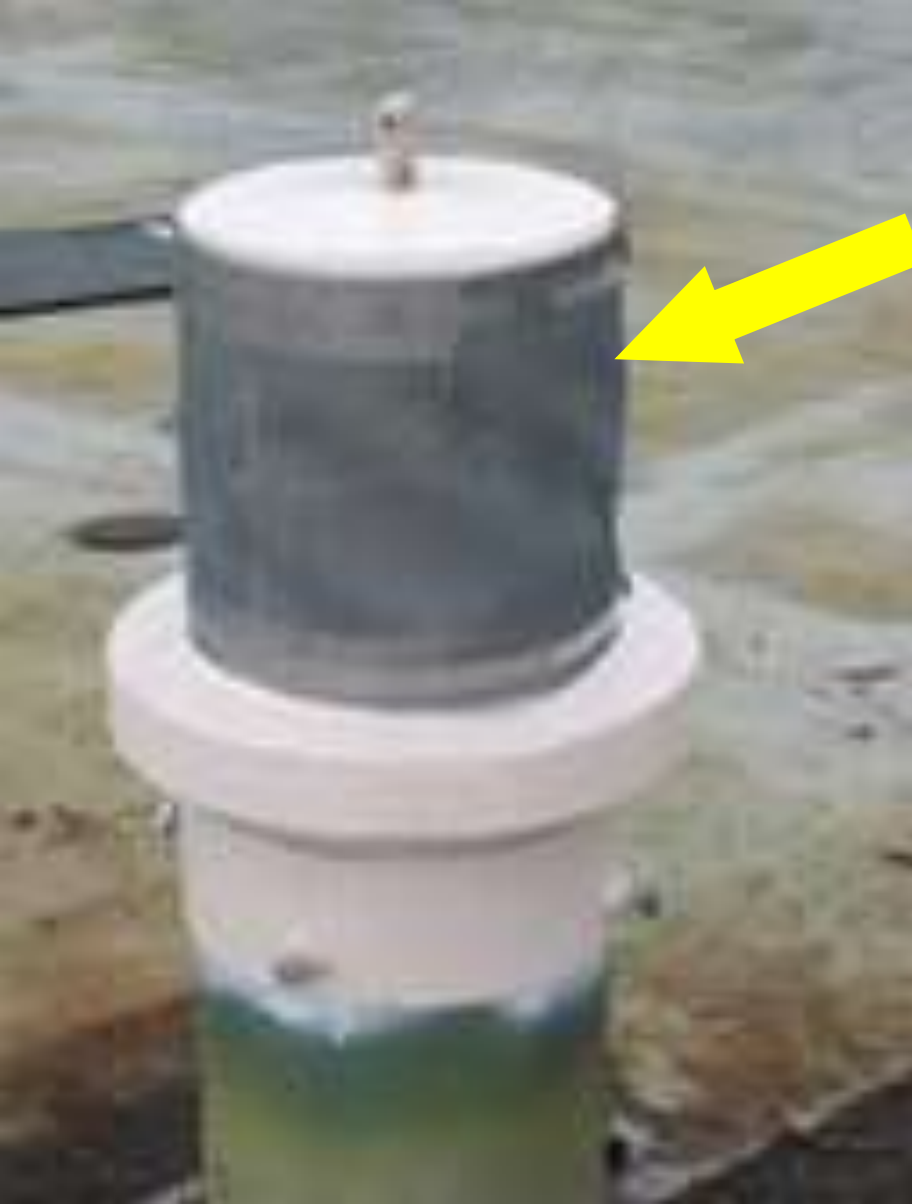
For a flexible screen vent, ask that the flexible inner screen be #24 mesh. The flexible screen is typically wrapped twice, the vertical seam needs to be sealed. When frost builds up on the flexible screen, vacuum and pressure will move the screen breaking up frost buildup.

A bird screen fits over the flexible screen to protect it against being torn apart by birds.

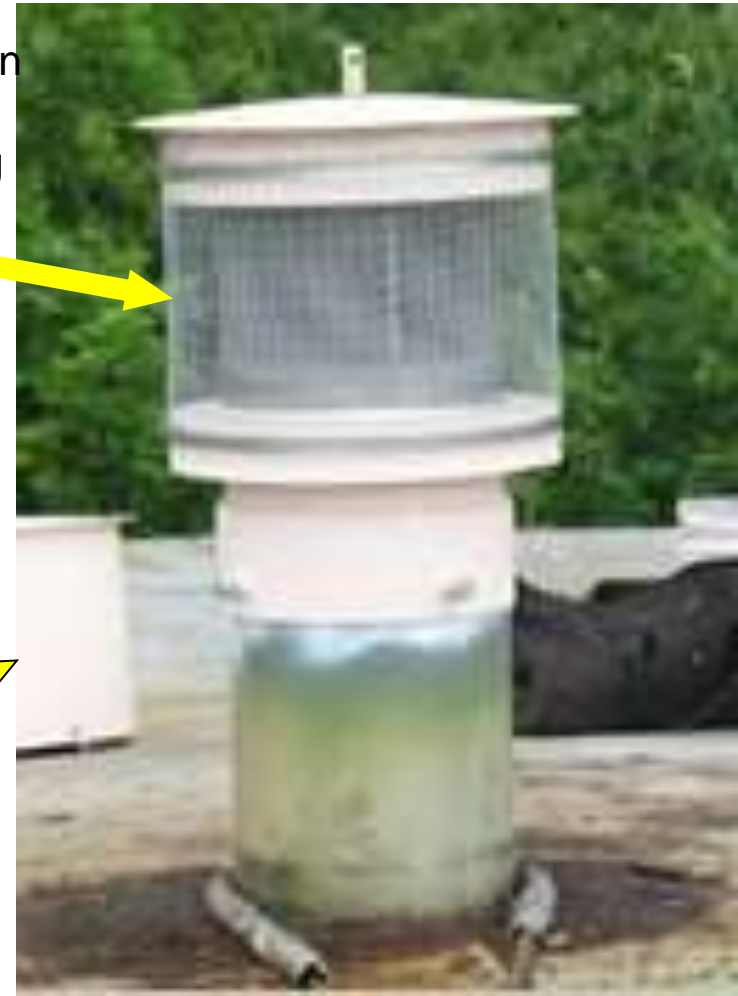
The solid water tight cover is placed over the bird screen and comes down at least to the bottom of the #24 mesh screen.

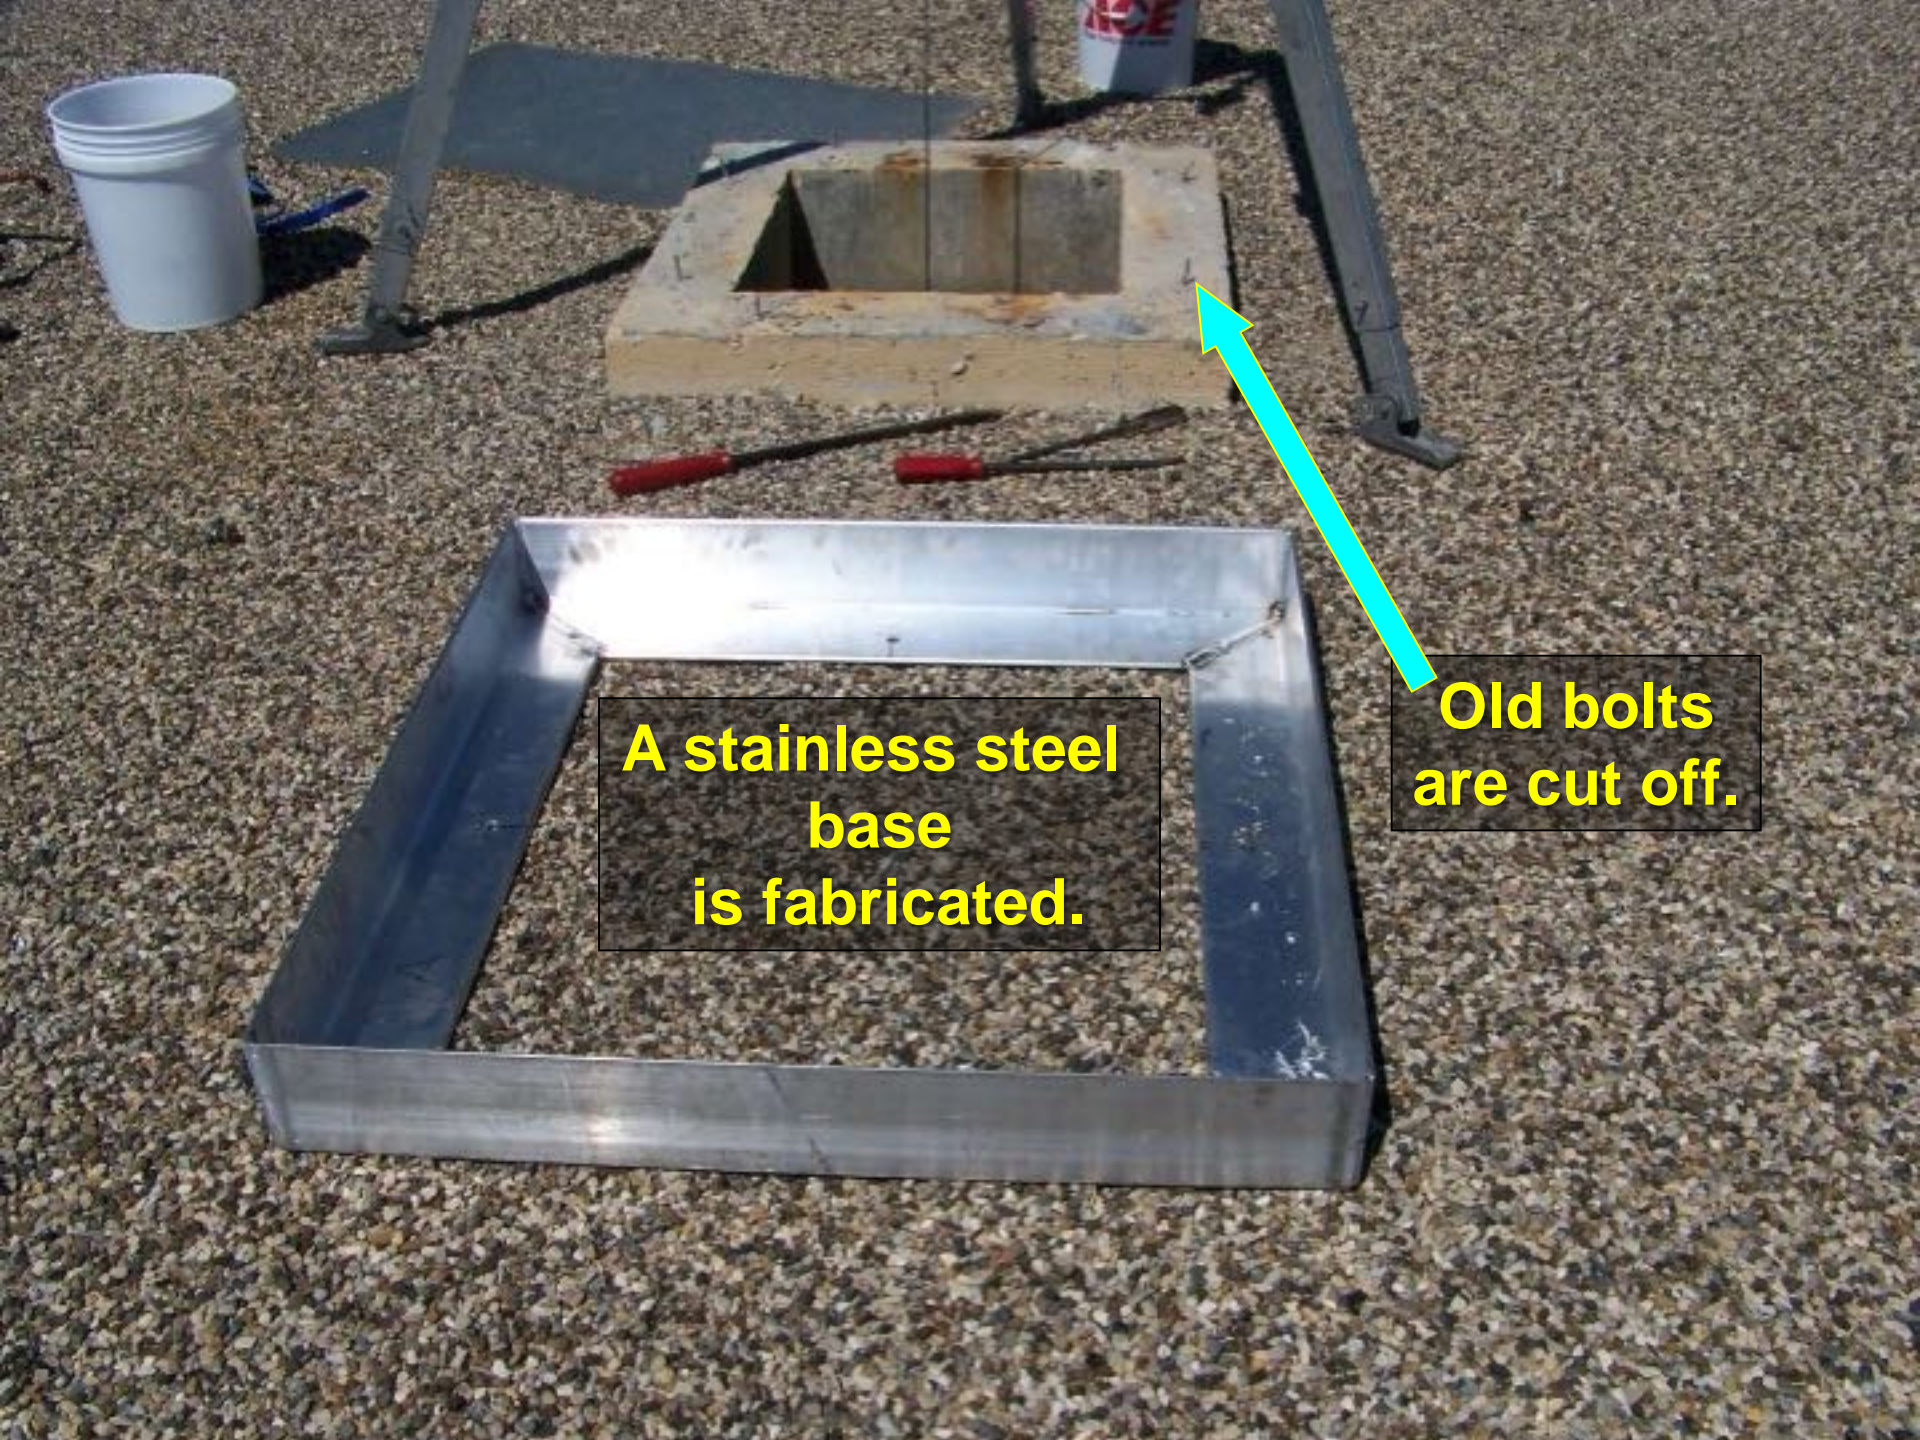
**A stainless steel  
base  
is fabricated.**

**Old bolts  
are cut off.**

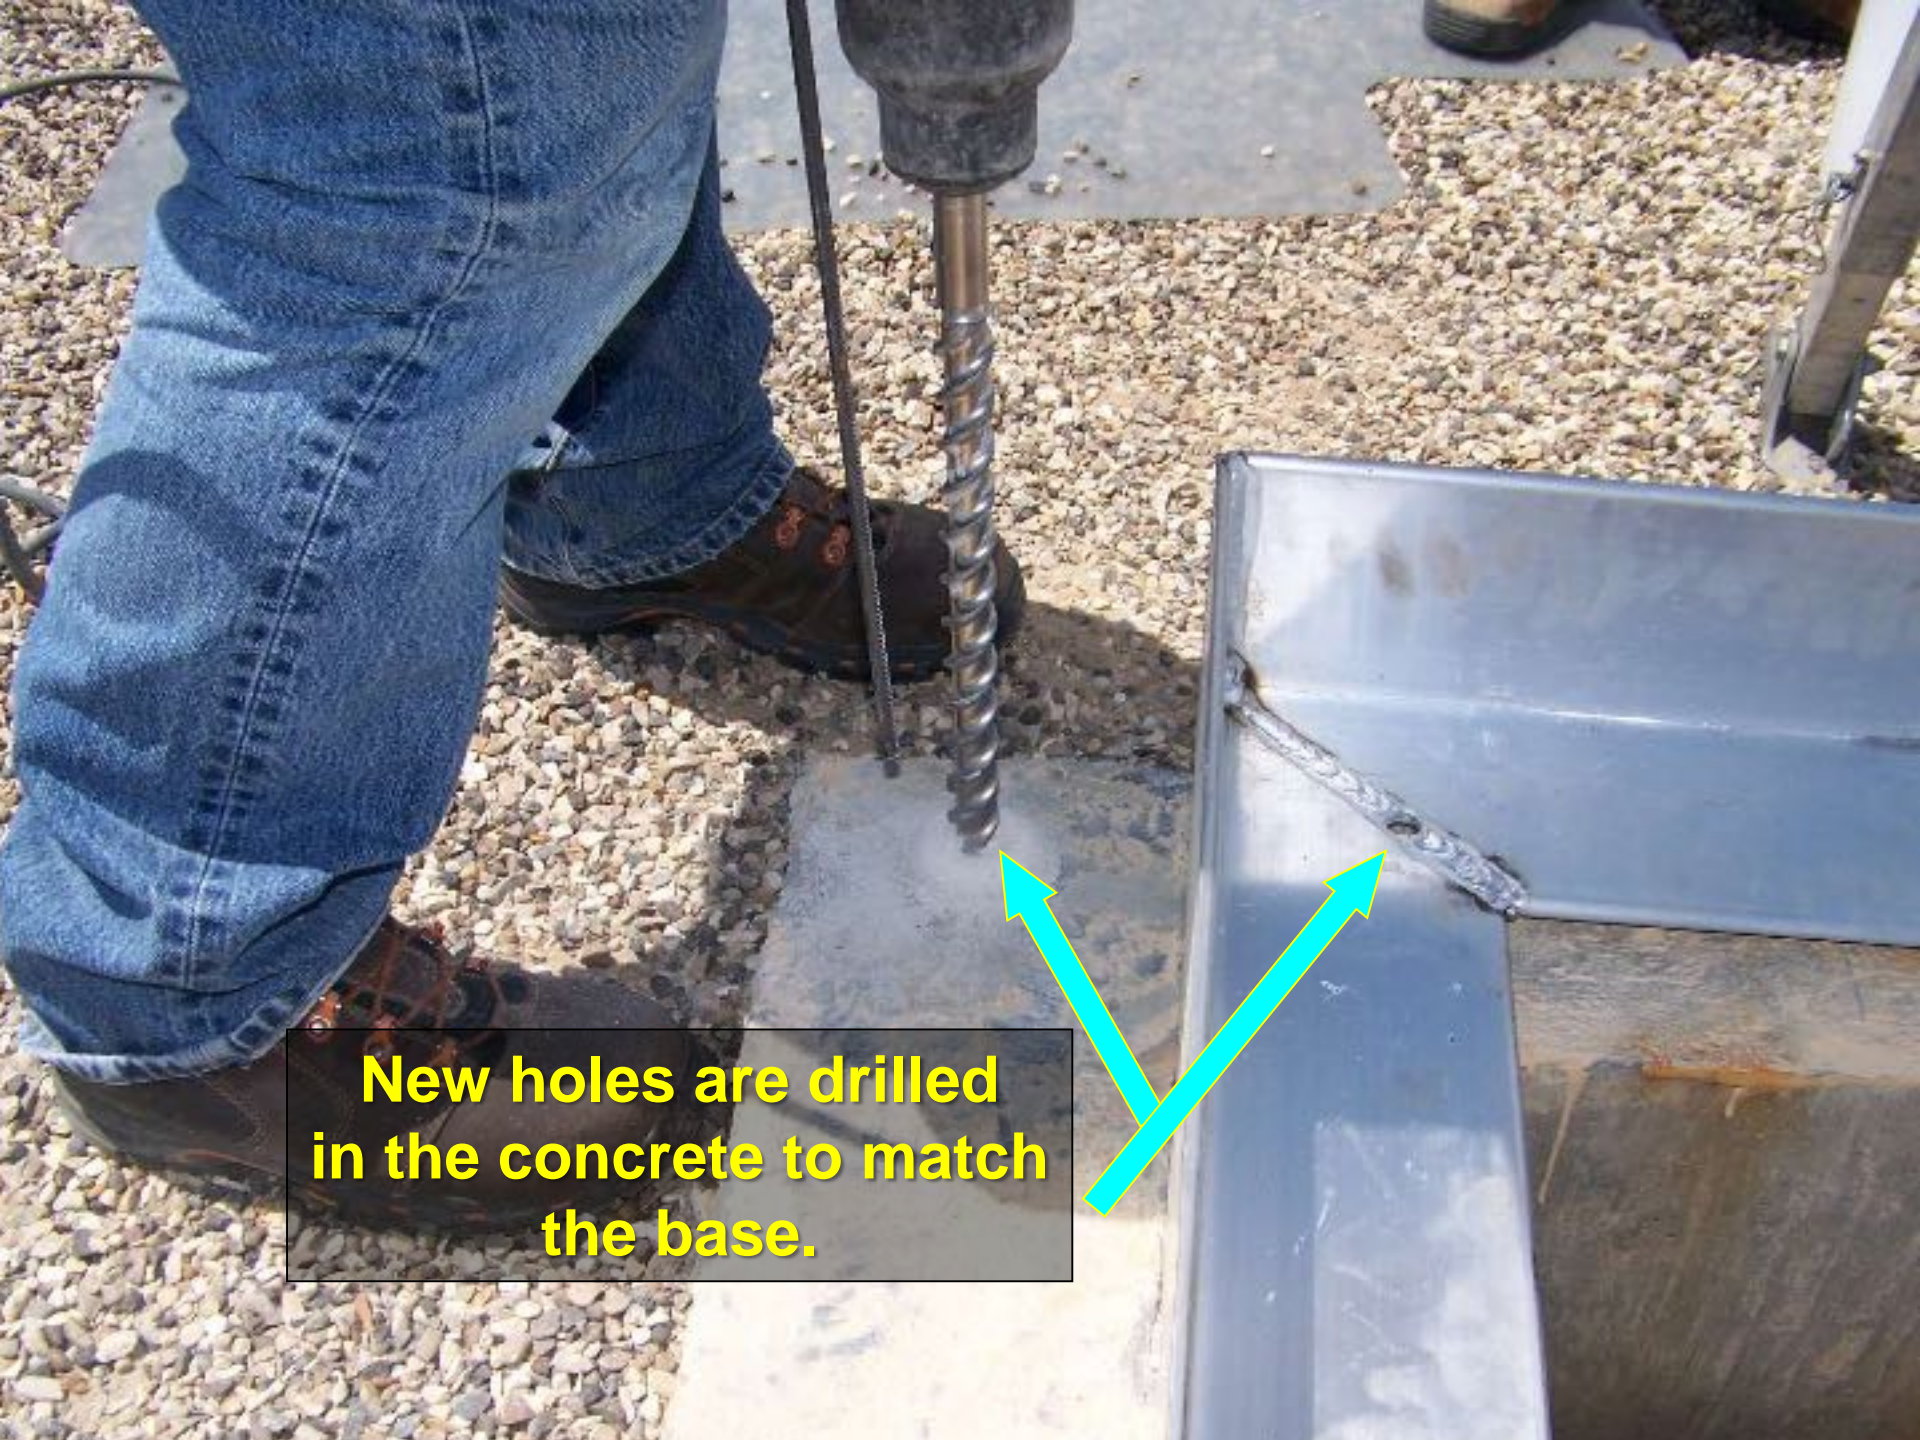
**New holes are drilled  
in the concrete to match  
the base.**

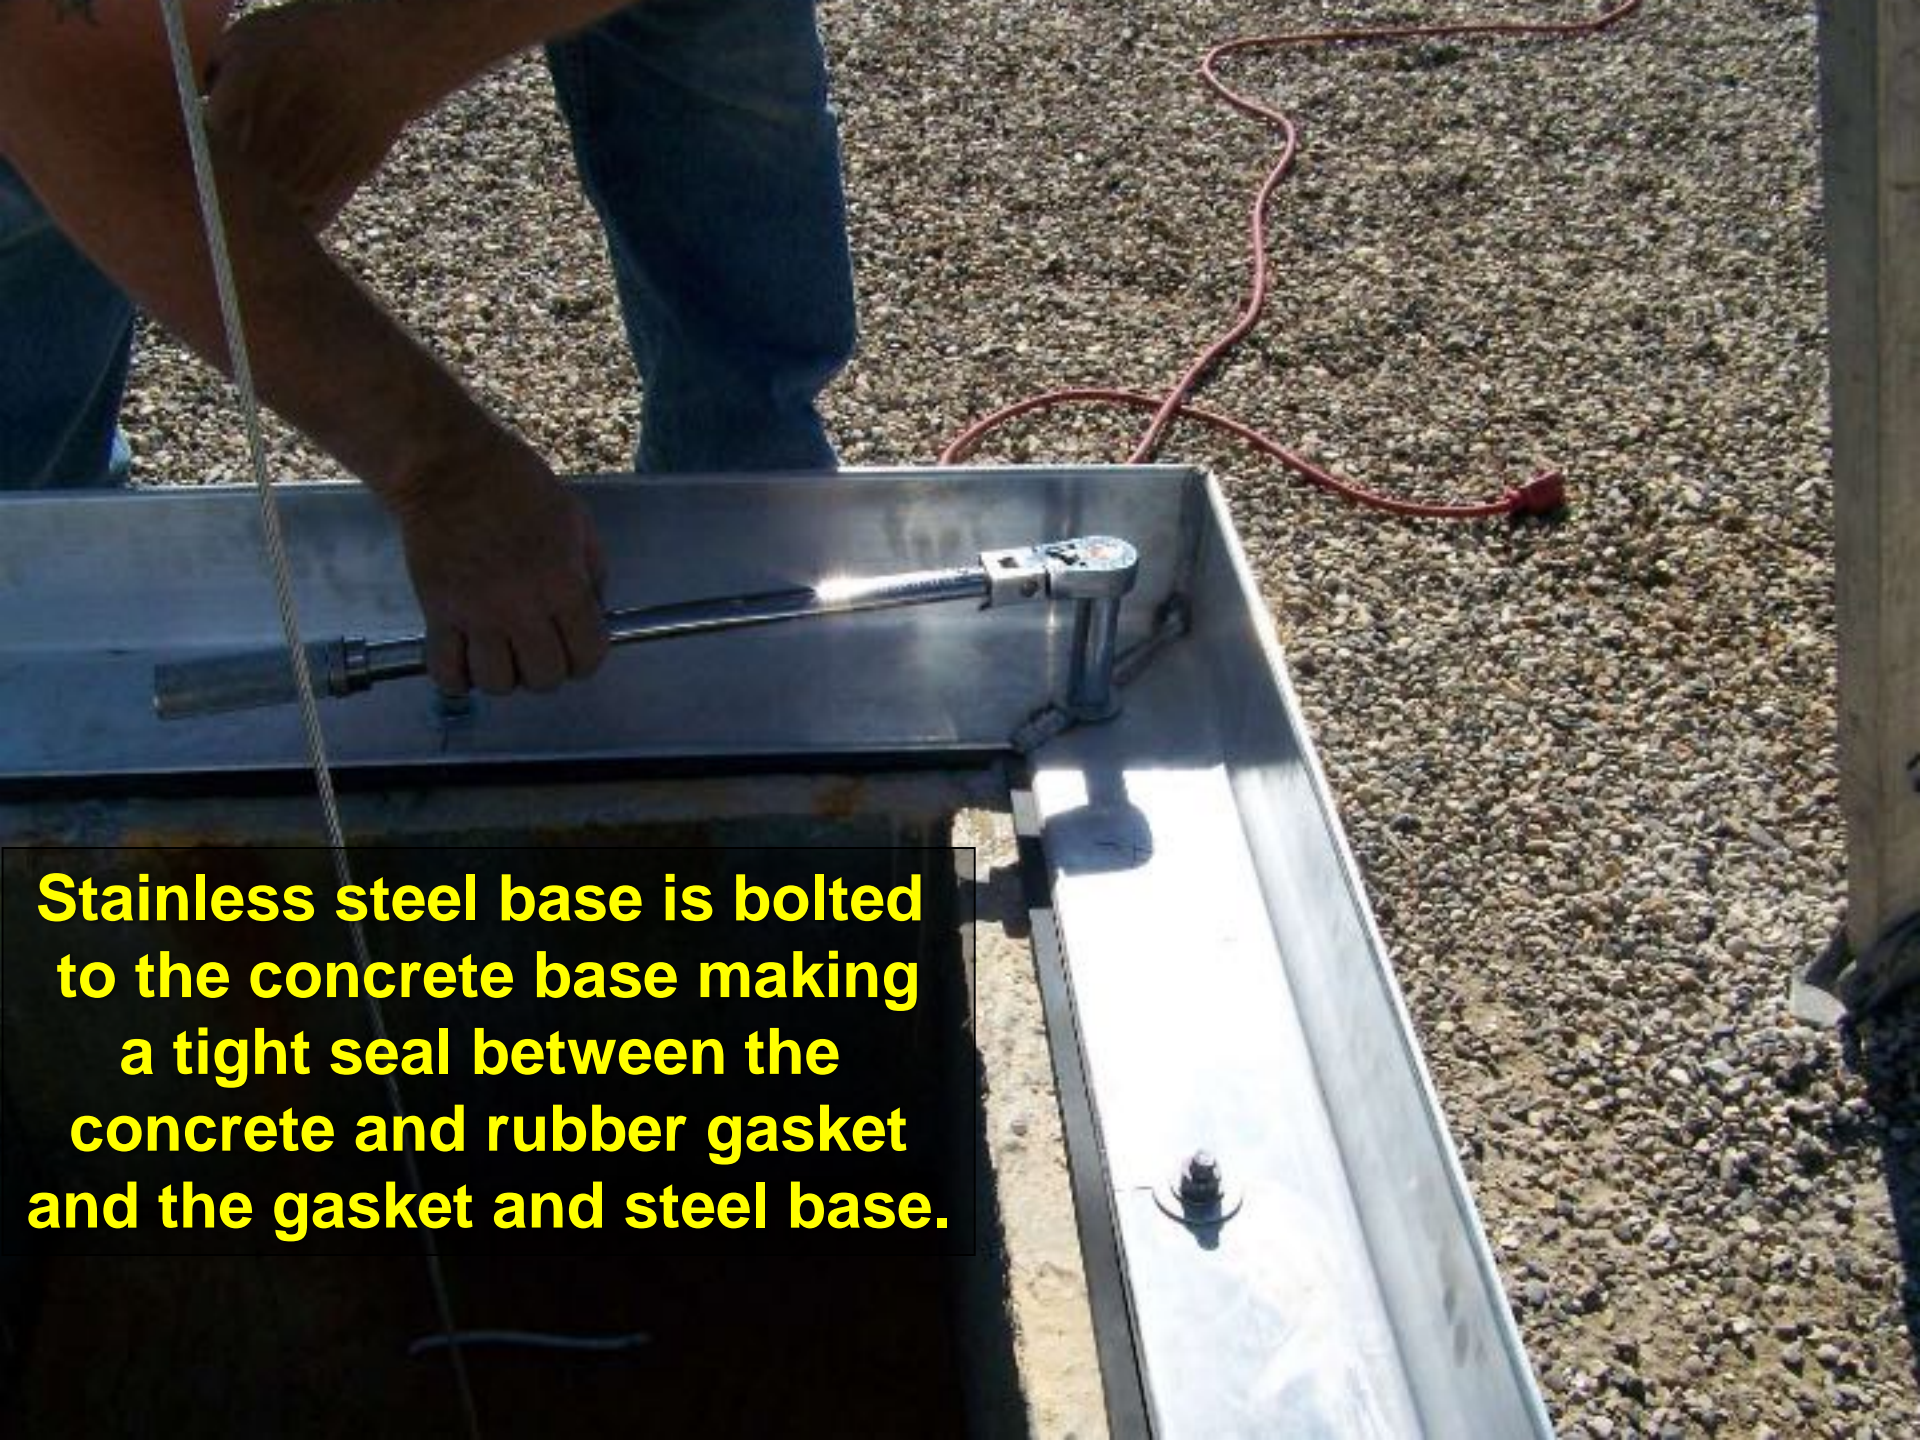
**Stainless steel base is bolted to the concrete base making a tight seal between the concrete and rubber gasket and the gasket and steel base.**

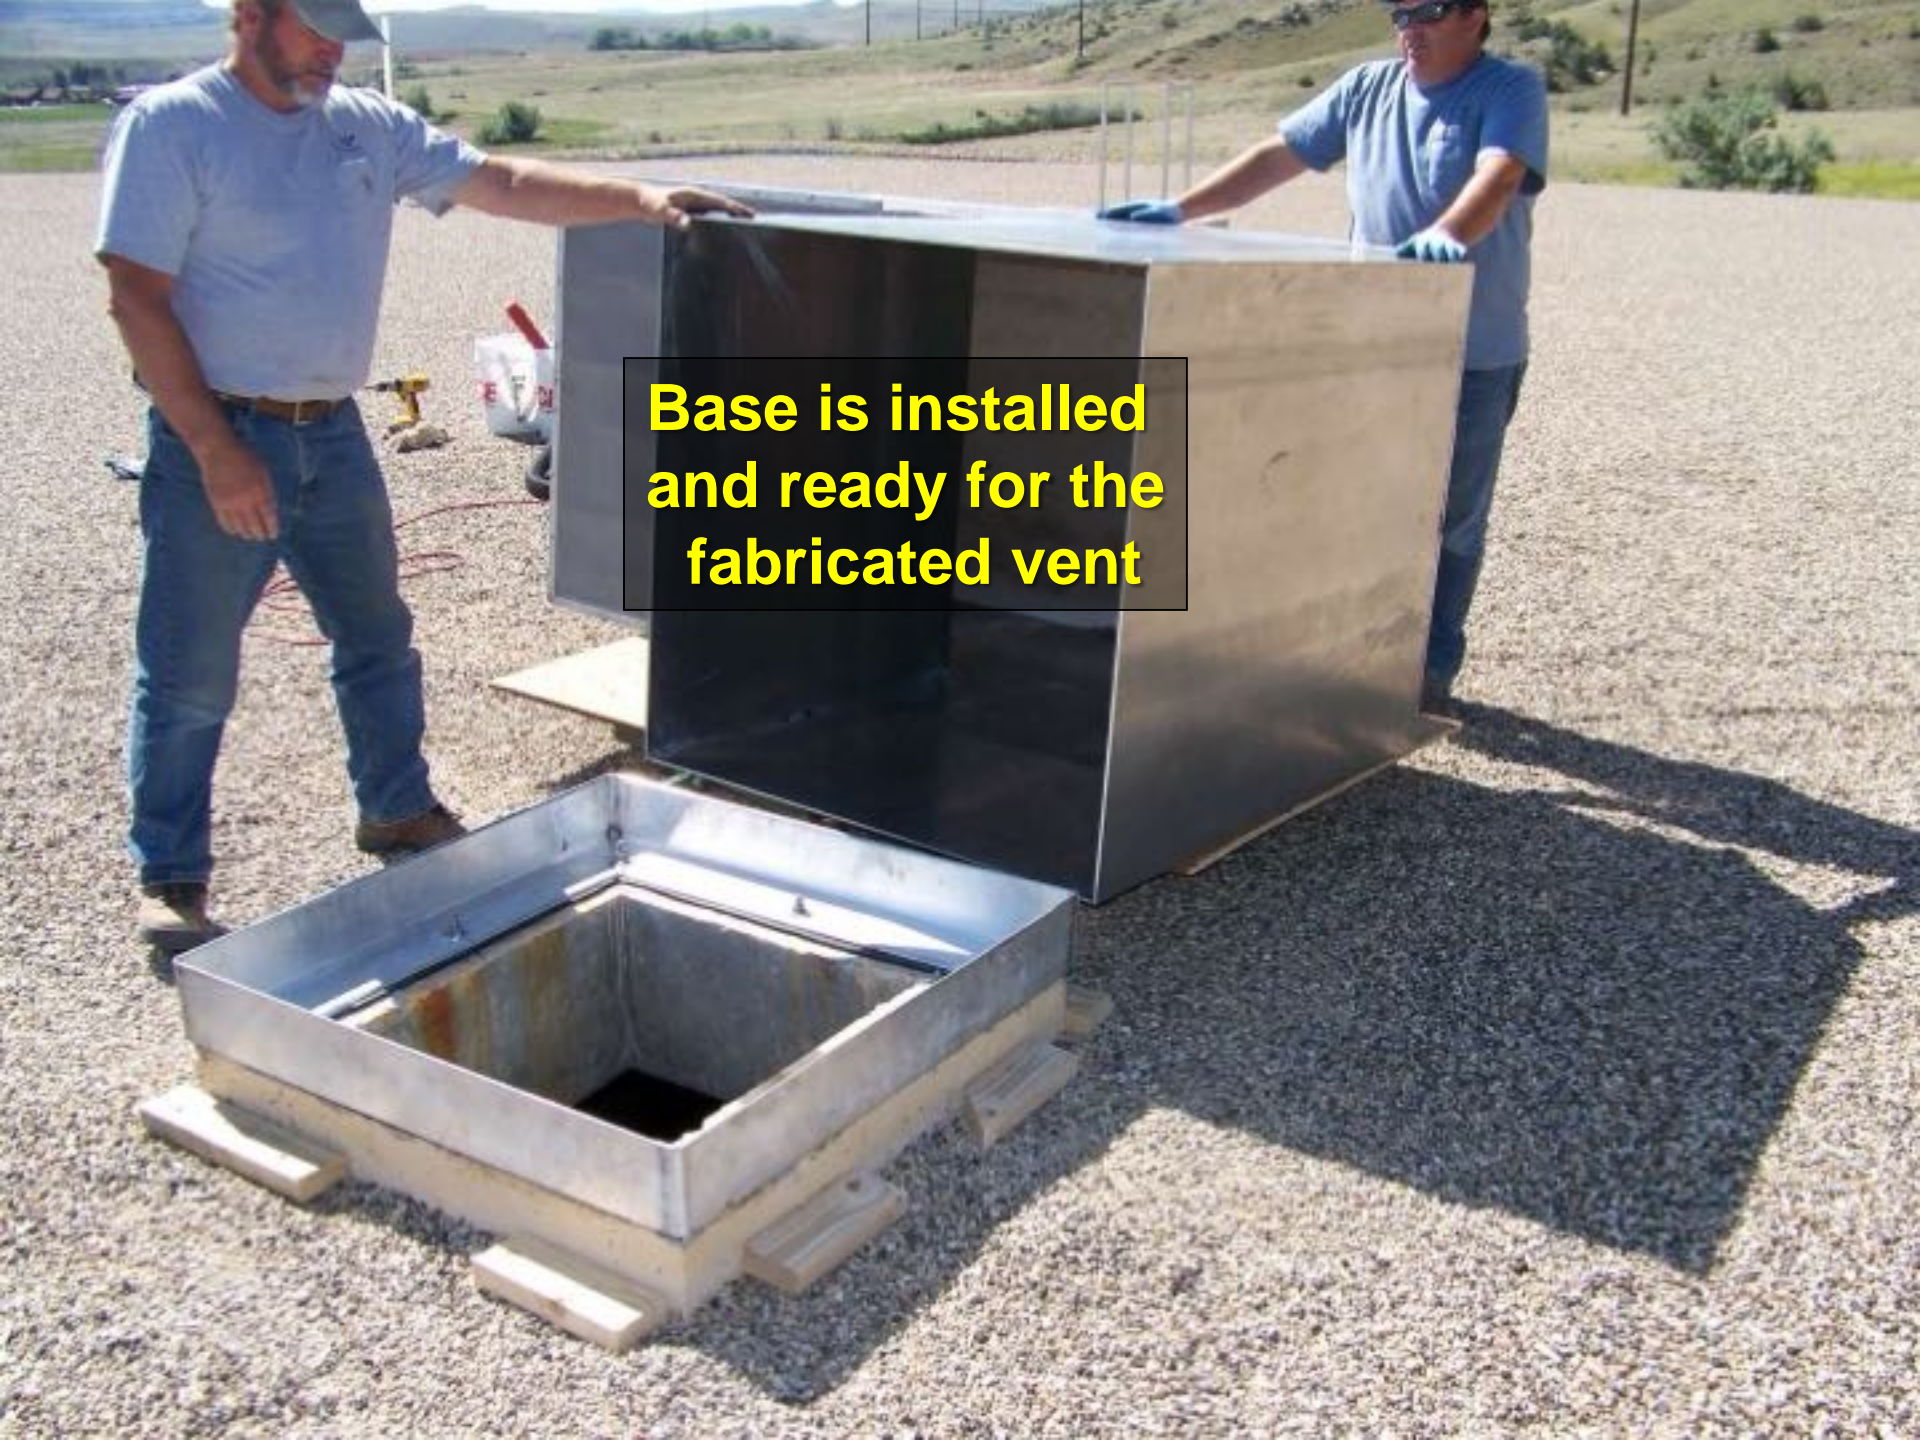
**Base is installed  
and ready for the  
fabricated vent**

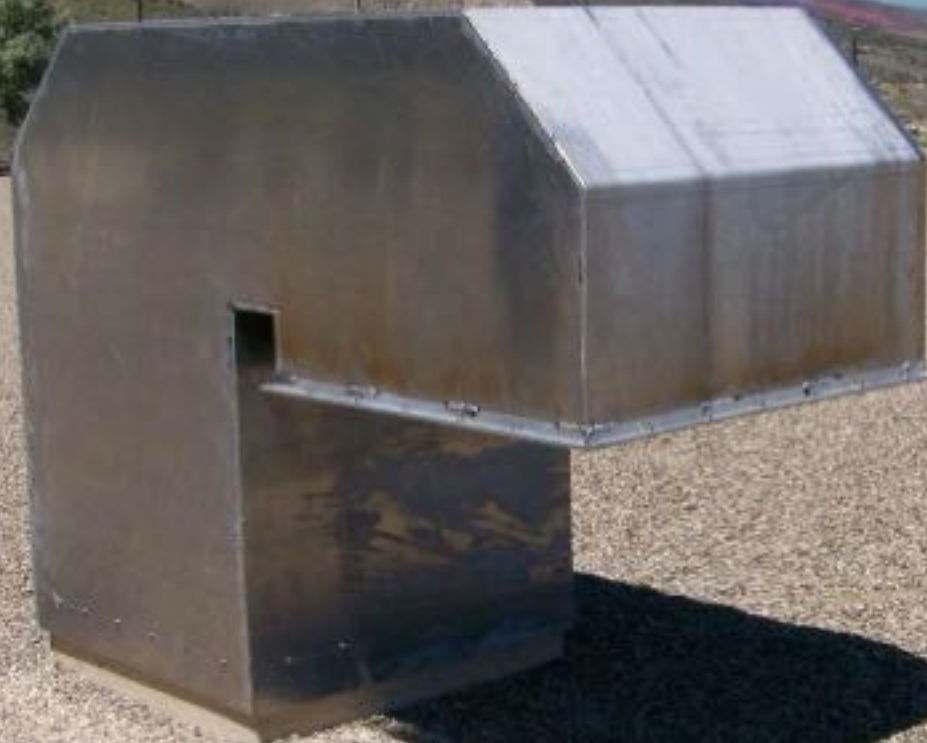
**The inhalation hazard is mitigated permanently. Vent is at least 24 inches above the roof and is easily able to be inspected.**

**Raising the vent was quite possible. The 24 inch requirement has been known to PWSs since the very first revision of Ten State Standards in 1962.**

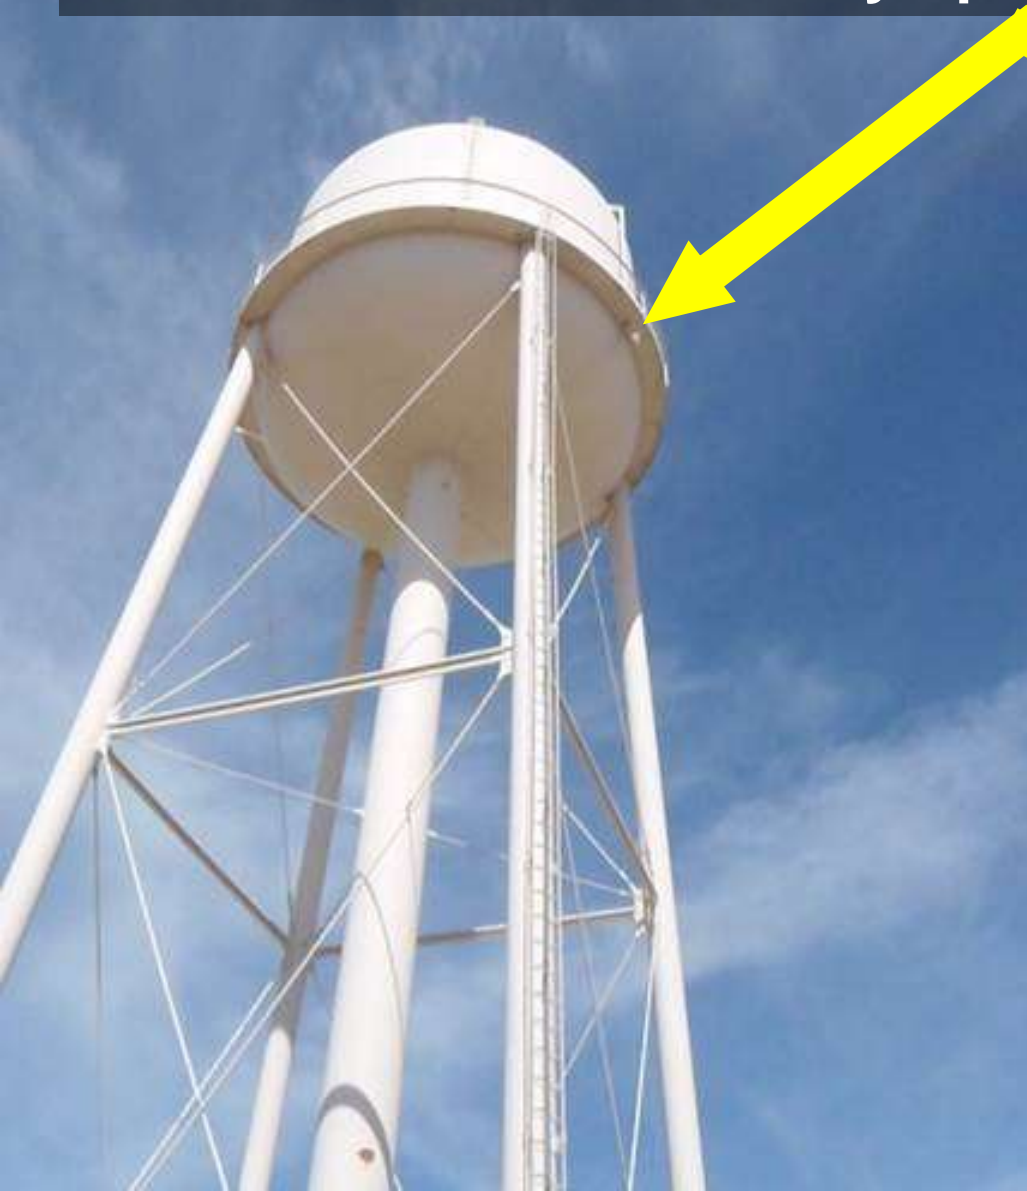
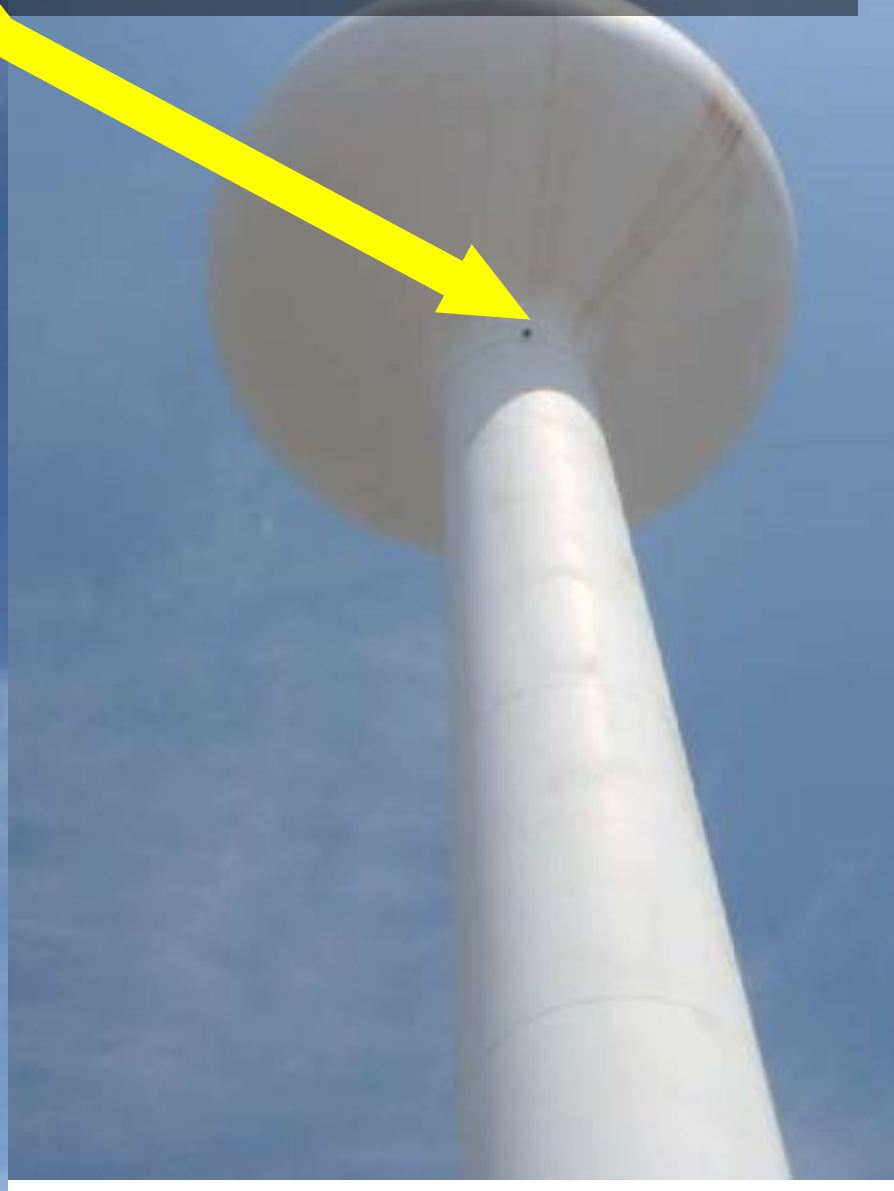
**When the #24 mesh screen is wrapped around the overflow it is very likely the overflow event will push the screen off the pipe. If it is not inspected immediately and replaced rodents could enter.**
