# Understanding the Significance of

# Breaches to and Sediment Buildup in Finished Drinking Water Storage Tanks

Bob Clement, Environmental Engineer M.S., Microbiologist EPA Region 8, April, 2016

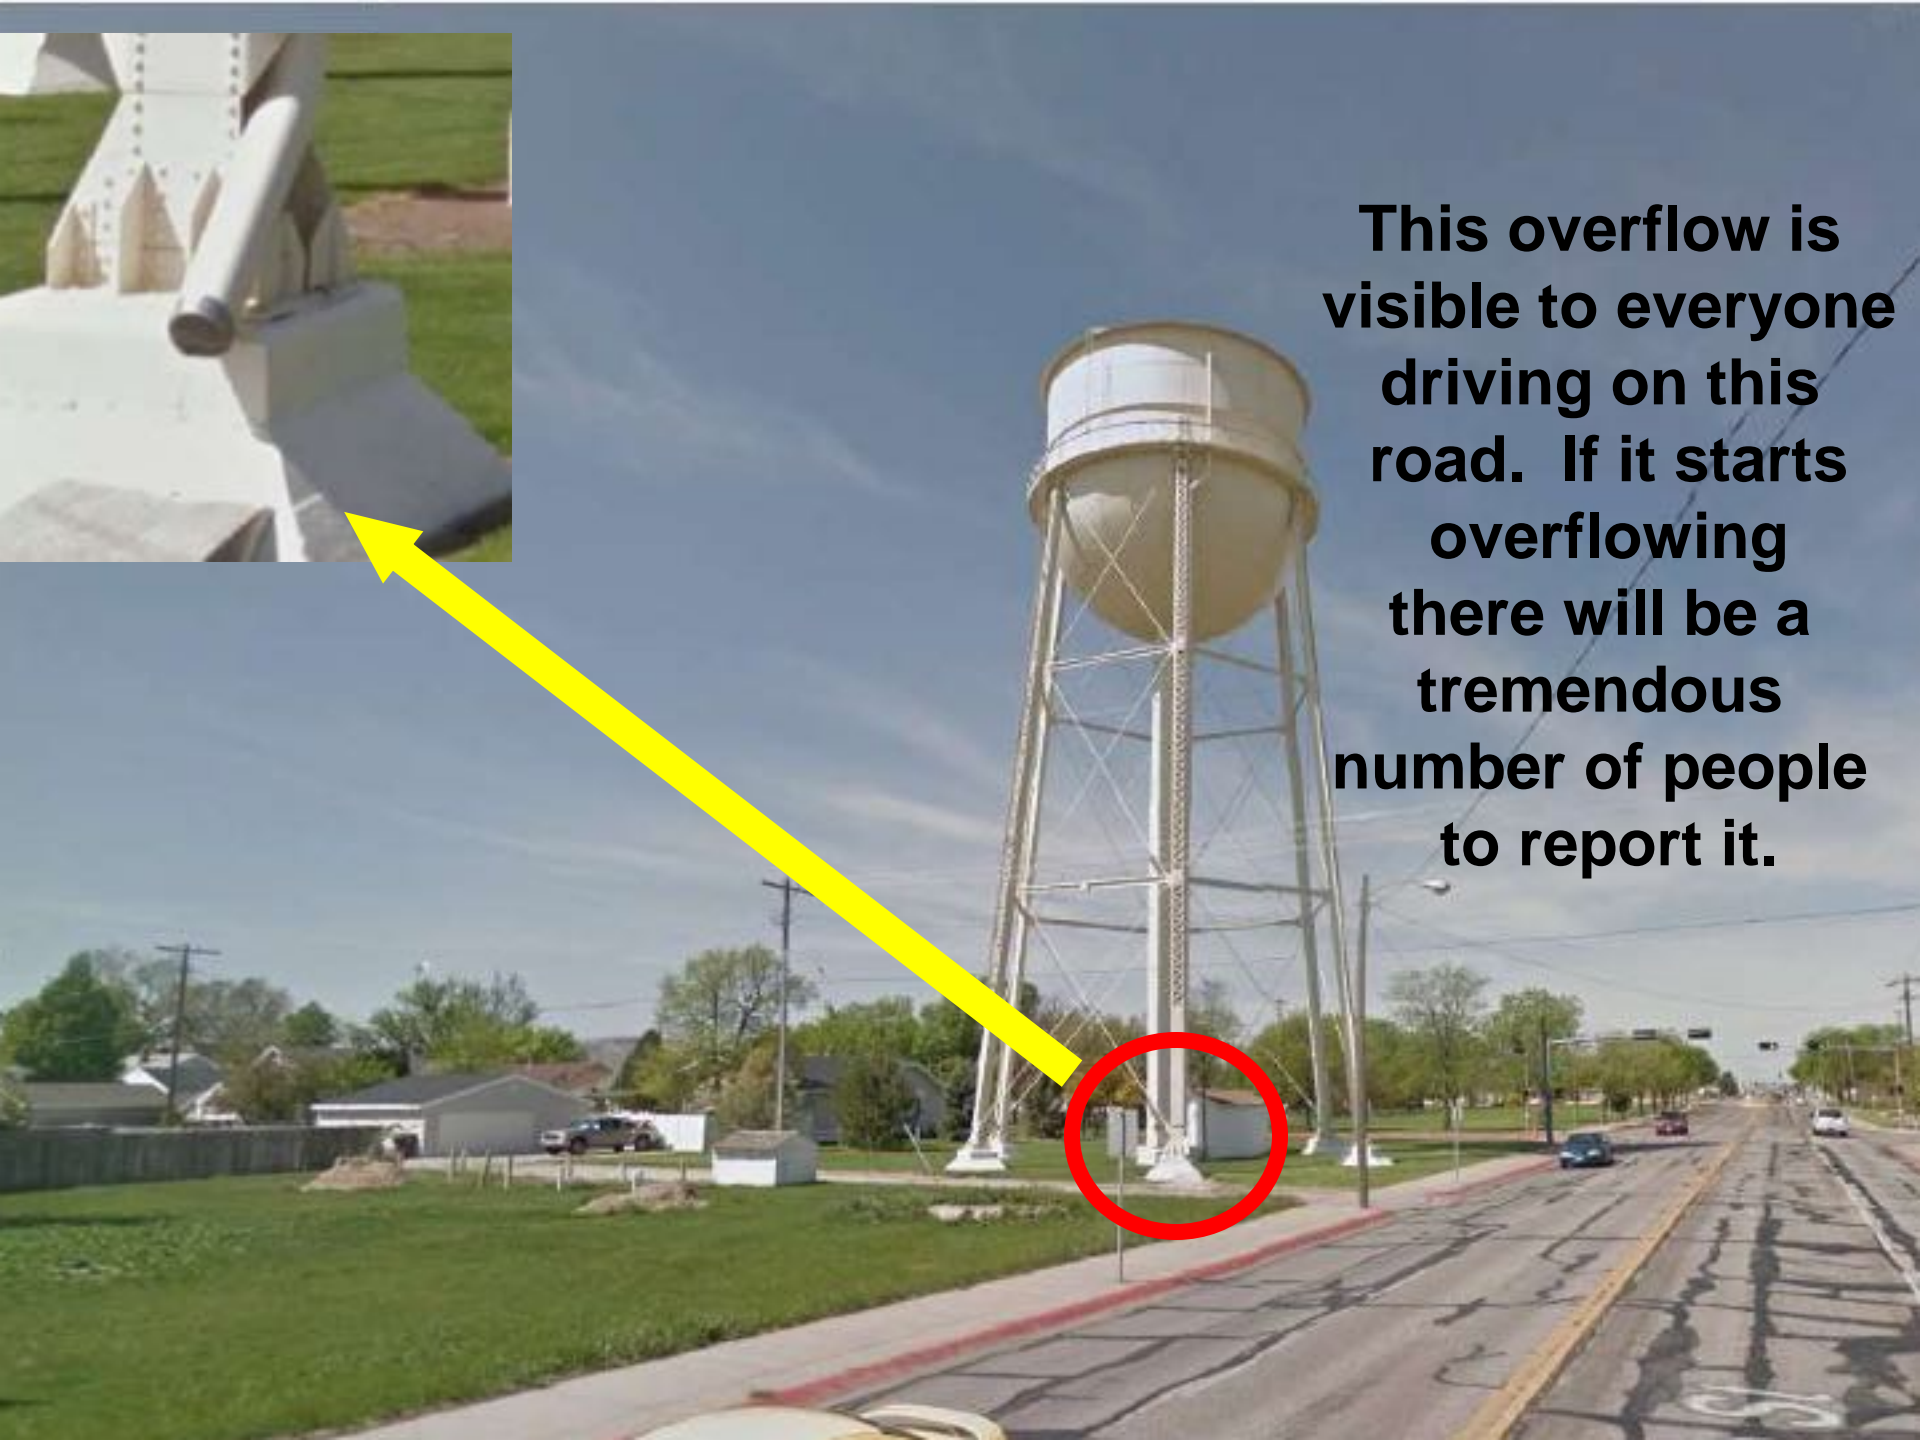
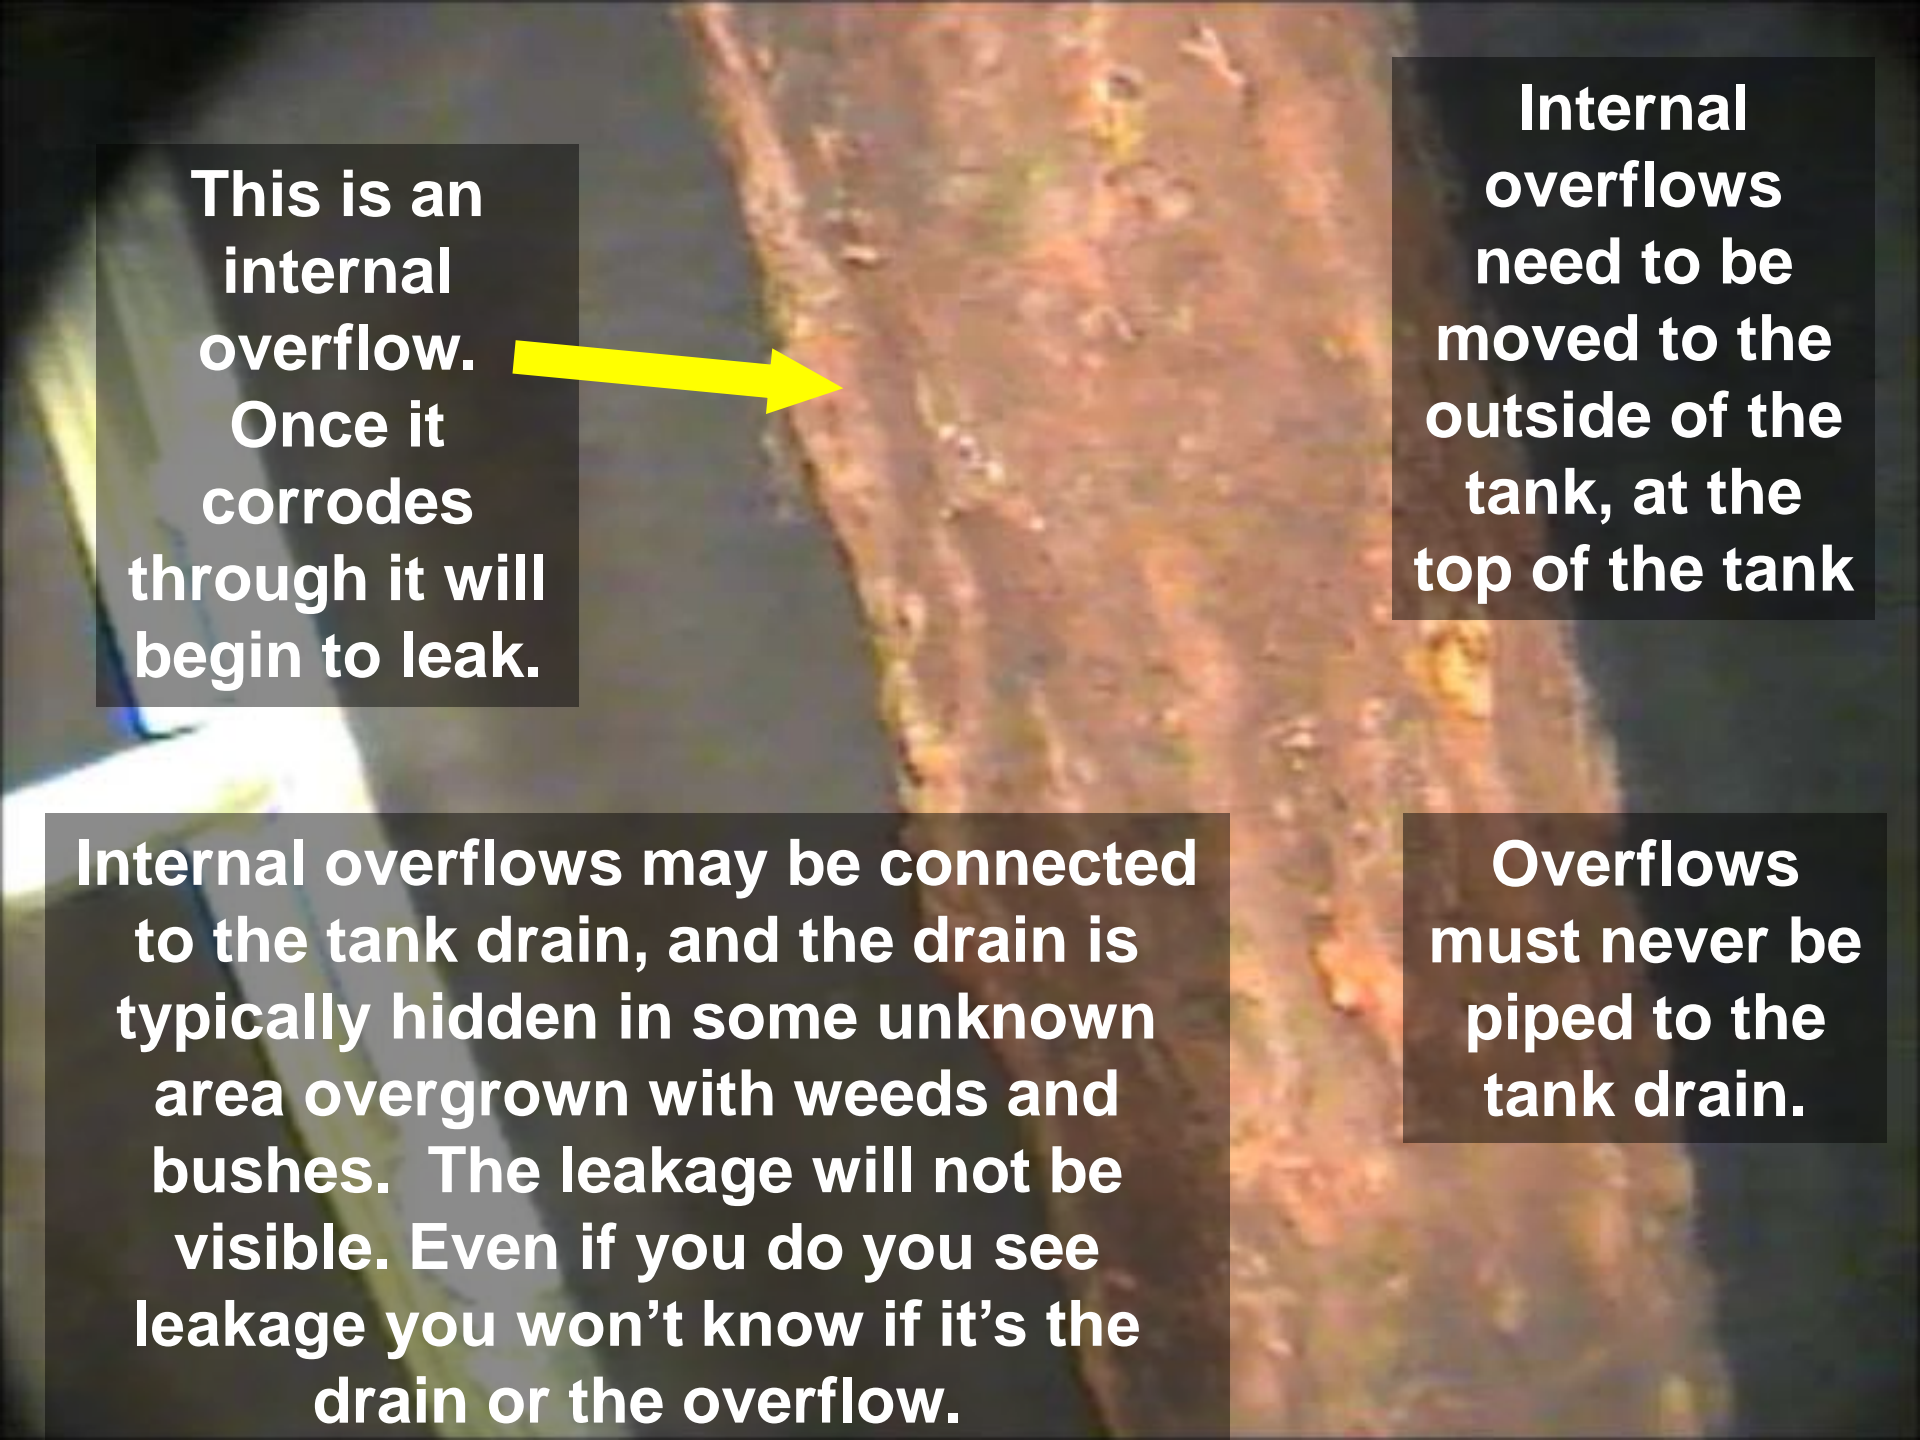
**This is an internal overflow. Once it corrodes through it will begin to leak.**

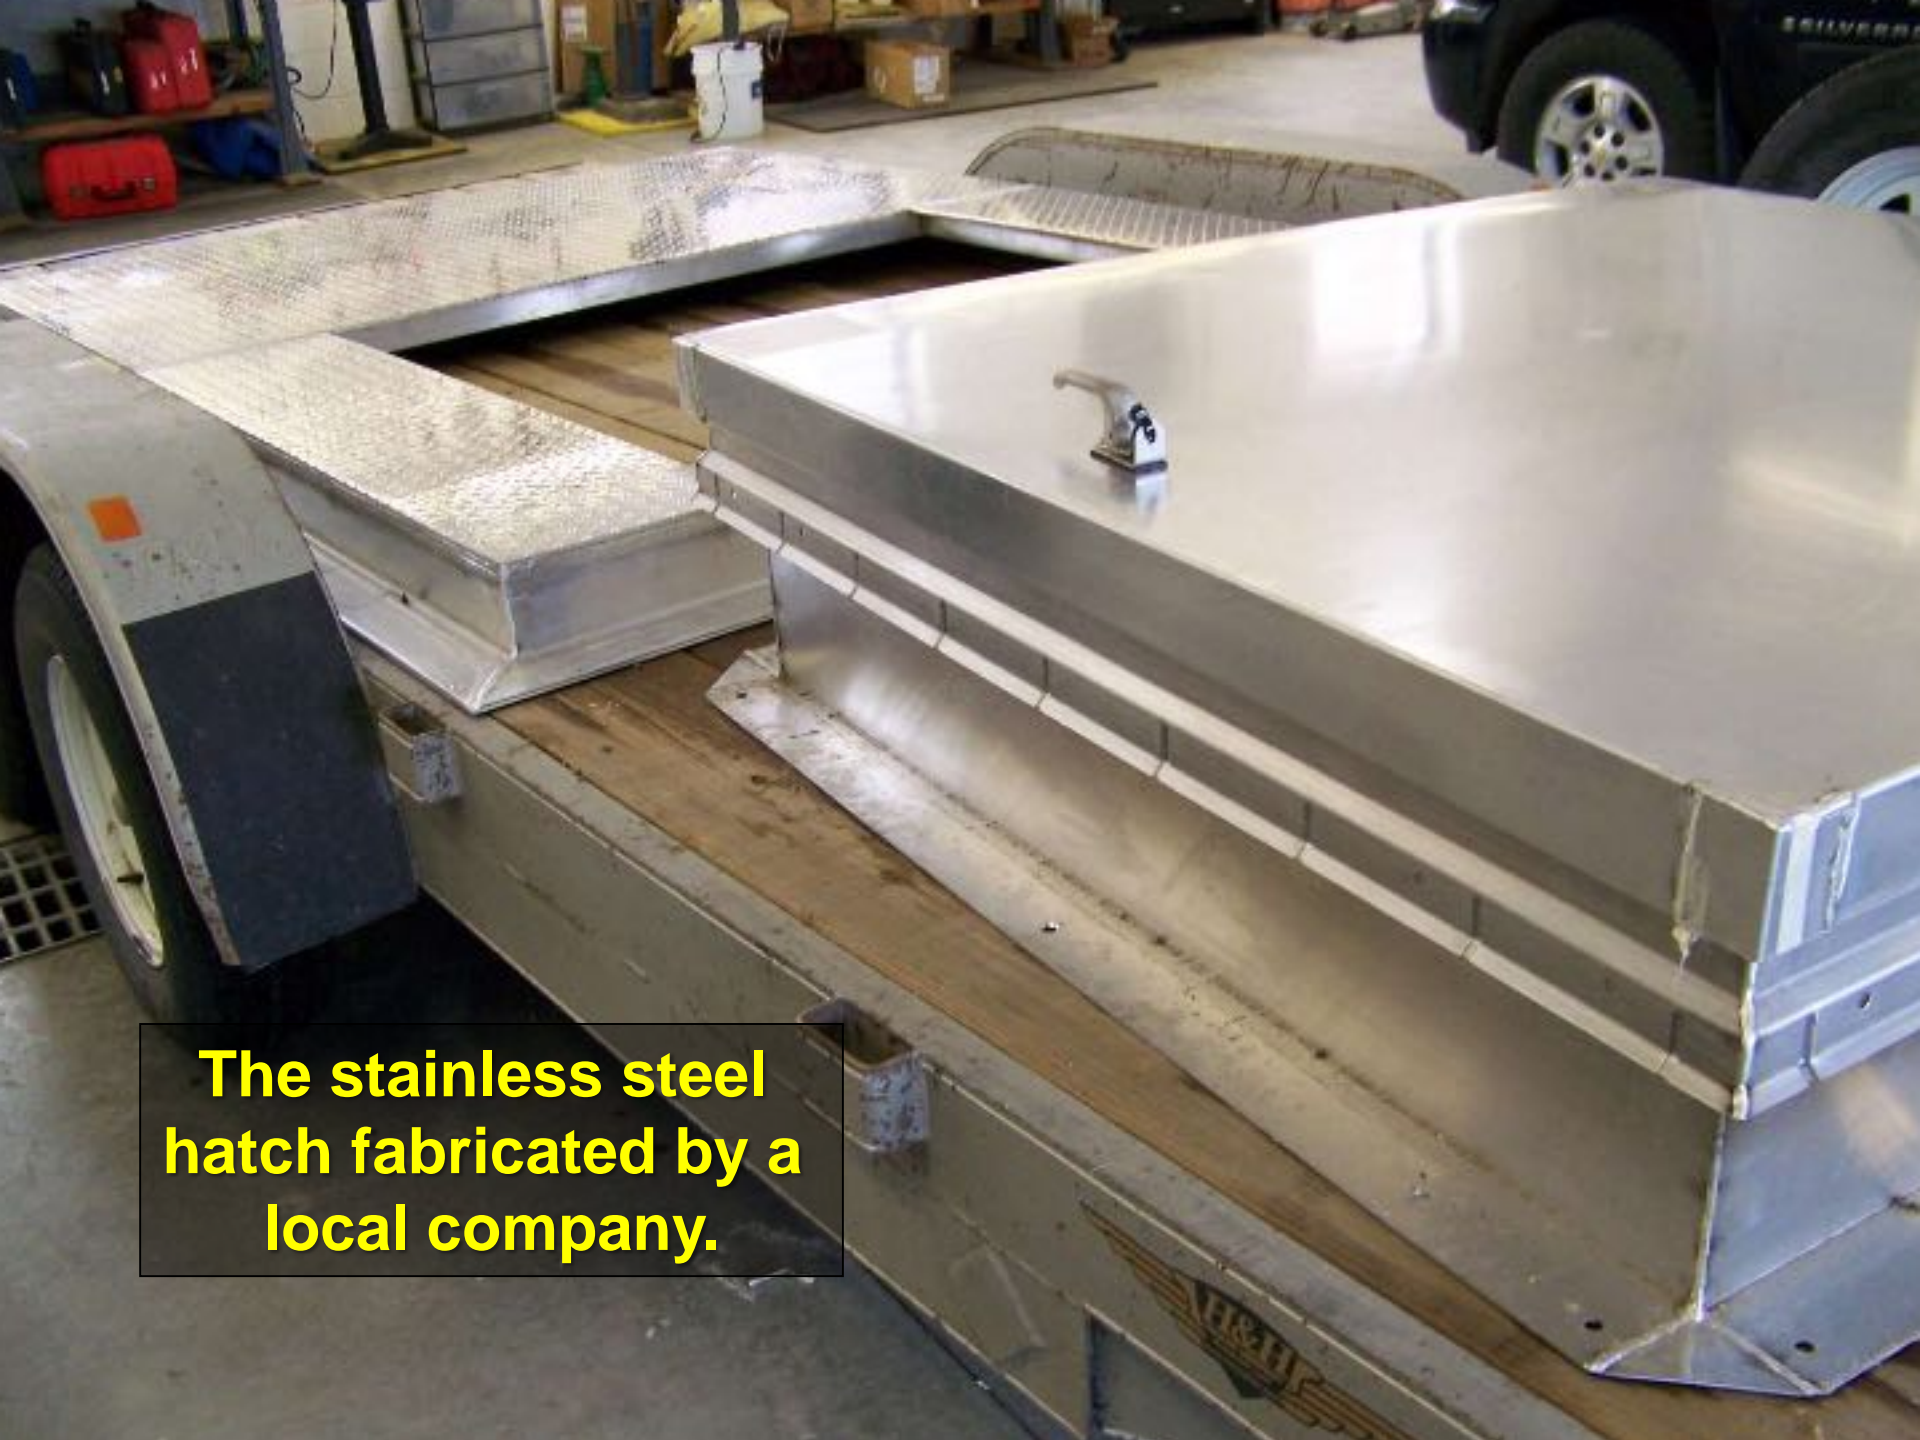
**The stainless steel hatch fabricated by a local company.**

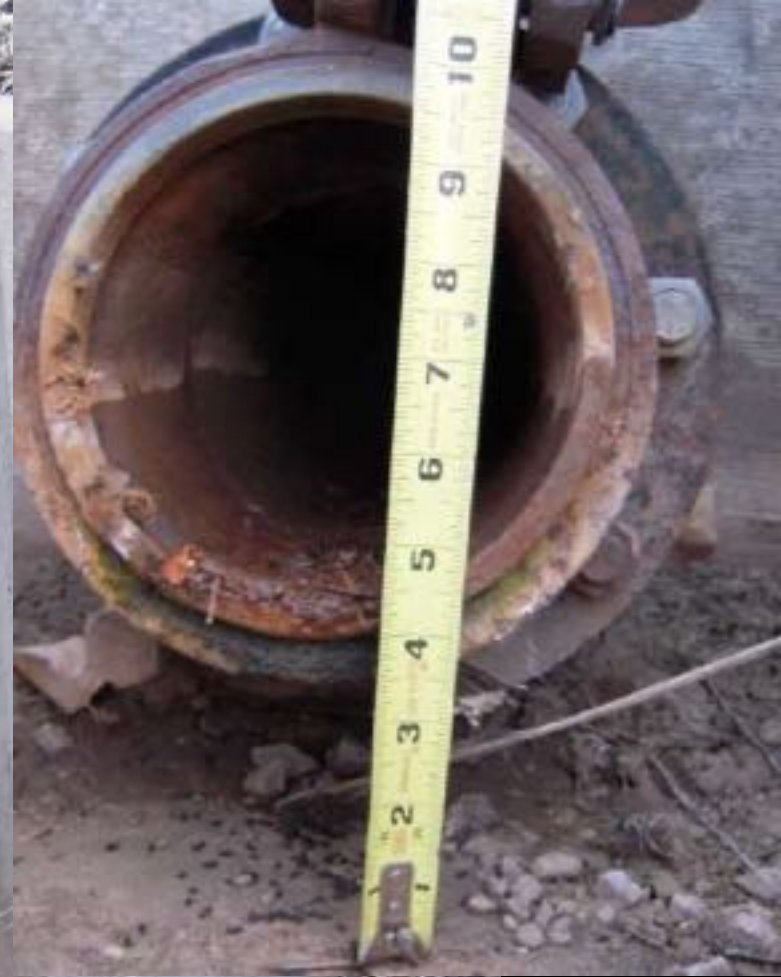
**Submerged drains should be regraded such that they are not submerged during a typical rain event and that water does not pool at the drain. Stagnant water is host to a broad array of microorganisms and is unsanitary. Any unsanitary condition at any tank component needs to be eliminated to reduce the risk of disease transmission.**

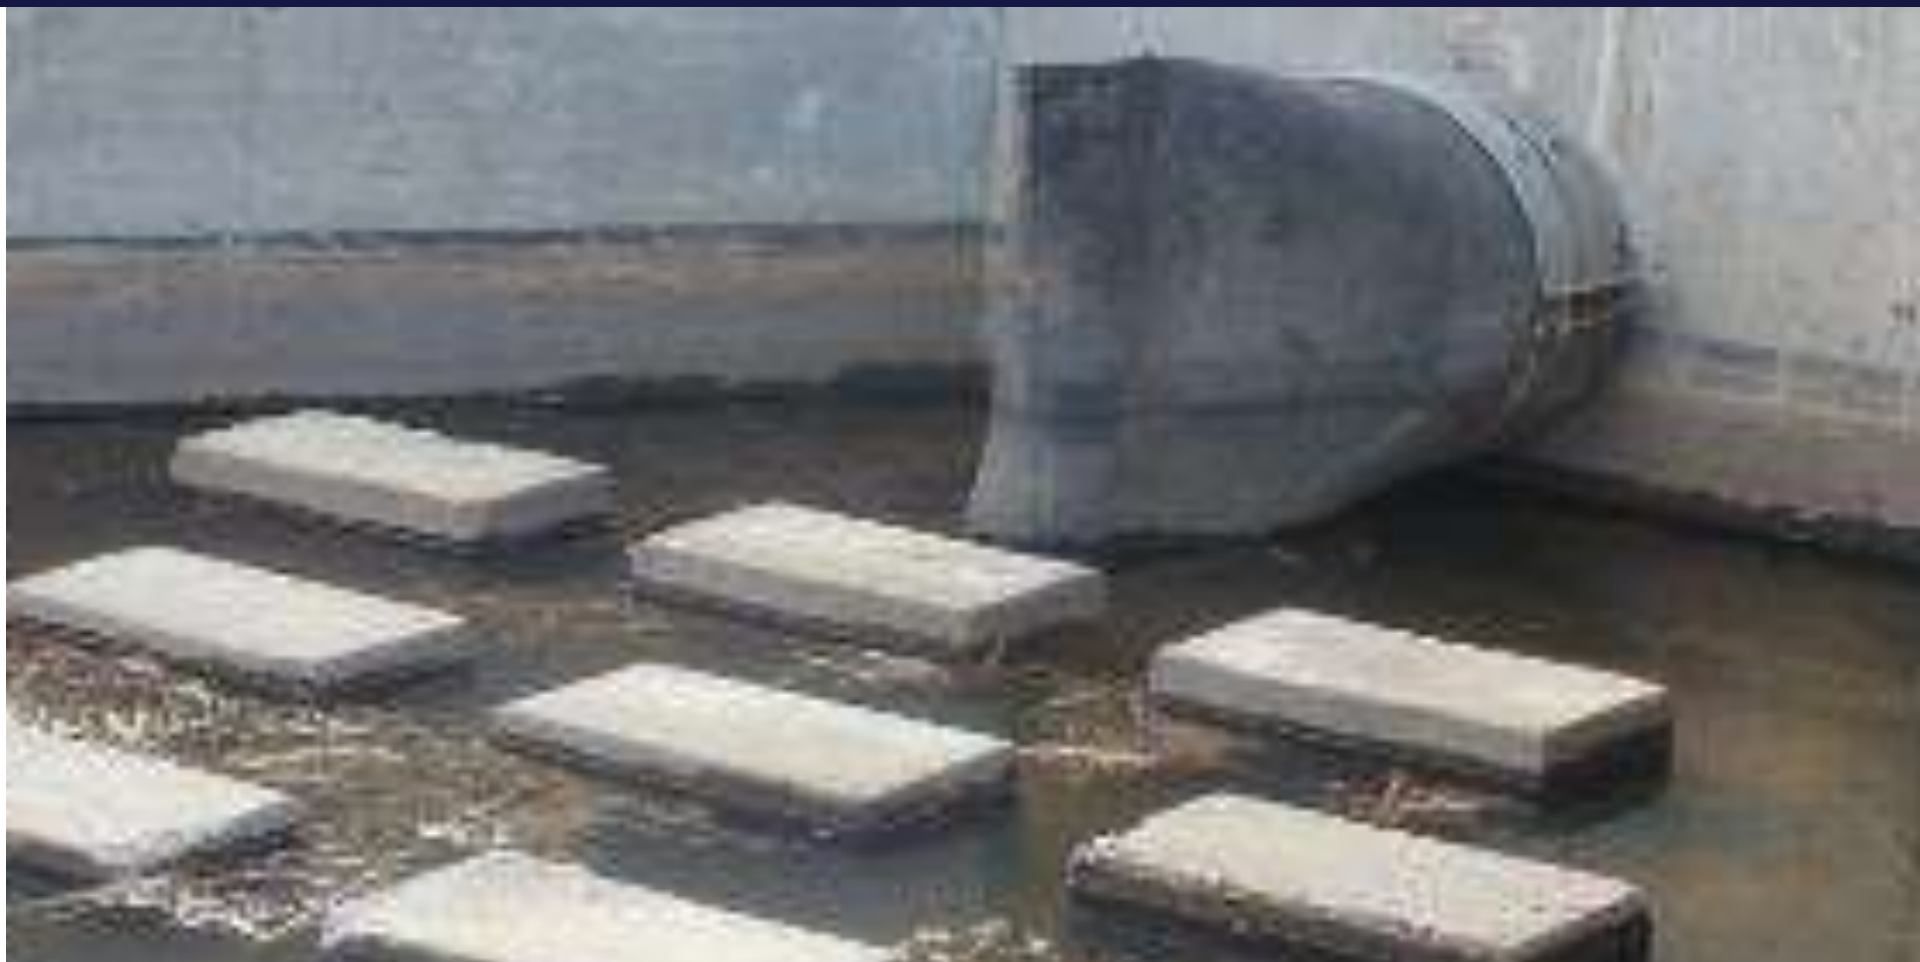
**Mouse droppings show the drain structure was a protected area for mice. If the flapper was propped open just slightly the mice could enter. No screen allows the mice to freely enter right up to the gate valve.**
